# Wind Turbine Lightning Protection Project

1999—2001

Brian McNiff  
*McNiff Light Industry*  
*Harborside, Maine*

**National Renewable Energy Laboratory**

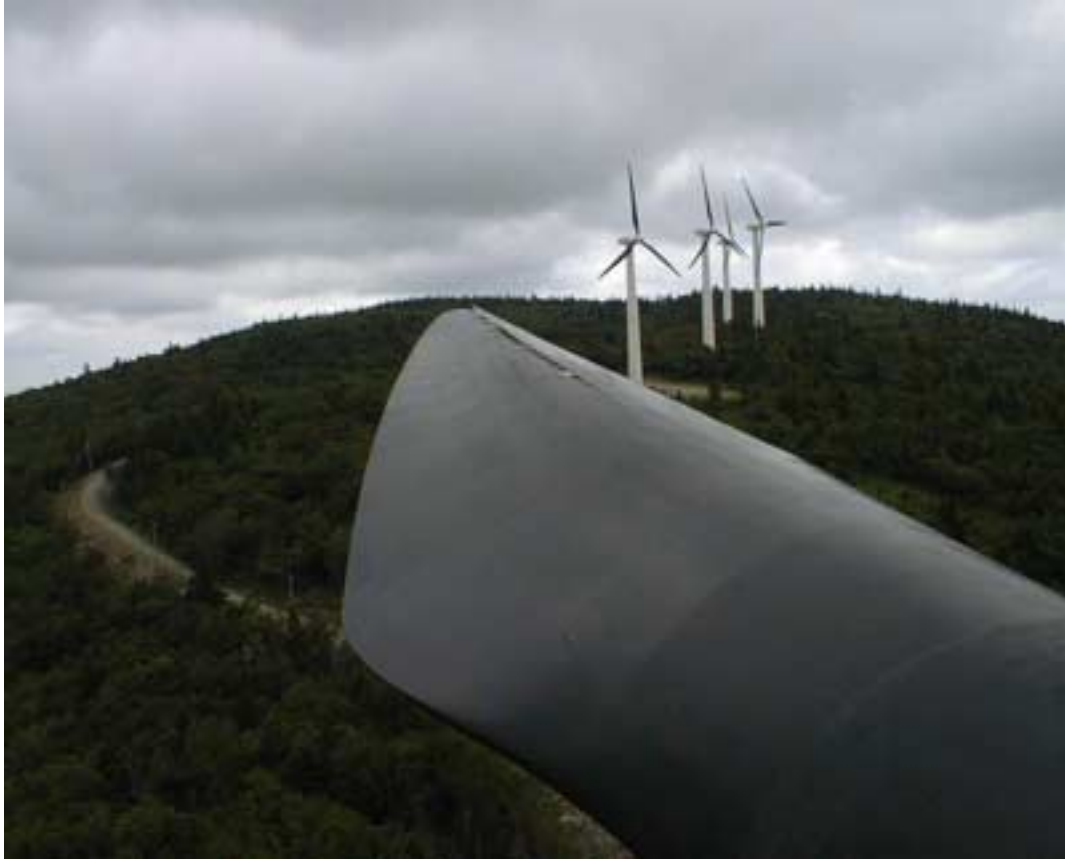
**Figure 3. Damaged Zond Z40FS blade at GMP site**

The Searsburg project suffered major damage to 3 turbines in July 1998. A picture of catastrophic blade damage to unit 7 is shown in **Figure 3**. This was removed and replaced by Zond. The blade damage on the other two units was repaired without removing the blades. The GMP Searsburg project also experienced several lightning-related problems in 1999, including extensive damage to a controller on turbine 1. At Algona, the primary lightning-related problem was a fault condition in such noise was generated on the serial communication line between the pitch controller and the main controller. In Springview, a blade was struck by lightning resulting in catastrophic failure, which Zond replaced quickly. At the same time, and on one other occasion, the turbines in Springview suffered damage to the controller and power electronics, which also took time to repair because spare parts were not available.

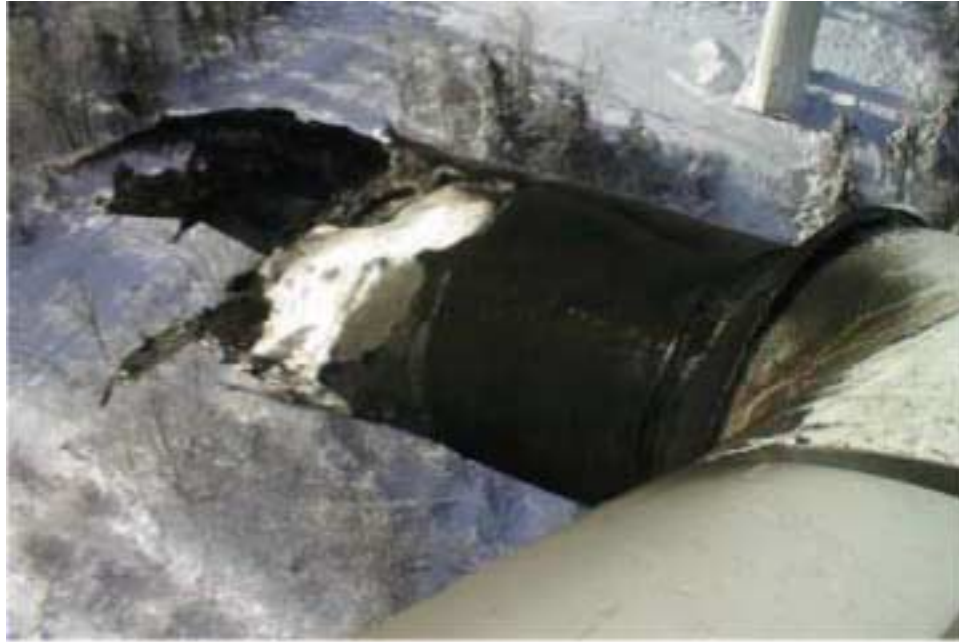
**Figure 4. GMP/Searsburg Z40FS blade strike damage**

The Searsburg site experienced a second blade failure from a direct lightning strike on January 11, 2000, as shown in **Figure 4**. The Big Spring project was not fully operational until late in 1999, so it is not included in these tables. Also, the Wisconsin turbines did not suffer any appreciable lightning damage or downtime, presumably because of the protection afforded by very tall communications towers nearby, integral blade protection (conductors), and good shielding techniques in the turbine controls.

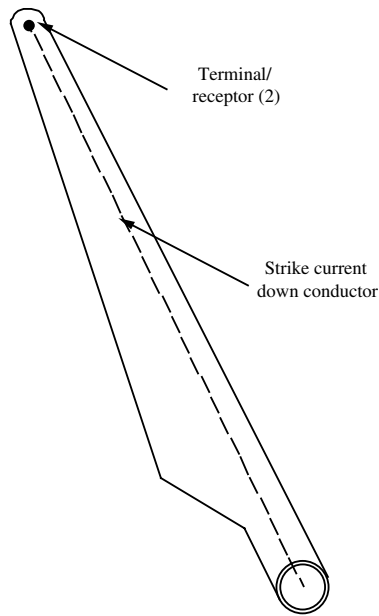
**Figure 5. Zond blade conductor retrofit**

One of TVP’s primary findings was that the Zond turbines had no blade conductors, except for the Z-40A, which has an aluminum push rod in the blade to actuate the ailerons. The Tacke and Vestas turbines both had blade conductors designed for lightning protection. Both of the Zond turbine models without blade conductors have suffered lightning-related blade damage. Zond developed and tested a retrofit for the Z-50 blades in early 2000, and installed conductors in Algona and Springview that spring. Schematically shown in Figure 5, Zond’s “Lightning Guard I” conductor retrofit consists of a copper tube fed through the interior of the blade, held in place with expanded foam blocks, and connected to surface-mounted air terminals at the blade tip and the hub.

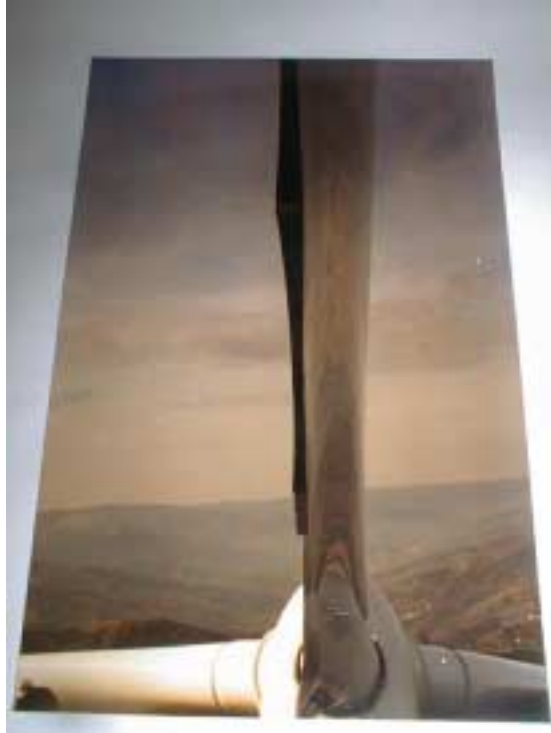
**Figure 7. IVPC/Vestas blade damage**

The lion's share of damage occurred on blades that have had to be replaced or repaired in the field. An example of typical blade damage is shown in Figure 7. Events that did not result in blade damage usually had some amount of downtime until the turbine could be inspected and the controller reset. In some such cases, sensors may have taken damage, but the repair cost was usually low compared to events with blade damage. It is interesting to note that as the population of turbines increased, the frequency of events experienced (per turbine) stayed in the same range of 6–8%.

IVPC estimated that *in situ* blade repair costs were about \$1900 including boom truck and labor. When a damaged blade was replaced, the cost was about \$45,000, and this included a new blade, half a day for a significant crane, and personnel time. Note that downtime is not included in these estimates.

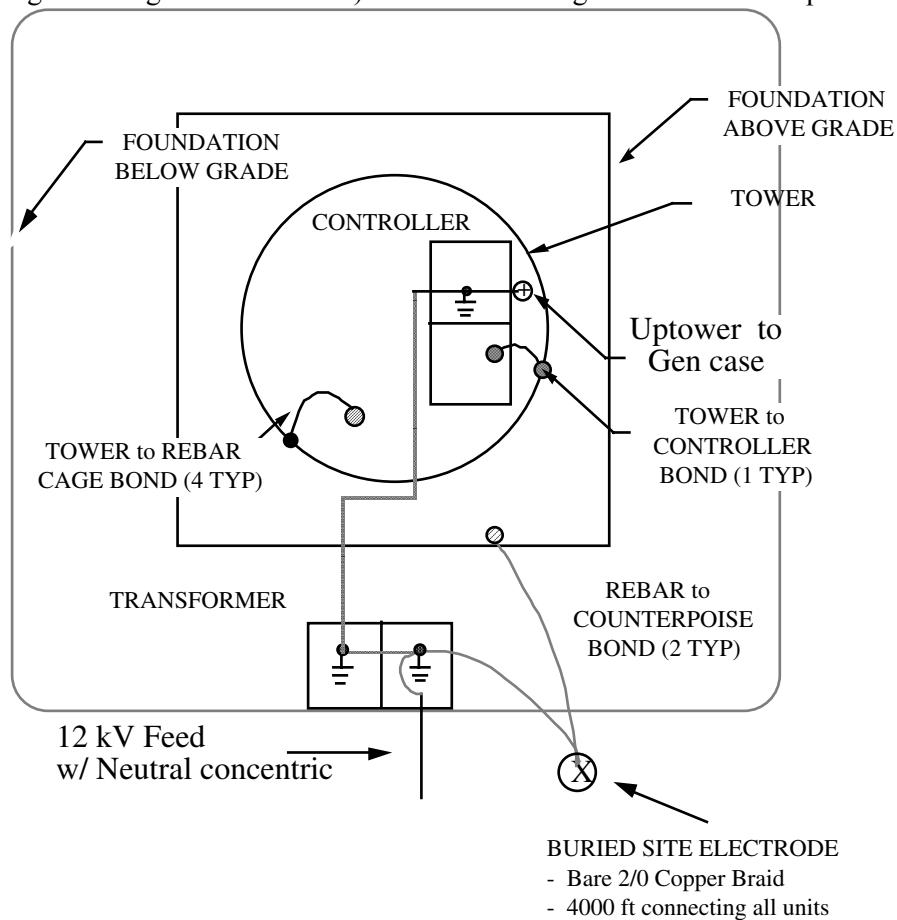
**Figure 10. GMP - Zond Z40 FS - grounding scheme**

1. Base control box has 4Ø insulated bond wire from its top to a near point on the tower.
2. Generator ground connects between ground bus in lower right of high-voltage (480 VAC) side of control box and the generator case (4Ø SO).
3. Generator ground also goes between generator case and tower at mid-section just below the droop clamp (4Ø SO).
4. Air terminal (lightning rod) is mounted above aft end of generator on nacelle cover (fiberglass) 1.5 m (5 ft) up. Lightning conductor is 4Ø SO bonded only at tower midpoint just below droop clamp (120° clockwise from generator ground conductor). Should bond to generator at closest point.

5. Ground straps (2Ø bare braid) bond between tower base and foundation rebar at 4 radial locations. All indications are that the rebar is not augmented with a Ufer ground (coil of copper braid at base of foundation).

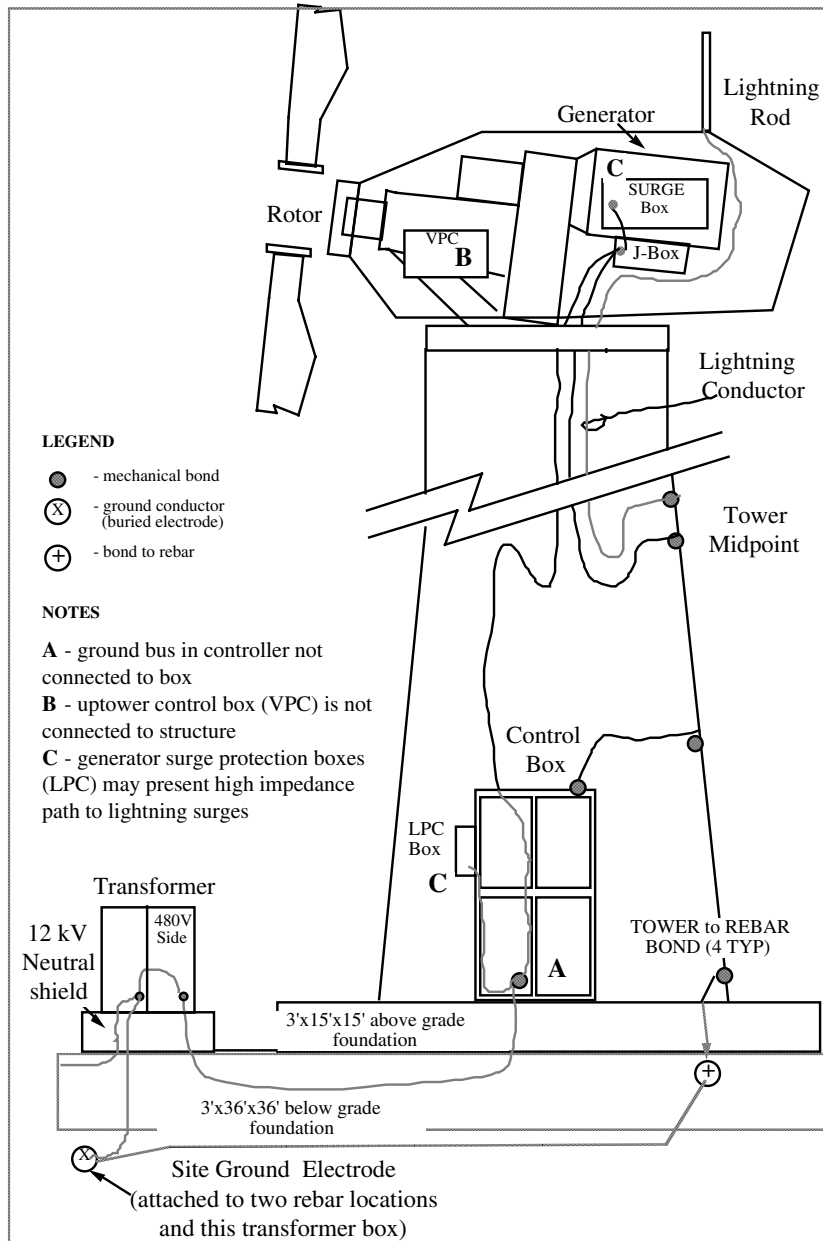
**Figure 11. GMP/Zond Z-40FS grounding and bonding**

7. Each turbine has a separate transformer (wye-wye, 12 kV to 480 V), and its primary is conducted with concentric neutral braids on all three conductors. These braids are terminated on a ground bus on the primary side of each transformer case. A bare conductor (2Ø bare braid) is buried in the feeder trench (direct burial in crushed granite and gravel) throughout the whole site to augment the ground. This is probably 1.2 km (4,000 ft) of buried conductor. All transformer ground buses are connected to this counterpoise by 2Ø bare braid.

8. This site counterpoise is connected to the neutral conductor coming up from the substation at the point of common coupling (a Y in the road where the feeder splits). It is also connected to the turbine

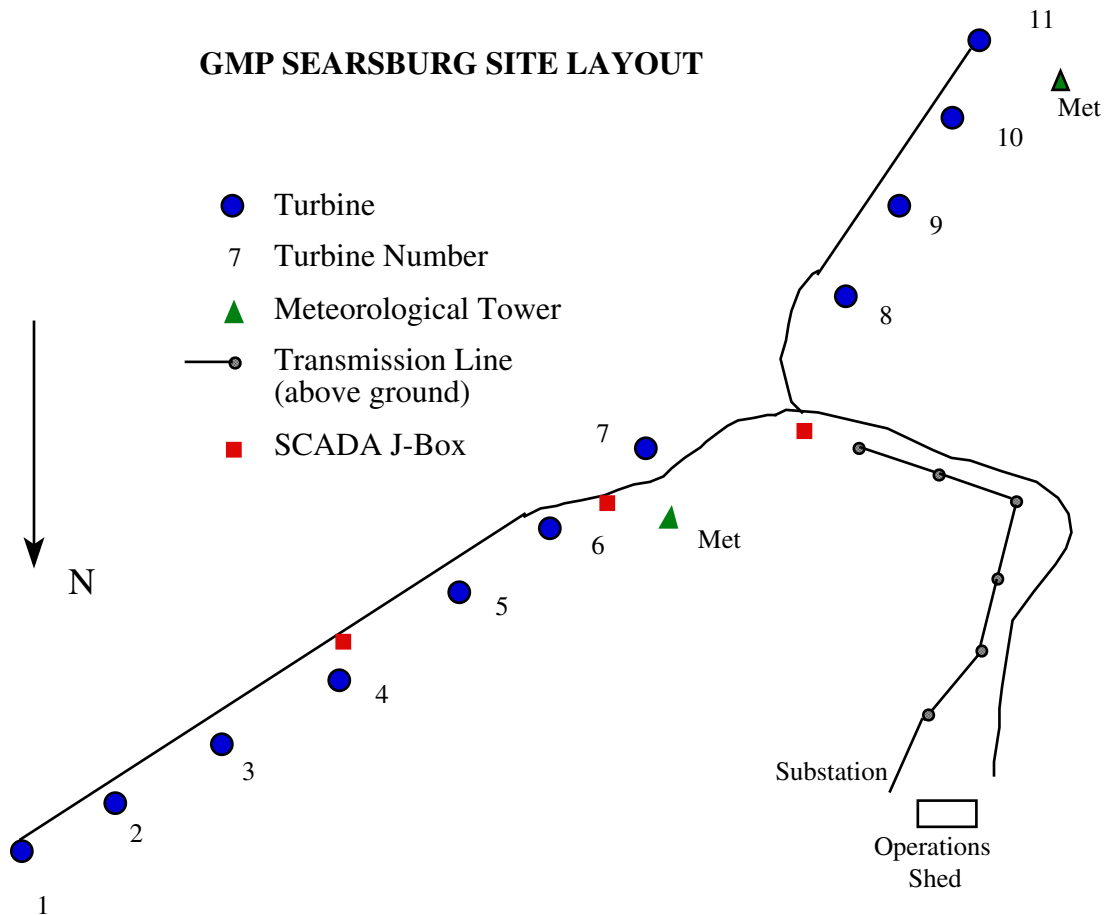
Figure 12. GMP site layout

1. Full foil shields on SCADA communication wires are not terminated to ground anywhere.
2. Pedestal junction boxes (near units 4, 7, and 8) have shields ganged together but not to ground.

3. The only protection for clamping surges is gas-tube, spark-gap arrestors, which still allow 200-V transients to continue to the modems and SCADA multiplexer. Spark-gaps exist at turbine and before SCADA computer.

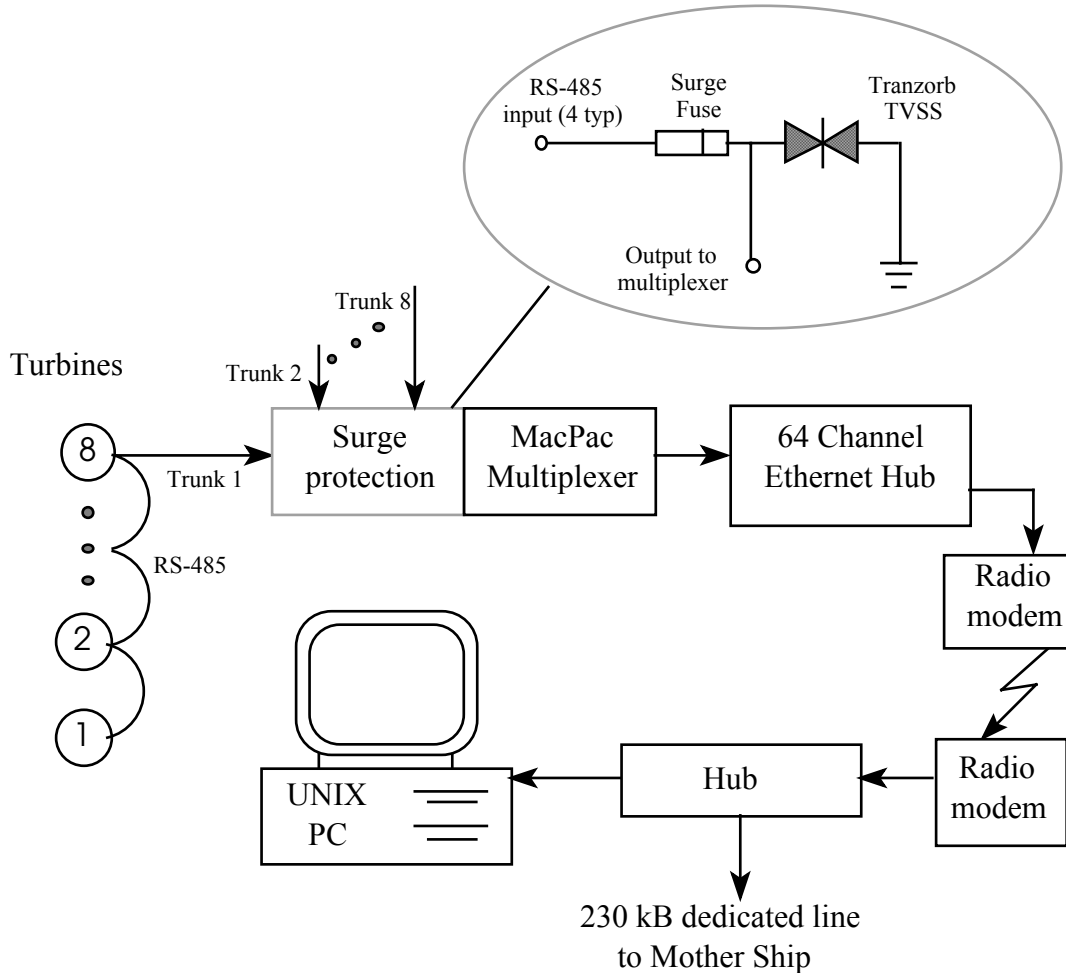
Figure 16. KVS-33 site communication system with surge protection detail

A SCADA system operates the turbines using a multi-drop serial connection to each turbine. This daisy chain approach included hard copper wiring throughout the site. The layout is described in Figure 16. This system has surge protection, but the wiring is not adequately protected from direct and indirect effects. It lacks good zone-by-zone protection methods, and site operators report that parts of the SCADA system are frequently damaged by lightning. This results in losing communication with turbine groups until it can be debugged. Damage is also frequently taken in the multiplexer inputs.

The system could be greatly improved by terminating the trunk line shielding at both ends and providing higher energy, but slower spark-gap devices in advance of the transient voltage surge suppressors (TVSS). Some impedance would be required between these two components in order to allow the spark-gap device to act before the cascading diode. Another TVSS across the transmit and receive pairs would also disallow any common mode differentials to pass damaging currents to the multiplexer components.

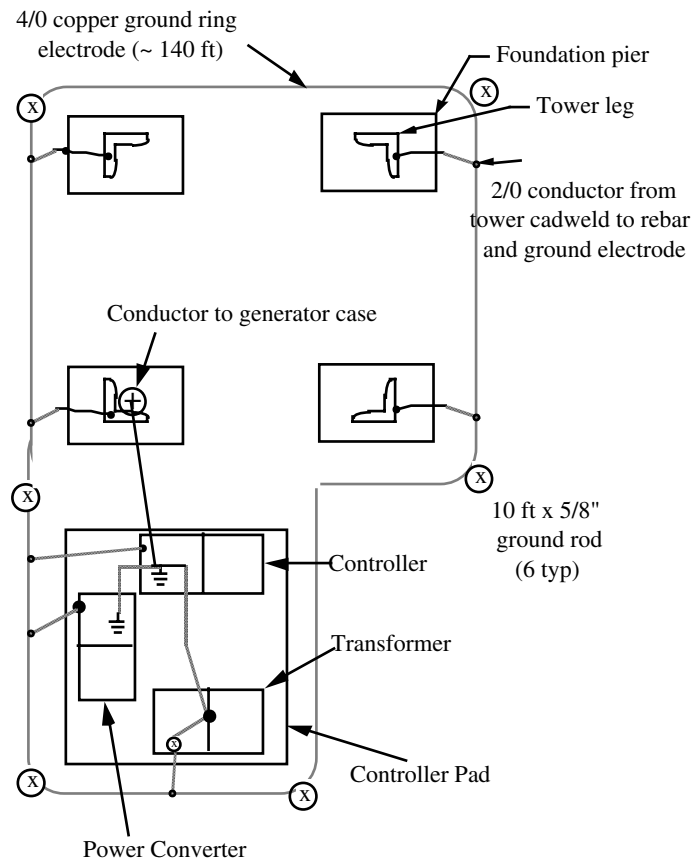
Figure 20. NPPD Z-50 grounding scheme

This arrangement allows for significant circulating current in the 480 VAC ground conductors. We solved this problem by removing the isolation mounts on the controller SPG and thereby bonding it to the control box.
