Controls Advanced Research Turbine: Lessons Learned during Advanced Controls Testing

K. Johnson, L.J. Fingersh, and A. Wright

Technical Report
NREL/TP-500-38130
June 2005

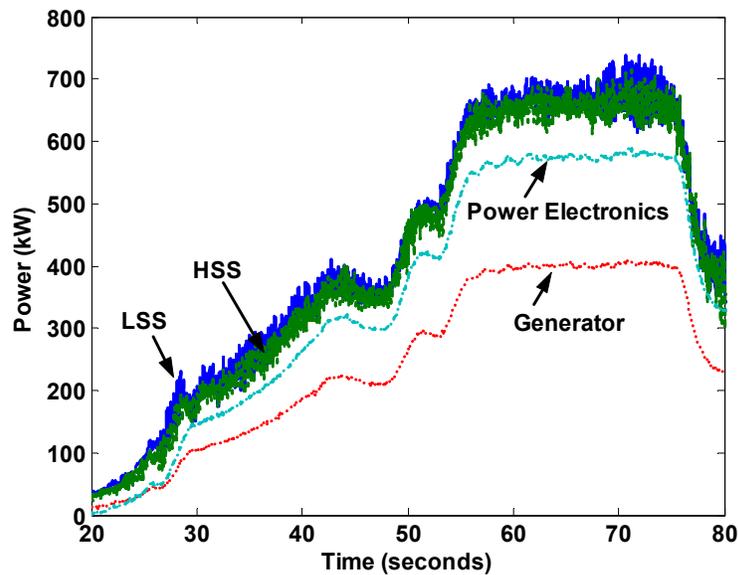
Figure 7. CART power data. The generator power curve is much lower than possible compared to the LSS, HSS, and power electronics power readings.

variable-speed testing. Because the power electronics were energized in variable-speed mode but not in constant-speed mode, and the erroneous HSS Prox readings corresponded exactly to the variable-speed operation, we concluded that the noise resulted from the power electronics. However, we were unable to shield the signal or find another means to eliminate the noise problem, so instead we stopped reading the sensor. The high-speed shaft speed was already being calculated from the high-speed shaft position encoder, so the HSS Prox sensor was really unnecessary.

Generator Power Sensor Failure. The cause of the generator power sensor failure is likely related to the power electronics as well, because the failure corresponded to the transition from constant-speed to variable-speed testing. We know the power sensor measurements are erroneous because they show lower generator power levels than those measured at the power electronics further down the line. The power electronics power measurements are consistent with the high- and low-speed shaft power measurements, given the expected losses. Figure 7 shows the four time-series power plots, with the power electronics power being nearly 50% greater than the generator power. Since it is impossible to create power between the generator and power electronics, the generator power sensor is clearly wrong.

Because both the HSS Prox sensor and Generator Power sensor are redundant, we spent less time trying to fix the problems than we would have if there were no other sensors performing the same or similar measurements. However, we caution that the data from these two sensors should be ignored in those data files in which it is present.

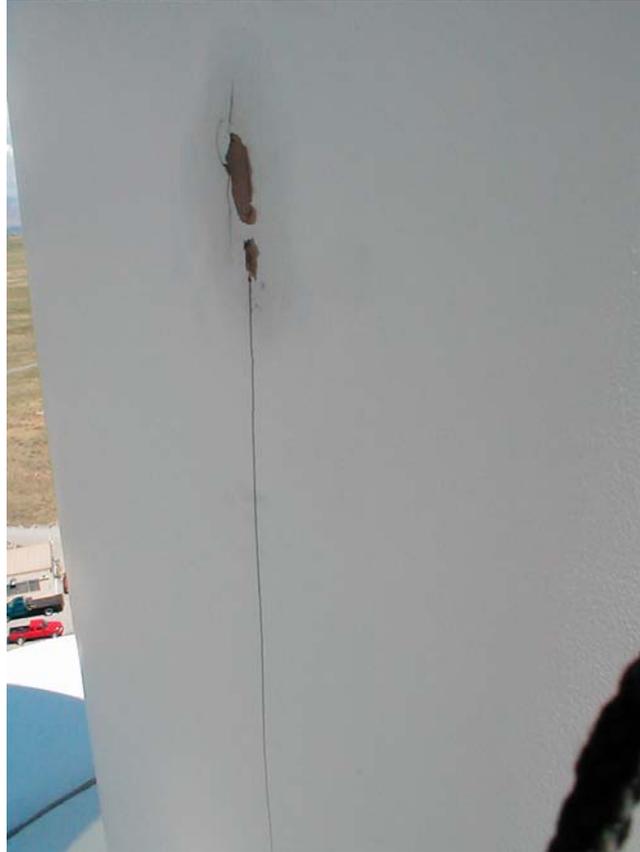
Blade Crack. Another problem we encountered with the CART was a crack in one of the blades near the root. Figure 8 shows the 59 cm crack, which we noticed during a routine inspection. While we do not know what caused the crack (i.e., a sudden event or wear and tear over time), we determined that the crack was only deep enough to damage the blade's external coating. After researching our options for repairing the damage, we decided that, as the crack did not pose a structural risk to the blade, it could be repaired by filling and covering it. We

Figure 8. CART blade crack. The total crack length is approximately 59 cm.

have run the turbine for more than a year since the repairs were completed and have seen no indicators that it has gotten worse.
