Accelerated Testing and On-Sun Failure of CPV Die-Attach

Nick Bosco, Sarah Kurtz, and Adam Stokes

National Renewable Energy Laboratory Golden, CO

NREL/PR-5200-49243

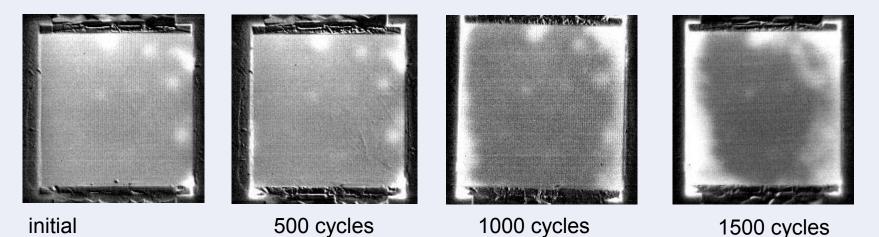
Thermal fatigue will cause die-attach cracking ultimately leading to cell failure via thermal runaway

infrared imaging of CPV cell through thermal cycling

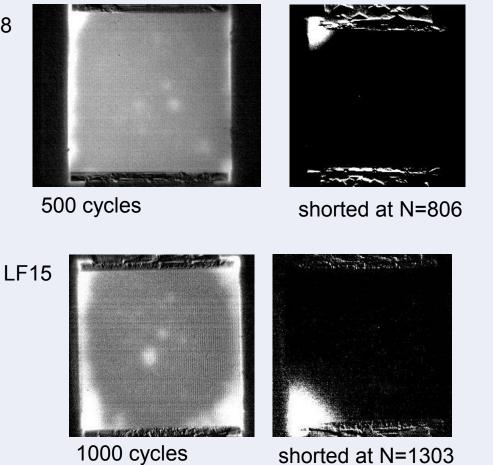
LF18

thermal cycling failures

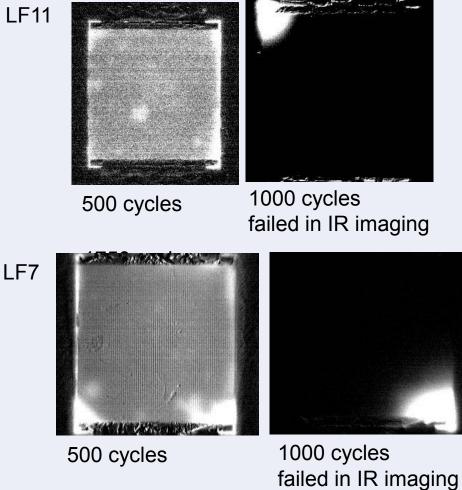
IR imaging failures

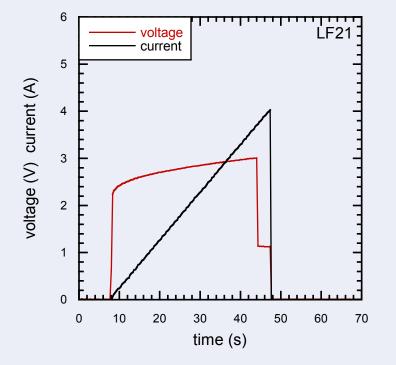
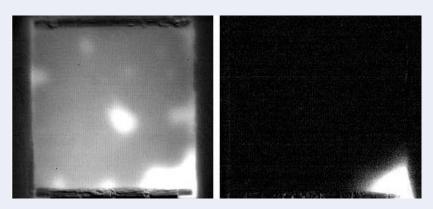
current ramp failures

500 cycles

Failed current ramp @ 3.4A

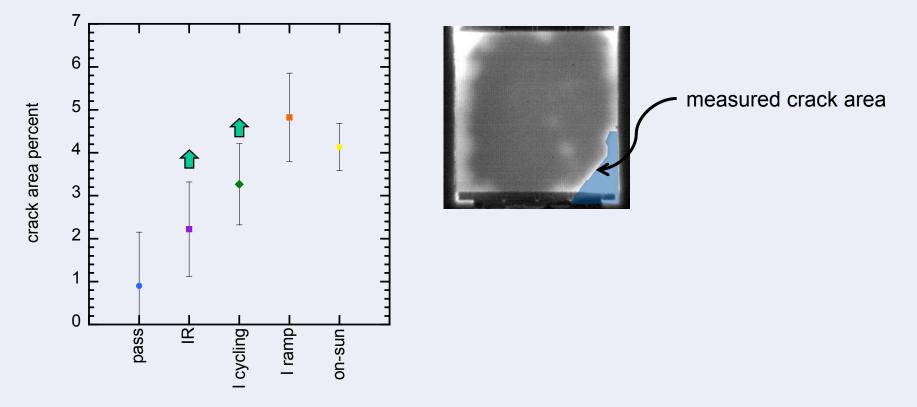
Summary of Results: sorted for increasing crack damage

IR imaging and shorted samples represent lower bounds to their crack area %

- 3 A current application for thermal cycling is benign to a healthy die-attach
- A corner crack ~3 area% of the cell is required to precipitate a representative failure.
- Die-attach damage severe enough to cause an on-sun failure is similarly detected via power cycling and the 4 A current ramp.
