# Performance Evaluation and Opportunity Assessment for St. Bernard Project

Bruce Dickson  
*IBACOS, Inc.*

June 2011

## **Technical Report: Performance Evaluation and Opportunity Assessment for St. Bernard Project**

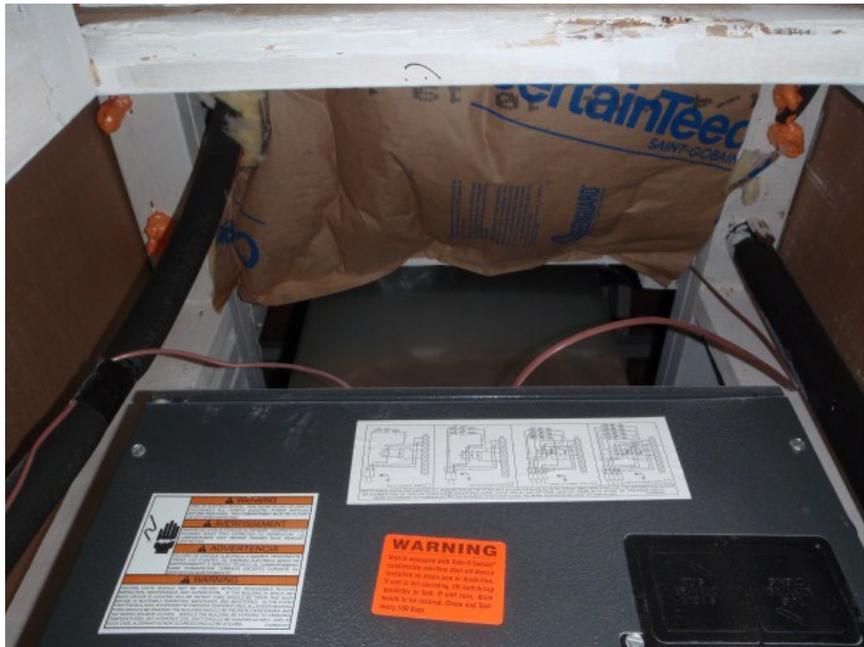
Not sealing the lid at the top of duct or other mechanical chases may lead to 1) increased utility bills for the homeowners due to decreased thermal performance, 2) comfort issues due to the unwanted exchange of air from unconditioned to conditioned spaces.

Figure 10. Photo of Open Mechanical Chase Lid

The best method to seal duct chase lids is to install a panel product over the top of the chase and then cut the duct penetration through. This enables the installer to create a better fit through the lid and makes it much easier to seal. Fiberglass chinking is minimally effective in preventing the passage of air and so should not be used for air sealing. Expanding foam is the most effective sealant to use at this location.

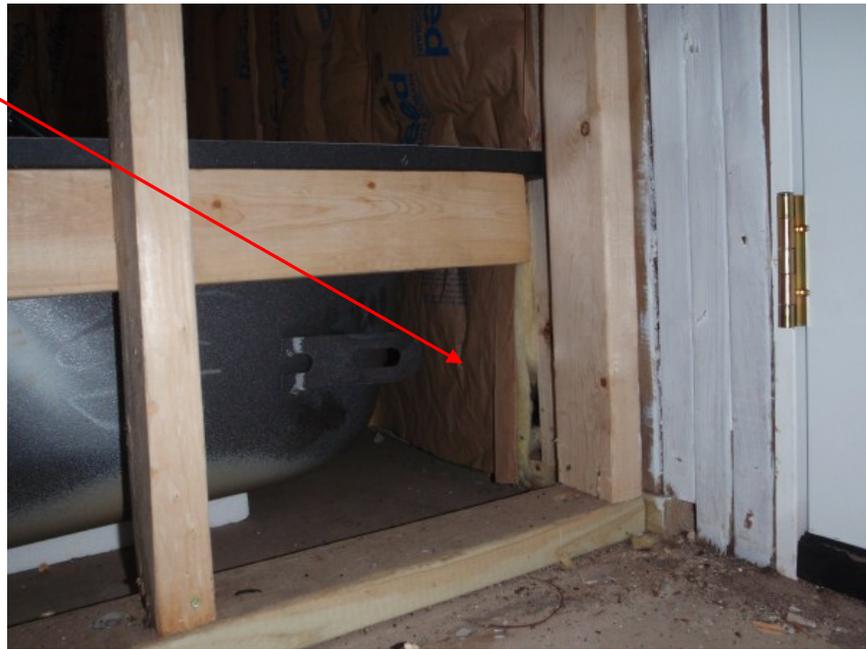
Exterior walls behind tub and shower units are insulated but did not have any type of sheathing installed over the insulation to prevent drafts and convective air currents.

Figure 12. Photo of Missing Draftstopping

A convective loop occurs when air rises along a warm surface and falls along a cold surface creating a circular movement of air. Such a loop transfers heat through the building assembly, requiring more energy to replace the lost heat in heating seasons and the lost cool air in cooling seasons.

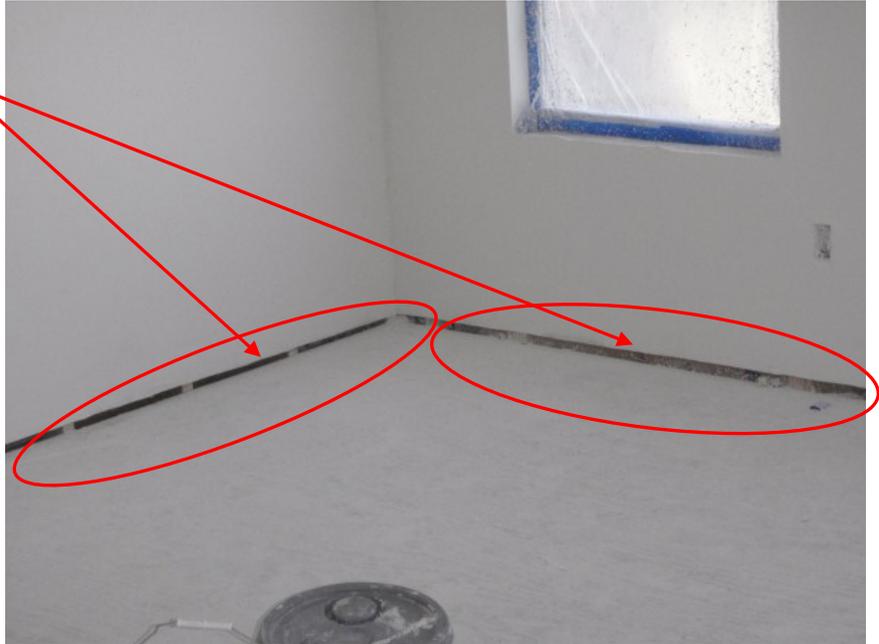
In homes with ceilings that are taller than the standard 8 feet a large gap was left open at the base of walls. While baseboard will cover this area it will still permit air infiltration or exfiltration if left unsealed.

Figure 14. Photo of Drywall Gaps

Gluing the drywall to the perimeter framing will greatly increase the overall effectiveness of the insulation and air barrier.

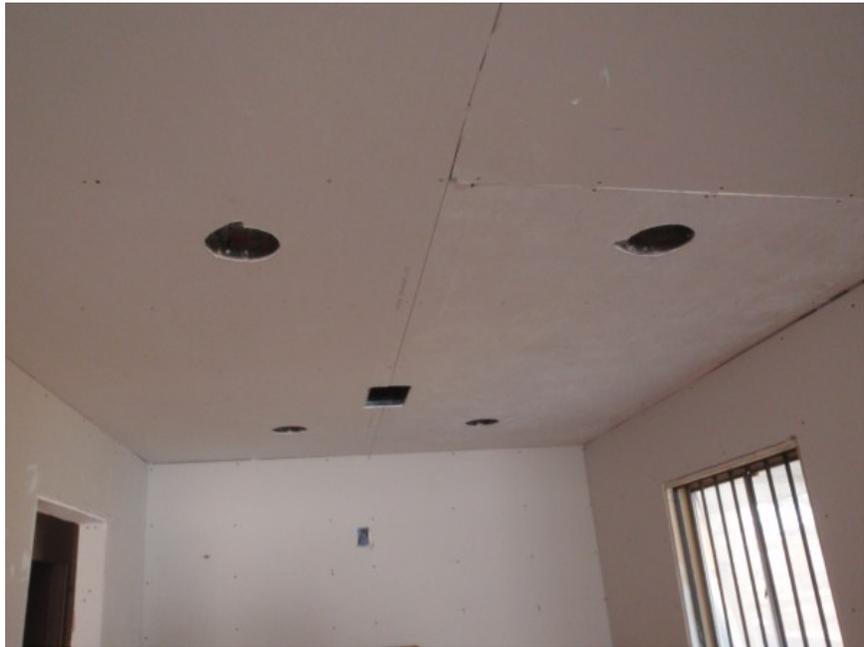
Figure 16. Photo of Recessed Light Fixtures

Drawing showing the location of sealant between the trim ring and finished ceiling.

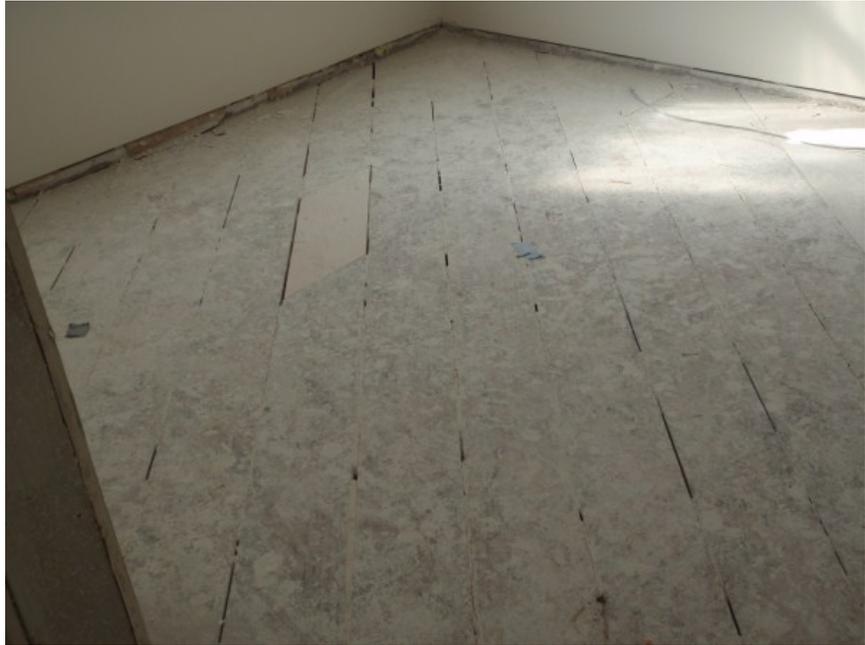
Establishing a continuous and thorough air barrier between the thermal shell and outdoors is critical to the overall efficiency and comfort of the indoor environment. This open plank floor should be addressed and sealed with a panel product on the top surface or a continuous spray foam seal from beneath prior to installing the finished flooring.

Figure 18. Photo of Open Plan Flooring

The most effective insulation and air sealing solution at framed floors on open pier foundations is to use a wash of closed cell foam over the entire underside of the floor system.

As an alternative, sealing the joints in the floor boards with canned spray foam and scraping the excess off once cured is an acceptable approach that requires additional labor and time.

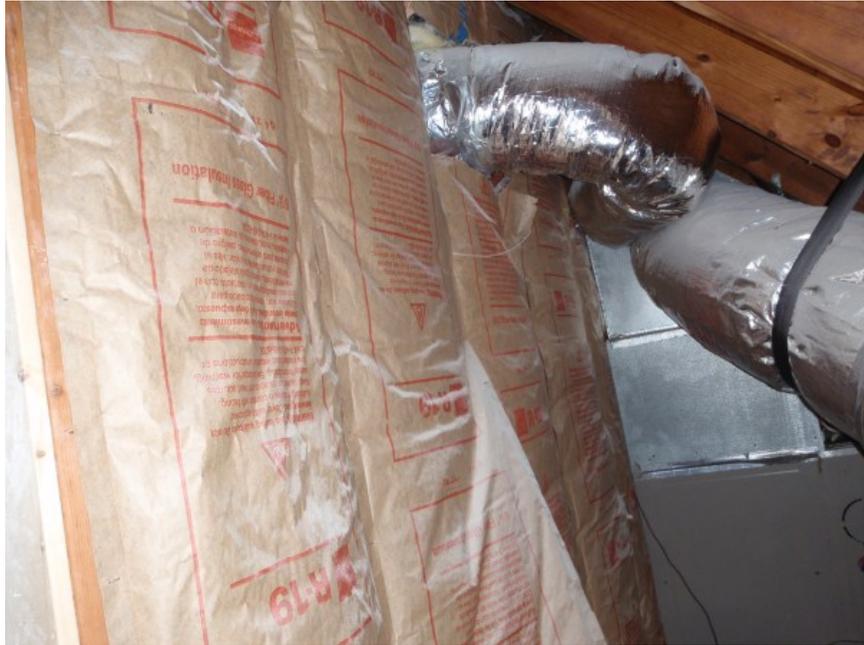
At locations where insulated walls are adjacent to unconditioned attic space, the attic side of the wall should be sheathed, both to improve the airtightness of the wall assembly and to fully encapsulate the insulation so that the proper R-value is achieved.

Figure 20. Photo of Unsheathed Attic Knee Walls

Sheathing the attic side of all kneewalls will ensure the batt insulation within the walls is encapsulated on all six sides. This will also ensure the effectiveness of the thermal envelope by preventing convection loops in the insulation.

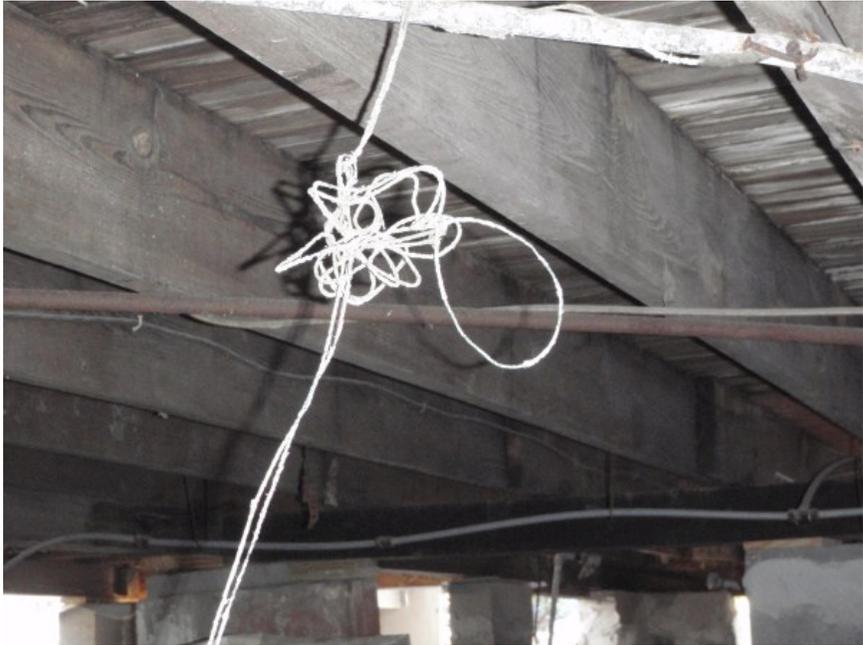
A consistent strategy to maintain the thermal boundary at raised floors on open pier foundations needs to be established.

Figure 22. Photo of Uninsulated Raised Floors

The most effective insulation and air sealing solution at framed floors on open pier foundations is to use a wash of closed cell foam over the entire underside of the floor system. Thickness of closed cell foam will be dependent on desired R-value of the floor system.

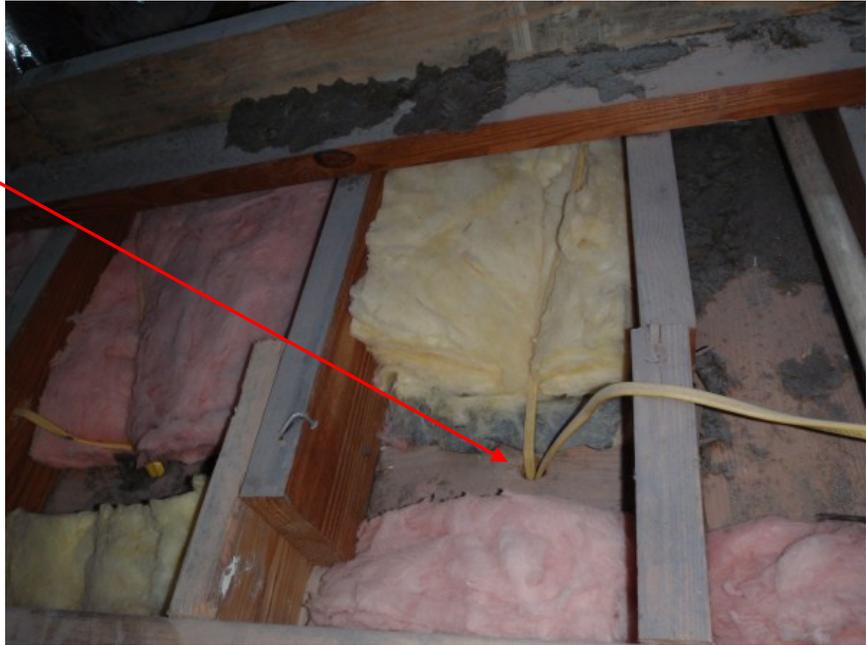
Instances of missing insulation and air sealing at penetrations were observed in most attics.

Figure 24. Photo of Missing Attic Insulation at Ceiling

The best practice at attics is to inspect the attic before insulation to ensure that all penetrations are sealed and then use a loose fill fiberglass blown in insulation (R-30) over the entire attic floor.

Due to the moisture retention capabilities of cellulose insulation, fiberglass fill is recommended for the hot humid New Orleans region.

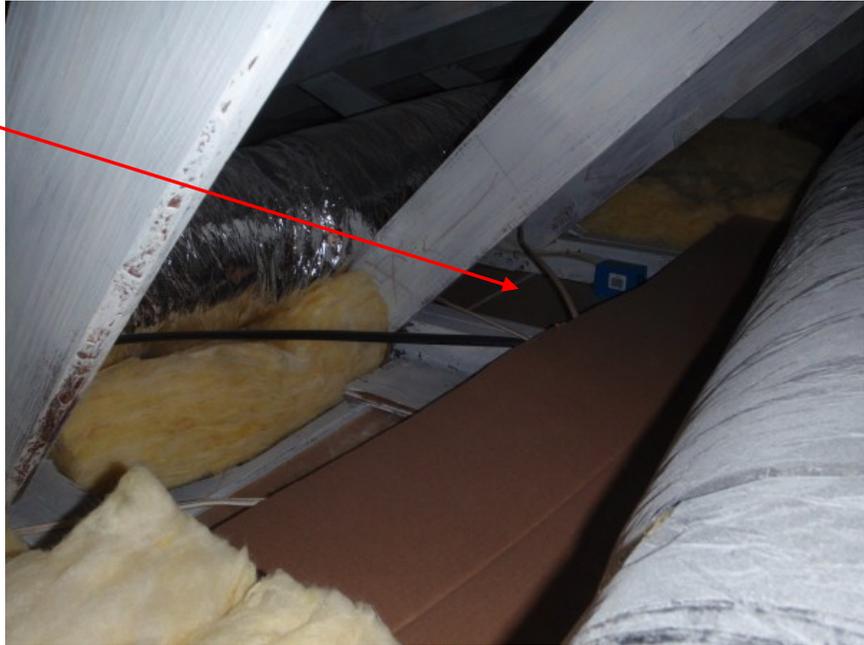
Another instance of missing insulation in the attic.

Figure 26. Photo of Missing Attic Insulation

An alternate method of insulating the attic would be to insulate against the roof deck with closed cell foam. This practice provides a total air seal and thermal boundary that minimizes the extreme temperature effects on the air handling equipment and ductwork.

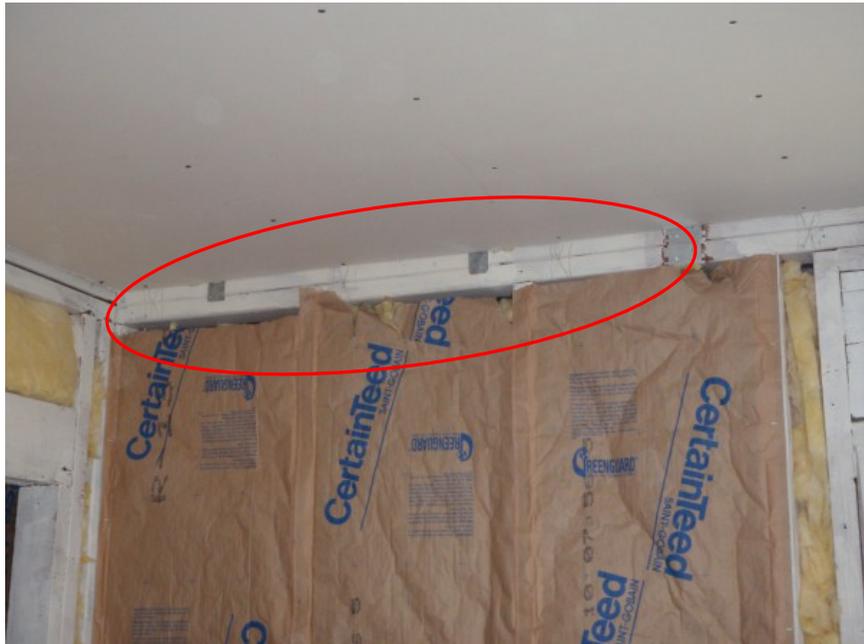
The use of Kraft-faced batts is not recommended for hot and humid climate regions. The use of unfaced batts is the better approach that will provide more drying capability to the wall assembly.

Figure 28. Photo of Short Kraft Faced Fiberglass Batts

Use of fiberglass insulation without any vapor barrier allows the wall assembly to breathe and dry to the inside. Additionally, it is far easier to do a thorough installation with unfaced batts.

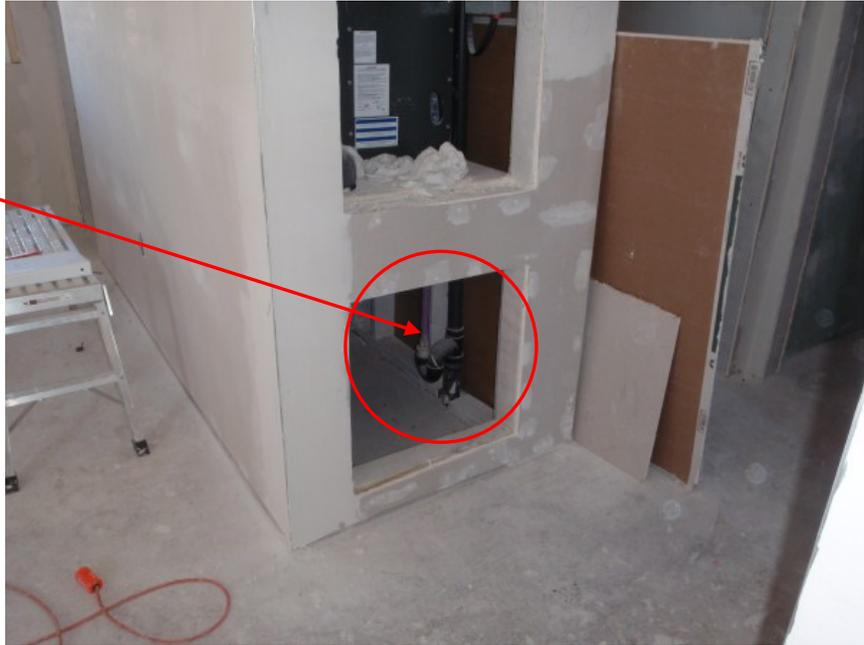
Panned, or using framing cavities for duct return systems are inherently difficult to seal and tend to draw air from building cavities instead of living spaces which may lead to comfort and efficiency issues.

Figure 30. Photo of Panned Return

Building a sealed return plenum box beneath the air handler is the best way to maximize the return air capability of the unit and ensure that the air is coming from the living space instead of framing cavities or the attic.

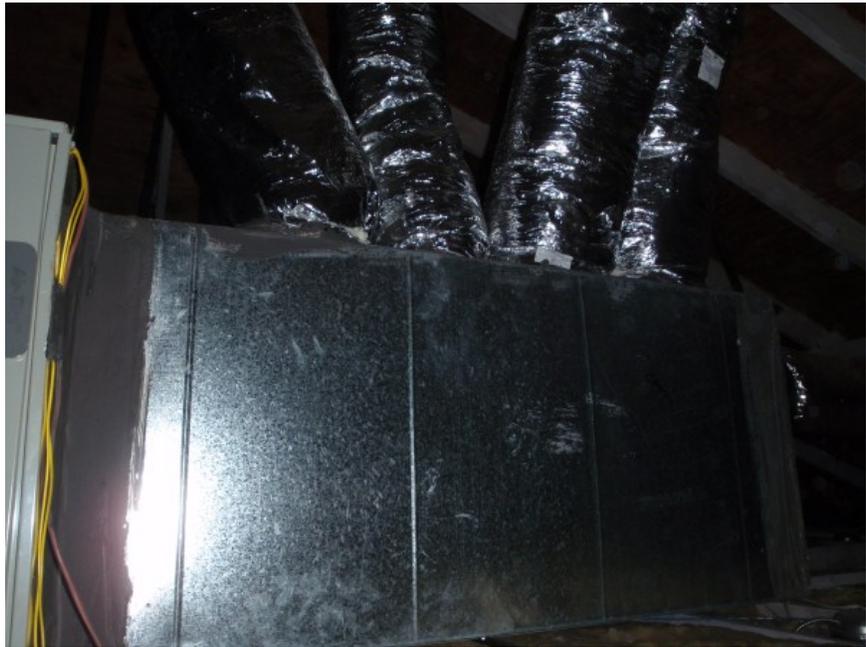
Many of the duct systems that were observed did not seem to have any definitive sizing strategy. Duct systems that use similar size branch ducts may not deliver the necessary air amounts to certain rooms. This practice may result in comfort and efficiency issues that a homeowner will compensate for by adjusting the thermostat.

Figure 32. Photo of Identically Sized Ducts

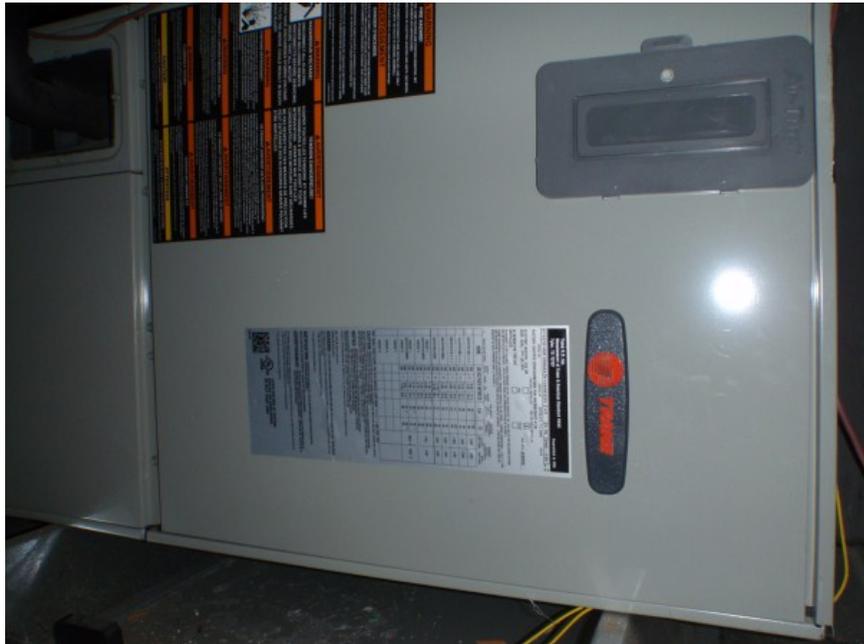
Figure 34. Photo of Oversized HVAC Equipment

Sizing of air handlers and cooling system should be verified to Manual J loads on each dwelling. This will maximize efficiency and allow better humidity control and comfort within the living spaces.

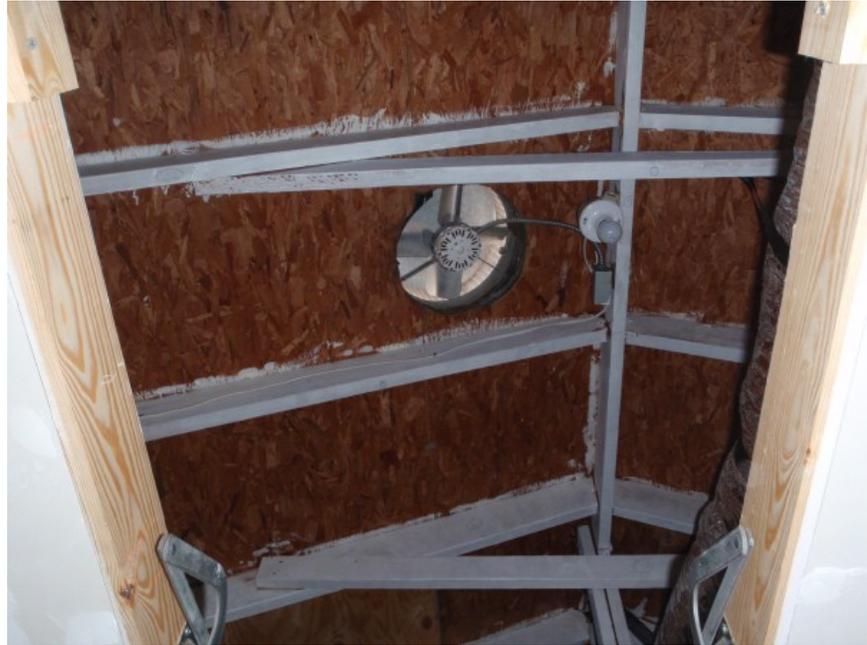
Concerns regarding attic exhaust fans exist due to the lack of a comprehensive and thorough air sealing between the attic and living space. Without a tight air barrier, the attic fan can pull conditioned air from the living space and induce air intrusion from outdoors.

Figure 36. Photo of Attic Exhaust Fan

Installing the appropriate soffit and either ridge or off ridge venting to remove excess heat from the attic is a better practice than the electric exhaust fan due to the impact on the living space that the fan can induce.

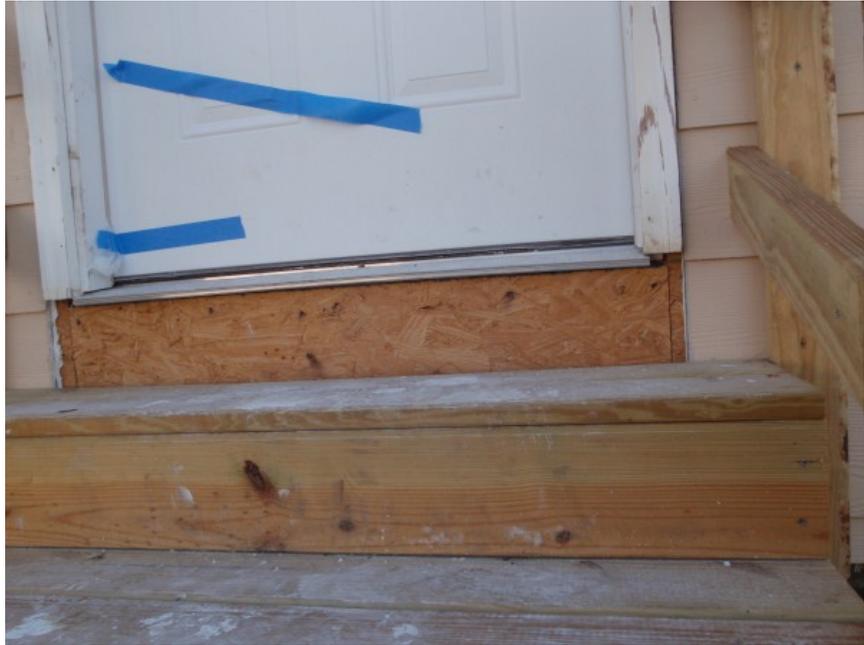
No comprehensive flashing strategy was observed at exterior entry doors. Standardizing a complete strategy that includes a pre-formed sill pan beneath the threshold and integrating the sill pan with self-stick flashing at the jambs and head will insure a weather tight assembly.

Figure 38. Photo of Missing Door Flashing

Example of a pre-formed sill pan beneath an entry door with the front lip extending out and over the drainage plane.

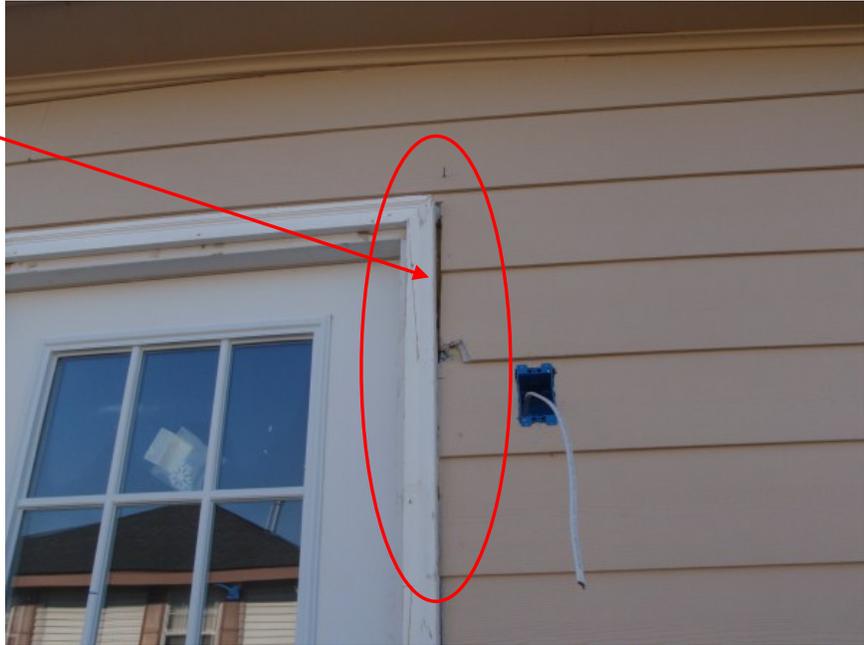
No comprehensive flashing strategy was observed at entry doors.

Figure 40. Photo of Missing Door Flashing

Standardizing a flashing strategy for new door installations that includes a sill pan beneath the threshold and properly applied self-stick flashing and drip edge over the head will minimize any potential for water intrusion at doorways.

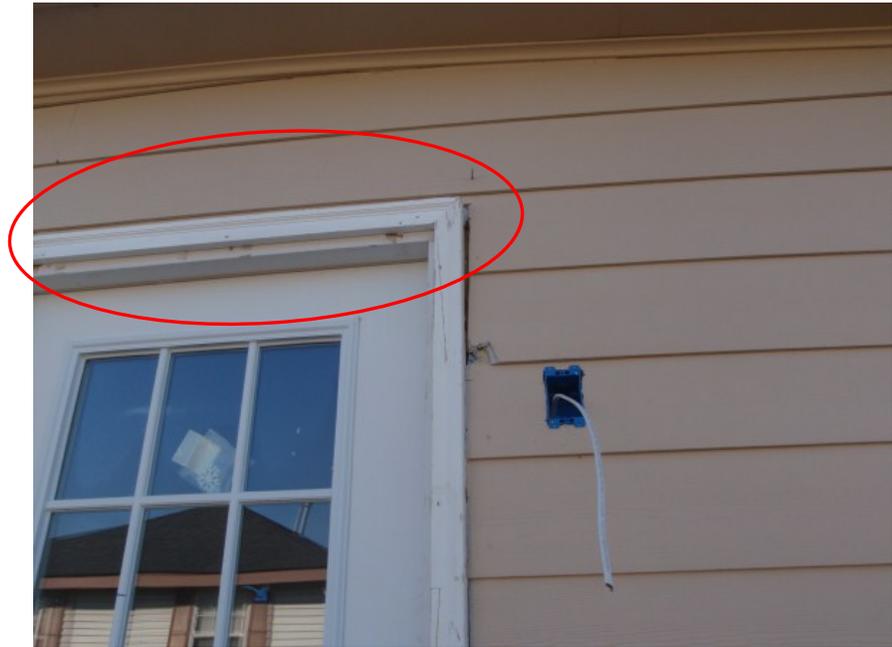
No “z” flashing or drip edges were installed on the brick mould over the heads of doors.

Figure 42. Photo of Missing Drip Cap at Door Head

Extend the drip cap 1" past the jamb on each side.

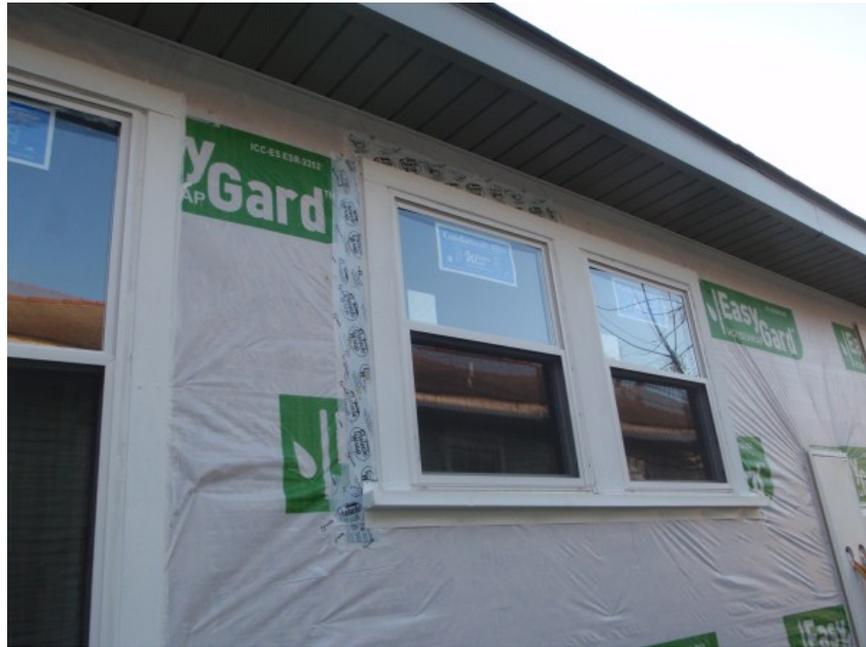
Self-stick window flashing was observed on exposed windows. Often the flashing pieces were mis-lapped with one another and did not maintain the shingling effect.

Figure 45. Photo of Mis-lapped Window Flashing

Flashing should start at the sill with the side jamb pieces layering over the sill and the head over the jambs. Cutting 2 angle cuts in the house wrap at each corner of the head and creating a flap that can be folded over the flashing and taped is the best strategy at maintaining the shingling effect when flashing windows.

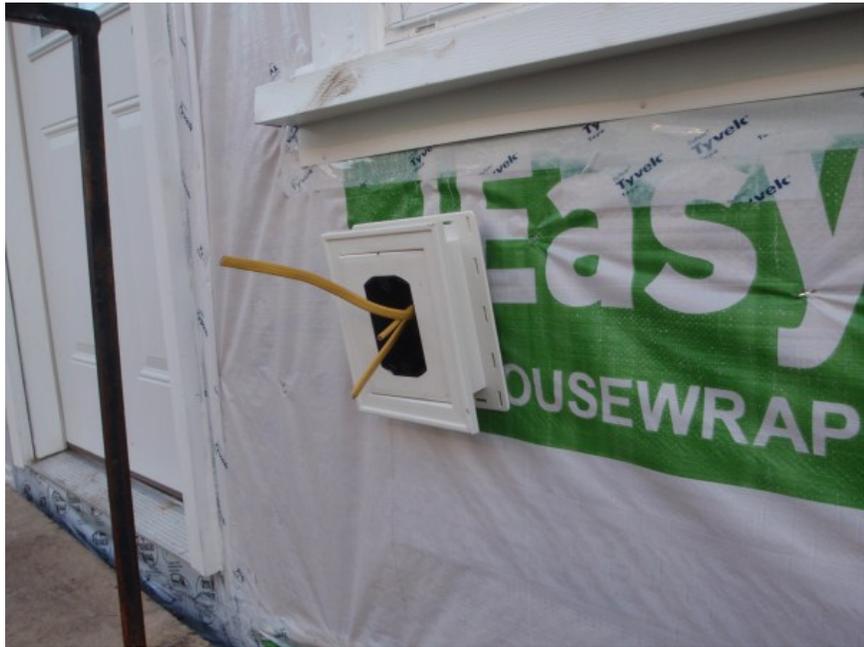
Wire penetrations and decorative trim boxes are common leak points if not detailed correctly.

Figure 47. Photo of Unsealed Wall Penetration

Utilizing self-stick flashing in the proper shingling sequence will minimize any potential for water intrusion at these locations.

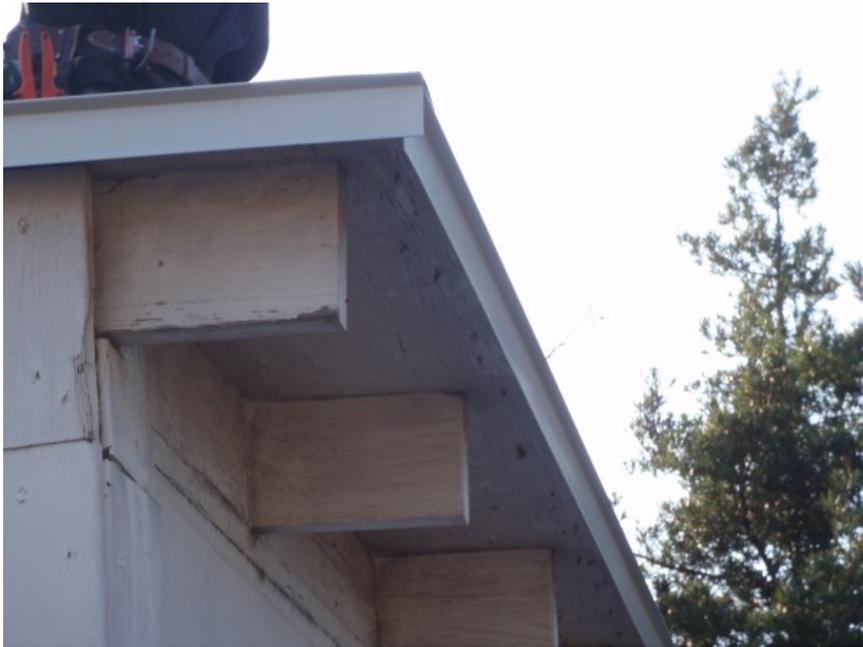
Inconsistent practices were observed at drip edge applications at roof edges. The drip edge should be installed directly against the roof deck at the eave followed by the underlayment paper followed by the drip edges on the rakes. This layering sequence maintains the shingling effect to the gutters.

Figure 49. Photo of Improperly Installed Drip Edge

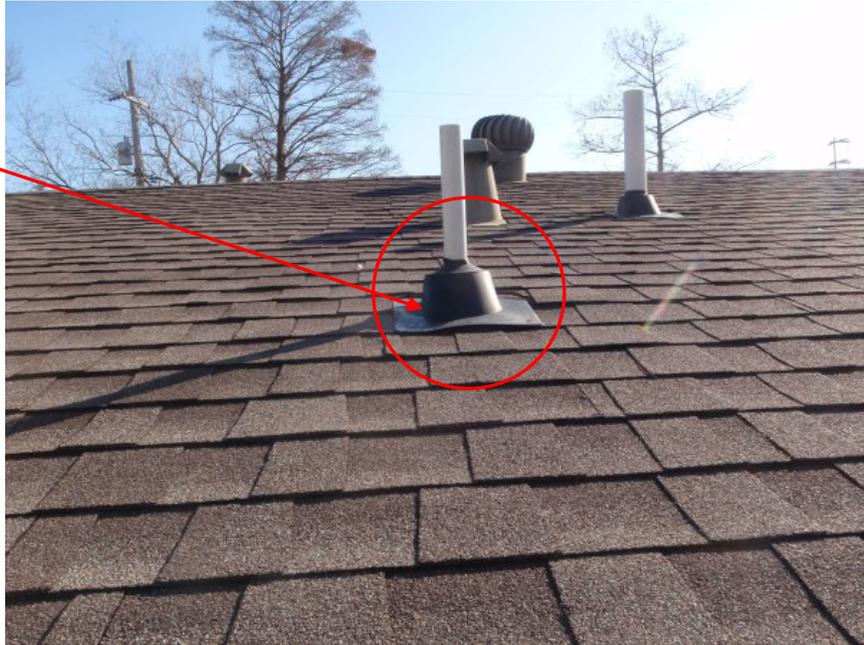
Proper roof boot coverage is necessary to promote good drainage. In this instance, there is not adequate shingle coverage at the edges.

**Figure 51. Photo of Improper Roof Boot Installation**

Example of a proper installation. The lower part of the flange overlaps the lower shingles and the side and upper shingles overlap the flange.

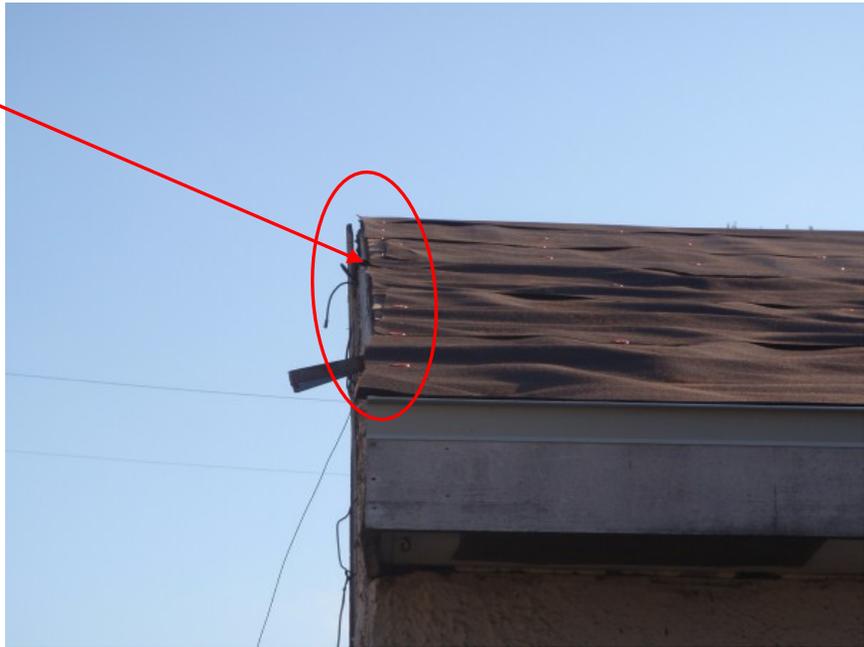
When roofing practices were observed, the roofing paper underlayment did not completely cover the roof rake edges.

Figure 53. Photo of Insufficient Underlayment at Roof Edge

Running each course of building paper all the way to the rake edges is the best practice.

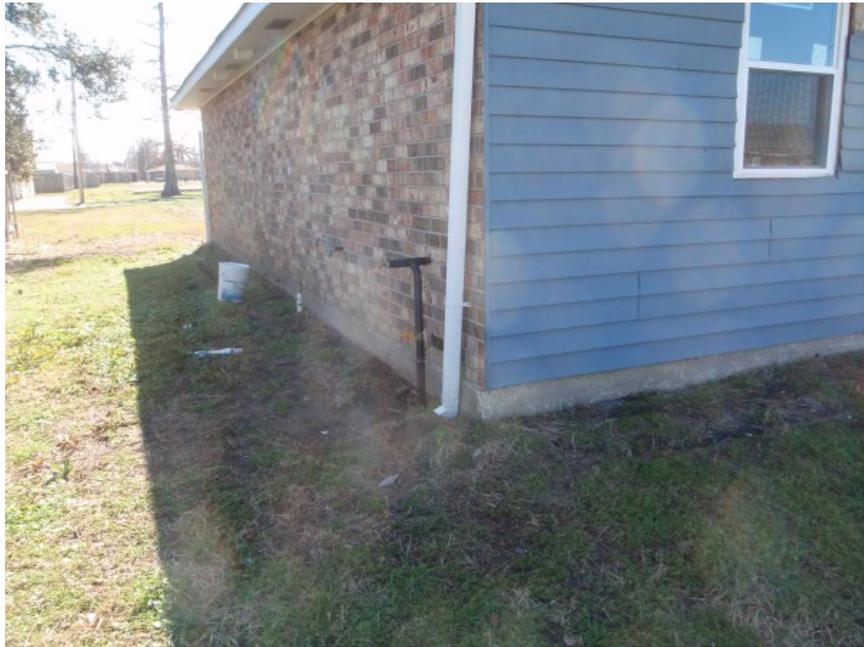
Rain water and ground water must be properly managed at the foundation and site in order to enhance the long-term durability of a home. If the ground around the house and the foundation system are saturated, then the possibility for water to penetrate the foundation or for moisture to wick through the foundation by capillary action is greatly increased.

In many instances, gutter downspouts deposit bulk water from the roof next to foundations.

**Figure 55. Photo of Downspout Discharge Against Foundation**

The best way to eliminate any potential moisture issues at the foundation is to direct water from downspouts to a yard bubbler or sump pit in the yard.

If that is not feasible, at a minimum, taking the time to properly position splashblocks at downspouts so as to direct bulk water away is recommended.

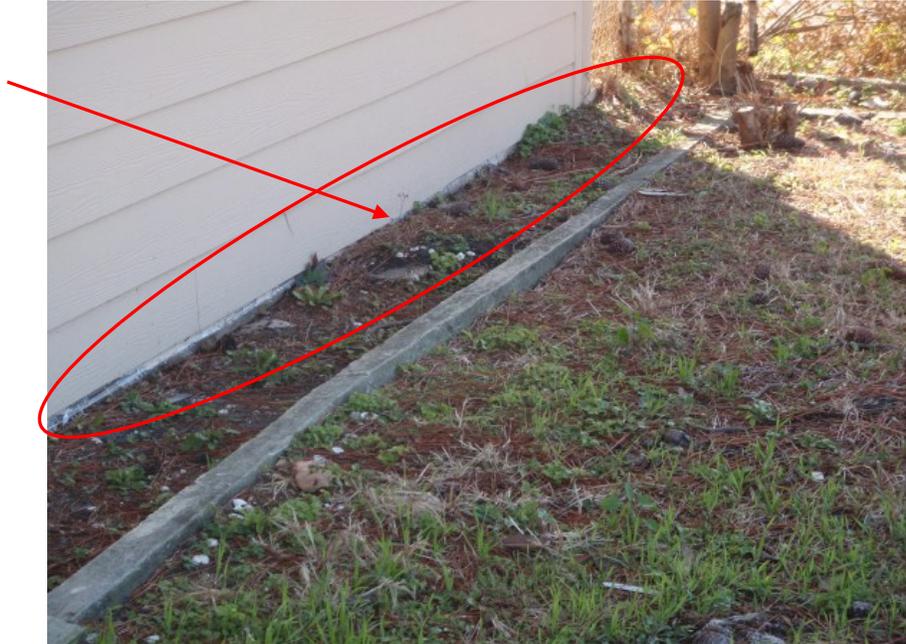
Figure 57. Photo of Insufficient Grade Separation

Ideally, there is a minimum of 6 to 8 inches between the ground surface and the starting course for siding. This separation eliminates any potential for moisture wicking into the cladding or framing material. The gap also hinders insect activity into the framing.

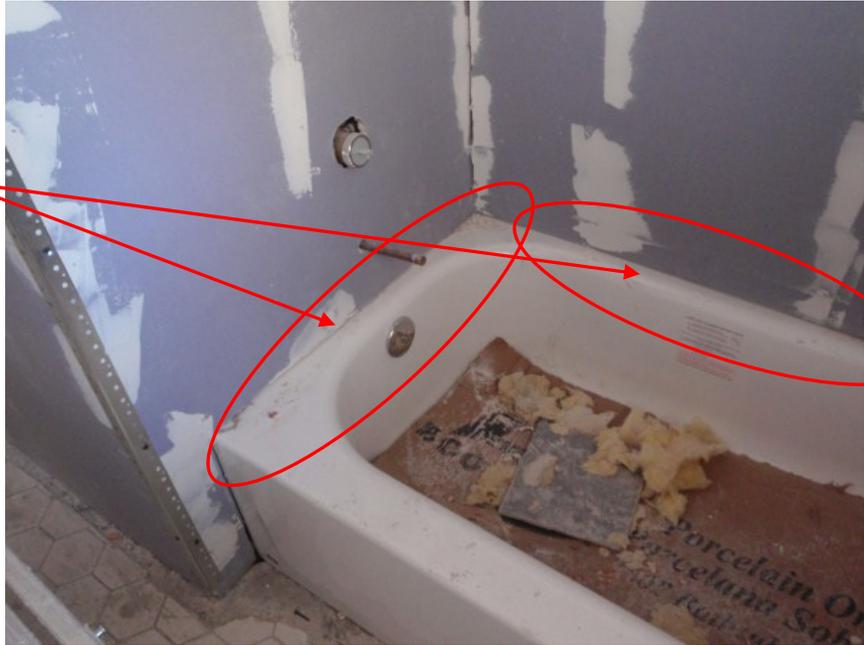
Figure 59. Photo of Insufficient Flashing Surrounding Tub

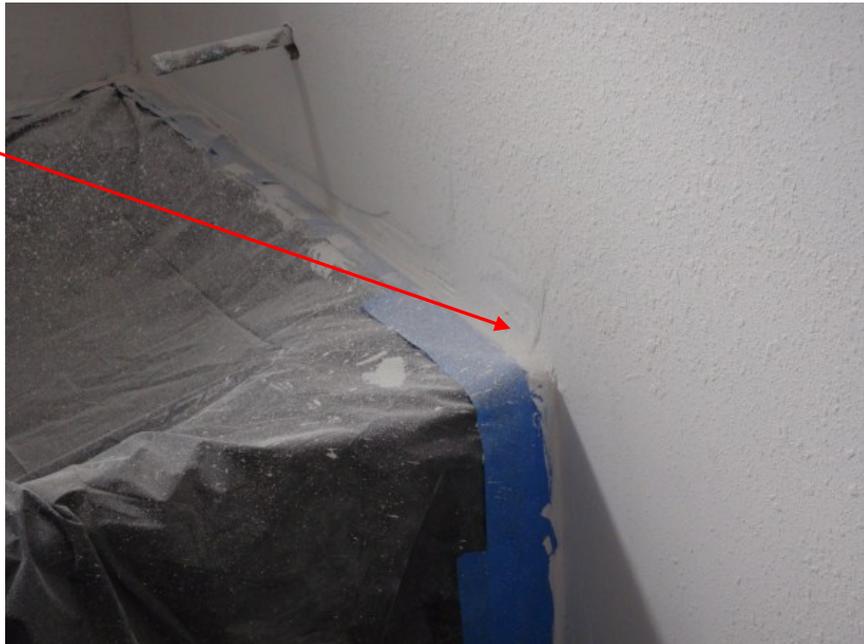
Figure 62. Photo of Improper Backer Board Installation
