Leveraging Limited Scope for Maximum Benefit in Occupied Renovation of Uninsulated Cold Climate Multifamily Housing

K. Neuhauser, D. Bergey, and R. Osser
Building Science Corporation

March 2012

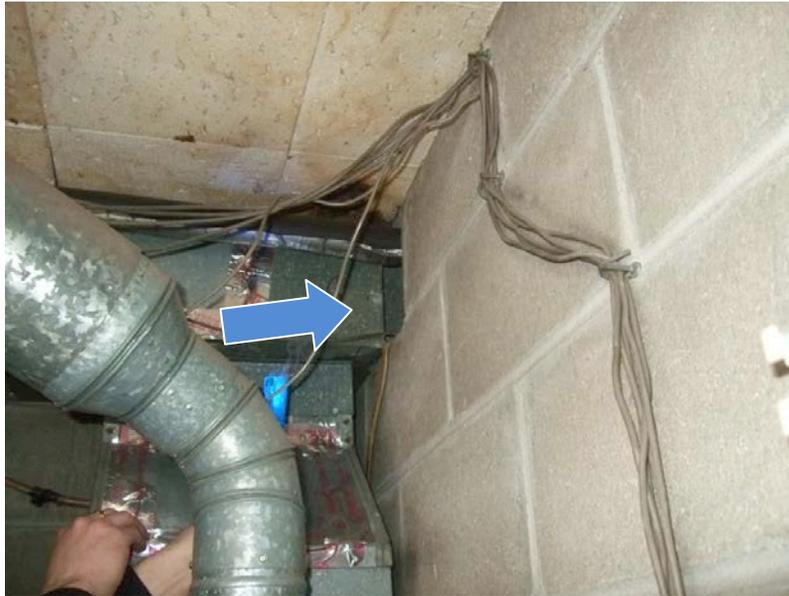
Figure 2. Typical gap around supply plenum in separation between mechanical room and apartment.

- Seal the gap around the duct plenums (both supply and return) connecting the apartment to the mechanical closet (see Figure 2).
- Remove register grilles throughout the apartment and seal from the inside of the duct to the face of the drywall with appropriate tape. Trim the tape at the face of the drywall so that the register flanges will conceal the tape (see Figure 3).
- Caulk the steel frame of the entry door to the drywall; replace door gasketing where it does not provide a good seal.
- Seal the demising wall to exterior wall. At the corner of the demising wall and the exterior wall, remove a 2- to 4-in. wide strip of drywall from exterior wall to allow the drywall of the demising wall to be sealed to the exterior wall (concrete frame or concrete masonry unit [CMU] backup) (see Figure 4).³

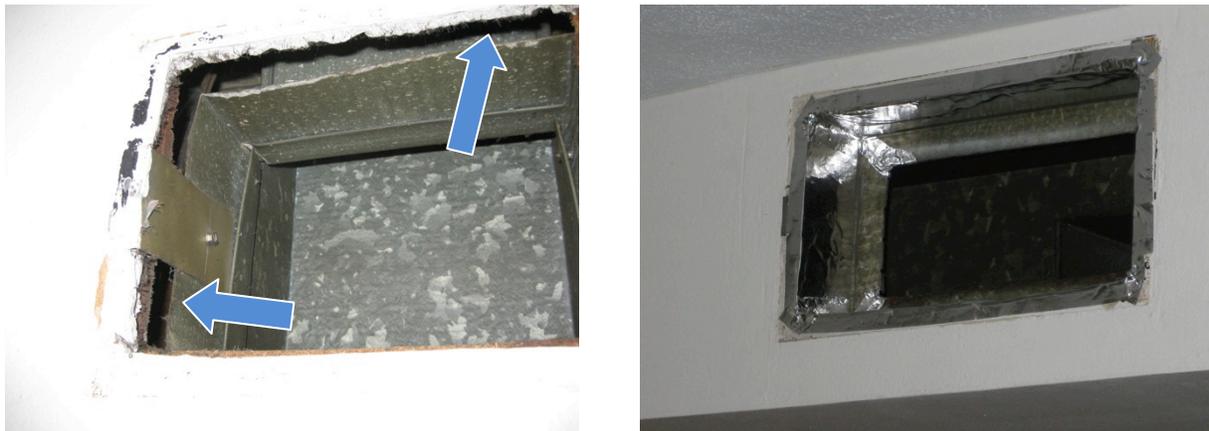
Figure 3. Left: Gaps between duct boot and drywall created a bypass for heating distribution and also represented significant leakage pathways into the demising wall and, consequently, between apartments; Right: The work scope called for metal extension sleeves and foil mastic tape to seal from the existing duct, over the extension sleeve to the face of the drywall.

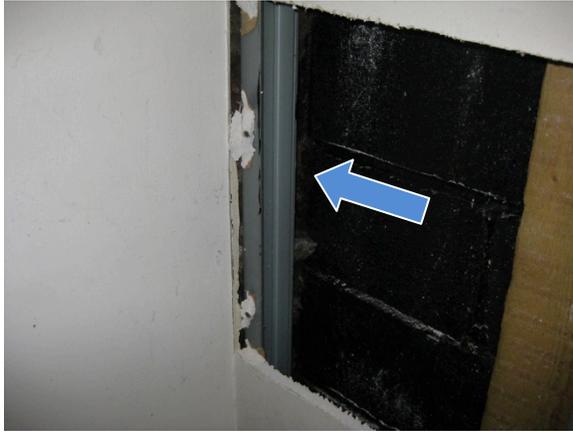
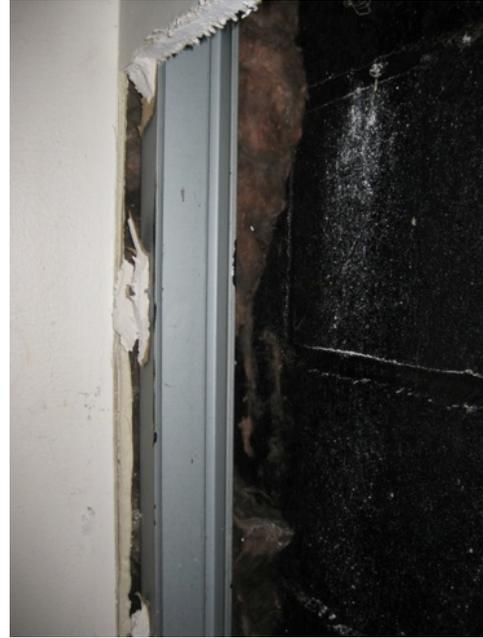
Figure 4. Furring cavity of exterior wall communicates with demising wall. Left: Drywall removed at section of exterior wall adjacent to demising wall; Right: Close-up of connection between furring cavity of exterior wall and demising wall.

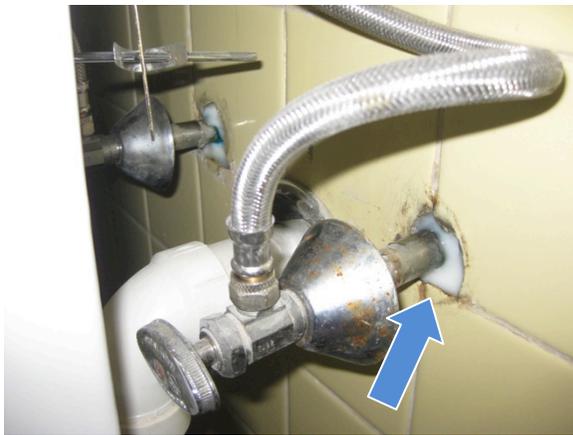
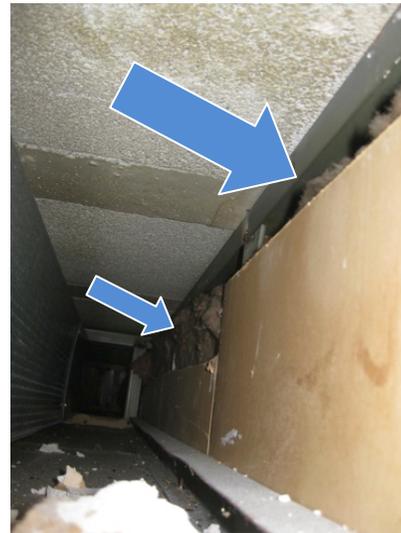
Figure 5. Left: Annular seal at easily accessible plumbing penetration; Right: Within the duct soffit enclosure, the demising wall is not continuous to the ceiling.

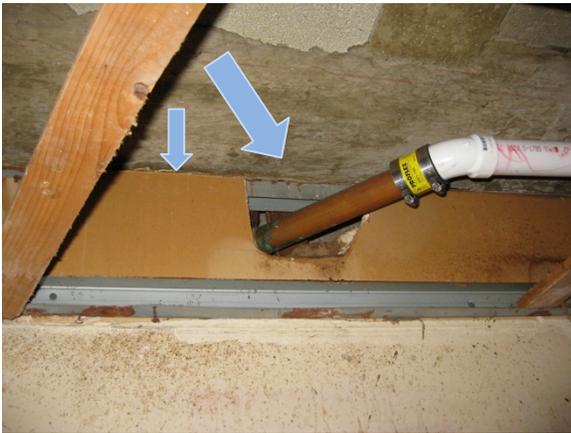
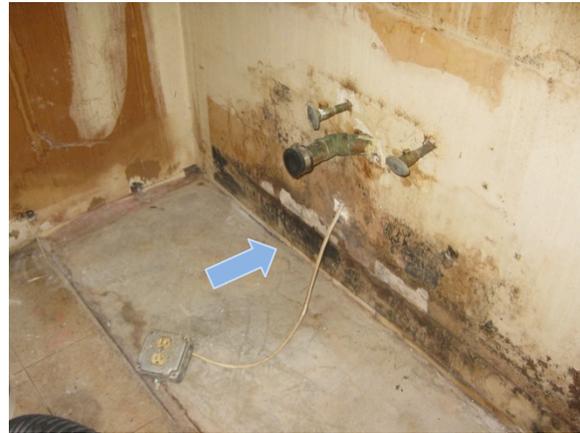
Figure 6. Left: Large discontinuities in demising wall surface round plumbing and other services above the soffit. Drywall surface is not sealed to floor/ceiling above; Right: Demising wall surface is not sealed to floor slab.

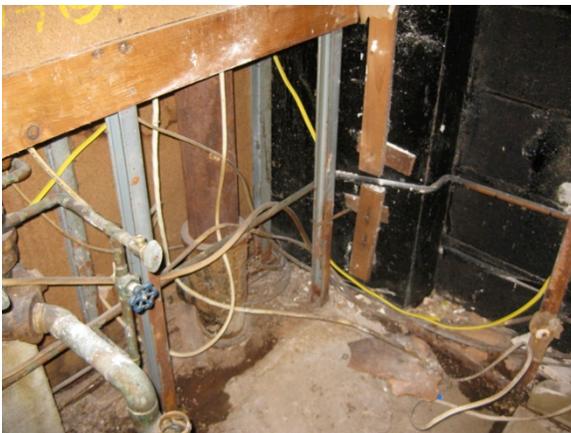
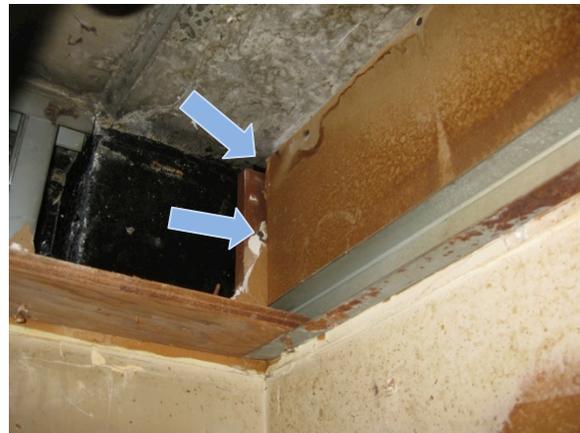
Figure 7. Left: Where work exposes the joint between the exterior wall and floor slab, there is an opportunity to ensure a robust air seal at this joint; Right: As seen in this exposed section above the kitchen soffit, the demising wall does not connect to the exterior wall structure. This leaves a path for airflow around the demising wall.

- Where the base of the exterior wall is exposed, clean the floor-external wall junction and apply a liquid-applied waterproof membrane to seal the block wall to the floor slab.
- Connect and seal the drywall of the demising wall to the exterior wall at the side of the kitchen adjacent to the exterior wall.
- Where the unused duct stub penetrates the surface of the demising wall, cut back the duct to allow the drywall to extend and seal to the floor/ceiling assembly, then cap and seal the duct.
- Provide airtight electric boxes throughout or seal each electric box with appropriate sealant.
- Where CMU backup wall of exterior wall is exposed, apply mastic over accessible cracks or minor holes. Patch major holes (broken block) in CMU wall.

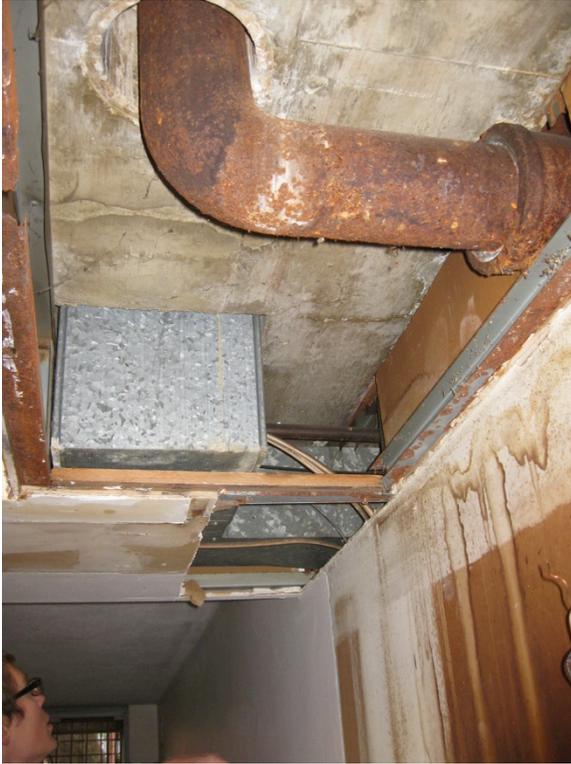
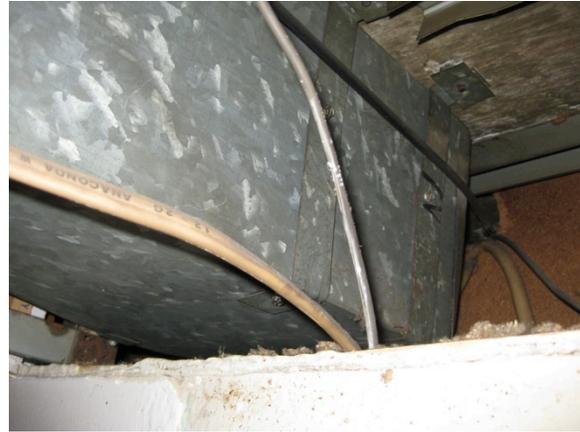
Figure 8. Dead-end stub of supply plenum extends through demising wall. Left: View of supply plenum with kitchen soffit and cabinets removed; Right: View into demising wall cavity through large opening around dead-end stub of supply plenum.

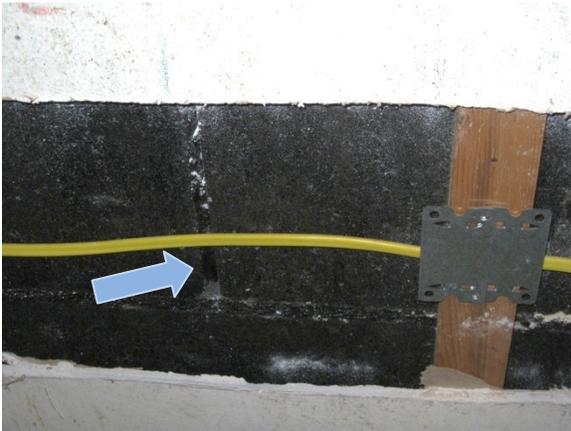
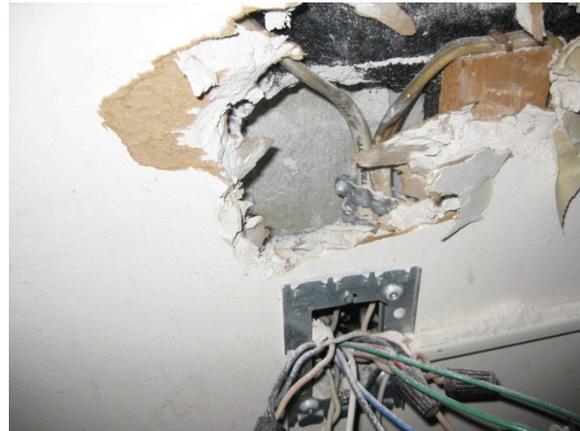
Figure 9. Left: Small hole in mortar joint of exterior wall; Right: Large existing hole in CMU of exterior wall apparently created to accommodate electrical and communication services.

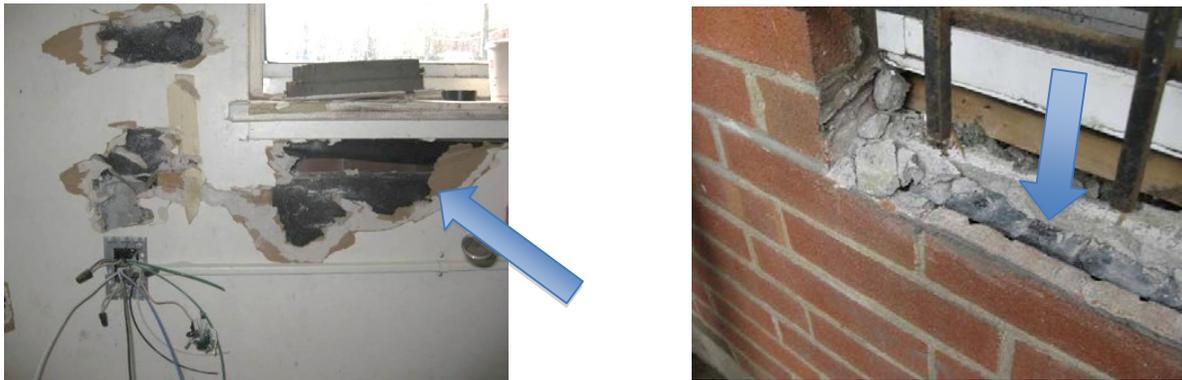
Figure 11. Destructive investigation into existing window assembly and installation. Left: Interior view of existing window installation in mock-up unit. Note the gap between masonry opening and sill; Right: Exterior view of existing window installation in mock-up unit. Note the sill membrane forming a trough that is filled with mortar.

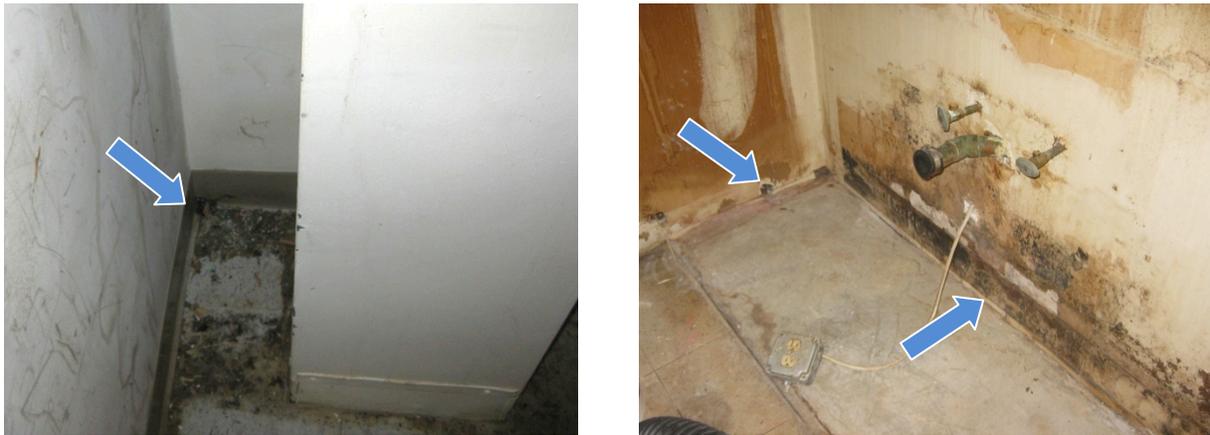
Figure 17. Left: Copious evidence of rodent activity on floor of second floor closet; Right: Rodent hole behind kitchen cabinet location and apparent pre-existing attempt at sealing base of wall to floor with joint compound.

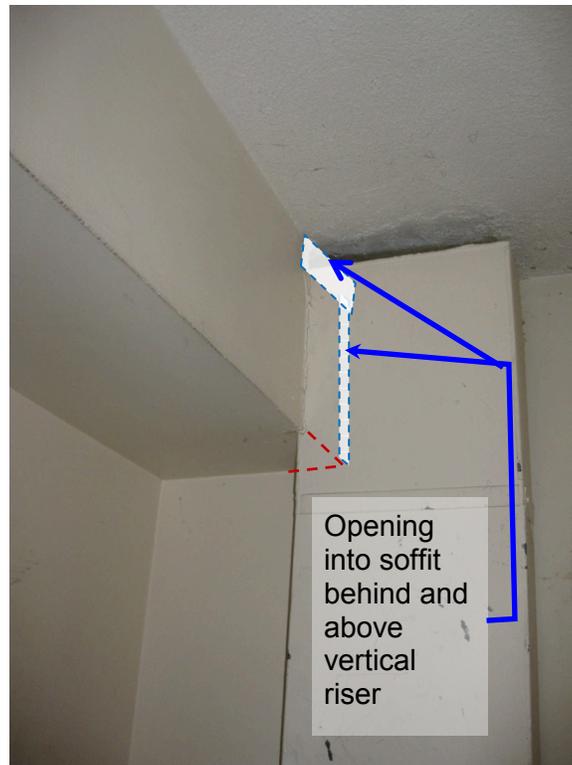
BSC observed a condition in this apartment unit where the duct soffit (which, in turn was opened to the demising wall) is open to the apartment. This opening was found to contribute significantly to the total enclosure air leakage of the apartment. BSC worked with the general contractor and architect to devise a suitable remedy for this situation that was added to the air sealing scope of work. The remedy had to accommodate considerable variability found for the particular condition.

Figure 18. Opening into soffit at second floor of low-rise mock-up apartment.

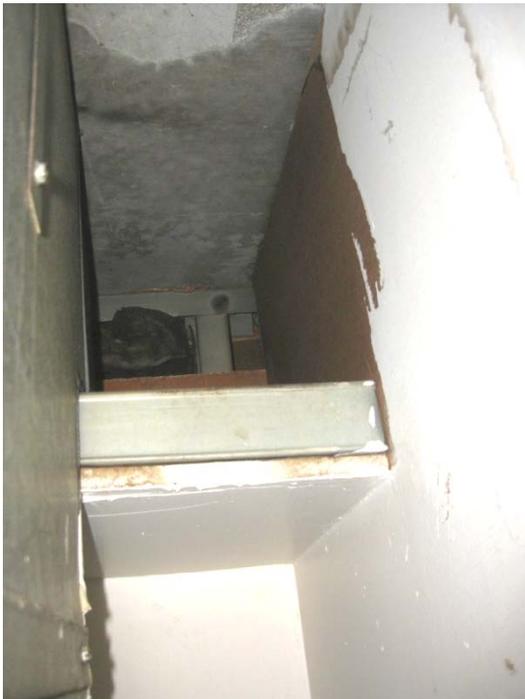
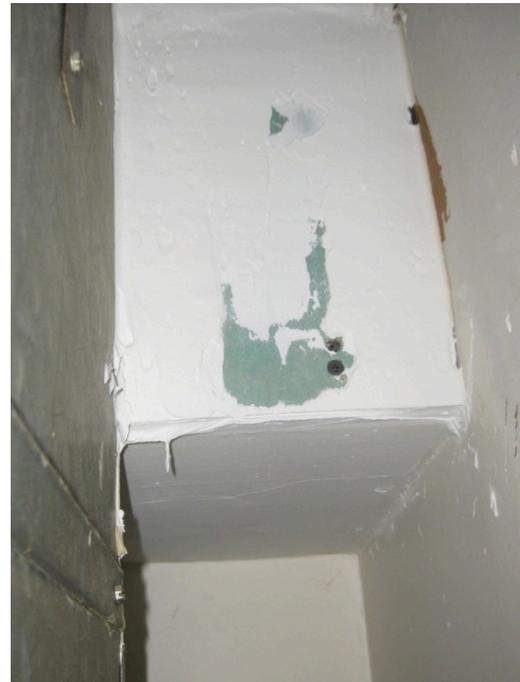
Figure 19. Left: Opening into duct soffit along side vertical riser. View into soffit and demising wall cavity (with dirty batt insulation) beyond; Right: drywall closure for duct soffit.

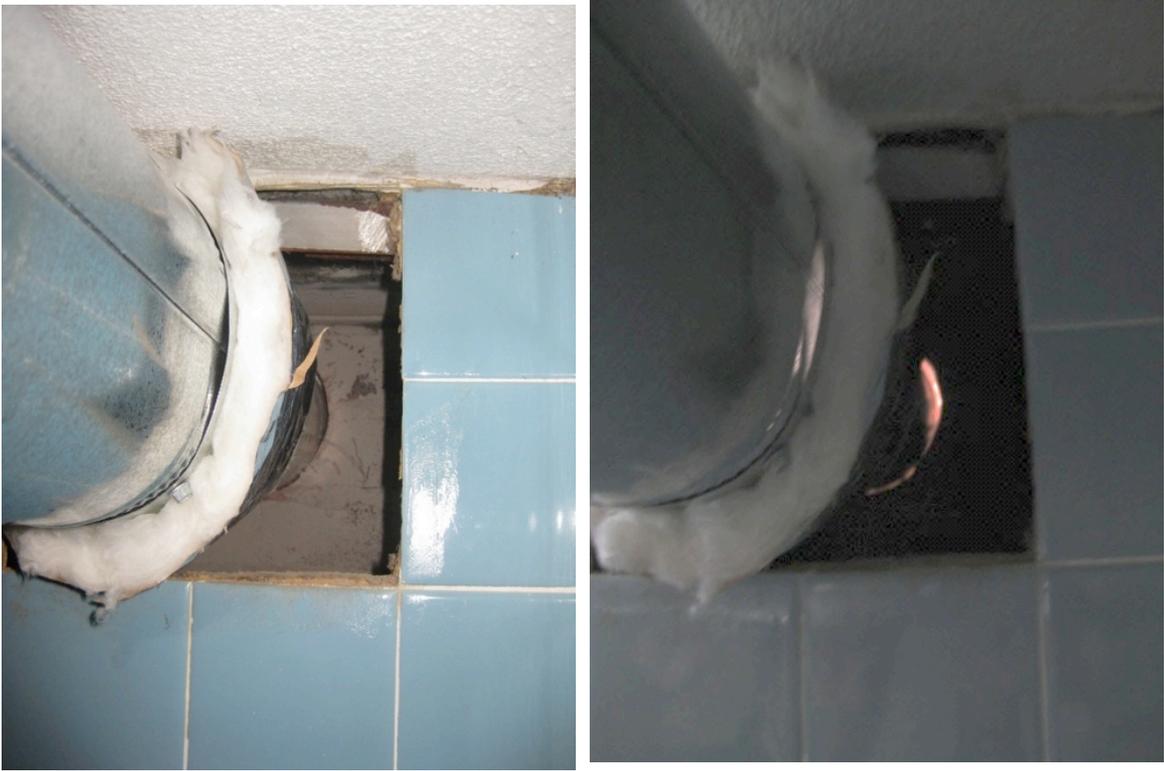
Figure 20. Left: Early attempt at sealing exhaust duct. Note annular seal between sleeve and duct but not between duct sections or sleeve and wall; Right: Backlit image of early attempt at sealing exhaust duct illustrates where air seal is needed.

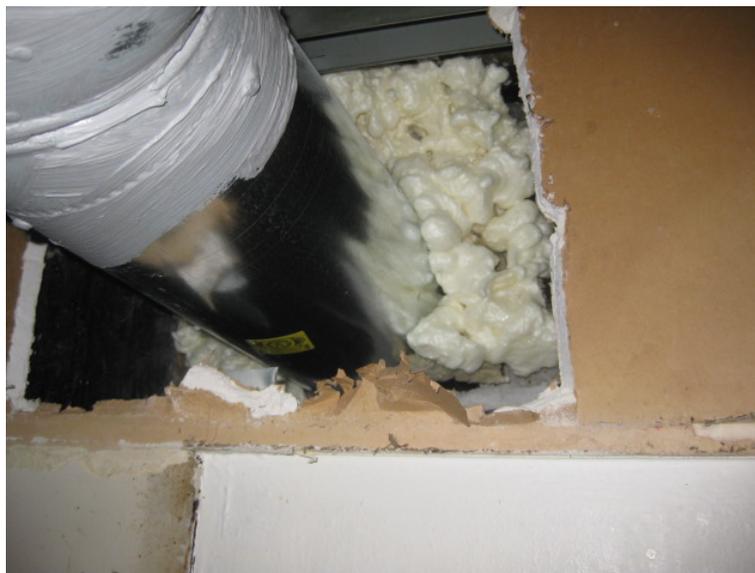
Figure 23. Large opening in drywall around exhaust duct allows access to exhaust duct penetration through CMU backup wall – the primary airflow layer for the exterior wall.

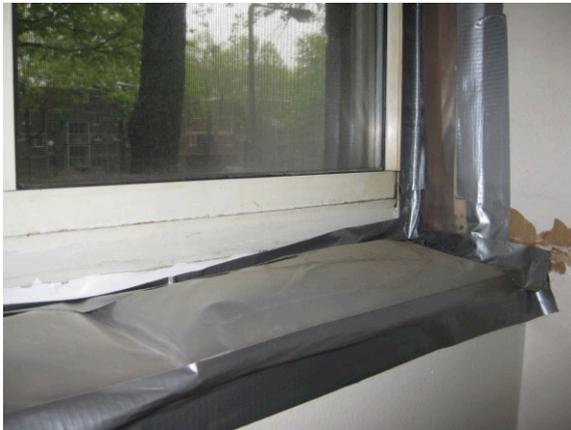
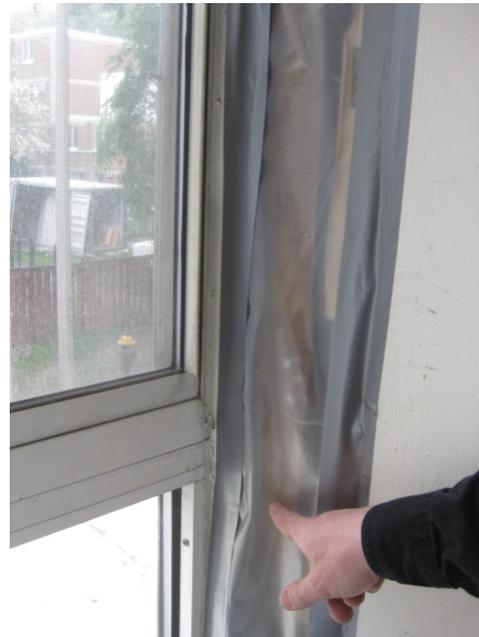
Figure 25. Left: Plastic sheeting at sill of window opening billowing inward during depressurization testing; Right: Plastic sheeting at window jamb return billowing inward during depressurization testing.

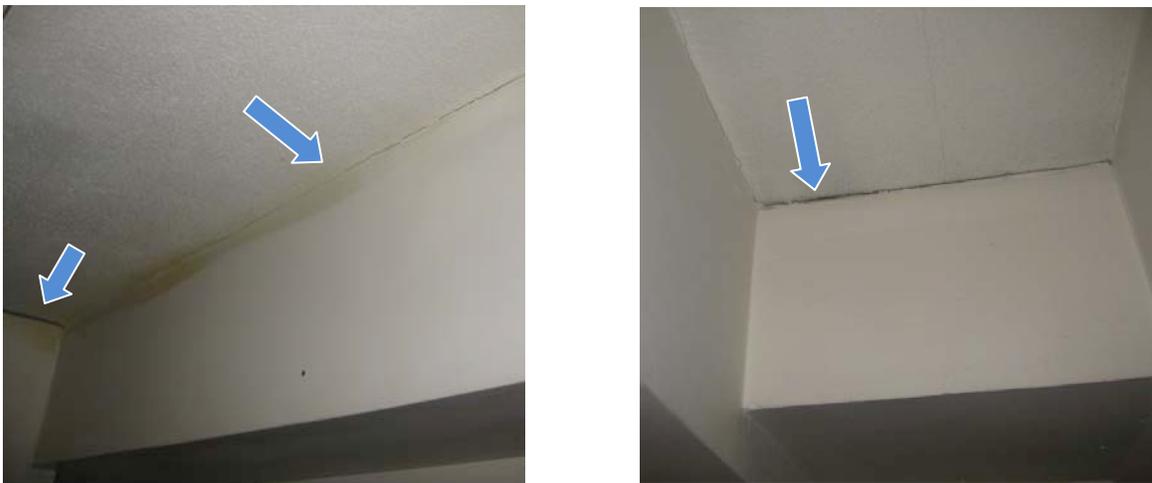
- At several locations on the second floor walls and soffits, the drywall surface appears to have settled downward, creating a gap between the drywall and the underside of the floor/ceiling assembly (Figure 27).

Figure 27. Gaps between drywall and floor/ceiling assembly observed at second floor

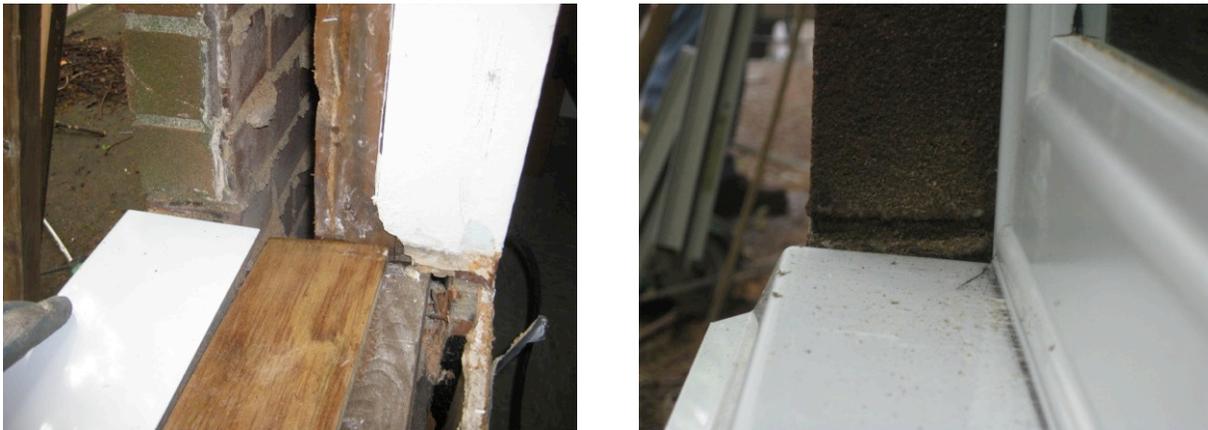
At the first apartment where windows were installed as part of the regular construction process, problems with the size of the window became apparent. Although the windows fit within the rough openings given by the existing wood bucks, the height of the stone sill at the exterior relative to the height of the sill buck varies. For the sill flashing to be above exterior sill trim and/or slope onto the exterior sill trim, the window openings require varying amounts (heights) of blocking at the sill. Because of the tight tolerances of the window size relative to the rough opening, the window installers were not always able to install sufficient blocking to raise the sill flashing above the exterior trim (see Figure 29 and Figure 30).

Figure 30. Left: Exterior sill trim above height of sill blocking; Right: Back-sloped sill trim.

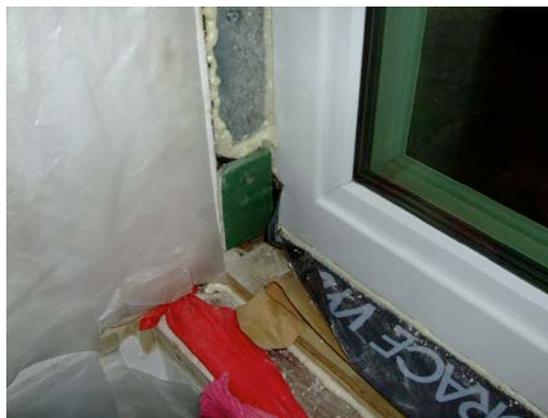
Figure 31. Corner of sill pan flashing in a very tight spot. Note that backing is left on the portion of the flashing membrane to the inside of the window to facilitate turning the membrane up at the sill to form a back dam.

Preformed corner pieces would be preferable to a membrane for the sill pan flashing as these would be less likely to be abraded, cut, or torn by the corners of the window during window installation.

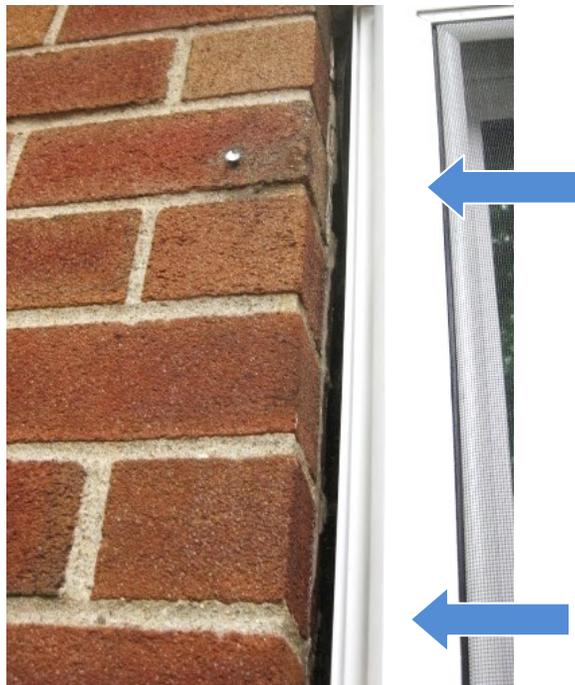
It is possible that dust and debris on the brick surface prevented good adhesion of the membrane. In this project, it was not possible to scour the brick clean because of the presence of asbestos-containing caulk on the brick around the window opening. A liquid-applied primer may have helped with the adhesion of the membrane. It is also possible that a membrane better suited to adhering to irregular surface would provide a more robust jamb flashing for the window opening. BSC recommended that the installation incorporate the use of a liquid primer at the brick openings.

Figure 32. Jamb flashing membrane poorly adhered to brick substrate as evident in gaps between the membrane and the brick.

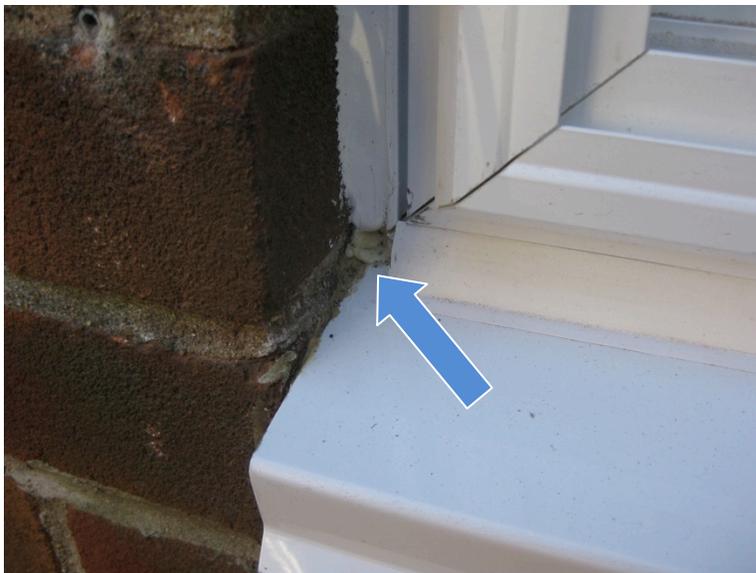
The weep opening at the corner also provided a potential path for rainwater entry at precisely the most vulnerable location of the window opening. BSC recommended to the project team to continue the sealant joint at the jamb down to the sill trim and provide weeps for the window opening by notching the closure piece with a "V" cut at roughly the ¼ points from to either side of the sill closure (see Appendix G). BSC also recommended that the sealant joint continue along the joint between the sill trim and the brick return at either side of the sill.

Figure 33. Sealant joint stopped short to allow drainage also presents potential path of water entry.

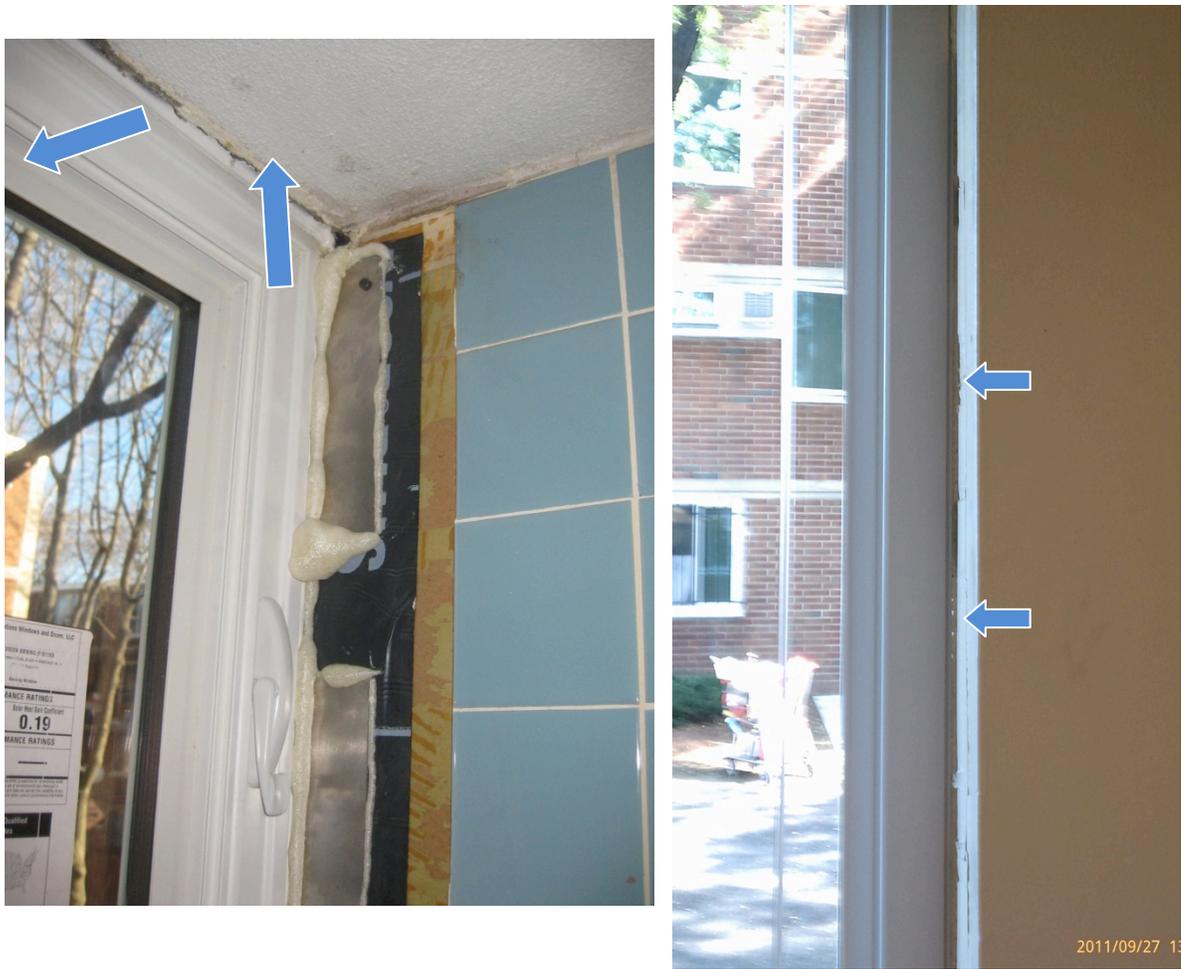
Figure 35. Left: Expanding foam sealant at window jamb and fillet bead of sealant at head of early window installation; Right: Poor seal at window perimeter with gaps permitting view to outside.

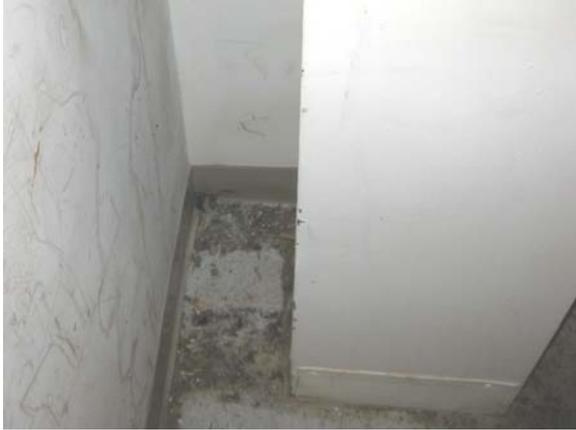
Figure 1: Copious evidence of rodent activity in second floor closet

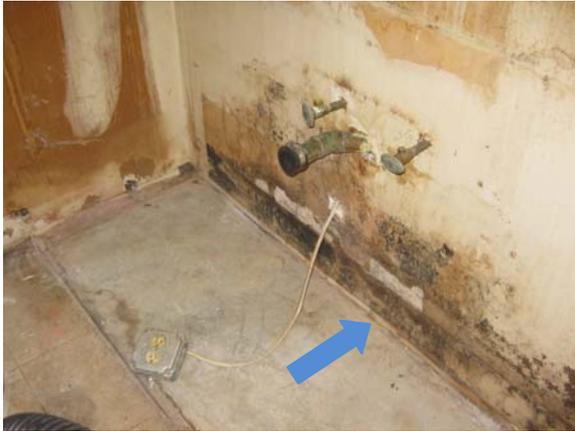
Figure 3: Apparent existing joint compound sealing at base of kitchen wall

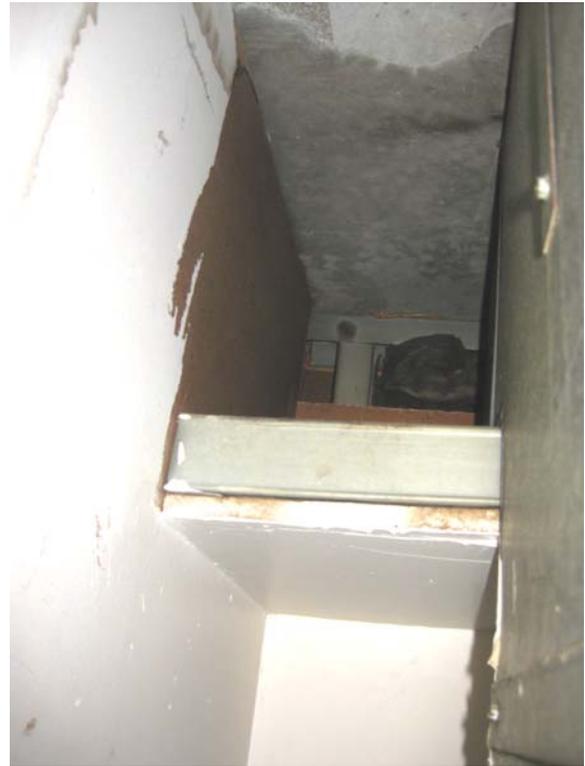
Figure 7: Opening into soffit at second floor of present low-rise mock-up apartment. Note opening into demising wall.

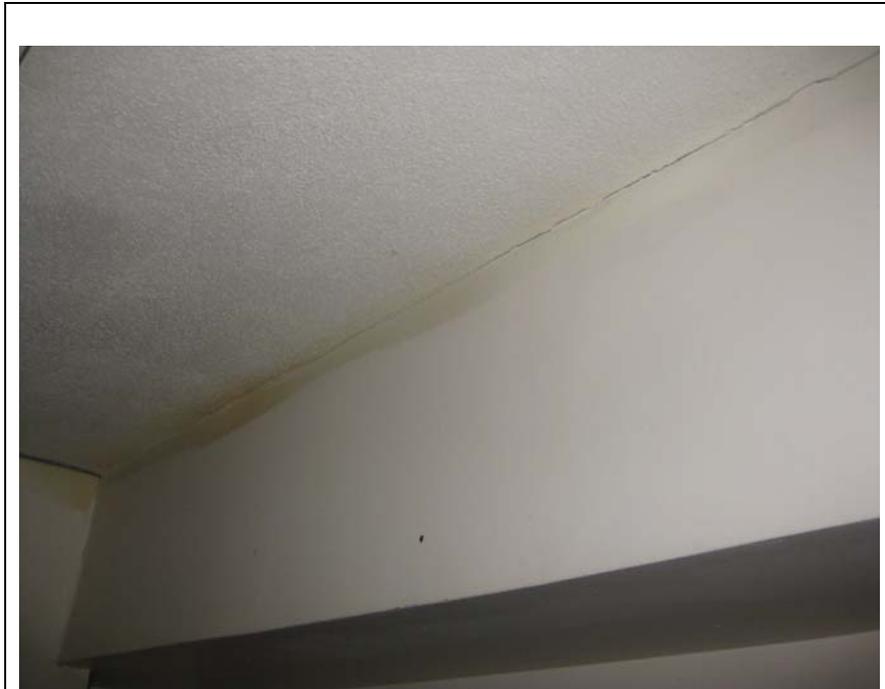
Figure 8: Gap between drywall and floor/ceiling assembly at second floor

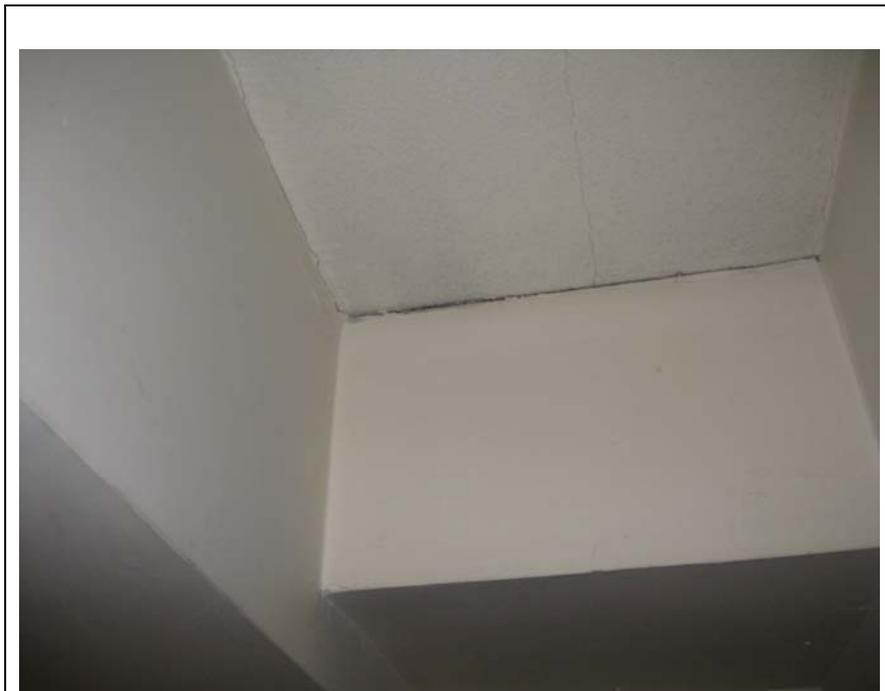
Figure 9: Gap between drywall and floor/ceiling assembly at second floor
