Observed field failures and reported degradation rates

Thin Film PV Workshop,

**Dirk Jordan, Michael Kempe, David Miller, Corinne
Packard, John Wohlgemuth, Sarah Kurtz**

2/28/2013

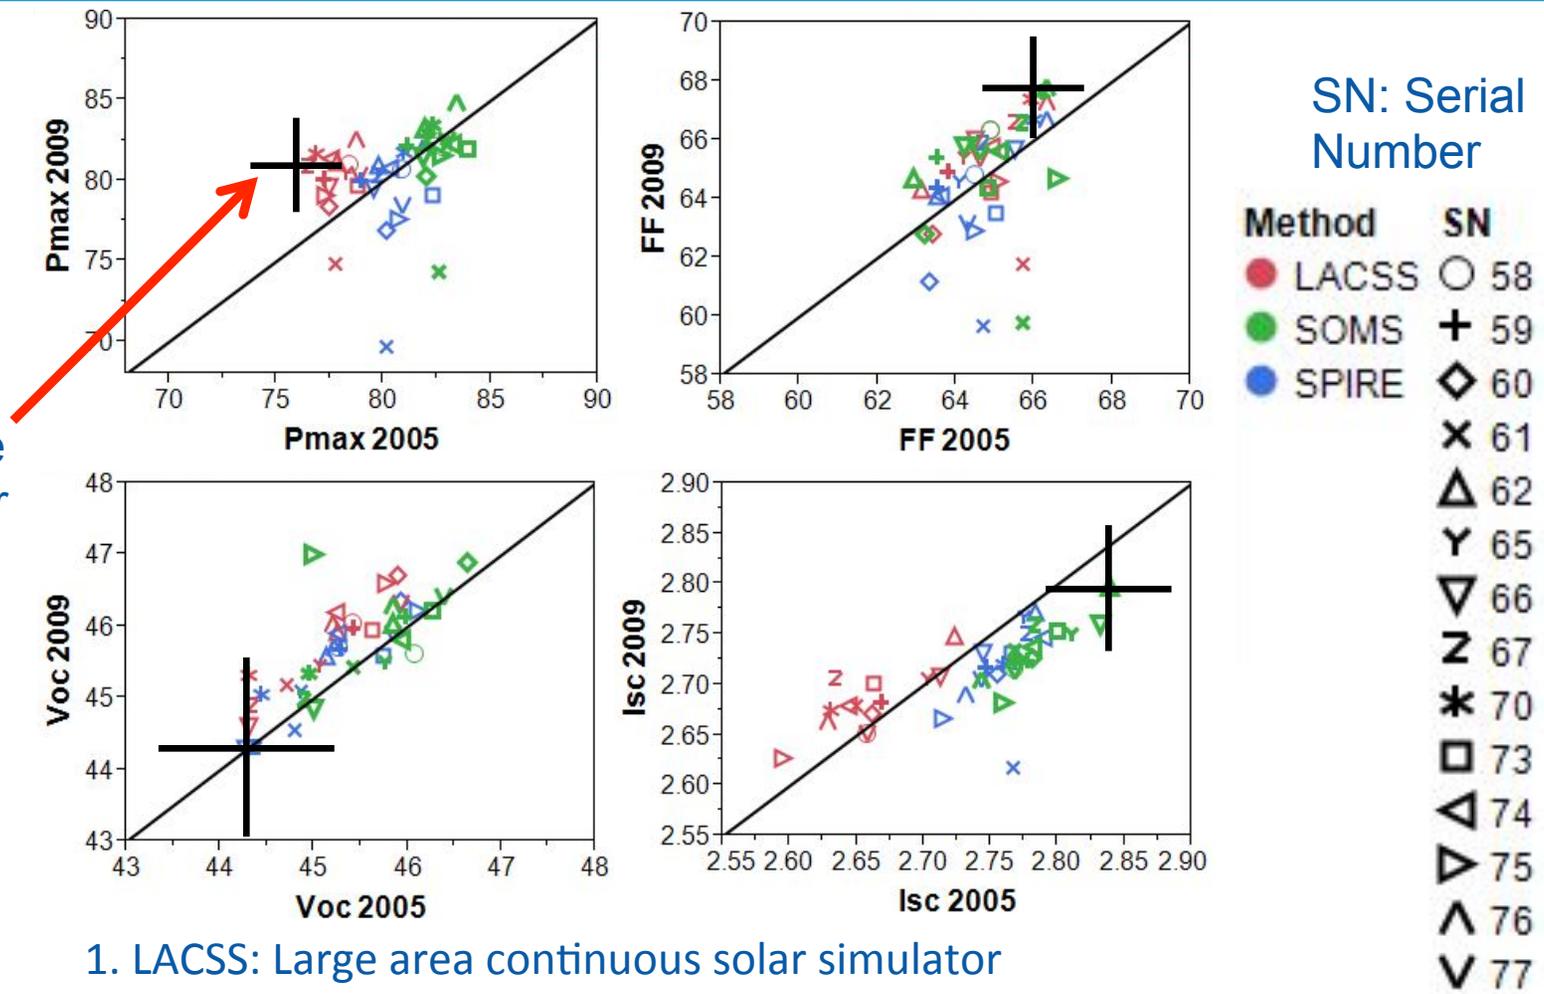
Only Module 61 shows clear signs of degradation

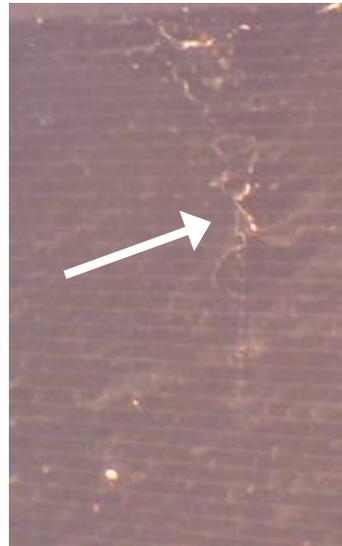
Optical image

Scratch across cells

Hot spot developed along presumed manufacturing defect

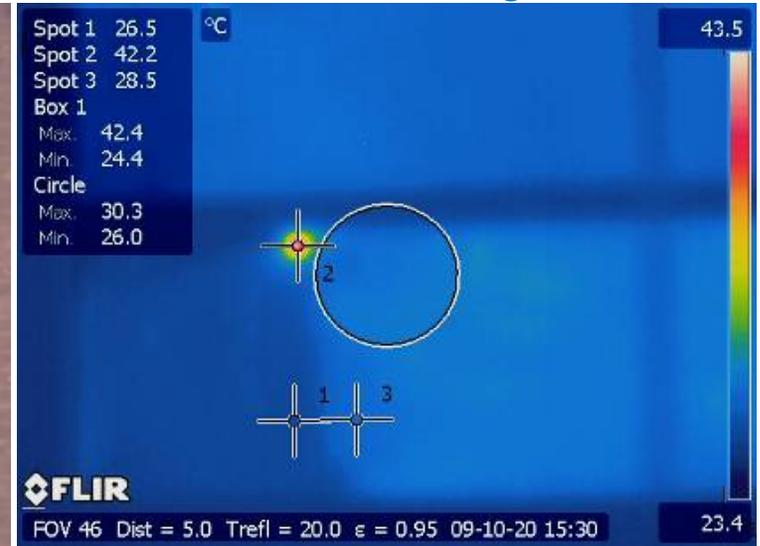
Infrared image

Hot spot at the end of scratch

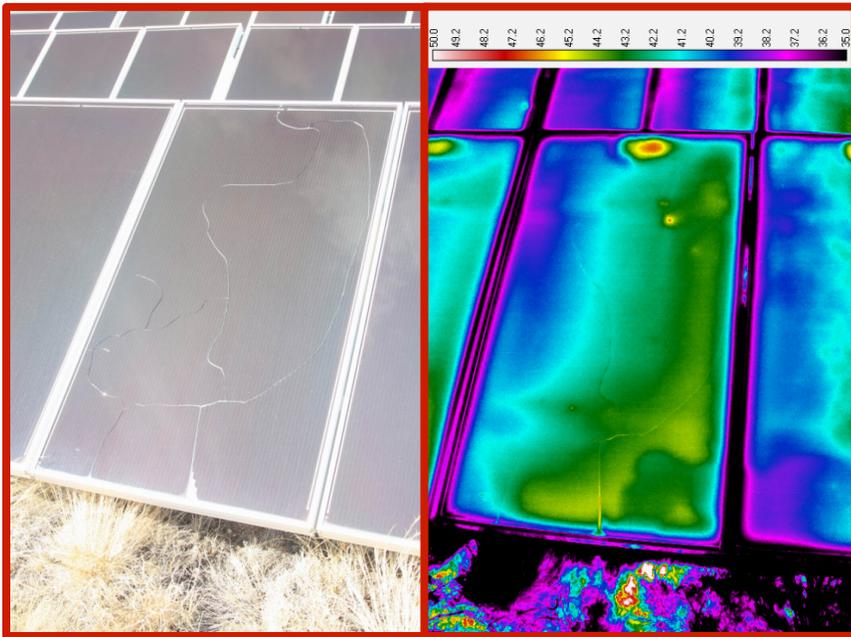
Severely broken front

- Wide variety of fracture morphologies and extent of damage
- Neither front or back glass is tempered.
- Front side: 6/400 modules.
- Back side: 11/400 modules.
- Both sides: 5/400 modules.

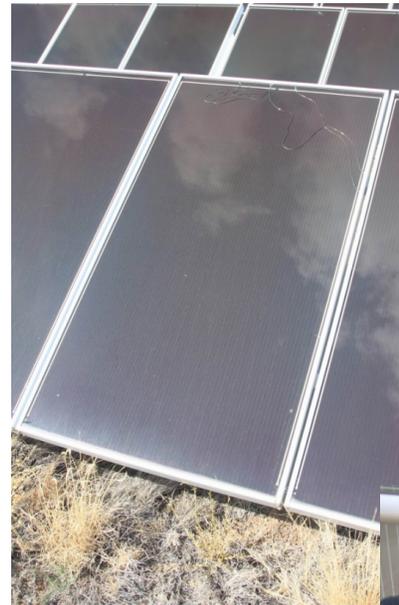
Less severely broken front

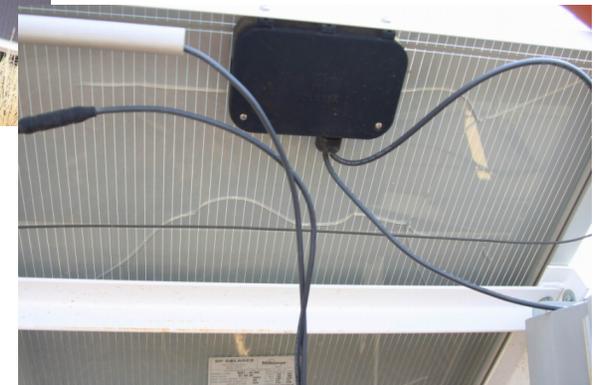
Broken back

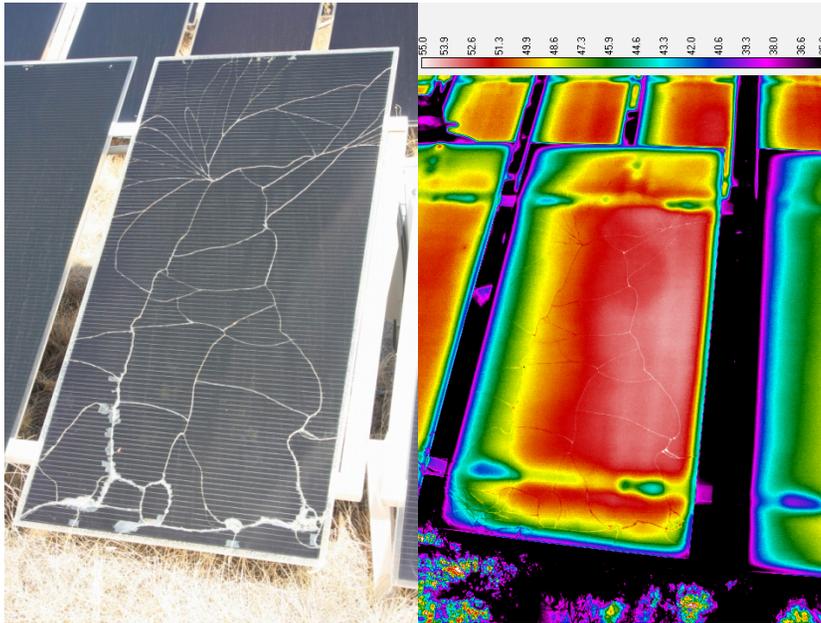
Optical (left) & IR (right) image

- Fracture did not always couple to the back from the front
- Extent of damage varied widely
- Usual hot spot may not be observed on modules with broken glass
- Relative occurrence: 3/450 in original (old edge seal) modules.
- Minimal thermal signature
- (diode is probably on)

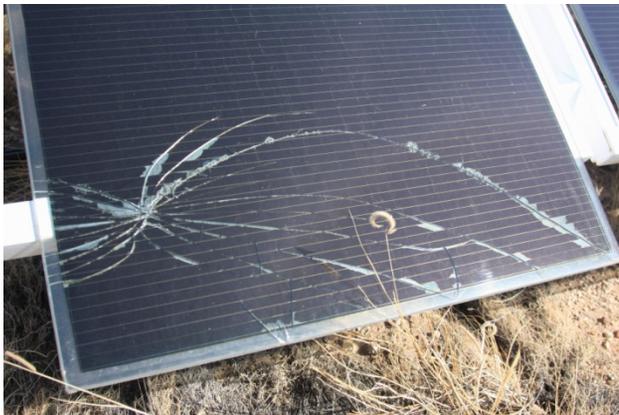
Optical image of only damage at base of module

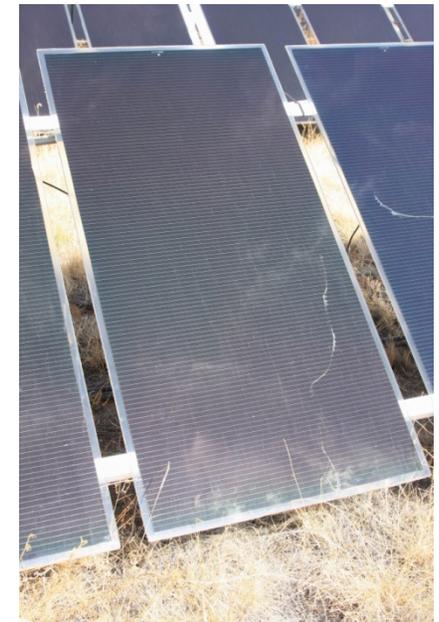
Optical image of less damaged module

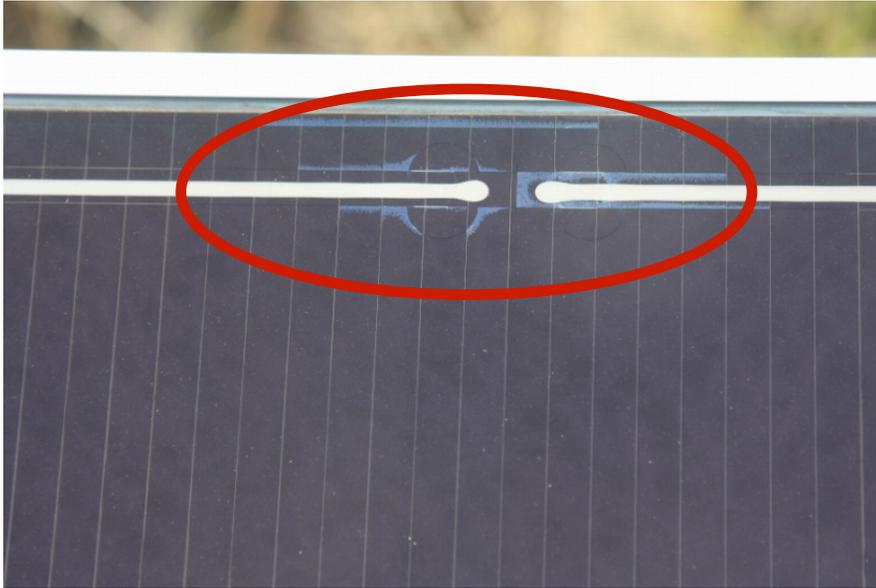
Optical image of delamination at module top

- Localized delamination observed at top of module (over j-box)
- $T_{\text{hot spot}} \sim 50^{\circ}\text{C}$; $T_{\text{front glass}} \sim 45^{\circ}\text{C}$
- Relative occurrence: every module
- Delamination corresponds to a hot spot observed on every module

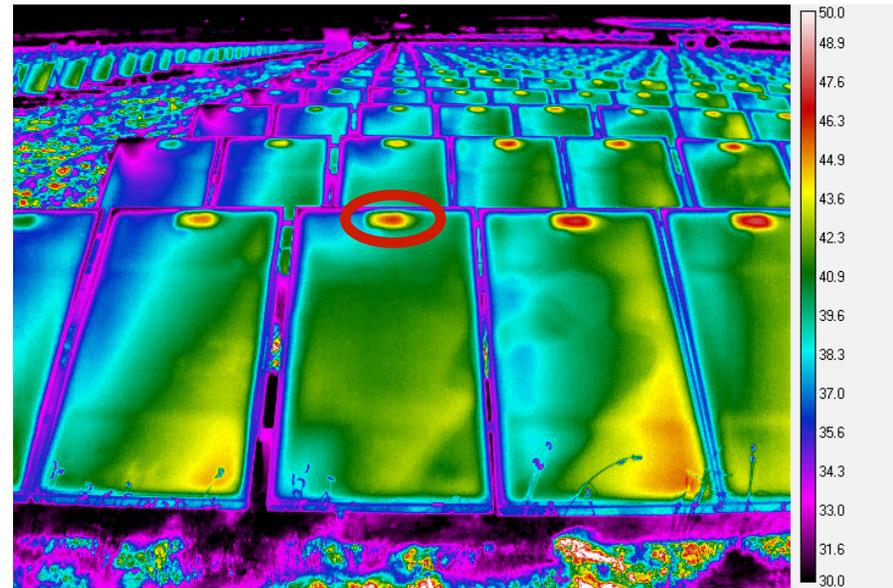
IR image of multiple modules within the array

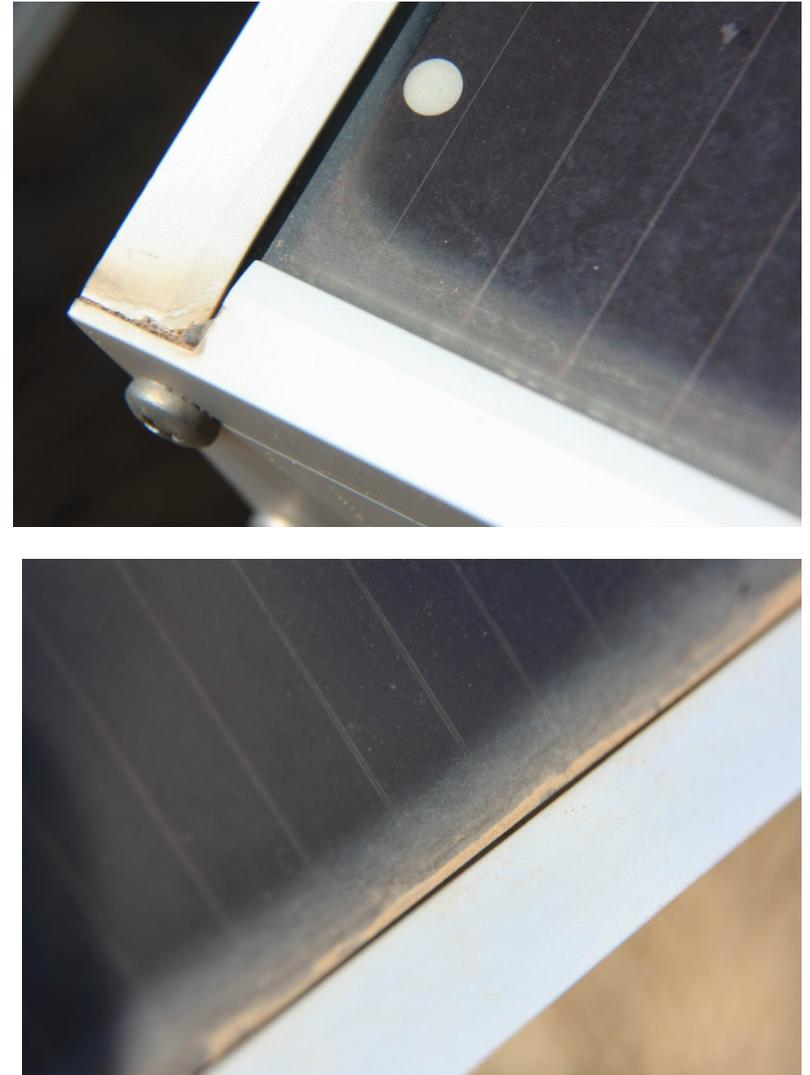
Permanent Soiling

- A narrow (0.5") region at the bottom of the area was typically soiled
- Location corresponds to where frame would retain water runoff
- The contamination is extremely difficult to remove
- The orientation of the modules (and cells) minimizes shading loss at the soiled region; also minimizes shading loss from grass, plants, etc.
- Relative occurrence: every module

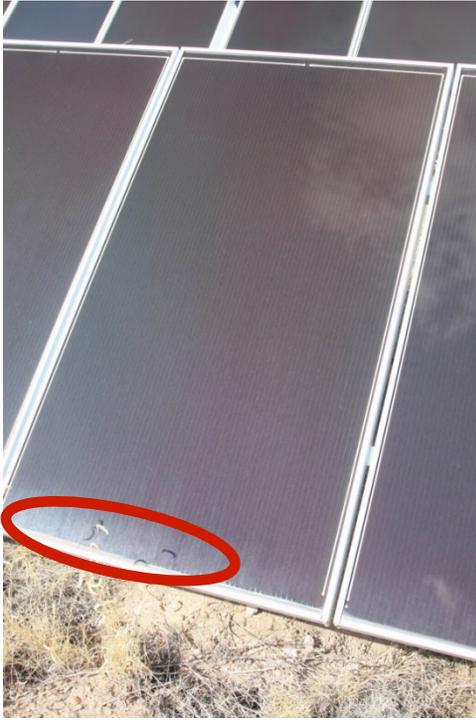
Effected region
identified (circle) on
module

Relative occurrence 128/400 modules

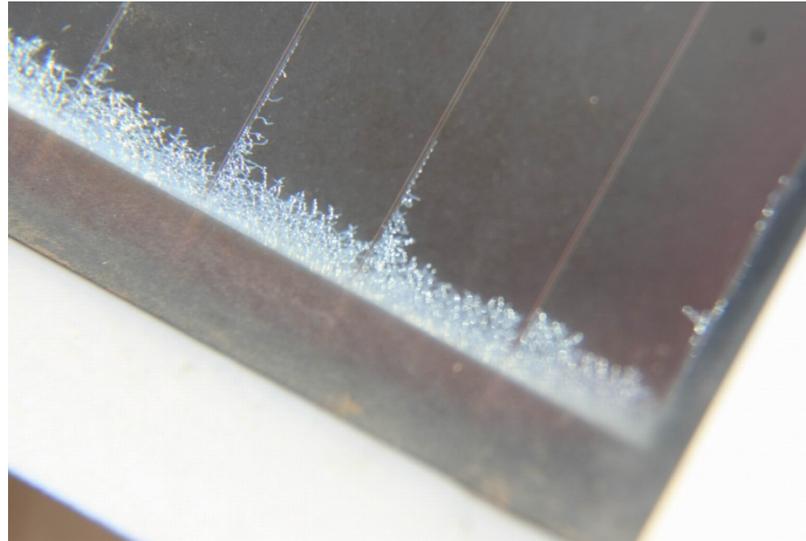
Detail of the effected region on the same
module

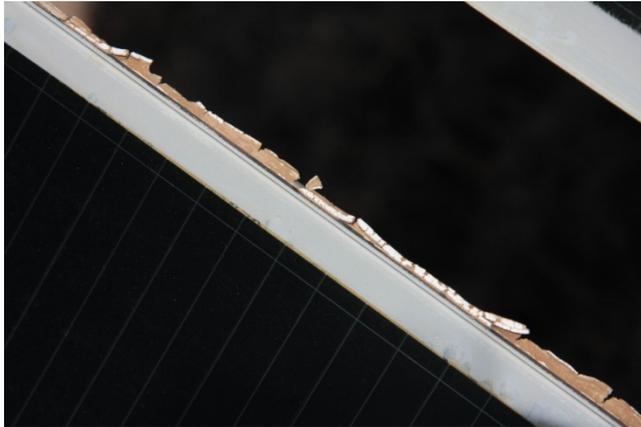
“Edge seal”, from front

- all “extruded” modules have at least bubbles.
- “Extrusion” could result from O₂ or N₂ absorption in sieve in seal or outgassing from residual peroxide in EVA
- No evidence of damage on replacement modules, all with edge seal.
- (change in material by manufacturer?)
- 3/450 “extruded” modules cracked.

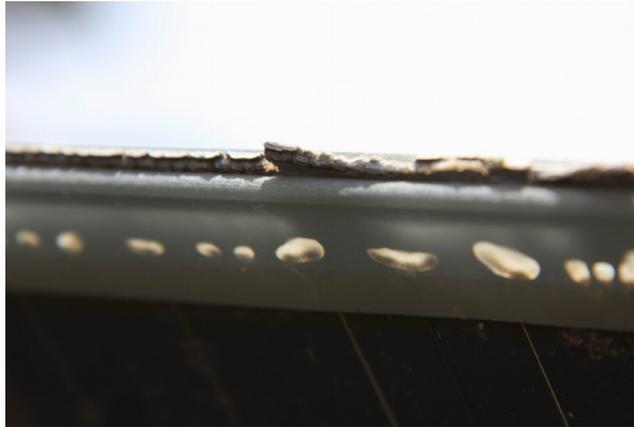
Less damaged region, photo from back

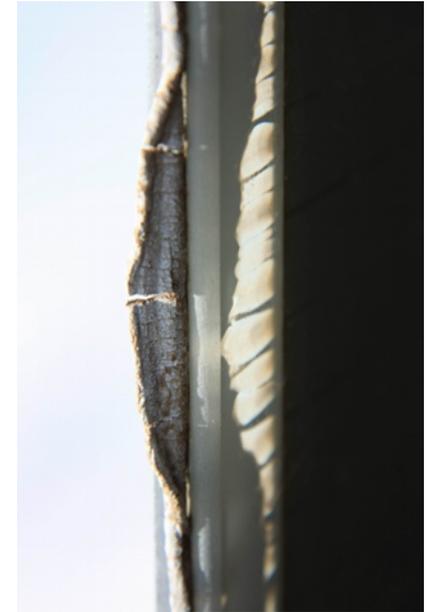
Severely damaged region,
photo from back

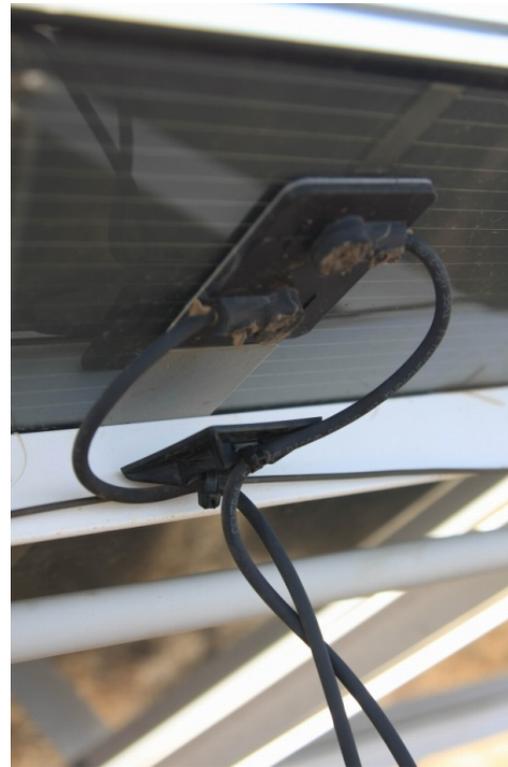
Weathered interconnect system

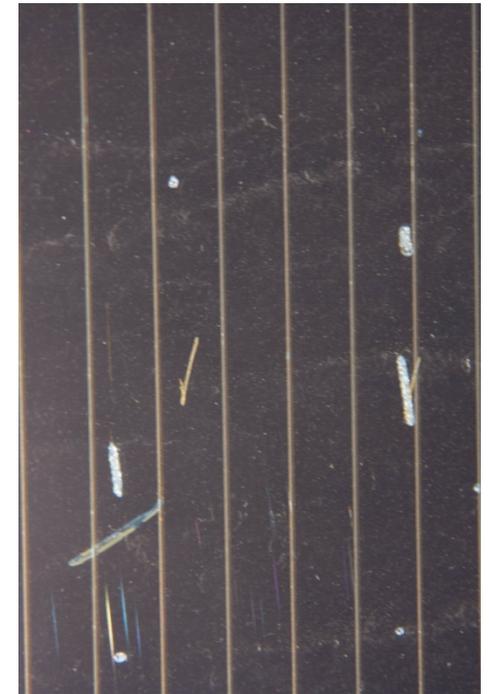
Delaminated relief pad

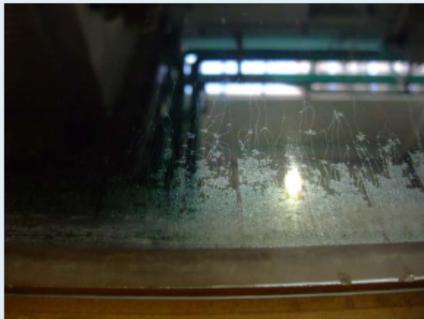
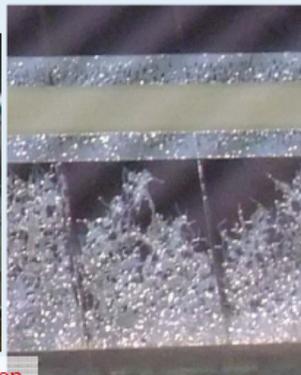
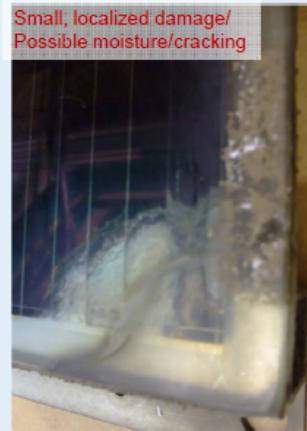
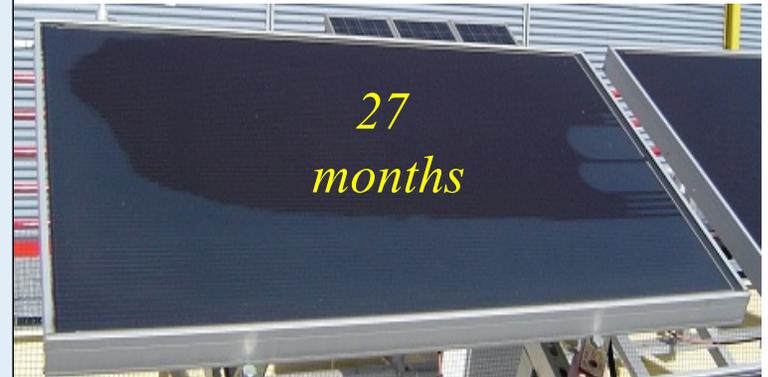
Small, localized damage/
Possible moisture/cracking
