CPV Cell Characterization Following One-Year Exposure in Golden, Colorado

Preprint

Nick Bosco and Sarah Kurtz

Conference Paper
NREL/CP-5J00-62484
August 2014

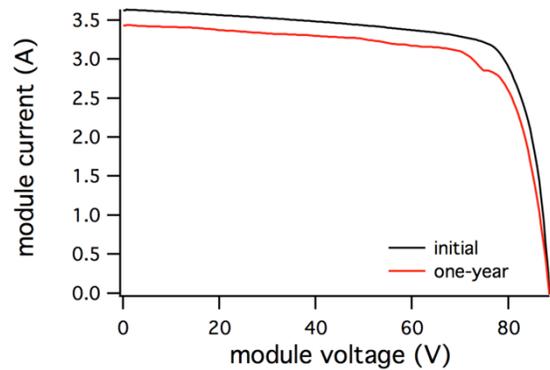
On-sun module level I-V curves taken shortly after commissioning and just prior to the one-year analysis are presented in Fig. 1. The conditions during these measurements were an irradiance of 925 W/m^2 and ambient temperature of 24.5 C . The module's short

circuit current had dropped 5.3 %, fill factor 5.2 % and power 10.2 %. The presence of at least one low-current cell is also evident.

Fig. 1 On-sun module level I-V curves taken upon commissioning and shortly prior to the one-year analysis.

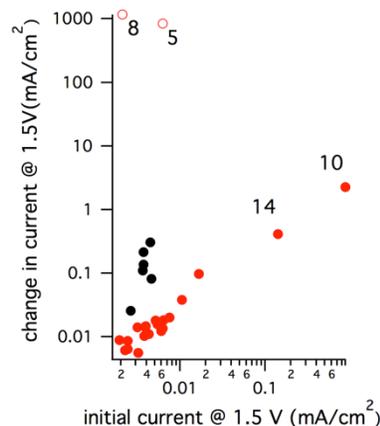
A comparison of each cell’s electrical performance before and after the one-year of service is presented in Figs. 2-4. Each cell’s shunt current is evaluated as its dark current response at 1.5 V forward bias, Fig. 2. Of the thirty cells evaluated, cells 5, 8, 10 and 14 showed the largest changes in electrical performance. A positive correlation of initial shunt current with an increase in shunt current is apparent in Fig. 2 for the majority of the samples. There appears to be no similar correlation for changes in short circuit current though its average decrease is 4 %, Fig. 3. The cell’s open circuit voltage was largely unchanged from their initial values except for two cells (5 & 8) that appear to be severely shunted, Fig. 4.

Fig. 2 Change in shunt current. Black symbols represent exfoliated cells, and open symbols shunted cells.

likelihood for contact with water. Cell 26 was observed to have the largest extent of exfoliation associated with water and also was one of the cells with the largest drop in short circuit current. The exfoliated cells exhibit a large change in shunt current that was not predicated by their initial shunt current and therefore stand out from the positive correlation in Fig. 2.

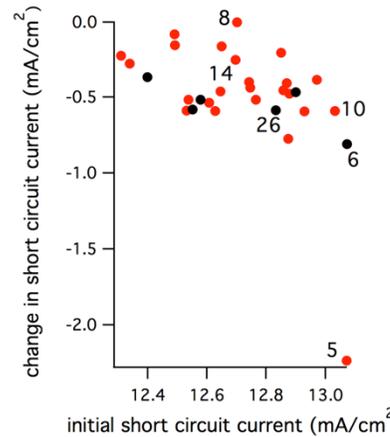
Fig. 3 Change in I_{sc} . Black symbols represent those cells that exhibited exfoliation.

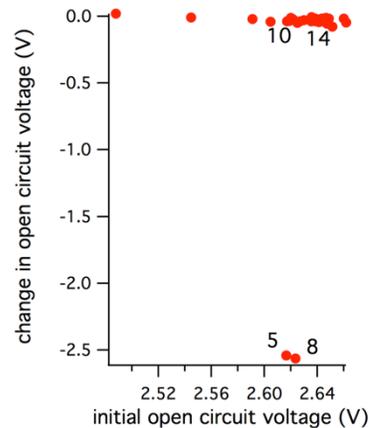
Fig. 4 Change in V_{oc}

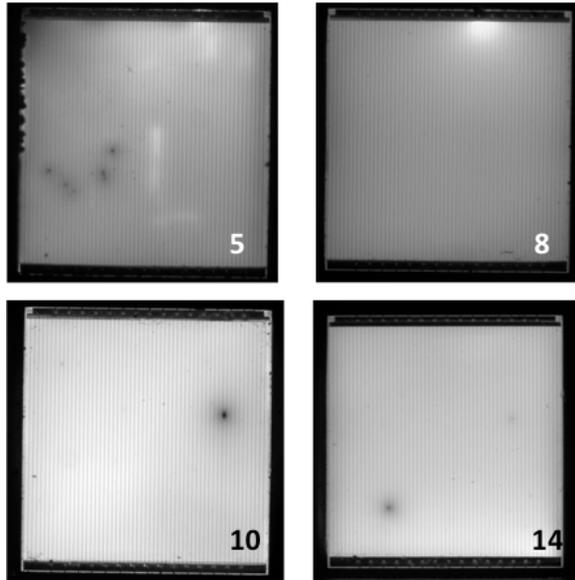
The electroluminescence (EL) images of the four cells showing the largest changes are presented in Fig 5. Cells 5 and 8 show evidence of a large shunt in the top sub-cell under the top bus bar. This is evident as a

bright spot in these un-filtered images. These cells; however, showed no anomaly in the initial I-V curve that would have predicted the formation of this shunt. Cells 10 and 14 contain a shunt within their interior likely present prior to exposure and the cause of their initially high shunt current.

Fig 5. EL images of the cells that showed the largest changes in electrical performance.

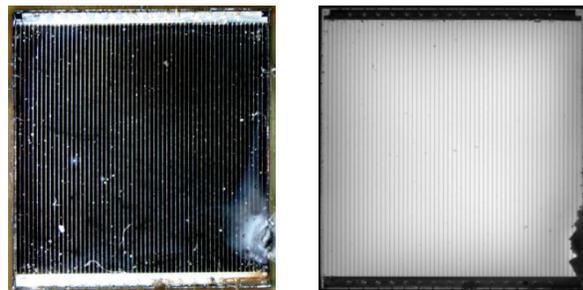
Exfoliation, characterized by a loss of EL emission at the cell’s perimeter, was observed for six of the cells evaluated, cells 1, 6, 15, 21, 26 and 30. These cells are represented by black symbols in Figs. 2 and 3. In three cases exfoliation was adjacent to charring of the package, cells 1, 6 and 15, presumably from an off-sun event, Fig. 6. Cell 6 exhibited the largest area of exfoliation of the cells with charring, and had the largest drop in short circuit current, besides the severely shunted cell 5. Exfoliation was also observed in three cells, cells 21, 26 and 30, that exhibited evidence of the presence of standing water, such as stains on the cover glass and aggregation of dirt and sand, Fig. 7. Each of these cells was located at the bottom of the module further corroborating

Fig 6. Optical (left) and EL image of cell 1 highlighting exfoliation coincident with charring at the cell's edge

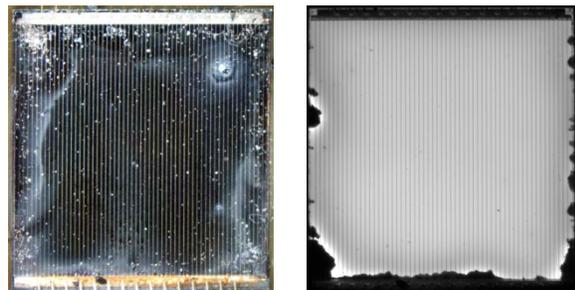
Fig 7. Optical (left) and EL image of cell 26, highlighting cell exfoliation coincident with the presence of standing water.

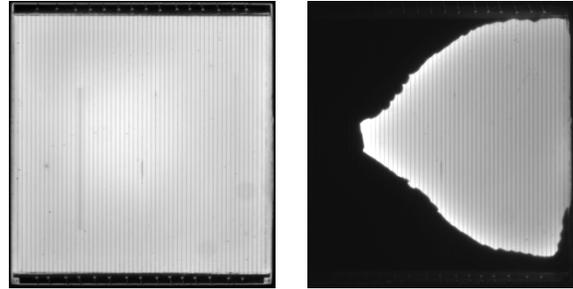
Fig 8. EL image before (left) and following 24-hour room light exposure in water.

The preceding observations prompted a quick investigation into the susceptibility of similarly packaged cells to exfoliate in the presence of water. The cell submerged in water and exposed to room light exhibited extensive exfoliation as evident in its EL emission, Fig. 7. The glass coverslip was subsequently removed from this cell for further analysis and resulted in the exfoliated portion remaining on the coverslip, Fig. 8. SIMS analysis of the exfoliated cell indicates that the top sub-cell was separated. The cell exposed in darkness showed no signs of exfoliation, suggesting the mechanism of exfoliation is an electrochemical reaction.

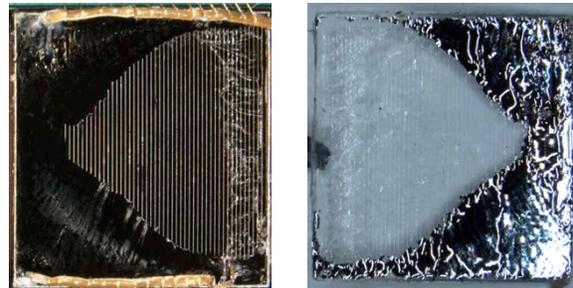
Fig 9. Optical images of cell (left) and removed coverslip following 24-hour room light exposure in water.
