Structural Testing of the Blade Reliability Collaborative Effect of Defect Wind Turbine Blades

M. Desmond and S. Hughes
National Renewable Energy Laboratory

Technical Report
NREL/TP-5000-63512
June 2015

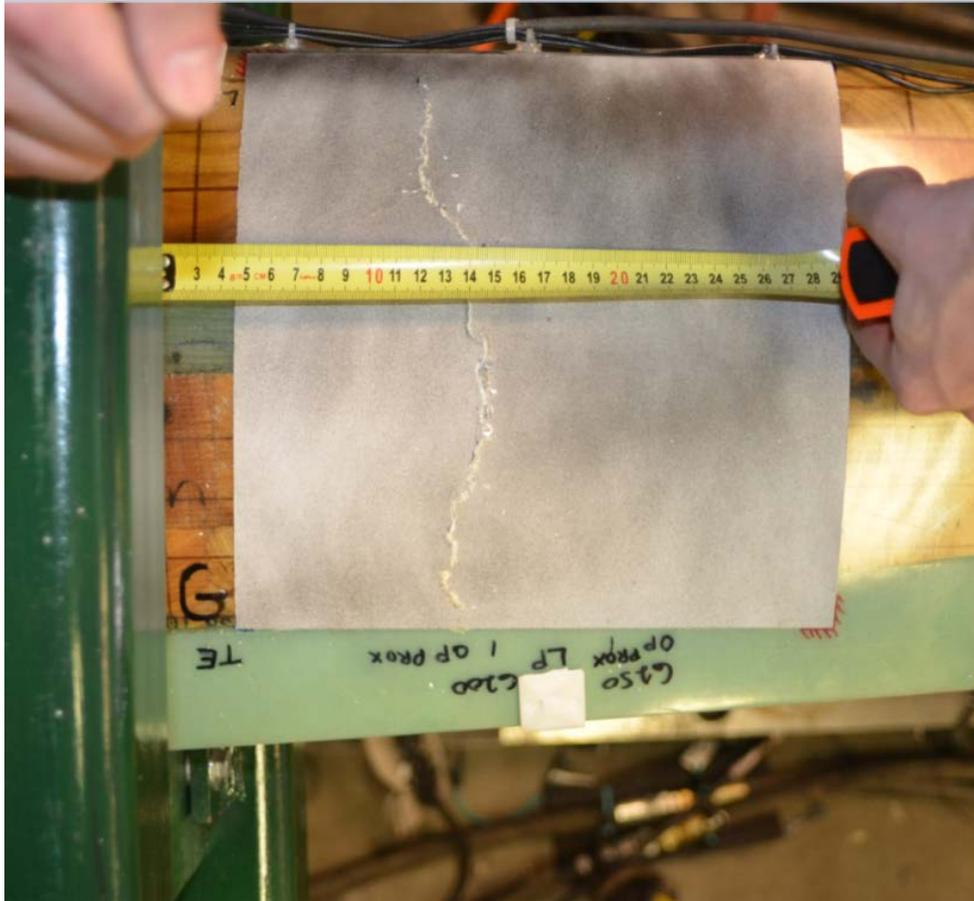
Figure 15 is a photograph of the failure region on the low-pressure surface at the 6.2-m station. The surface at this station had been patterned for DIC imaging. No destructive post-mortem inspections were performed following failures, allowing possible future coupon testing of properties. The failure location of 6.2 m coincides with the location of an out-of-plane wave in the spar cap.

Figure 15. Fiberglass spar cap blade failure area at the 6.2-m station, low-pressure surface.
Photo by Mike Jenks, NREL 32521

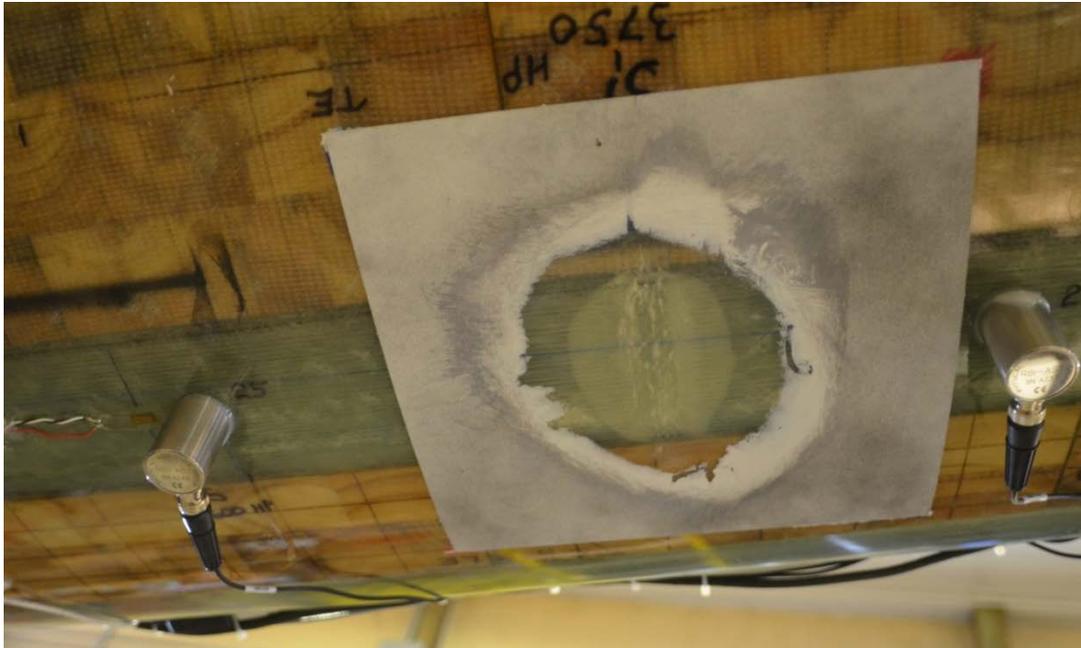
Blade failure occurred at the 3.75-m station on the high-pressure side. An out-of-plane wave flaw was built into the blade at this location. Prior to the final failure, increased AE activity along with changing strain gradients observed by the DIC system at the 3.75-m station warranted a closer inspection of the region. The DIC pattern was removed from the surface of the blade to reveal the features of the damage area. Figure 17 shows the damage area with the DIC pattern sanded from the blade. Matrix (epoxy) cracking is visible across the entire width of the spar cap, with light-colored laminate radiating from the cracks. Light-colored regions in this case are likely caused by delaminations within the spar cap laminate. The final failure at this station was a catastrophic failure of the entire high-pressure skin shown in Figure 18, with the high-pressure skin spanning the entire chord length from the leading edge to the trailing edge.

Figure 17. Fiberglass spar cap blade, high-pressure side damage area at the 3.75-m station prior to catastrophic failure.
Photo by Michael Desmond, NREL 32522

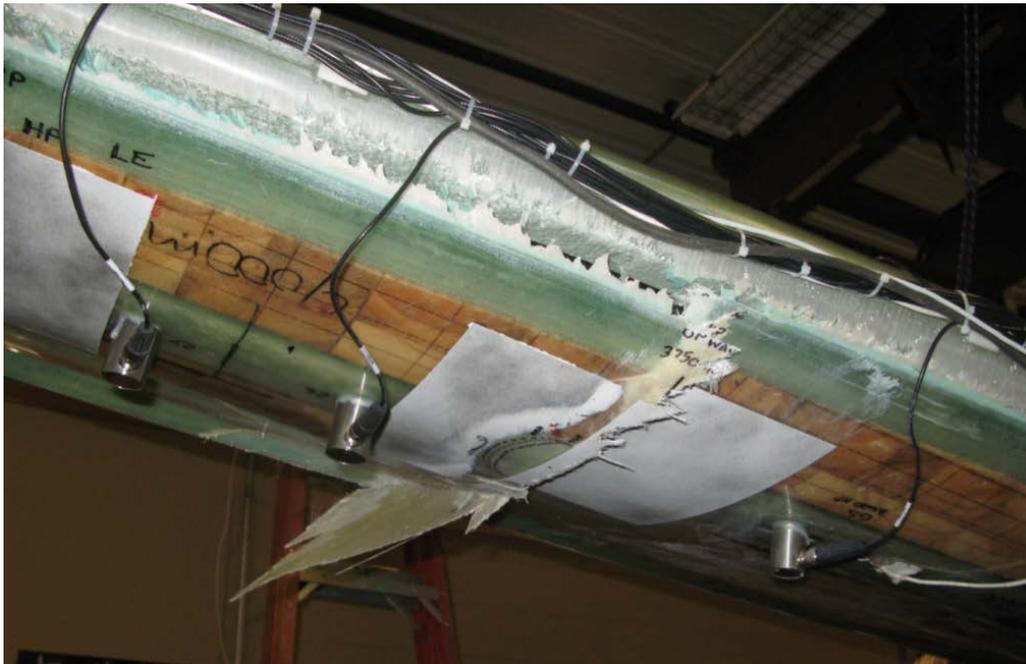
Figure 18. Fiberglass spar cap blade, high-pressure side catastrophic failure at the 3.75-m station.
Photo by Michael Desmond, NREL 32524

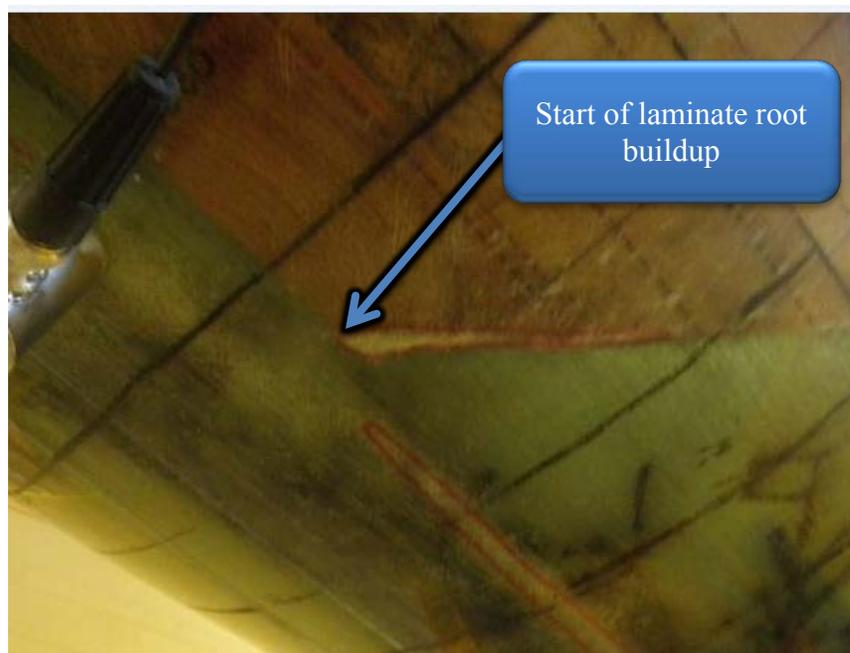
Figure 19. Fiberglass spar cap blade, damage area at the 1.2-m station on the high-pressure surface.

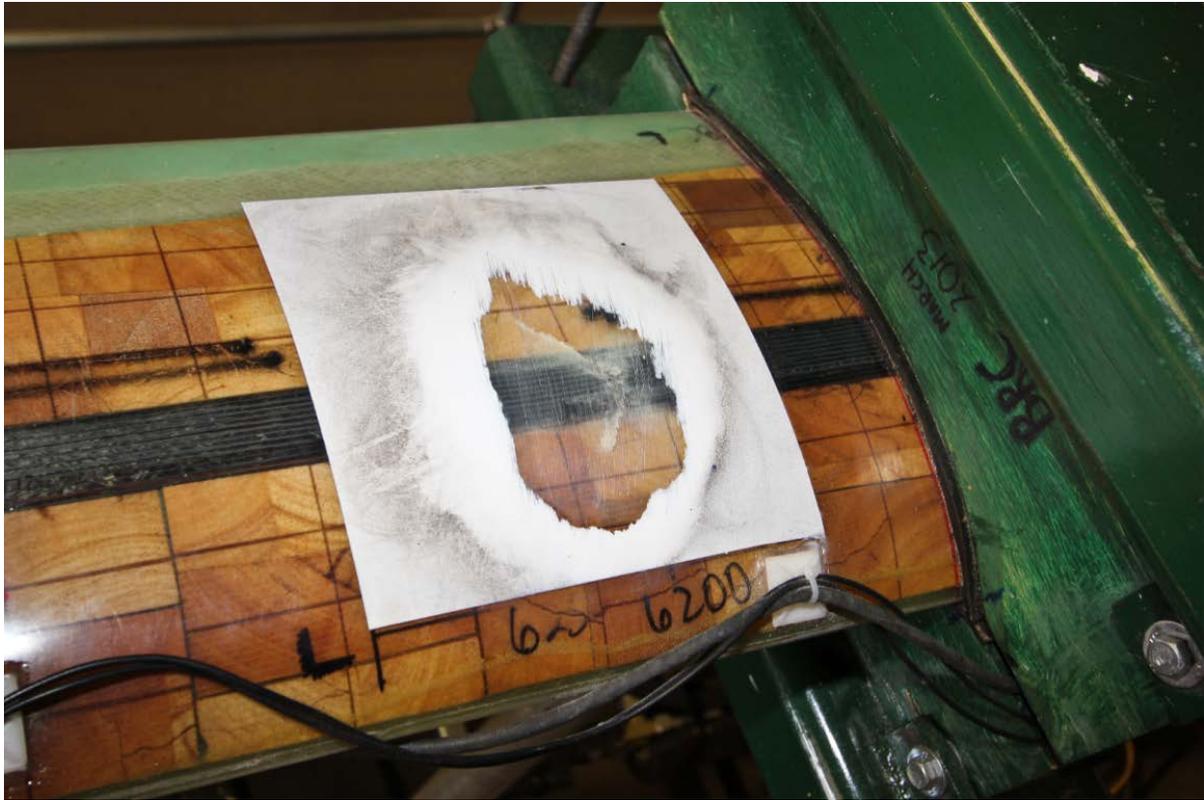
Figure 22 shows a photograph of the failure region on the low-pressure surface at the 6.2-m station. The paint used for DIC imaging had been removed to show the physical characteristics of the blade and failure area. The failure location of 6.2-m coincides with the location of an out-of-plane wave in the spar cap. Visual indications on the surface of the blade show matrix cracking across the width of the spar cap, cracks in the composite across the width of the spar cap that radiate into the leading-edge and trailing-edge panels. Light areas can be seen in the photo and are likely due to delaminations through the thickness of the composite.

Figure 22. Carbon fiber spar cap blade, low-pressure side failure area at the 6.2-m station.
Photo by Michael Desmond, NREL 32528

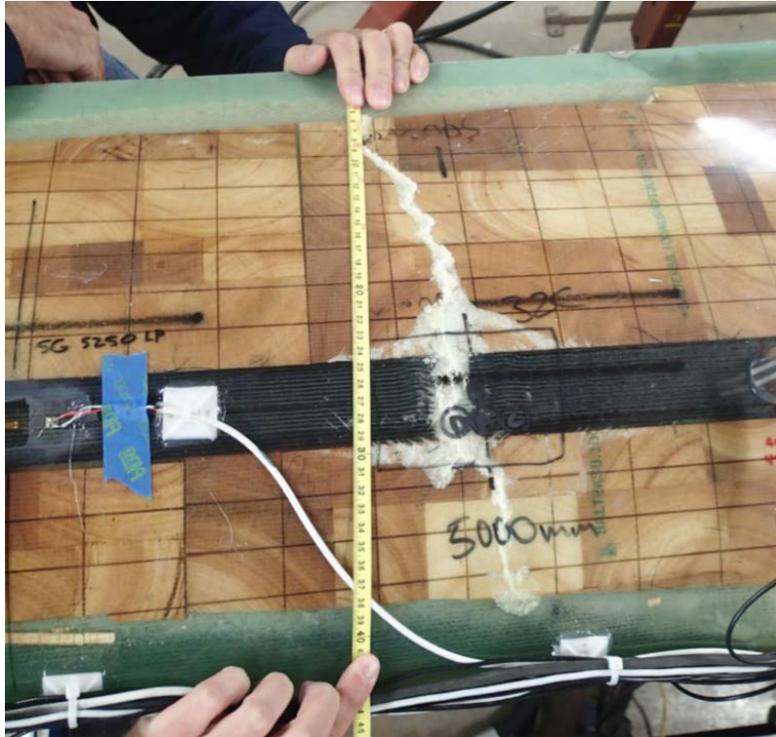
Figure 24 shows a photograph of the failure region on the low-pressure surface at the 5-m station. The failure location of 5 m coincides with the location of an in-plane wave built into the low-pressure side spar cap. Visual indications on the surface of the blade show matrix cracking across the width of the spar cap, cracks in the composite across the width of the spar cap with the final catastrophic failure cracking the entire low-pressure surface from the leading edge to the trailing edge. Light areas can be seen in the photo and are likely caused by delaminations through the thickness of the composite. These light-colored areas in the spar cap are closely confined in the region of the failure.

Figure 24. Carbon fiber spar cap blade, failure region on low-pressure surface at the 5-m station.
Photo by Mike Jenks, NREL 32529

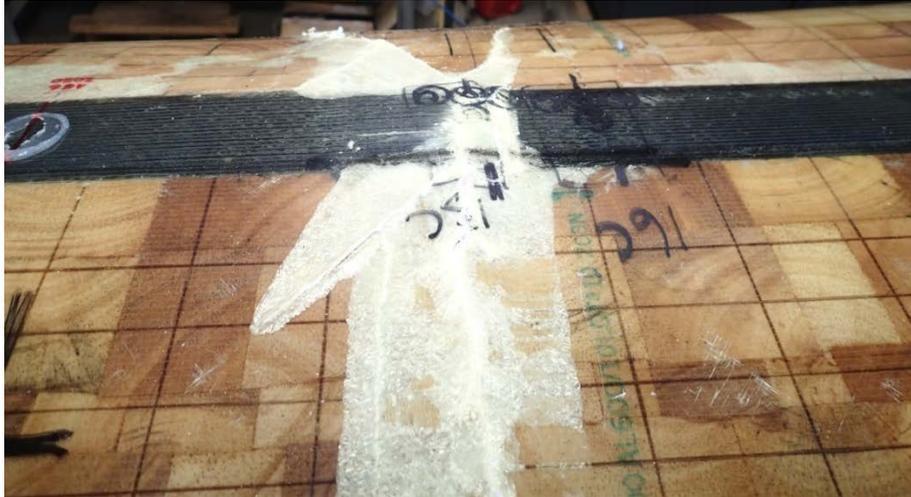
Figure 27 shows a photograph of the failure area. The maximum static bending moment achieved at the 2.25-m station during static loading was 88.8 kN-m. The failure appeared to be buckling with significant damage to the spar cap and cracking of the entire low-pressure surface from the leading edge to the trailing edge.

Figure 27. Failure area on the low-pressure side at the 2.25-m station, carbon fiber spar cap blade.
Photo by Michael Desmond, NREL 32530
