Photovoltaic Array Field Characterization Report: University of Toledo R1 Arrays

Timothy J. Silverman, Peter McNutt,
and John Wohlgemuth
National Renewable Energy Laboratory

Technical Report
NREL/TP-5J00-64998
September 2015

Four ground-mounted PV arrays are situated on the south side of R1 (Figure 1). The systems were installed in two phases: the two southernmost systems in 2006 and the two northernmost systems in 2014. The systems installed in 2006 are the subject of this report. We visited the site from 2014-09-22 through 2014-09-25.

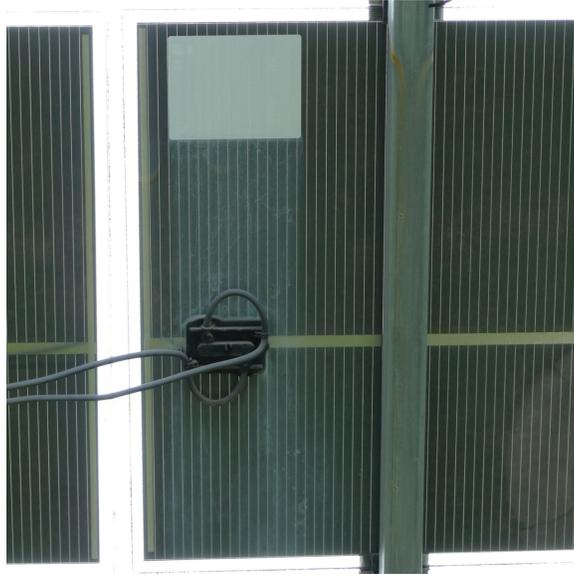
Every module’s nameplate was nearly illegible because the black text had been bleached white. The chalky texture of the labels had some contrast where lettering once was, enabling the reading of serial numbers at certain angles. The chalky residue appears to have washed down the backs of the modules, leaving streaks behind (Figure 2).

Figure 2: Degraded nameplates on this system left streaks of chalky residue on the backs of modules. Text on the labels was nearly illegible.

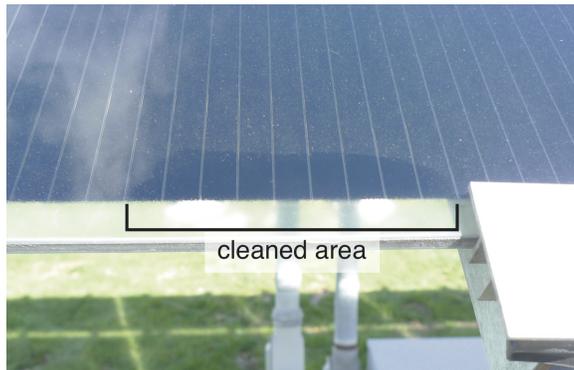
Immediately before our visit, the site received enough rain to clean the modules. We cleaned a small area of one module to visualize the extent of the soiling that was not washed away by substantial rainfall (Figure 3). On subsequent days, dew on the modules trapped considerable additional soil from a construction site across the street.

Figure 3: Light soiling present even after substantial rainfall is evident when a small area is cleaned completely.

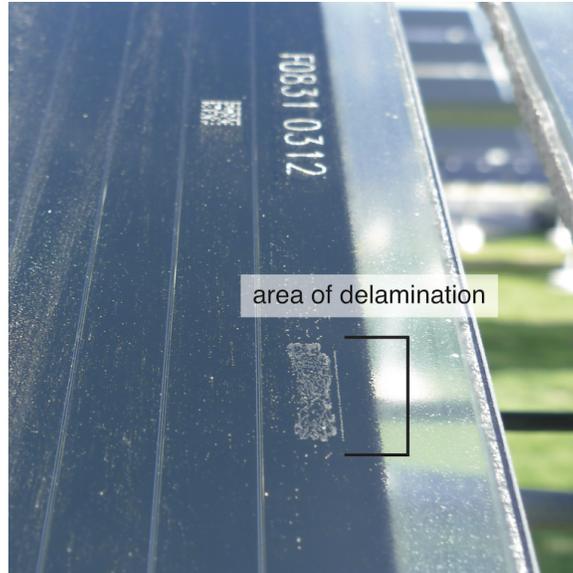
The modules use metallic bus tape to connect the junction box to the terminals of the first and last cells. On about 75% of the modules, a small area of delamination was visible near the serial number, at the intersection of the bus tapes at the junction box end of the module (Figure 4). On some specimens, this delamination extended to areas of the bus tape beyond this intersection, but was always most visible at the intersection. On modules having this delamination, minor discoloration of the encapsulant was visible at the bus tape intersection (Figure 5). Series 3 First Solar modules use a substantially different bus tape design.

Figure 4: A small area of delamination was present in the same location on about 75% of modules. This location is the intersection of one pair of bus tapes.

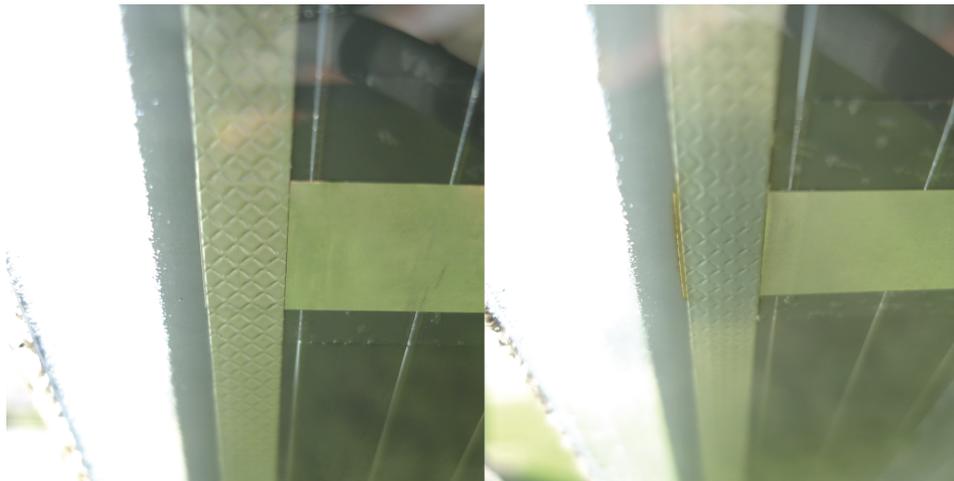
Figure 5: On modules without the type of delamination shown in Figure 4, there was no discoloration at the bus tape intersection (left) but those with the delamination showed brownish discoloration of the encapsulant at this intersection (right).

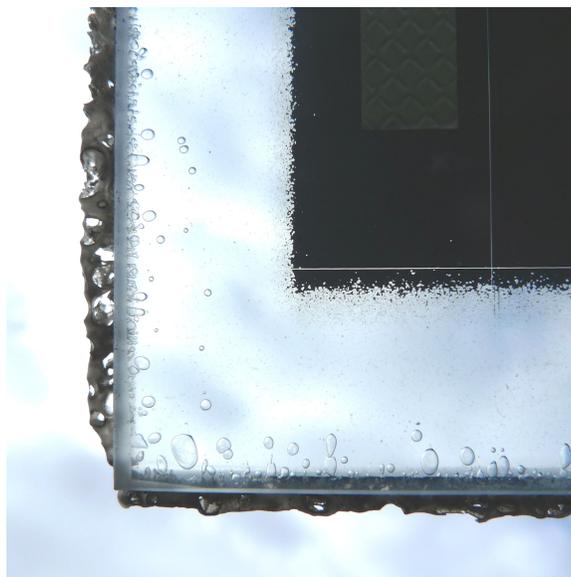
Most modules had a ring of extruded encapsulant around the periphery of the laminate (Figure 6). This extrudate contained many gas bubbles which, in some cases such as in Figure 6, continued into the margin of the encapsulant. The extrudate was gray in color, presumably due to trapped soil. The out-of-plane thickness of the extrudate was nearly the full thickness of the module and in many cases the outside edge of this extrudate was artificially flat (Figure 7), suggesting that it had been extruded against a form during manufacture and not in the field.

Figure 6: Every module had a porous band of extruded encapsulant around the edge.

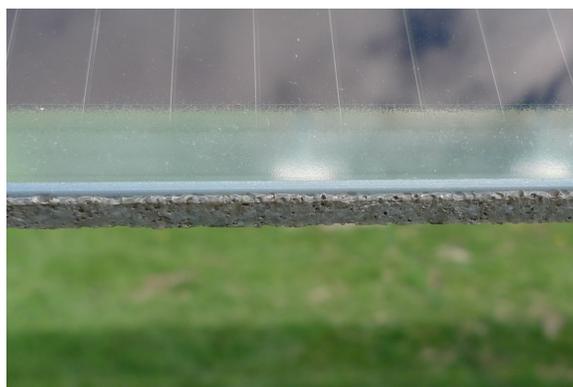
Figure 7: The encapsulant extrudate was nearly the entire thickness of the module and, in many cases, it was artificially flat, suggesting that it did not extrude in the field.

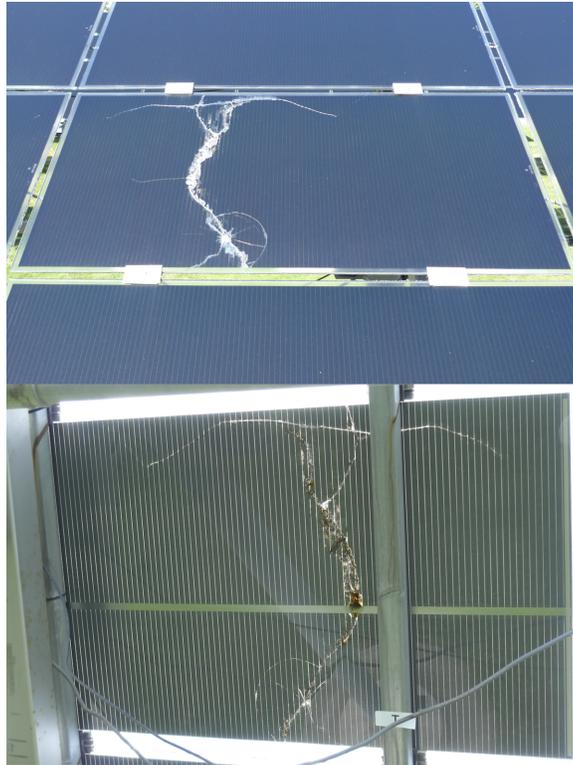
Two modules had broken front glass and one had broken back glass. The modules with broken front glass had visible impact sites and were both located on the array nearest the

street and sidewalk. The most extreme example is shown in Figure 8. Visible from the back side of the module was brown discoloration presumably due to locally high temperature at areas where the broken glass disturbed interconnection or allowed water ingress.

Figure 8: The front (upper image) and back (lower image) sides of a module with broken front glass.

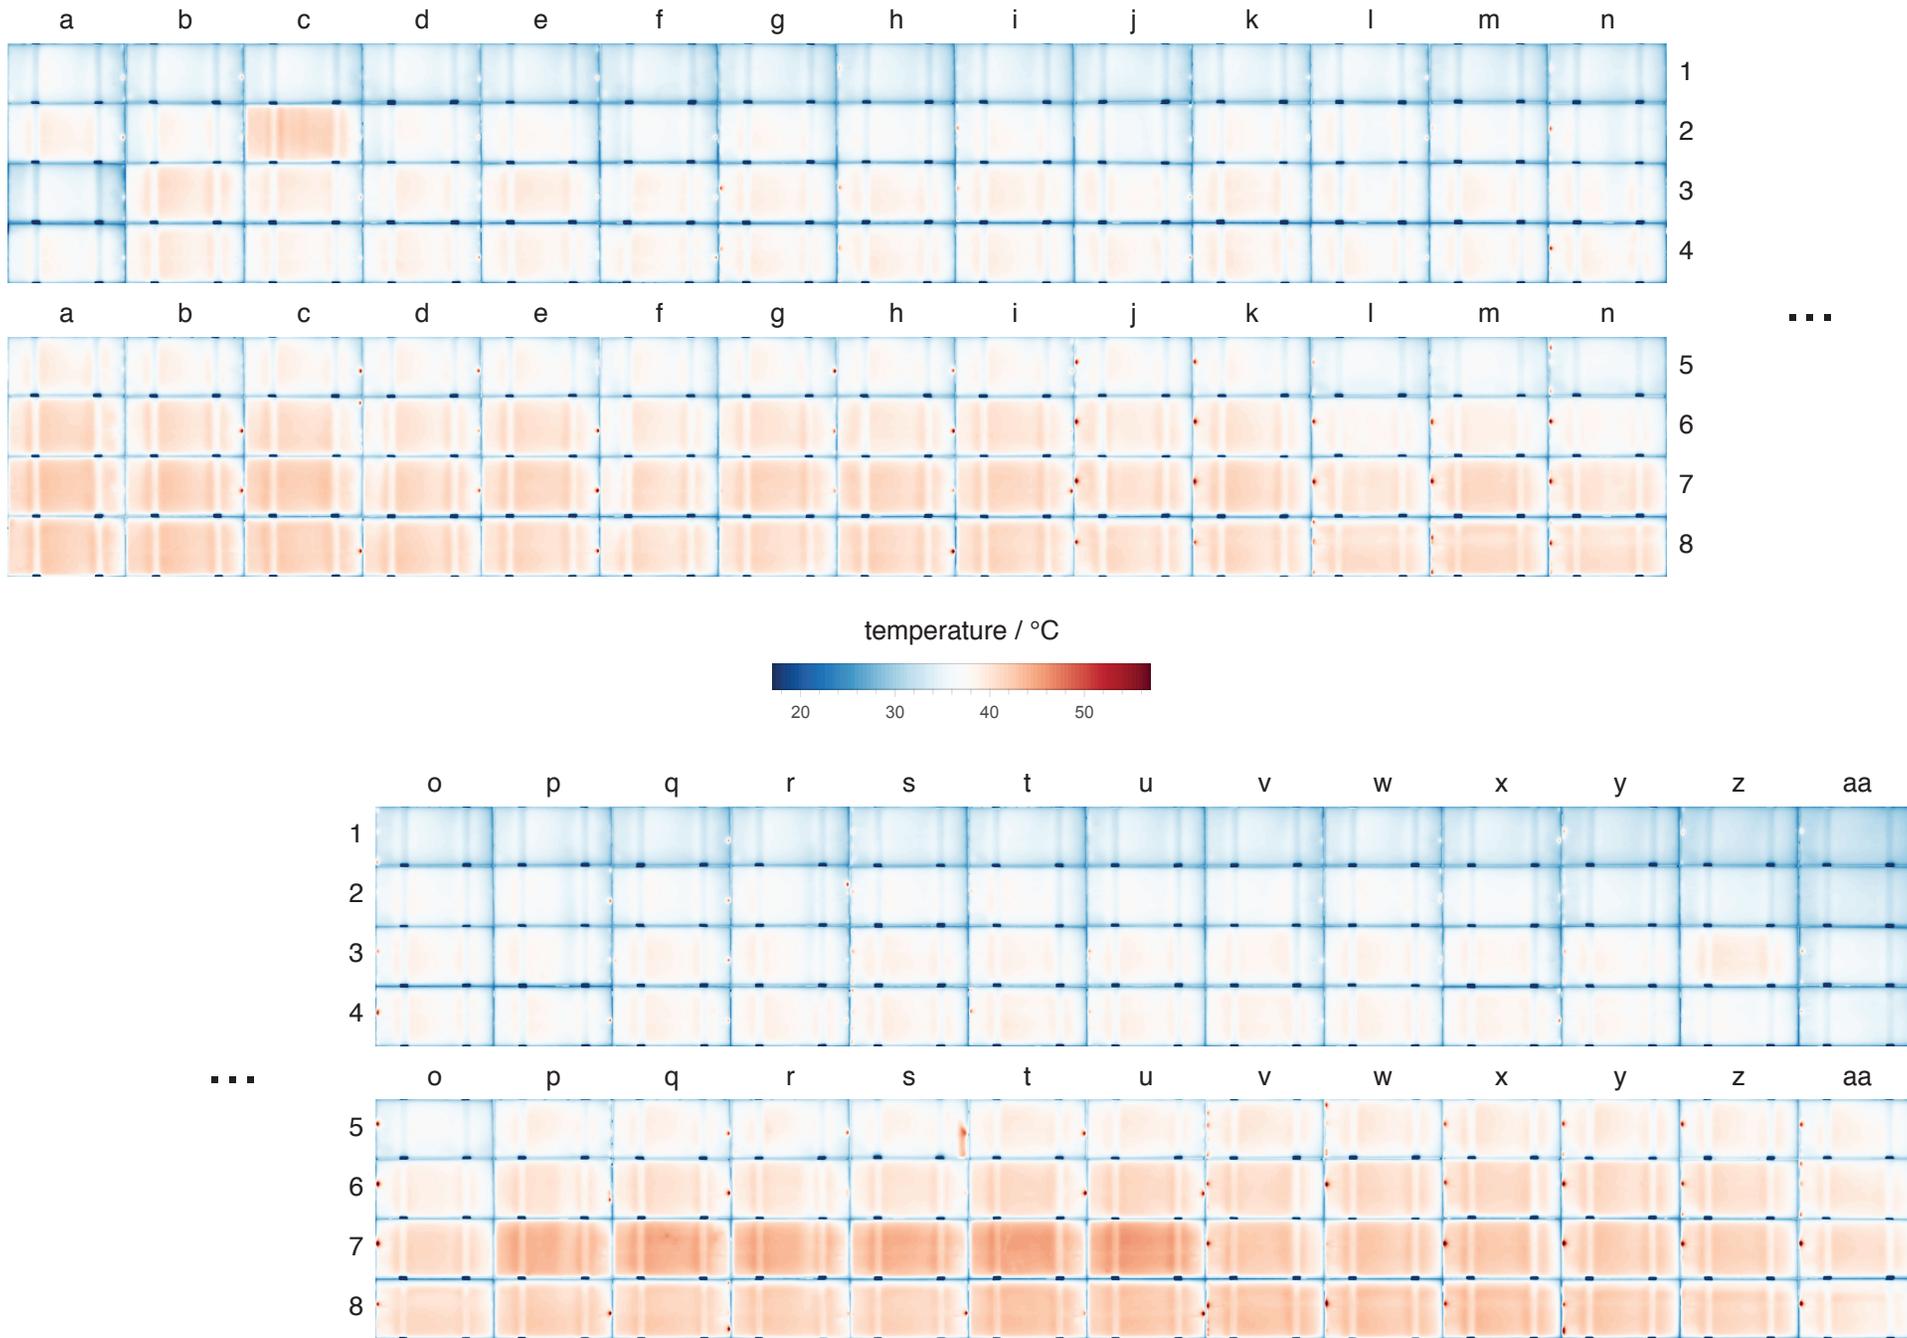
A temperature map of the systems is shown in Figure 9. The map is composed of images collected of each north-south pair of modules. The northernmost modules in each system were necessarily imaged at a shallower angle than the southernmost modules. No correction has been made for sky reflection, so these rows are artificially cooler in the map.

The map shows the bus tape defect on 75% of modules. Typical modules with bus tape heating show a single spot (Figure 10), while some, such as s4 and h8 (shown in detail in Figure 11), have multiple hot spots along the bus tape. One string of six modules (p7–u7) is hotter than the surrounding modules because the broken module t7, shown in Figure 8, places the entire string at open circuit.

Figure 9: An uncorrected temperature map of both systems. Note that modules n1–n4 and n5–n8 are physically adjacent to o1–o4 and o5–o8, respectively. The upper rows appear cooler because their images were collected at a shallower angle.

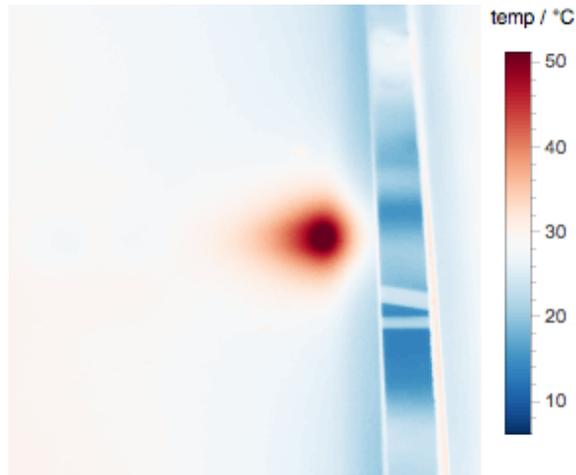
Figure 10: Most modules with bus tape heating show only a single hot area at the intersection of the bus tape. This is over the same area indicated in Figure 4.

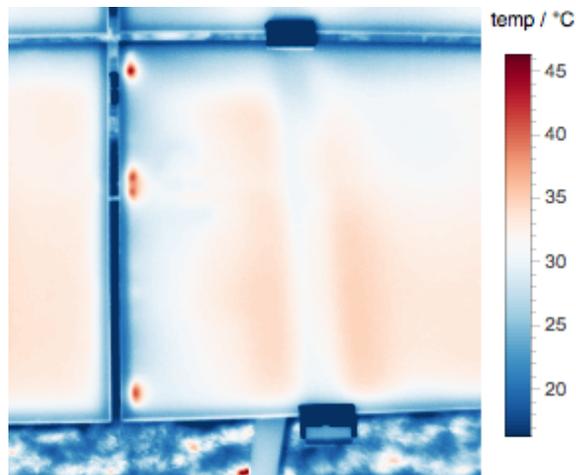
Figure 11: Module h8 is a specimen with multiple hot areas along the bus tape.

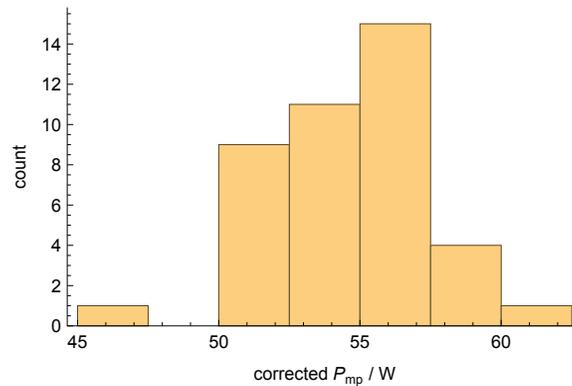
A histogram of corrected power is shown in Figure 12. The median power was 54.8 W, about 4% below the nameplate power rating, but the sampled population contains a higher fraction of modules free of bus tape heating than the array. Weighting the with-heating power measurements by 0.75 and the without-heating measurements by 0.25, the mean corrected power was 53.6 W, about 6% below the nameplate power rating. The median corrected P_{mp} values for the “row 1” and “row 2” systems were not significantly different.

Figure 12: Median corrected P_{mp} for the 47 sampled modules is about 4% below the nameplate rating.

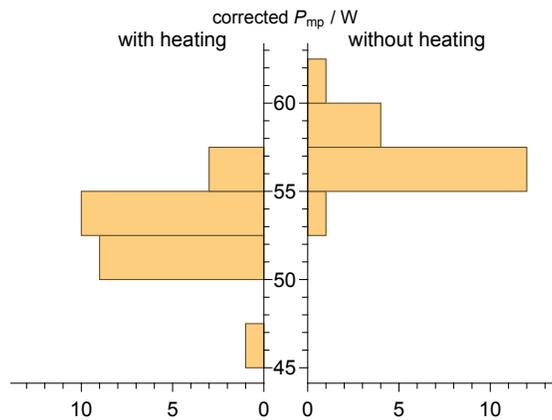
A paired histogram of corrected P_{mp} for modules with and without bus tape heating is shown in Figure 13. The medians were 52.6 W and 56.7 W, respectively, suggesting the bus tape delamination was responsible for a 4.1 W (7%) reduction in power. The median values of P_{mp} for the two populations were significantly different according to a Mann-Whitney test ($p < 0.001$).

Figure 13: Corrected P_{mp} for modules with (left) and without (right) bus tape heating. The median P_{mp} values from these two populations were significantly different.

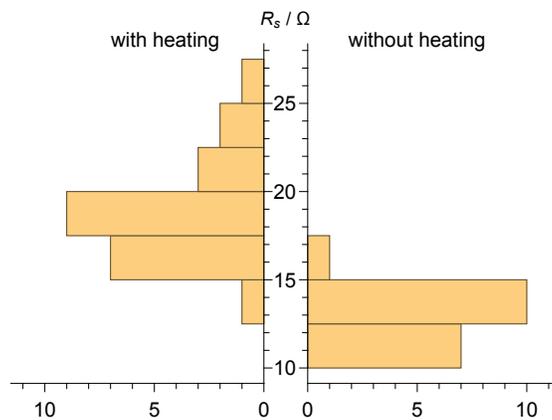
We fitted each I-V curve using the single diode model [3] to determine each module's series resistance, R_s . A paired histogram of R_s for modules with and without bus tape heating is shown in Figure 14. The medians were 18.3 Ω and 12.7 Ω , respectively, suggesting that the bus tape delamination was responsible for a 5.6 Ω (44%) increase in series resistance. The median values of R_s for the two populations were significantly different according to a Mann-Whitney test ($p < 0.001$).

Figure 14: Series resistance (R_s) for modules with (left) and without (right) bus tape heating. The median R_s values from these two populations were significantly different.
