Mariah Windspire Project Summary

As part of the National Renewable Energy Laboratory and U.S. Department of Energy (NREL/DOE) Independent Testing project (<http://www.nrel.gov/wind/>), NREL was testing Mariah Power's Windspire Giromill small wind turbine at the National Wind Technology Center (NWTC) through January 14, 2009 when NREL terminated its testing.

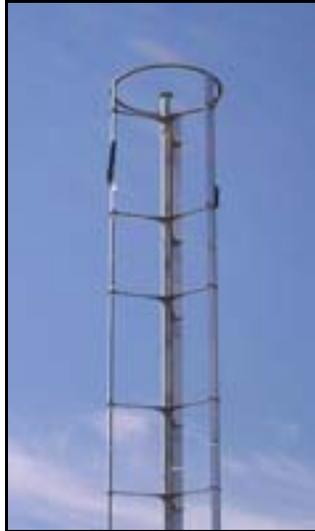
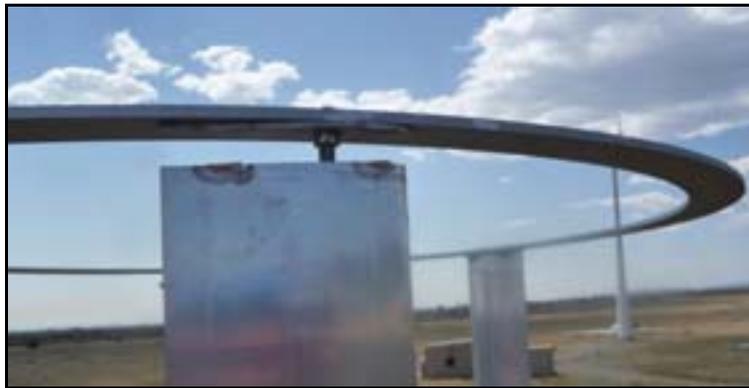
7/30/08

While the leading edge tape was being replaced (due to detachment), a broken weld was found at the top of the turbine and another crack was observed on a different weld. Initially, the welding was done in two spots per airfoil side. The airfoils also slid out of the struts that are supposed to clamp them. This may have caused the broken weld. The turbine was visibly wobbling and was tilted down.

The manufacturer was on-site to replace the airfoils and struts. This is a change that will be required for all production machines. The tower base bolts were replaced with bolts with set screws to keep bolts from loosening. The weld was improved to a continuous weld.

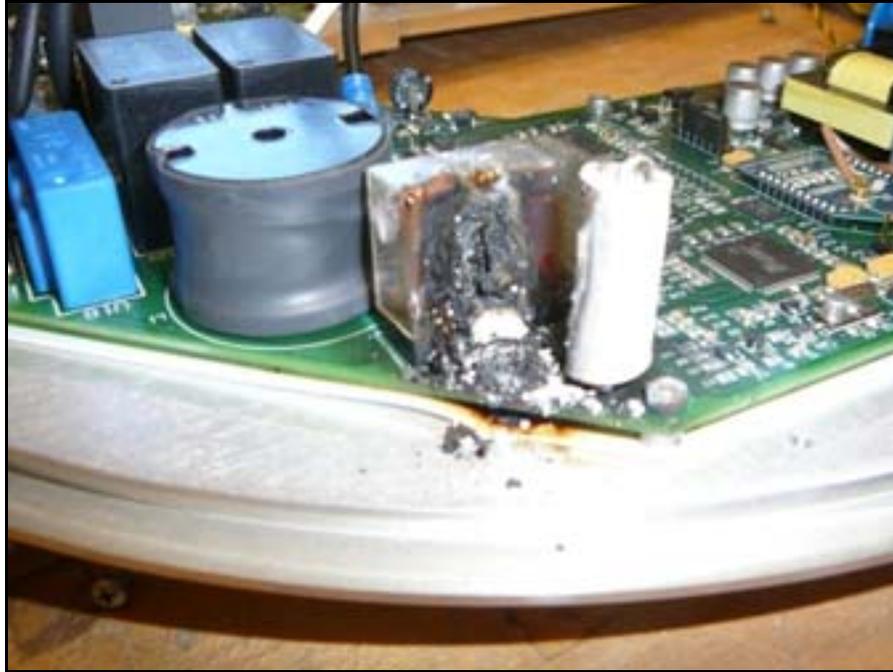
9/13/08

The inverter failure occurred because the set points of the inverter were set to optimize power performance. The increased performance caused the temperature to rise, and over time, caused the inverter to fail. The inverter was replaced. The set points were set for normal production.

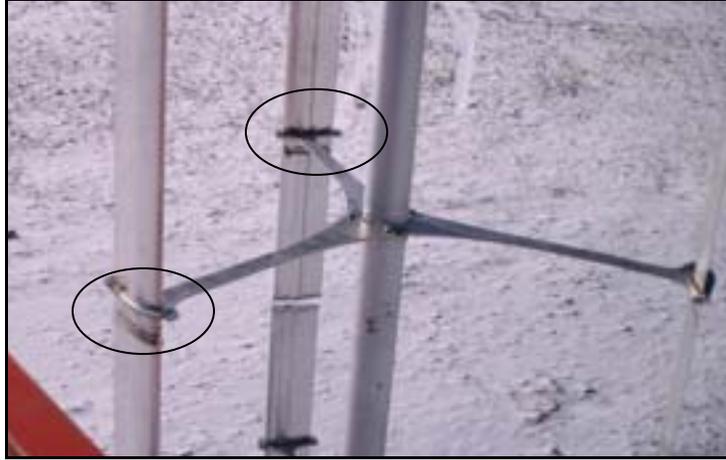
11/19/08

Two out of three airfoils slid down through the struts. In the picture, the black markings show where the airfoils used to be.

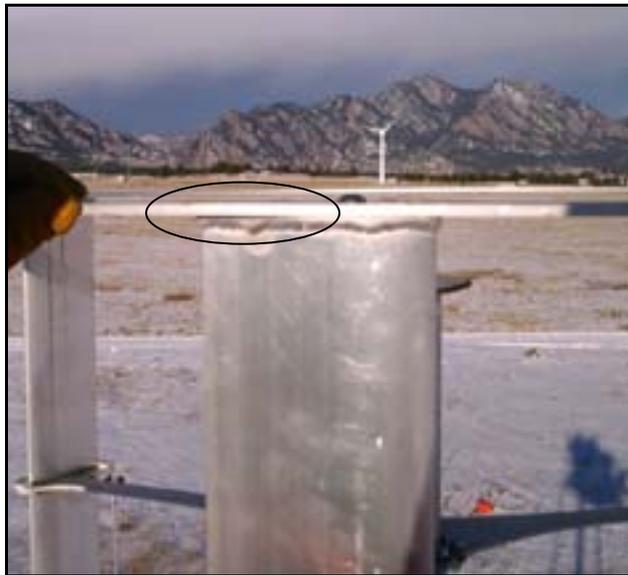
12/16/08

During the noise testing, a clanging sound emanated from the turbine. The testing team found two broken welds at the top of the turbine. The turbine was shut down until further notice. This photo shows one of the broken welds that caused the airfoil to separate from its end plate. However, the airfoil did not completely separate as it did in the previous occurrence.

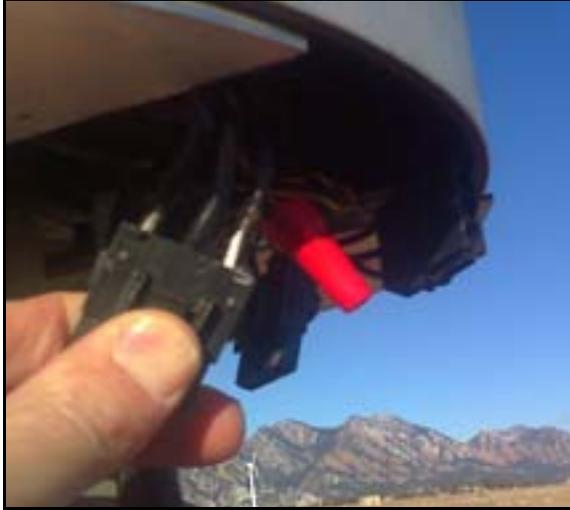
1/14/09

The testing team checked the turbine after it observed possible higher rotational speeds while the turbine was shut off. Measurements that were taken to check for generator continuity were varied when they should have been less than 5 ohms. The team found that two of the three wires from the generator were missing insulation and bare wire was exposed. There was no noticeable difference in resistance when force was applied while the generator was connected or not.

The turbine was lowered.
