Lightning Activities in the DOE-EPRI Turbine Verification Program

T. McCoy, H. Rhoads, and T. Lisman
Global Energy Concepts, LLC

*Presented at the American Wind Energy Association's
WindPower 2000
Palm Springs, California
April 30 - May 5, 2000*

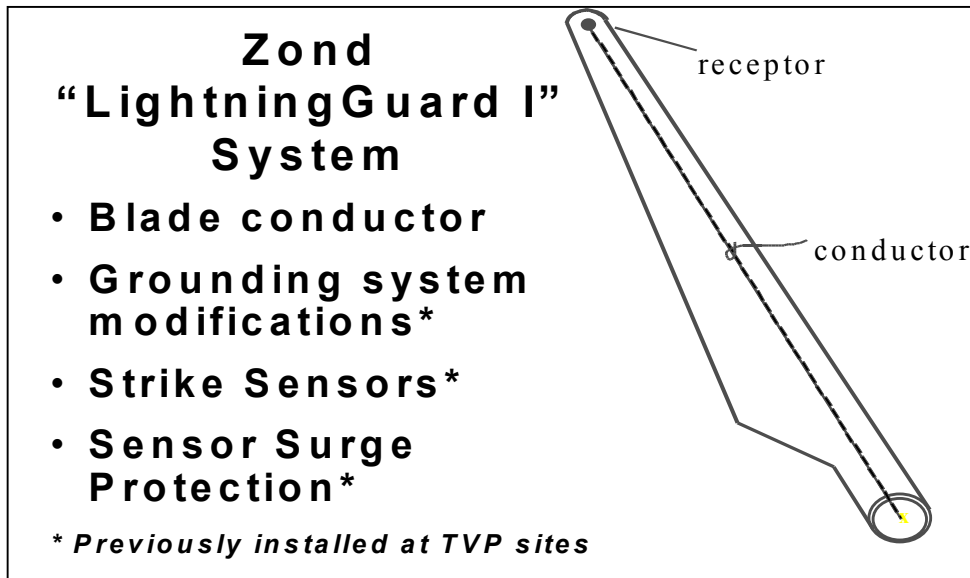
One of TVP's primary findings was that the Zond turbines had no blade conductors, except for the Z-40A, which has an aluminum push rod in the blade to actuate the ailerons. The Tacke and Vestas turbines both had blade conductors designed for lightning protection. Both of the Zond turbine models without blade conductors have suffered lightning-related blade damage. Zond recently developed and tested a retrofit for the Z-50 blades, and installed conductors in Algona and Springview this spring. Shown in Figure 6, Zond's "LightningGuard I" conductor retrofit consists of a copper tube that is fed through the interior of the blade, held in place with expanded foam blocks and connected to surface-mounted air terminals at the blade tip.

Figure 6. Z-50 “LightningGuard I” retrofit

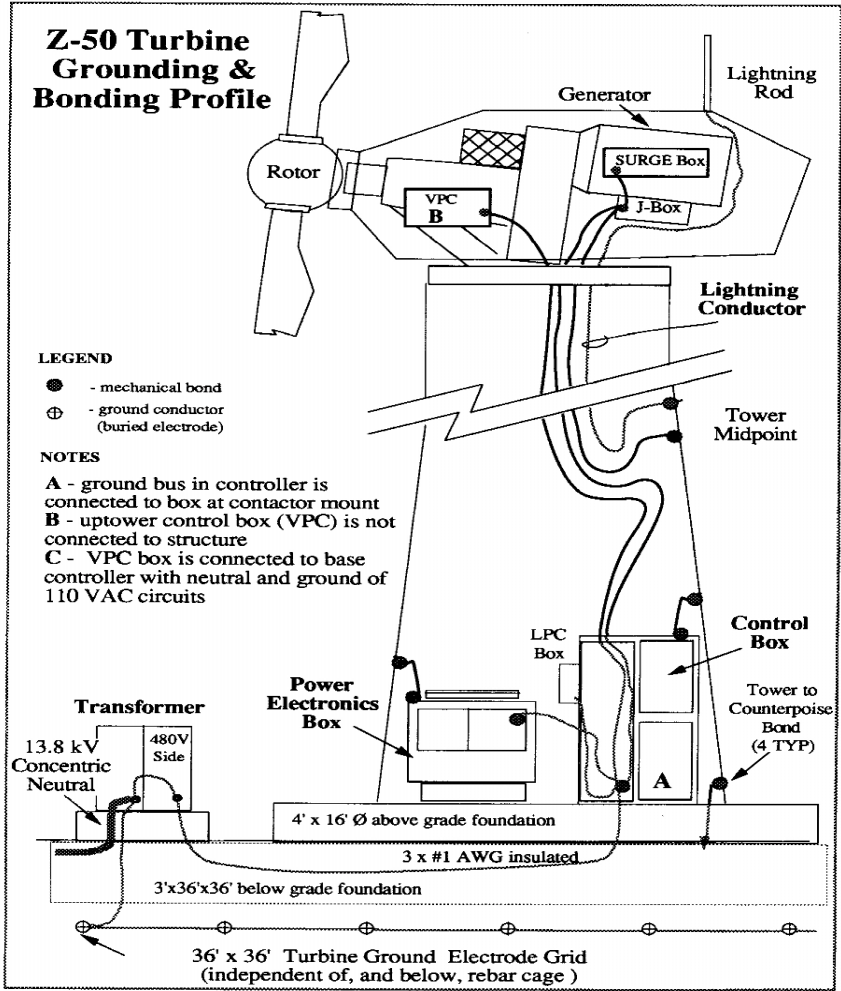
A variety of other retrofits were identified and implemented on the TVP turbines. These included improvements to the turbine grounding and the controller cable shielding. Figures 7 and 8 show additional modifications made to the Z-50s in Algona and Springview and to the Z-40A turbines in Ft. Davis. The recommended modifications to the Z-40FS turbines in Vermont are similar to those shown for the Z-50. These retrofits typically involve improving the grounding path through the turbine structure, shielding the sensor cables, and improving the earth ground at the foundation. On the Z-40FS and Z-50 turbines, the controller cable shielding was connected at the entry point of the controller enclosures and copper over-braid shield was provided in critical locations such as the anemometer cable.

Figure 7. Lightning protection for Z-50s in Algona, Iowa and Springview, Nebraska

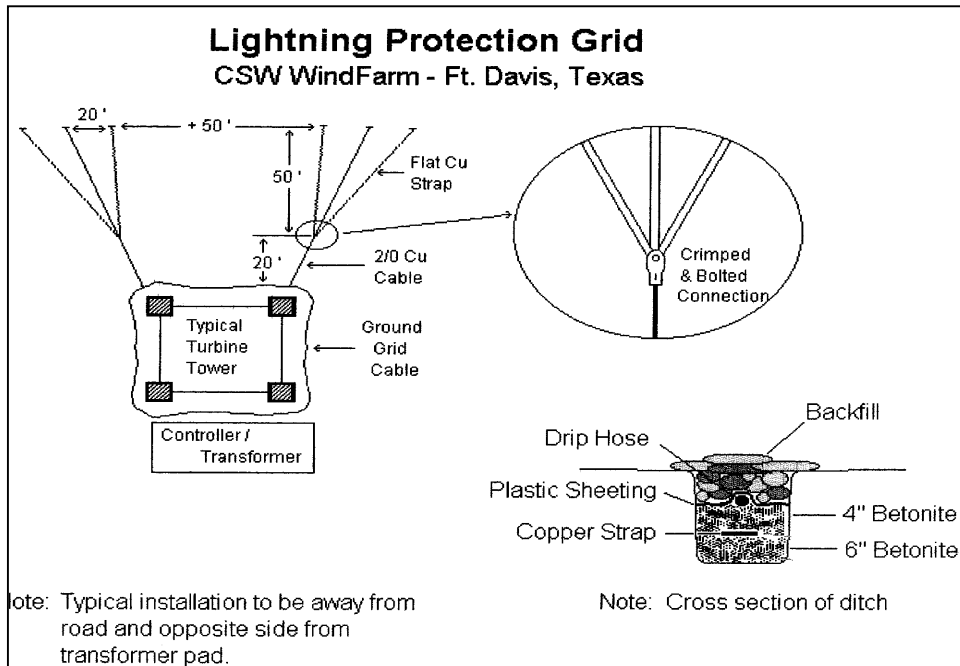
Figure 8. Lightning protection grounding grid in Ft. Davis, Texas

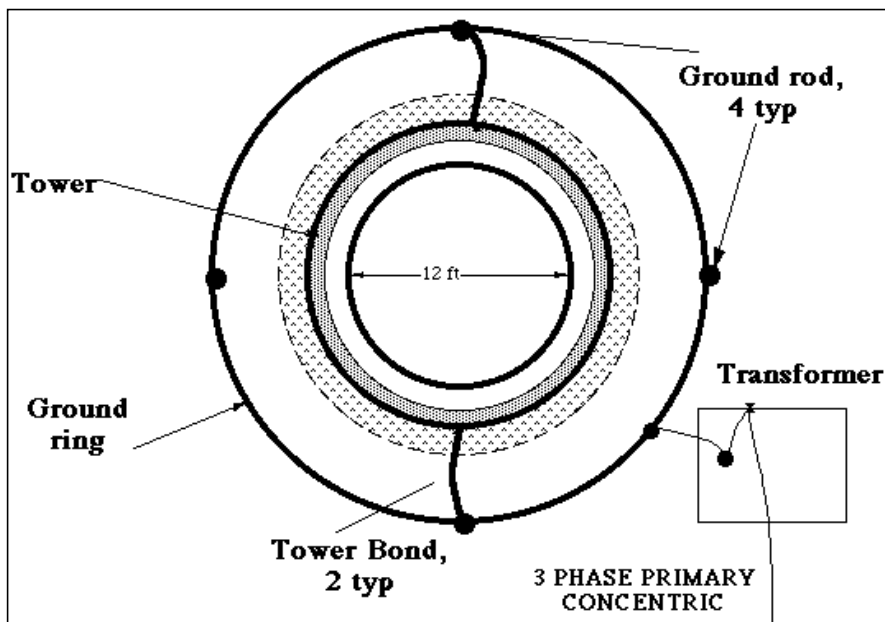
Figure 9 shows the earth-grounding arrangement in Big Spring. Vestas' lightning protection is a continuous grounding system, extending from internal blade conductors through the concrete foundations. Based on the experience of local electricians, Big Spring's project owner, York Research, installed lightning arrestors at each turbine transformer and in the overhead power lines in response to lightning-related interruption of radio communications during initial project operation.

Figure 9. V-47 and V-66 foundation grounding schematic at Big Spring, Texas
