Yakama Nation Housing Authority, Adams View: System Retrofit Research Report and Case Study Summary

February 23, 2004–January 15, 2005

CARB (Consortium for Advanced Residential Buildings)
Norwalk, Connecticut

Subcontract Report
NREL/SR-550-38263
November 2005

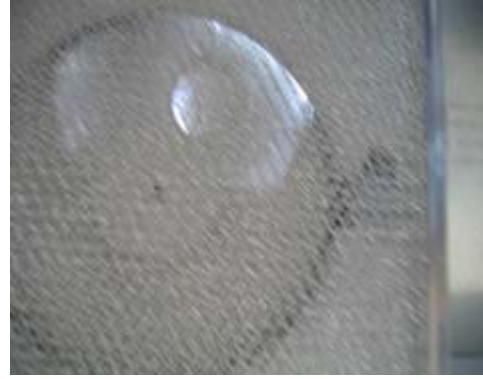
Figure 7. Looking up kitchen exhaust

There was also significant leakage through the exhaust fans. Up to 80 cfm was being drawn through the kitchen exhaust fans during the blower-door depressurization test. A backdraft damper should be installed in the flue or as a part of the fan housing, but these are either missing or improperly installed in the units tested. Figure 7 shows a picture looking up the kitchen exhaust for unit #303. Though difficult to see in the picture, there was no damper as is evident by the light penetration down the flue.

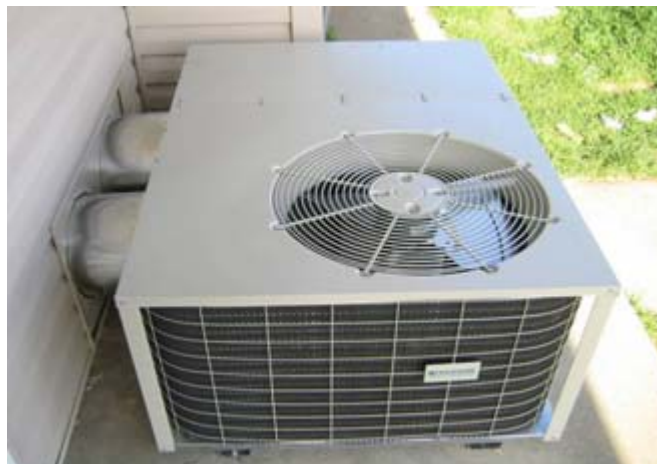
Figure 9. Packaged heat pump unit for house #303

There are inherent problems with an external heat pump; for example, uninsulated ductwork might be a concern (Figure 9). However, the supply duct is actually insulated and has an external metal sleeve to protect the insulation from rain and snow. One issue that was mentioned previously was concerns of vandalism. The heat pump in Figure 9 is actually the second heat pump installed at house #303. The first one was stolen from the site a few days before CARB's testing. The units are typically bolted down to the concrete pad, but the stolen unit had not been. In addition, the testing revealed higher duct leakage to the outside values than we initially anticipated with an internal air handler. Performance testing (Table 4) resulted in duct leakage to the outside of 55.5 cfm₂₅ (7%; with a 2-ton heat pump and assuming 400 cfm/ton).

A major design detail that is usually ignored is the proper sealing of ductwork. CARB recommends that all ductwork connections be properly sealed using mastic and that the ductwork then be completely buried in the attic insulation to provide additional thermal resistance to the ductwork and minimize losses of the distribution system. The Yakama climate is dry, making ducts buried in attic insulation a viable measure.

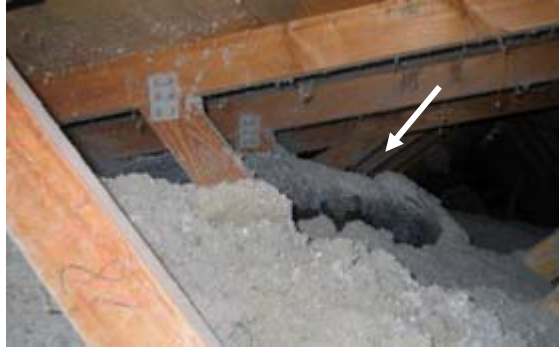
Figure 11. Ductwork partially buried in attic

CARB also recommends that the flexduct in the attic be buried under the cellulose insulation (Figure 11). Burying the flexduct in the cellulose, decreases heat loss and gains between the ducts and the attic space. This was successfully implemented except where the flexduct needed to cross the ceiling joists to get to the outer rooms.

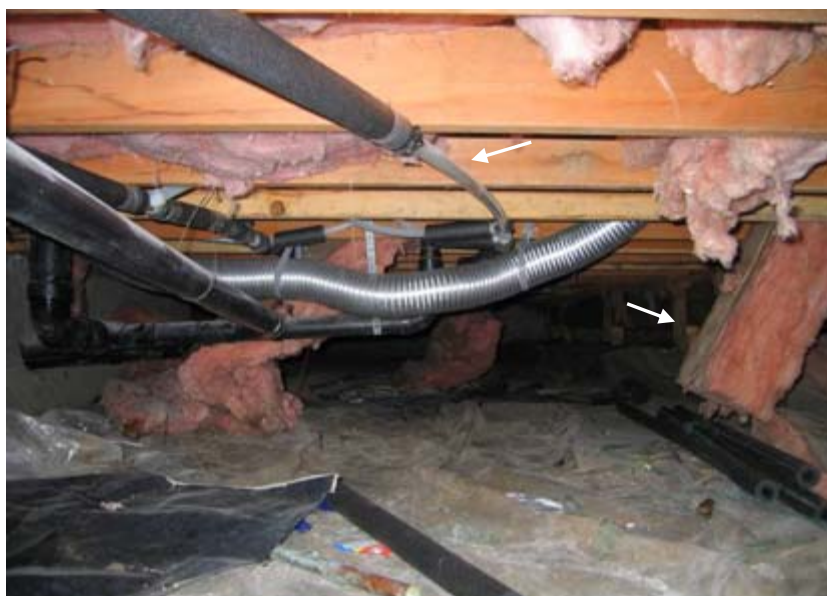
CARB has some concerns with the quality control of the floor truss insulation installation. It was observed in several of the crawlspaces that batt insulation placed in the floor is falling out in various places. This will allow for greater heat transfer through the floor and will derate the overall U-value of the floor. During the winter months, this poor installation will be more noticeable as homeowners will likely have comfort issues because of the cold spots and potential condensation problems.

Figure 14. Crawlspace of Unit #303

Either greater care needs to be taken in placing these batts or something like spring rods/batt hangers should be used during the installation (Figure 13). In addition, the PEX piping should have continuous insulation wrap on it. Exposed piping in the crawlspace will greatly increase hot water distribution losses (Figure 14).
