Investigation of Various Condition Monitoring Techniques Based on a Damaged Wind Turbine Gearbox

S. Sheng

Conference Paper
NREL/CP-5000-51753
October 2011

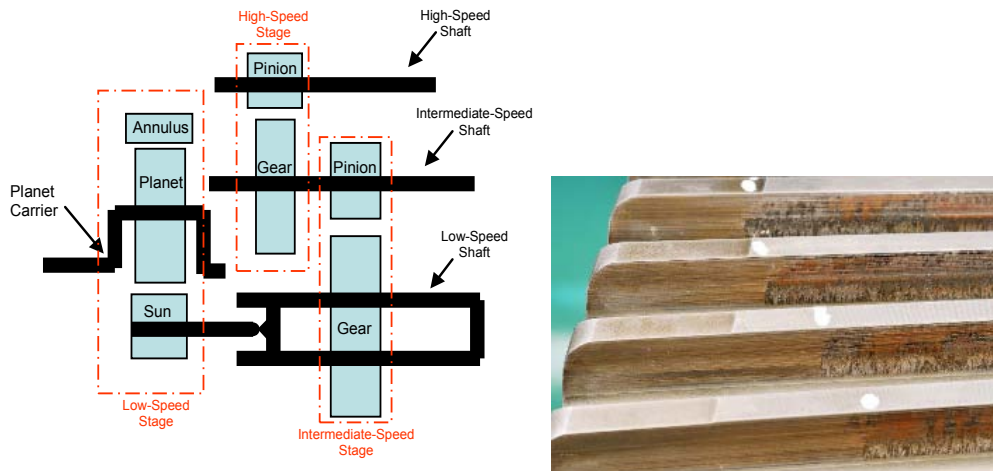
Figure 4 shows one type of damage that occurred to the test gearbox. The damaged component is the high-speed stage gear located on the Intermediate-Speed Shaft (ISS). The gear suffered from severe scuffing. The main root cause of this damage is lubricant starvation and overheating contacting gear teeth surfaces. The high-speed stage pinion has 22 teeth, and the gear has 88 teeth. At 1800 revolutions per minute (rpm), this gear set has a meshing frequency of 660 Hz. The detection of this damage will be used in the following section to illustrate the results obtained by various CM techniques.

Figure 3. Internal configuration of the test gearbox. Figure 4. Damage to high-speed stage gear.

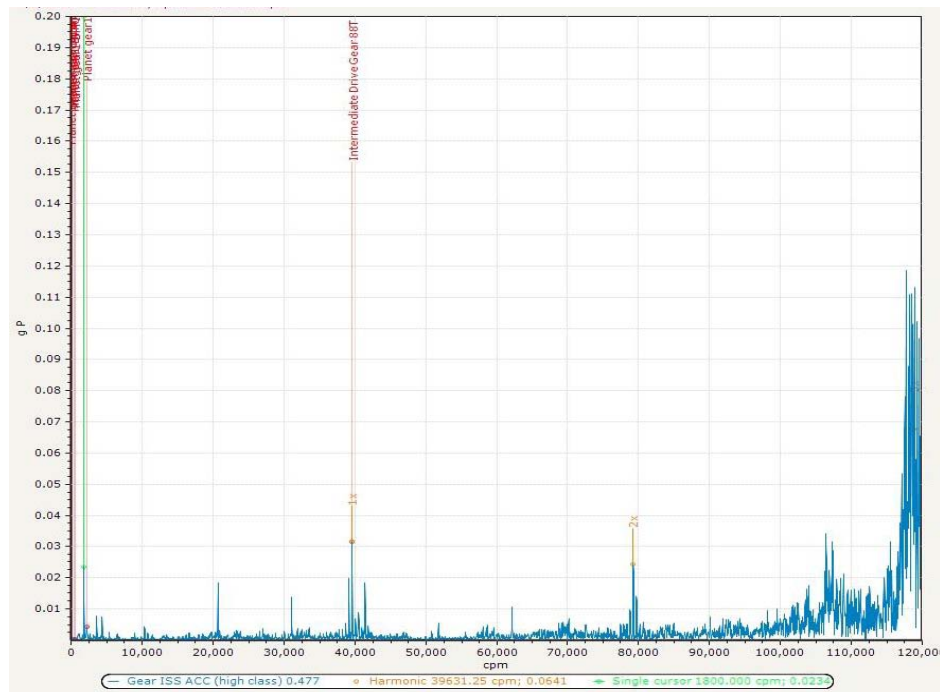
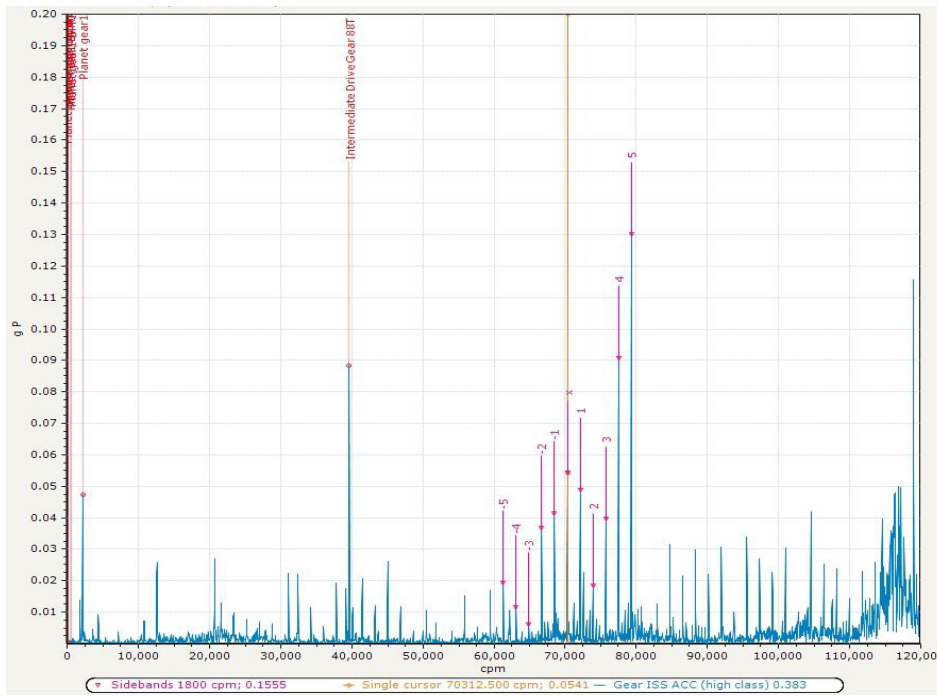
The first set of results (Figure 5 [4]) was obtained by the vibration-based CM technique. They are spectra of vibration data collected by one accelerometer mounted to the ISS on the back cover of the test gearbox. Figure 5 (a) shows measurements from the healthy gearbox, and Figure 5 (b) shows data collected from the damaged gearbox. For both figures, the horizontal axis shows frequency in counts per minute (60 cpm = 1 Hz) and the vertical axis shows acceleration with a g ($1 g = 9.8 m/s^2$). The fundamental high-speed stage gear meshing frequency (GMF) of 39,600 cpm or 660 Hz, and its 2nd harmonic are labeled in the figures. By comparing Figure 5 (b) to 5 (a), it is clear that the damaged gearbox has more frequency components and an elevated amplitude for GMF sidebands. For

illustration purpose, the ten sideband frequencies (five below and five above) the 2nd harmonic of the high-speed stage GMF are labeled in Figure 5 (b). Such a spectrum pattern as illustrated in Figure 5 (b) typically represents abnormal gear set behaviors. Since the sideband frequencies are clearly around 39,600 cpm, it is easy to tell that the problematic gear set is on the high-speed stage. In addition, the amplitude of the fundamental high-speed stage GMF has increased from 0.0325 g for the healthy gearbox to 0.0875 g for the damaged gearbox. Such an increase in GMF amplitude is another indication of abnormal gear set behavior. Even without a detailed calculation, it is obvious that the energy contained in the frequency spikes from the damaged gearbox is much higher than that from the healthy gearbox. This is a result of both increased amplitude of those frequencies already contained by the healthy gearbox and the addition of energy caused by new frequency components in the damaged gearbox. Based on these findings, it is reasonable to conclude that the vibration-based monitoring technique can successfully diagnose such gear set damage.

Figure 5. Readings from vibration-based CM technique.

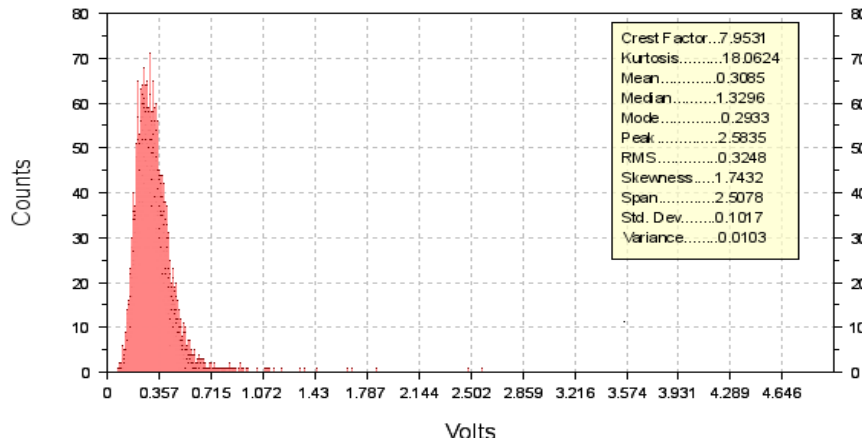
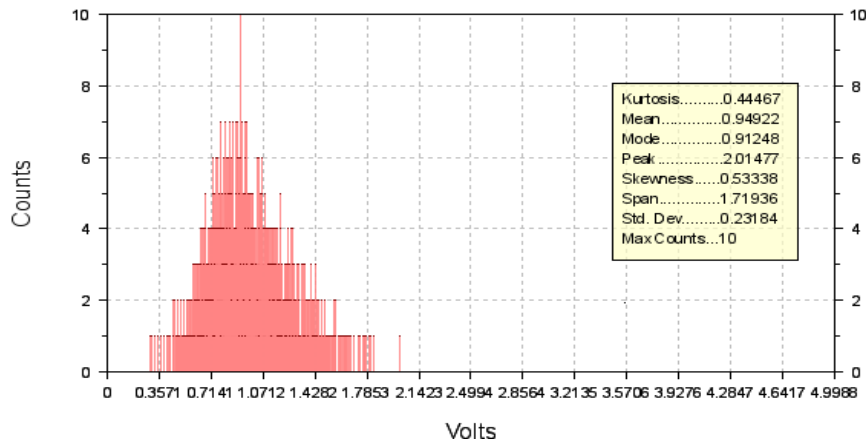
The second set of results (Figure 6) was obtained by the AE (specifically, stress wave)-based CM technique. The stress wave sensor was mounted axially in the middle of all three shaft ends on the back of the test gearbox. The sensor output is conditioned to generate a stress wave pulse train, which represents a time history of individual shock and friction events that have occurred in the monitored machine [5]. By first finding the peak amplitude of each of the pulses in the stress wave pulse train, and then distributing these peaks into voltage bins that correspond to the value of each reading, the resultant diagram—called a Stress Wave Amplitude Histogram [5]—as shown in Figure 6, is generated. In healthy machines, the distribution should be a narrow bell shape and located at the lower end of the voltage scale, as illustrated by Figure 6 (a). In abnormal machines, the distribution

should be much broader and shifted to the right on the amplitude scale, as illustrated by Figure 6 (b). Figure 6 (a) implies that the monitored gear sets were healthy and Figure 6 (b) implies that the monitored gear sets were problematic. In order to identify whether the damaged gear set is on the high-speed or the intermediate-speed stage, it is necessary to get some frequency domain information. Because such results are expected to be similar to those obtained from the vibration-based technique, they are not presented.

Figure 6. Readings from AE-based CM technique.

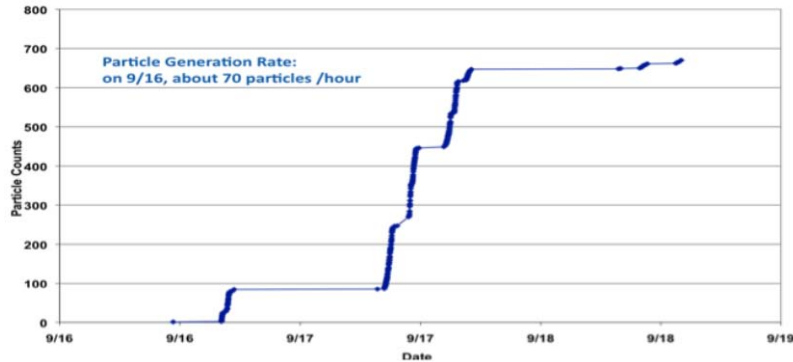
The third set of results (Figure 7) was obtained from the oil-based CM technique; specifically, these results were obtained from the inline oil particle counting sensor. The counts represent the number of ferrous particles with a size greater than 350 μm and detected by the sensor over a certain period of time. As shown in Figure 7, the particle generation rate reached about 70 particles per hour

on 9/16, when the damaged gearbox was tested. Comparatively, about 11 particles were generated over a period of 4 hours from a healthy gearbox [6]. It is therefore reasonable to conclude based on the oil particle counting results that the retested gearbox has high particle-generation rates. Some damage has occurred to its internal components, and further investigation is recommended. However, due to the lack of frequency information provided by either the vibration or AE-based technique, it is difficult for real-time oil CM to determine where the wear was generated.

Figure 7. Readings from oil-based CM technique.
