Gearbox Reliability Collaborative Update: A Brief

NREL/National Wind Technology Center

AWEA Operations & Maintenance Working Group Meeting

NREL/PR-5000-53804

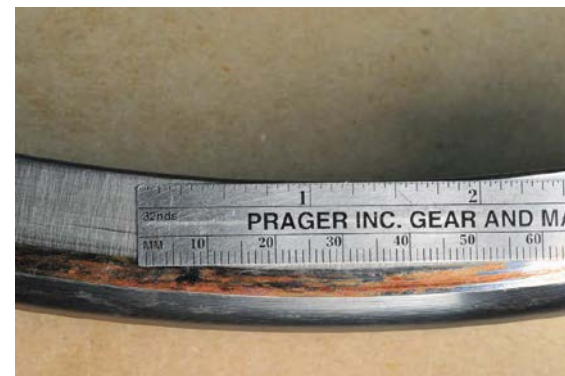
Bearing PLC-A Outer Raceway (Severe Fretting Corrosion) Photo from GEARTECH, NREL/PIX 19748

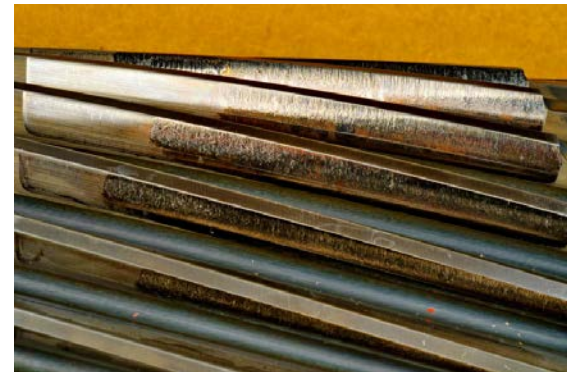
- Two main root causes
 - Oil starvation
 - Assembly damage
- Simple triggers may lead to complex damage

High-Speed Stage Pinion (Severe Scuffing)
Photo from GEARTECH, NREL/PIX 19743

- Simple causes may lead to complex damage
- Operation and maintenance improvements are necessary to minimize the possibility of oil loss
- Additional attention to assembly is needed to avoid damage
