# High-R Walls for Remodeling: Wall Cavity Moisture Monitoring

J. Wiehagen and V. Kochkin  
*NAHB Research Center*

December 2012

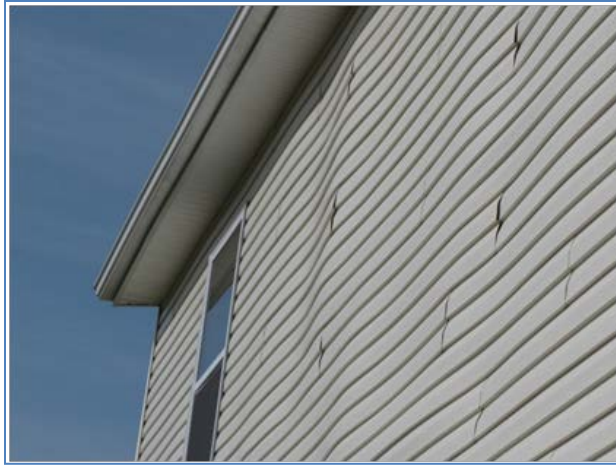
The team interviewed several builders who experienced this problem. The problem manifested itself as “wavy” vinyl siding (Figure 1 through Figure 4). The repairs typically involve removing the siding and replacing buckled OSB panels. Evidence of the panels having elevated moisture levels was observed during the repairs, including in some cases observations of a “mold-like substance” on the interior face of the panel. During repairs made in the winter months, in some cases, frost was also observed on the exterior face of the panel.

**Figure 1. Wavy lap siding resulting from buckled OSB panels on the rear wall of a house**

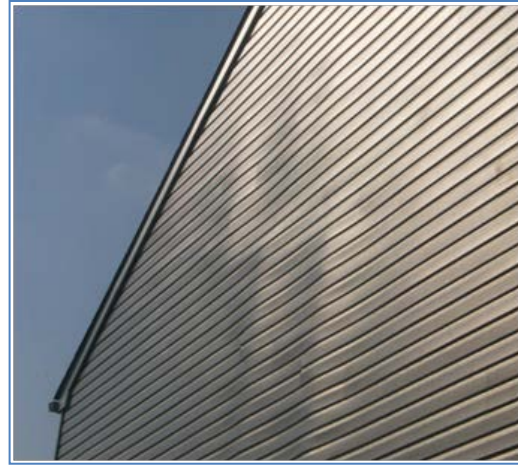
**Figure 2. Wavy siding resulting from buckled OSB panels on a side wall of a house**

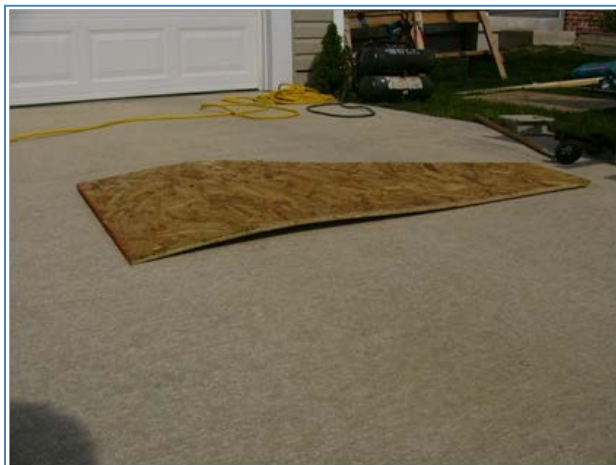
**Figure 3. Removed buckled OSB panel**

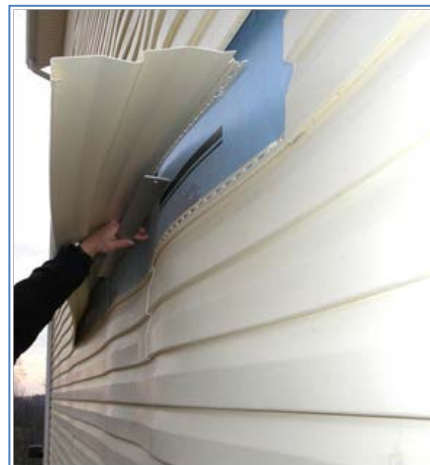
**Figure 4. Wall with buckled OSB panels (siding removed exposing the weather-resistant barrier)**

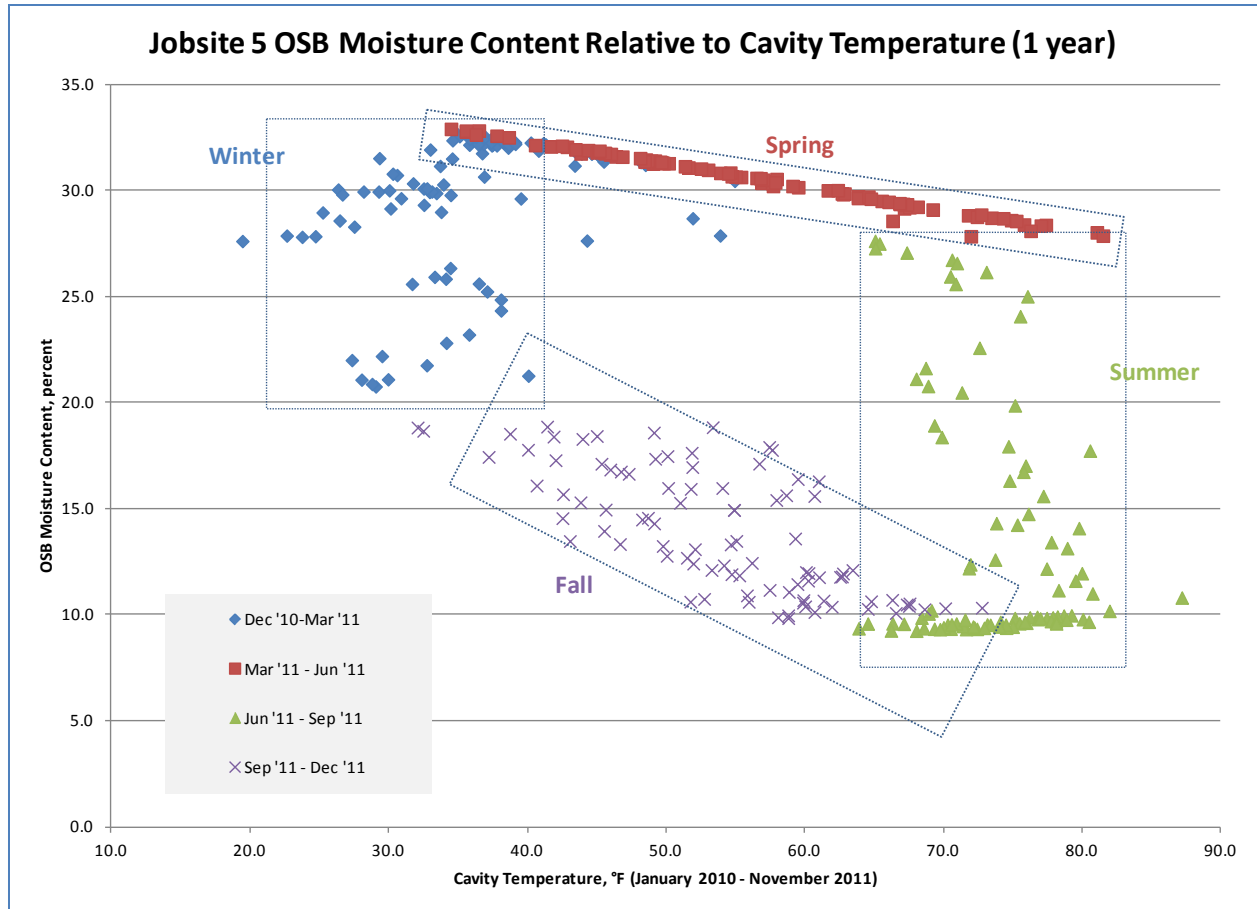
A number of wall cavities in Jobsite 5 show elevated MC readings for an extended time period, lasting into the early summer when the MC readings drop off quickly. Figure 22 represents data for a 1-year period in a wall cavity comparing the MC to the cavity temperature. The cyclic nature of the MC is clearly shown as well as the relationship between the cavity temperature and the MC where the MC levels greater than 20% span both warm and cold seasons (and cavities). This result is unique among the five jobsites where data are available for an extended period.

**Figure 22. Example of an elevated OSB MC in one wall section showing seasonal changes in MC**

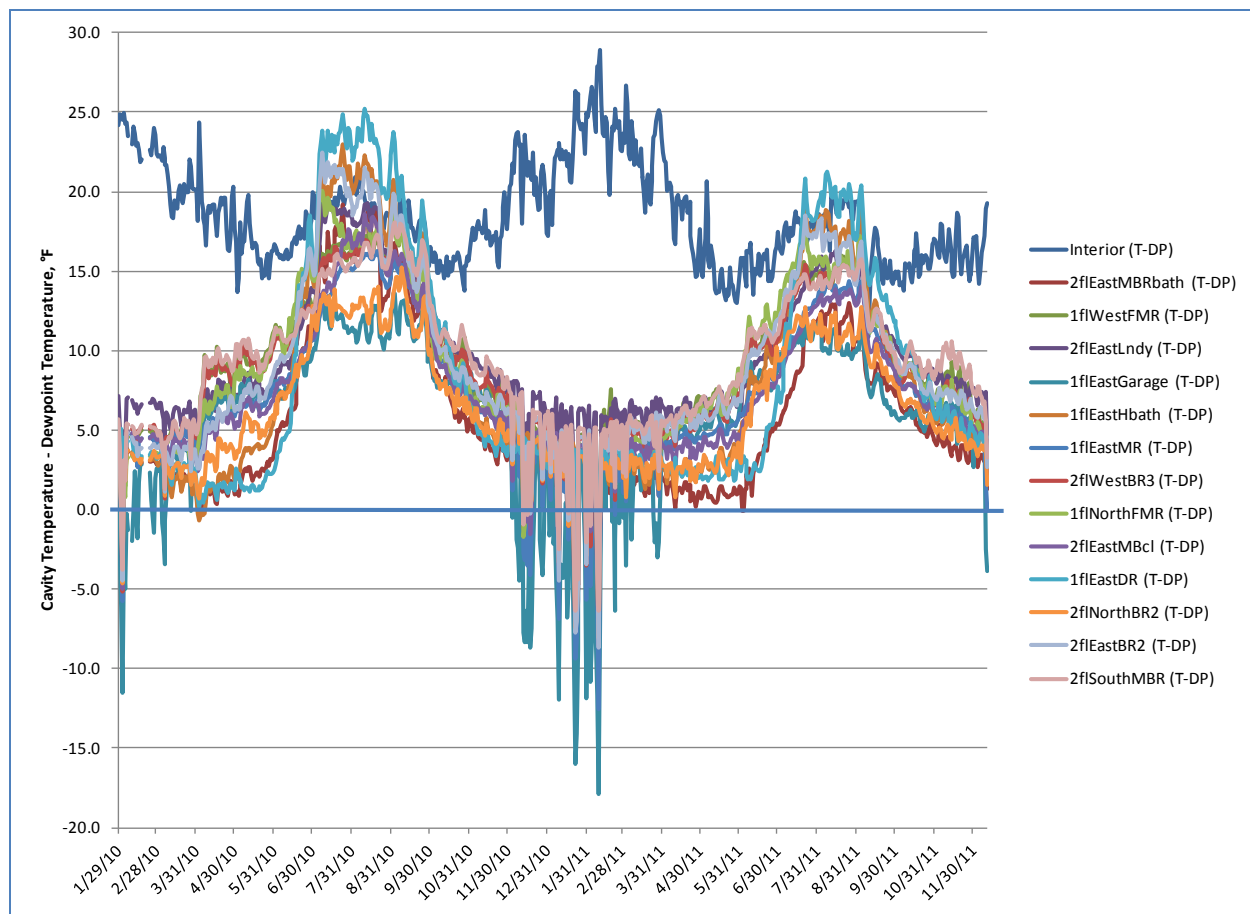
As RH increases in a wall cavity, the potential for condensation of water on the interior surface of OSB panels also increases. Figure 23 and Figure 24 are comparison plots for the test wall cavity temperature difference between the cavity temperature and the DP temperature for Jobsites 2 and 5. Negative values indicate a higher cavity DP than cavity air temperature near the OSB sheathing, resulting in the potential for condensation. Jobsite 2 has the most significant difference and Jobsite 5 has a much lesser degree of difference. The other jobsites have little or no calculated potential for condensation as measured.

**Figure 23. Jobsite 2 delta cavity temperature minus DP temperature (negative values indicate condensation potential)**

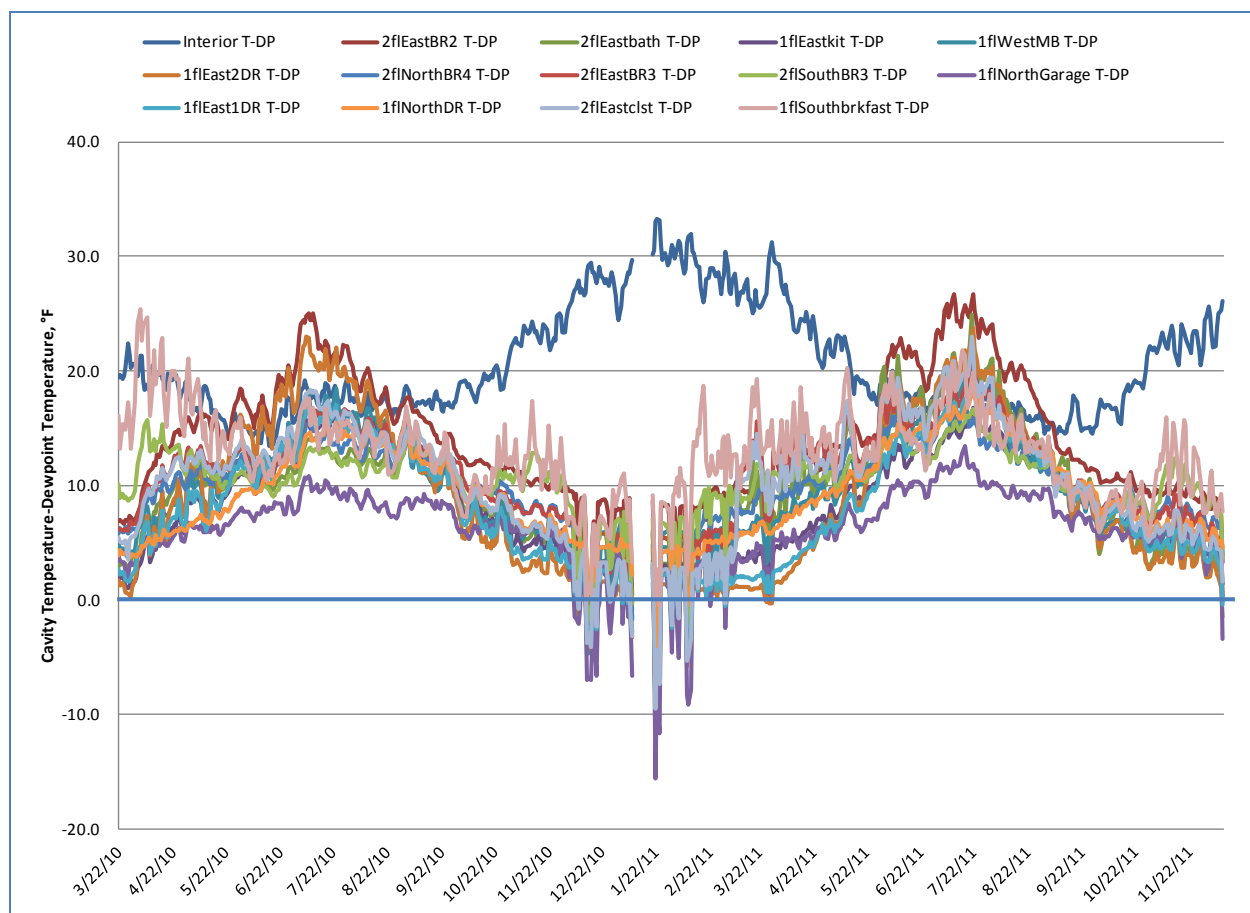
**Figure 24. Jobsite 5 delta cavity temperature minus DP temperature (negative values indicate condensation potential)**

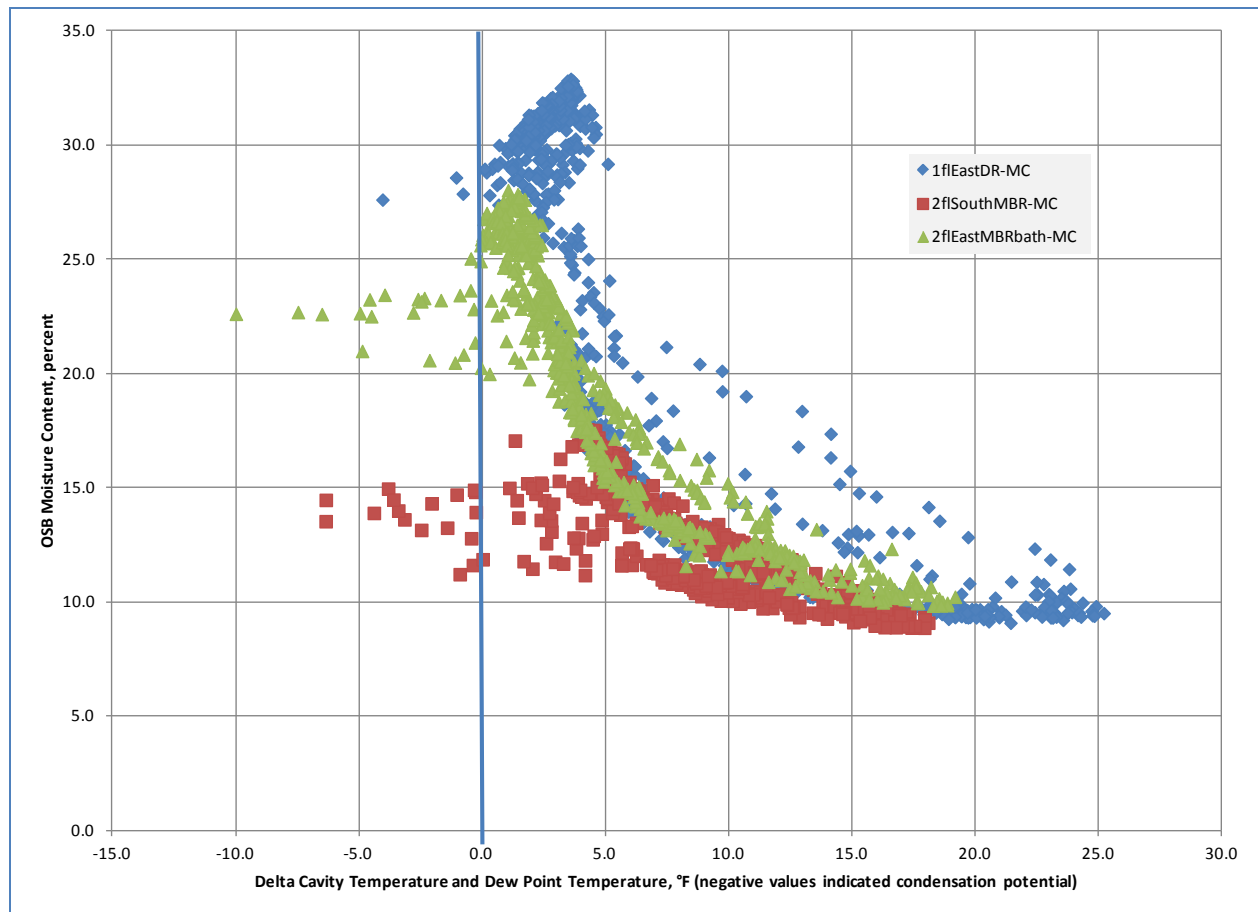
When evaluating the condensation potential (negative values for the air–DP temperatures) compared to the MC, the graphical results show an interesting relationship in which the higher levels of MC measured do not coincide directly with the calculated condensation potential (refer to Figure 25). In fact, the wall sections with the higher levels of MC appear to have lower overall instances of condensation potential.

**Figure 25. Jobsite 5 comparison of MC and DP**

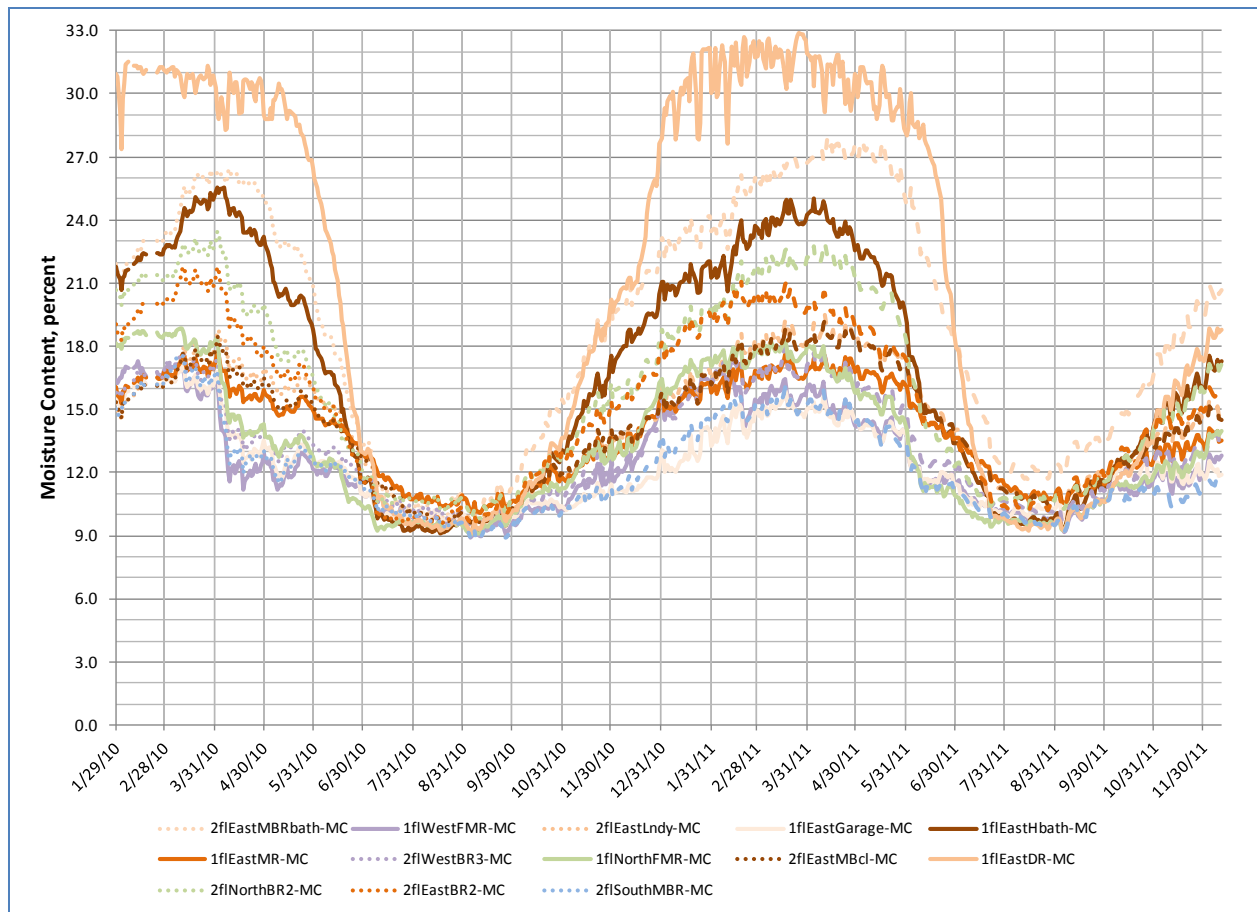
Furthermore, as shown in Figure 26, in this home where some cavities have higher levels of MC, the overall trends of all sections appear to track each other, although with different absolute levels of OSB MC. It does appear, however, that one or two cavities might have a source for air leakage (assumed from the interior), resulting in a much higher level of MC readings.

**Figure 26. Jobsite 5 MC comparison of all wall cavities**
