## Building America Case Study

# Investigating Solutions to Wind Washing Issues in Two-Story Florida Homes: Phase 2

**Project Name:** Investigating Solutions to Wind Washing Issues in Two-Story Florida Homes: Phase 2

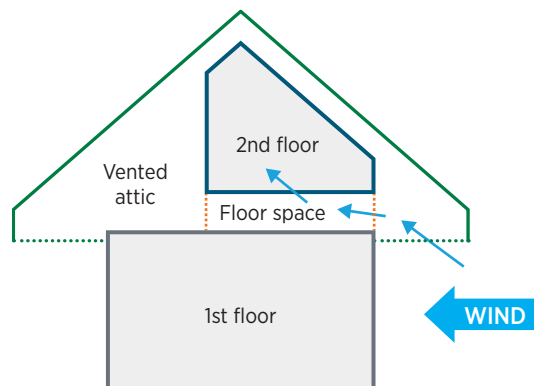
Figure 1. Wind washing is caused by air movement into the soffit, then into the attic, and finally into the floor space. Wind-driven attic air is pushed into the space between floors, bypassing house air and thermal boundaries.

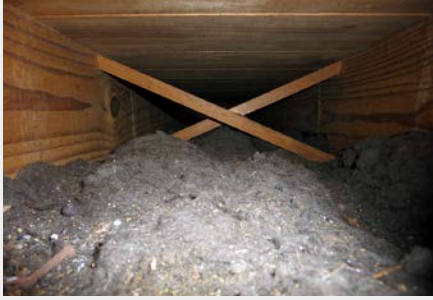
This image shows a floor cavity that is open to a vented attic on one end and has conditioned space above and below.

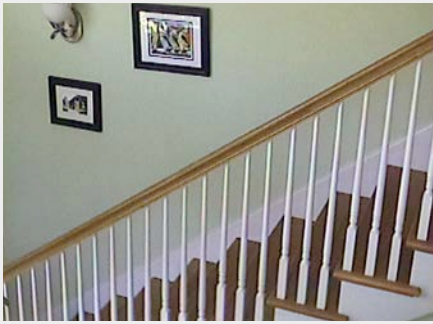
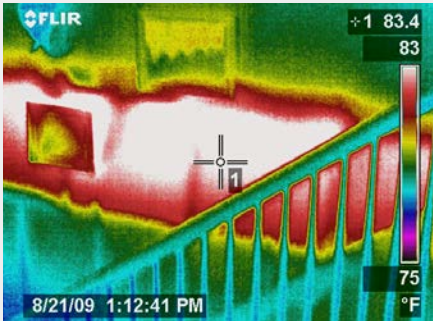
IR scans show temperature variations and reveal the operation of the wind washing phenomenon. As shown in the images above, thermal anomalies are occurring where hot attic air has penetrated into the floor cavity that lies behind the stairwell wall. The wall surface temperature was 83°F compared to 78°F room temperature.
