# Analysis of Joist Masonry Moisture Content Monitoring

Kohta Ueno  
*Building Science Corporation*

October 2015

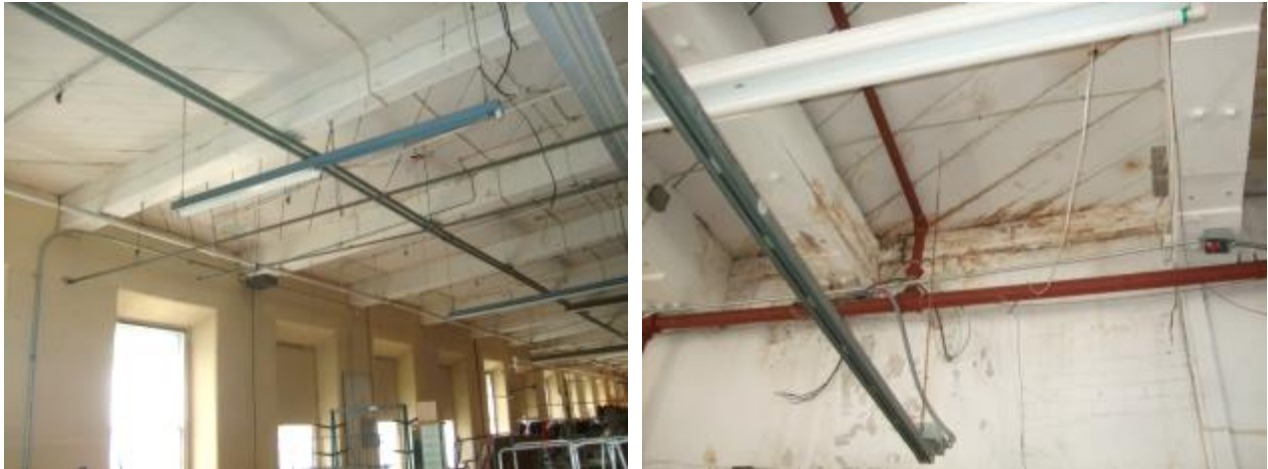
One common geometry, especially in mill or industrial buildings, is large timber beams (8–10 in. minimum thickness) at a wide spacing (Figure 5, left). The beams are fire cut (slant cut at the end to prevent wall collapse during a building fire; see Figure 30) and embedded in the masonry wall. Signs of water damage at the beam end (Figure 5, right) were relatively rare and were typically associated with roofing failures (on the top floor), water issues near grade, and poorly detailed roof-wall connections (which deposit excess water on the wall).

**Figure 5. Typical large beam geometry (left); water damage at beam end (right)**

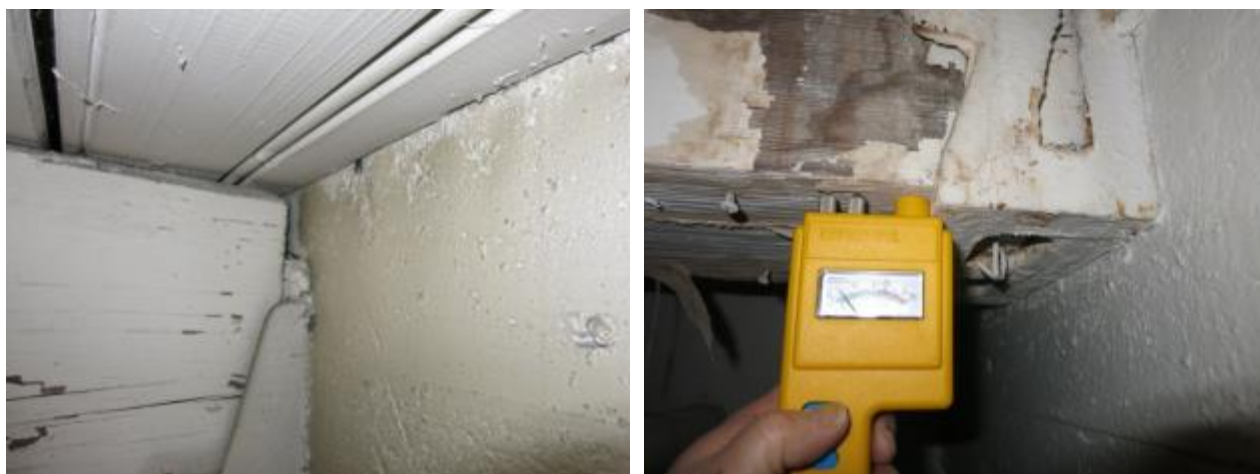
This wetting might have been caused by interior-sourced flooding, based on the water stain patterns (e.g., visible staining between subfloor gaps). Whatever the wetting source, however, this detail allows for greater drying than an embedded beam.

**Figure 9. Wood clear of masonry (left); low MC despite wetting stains (right)**

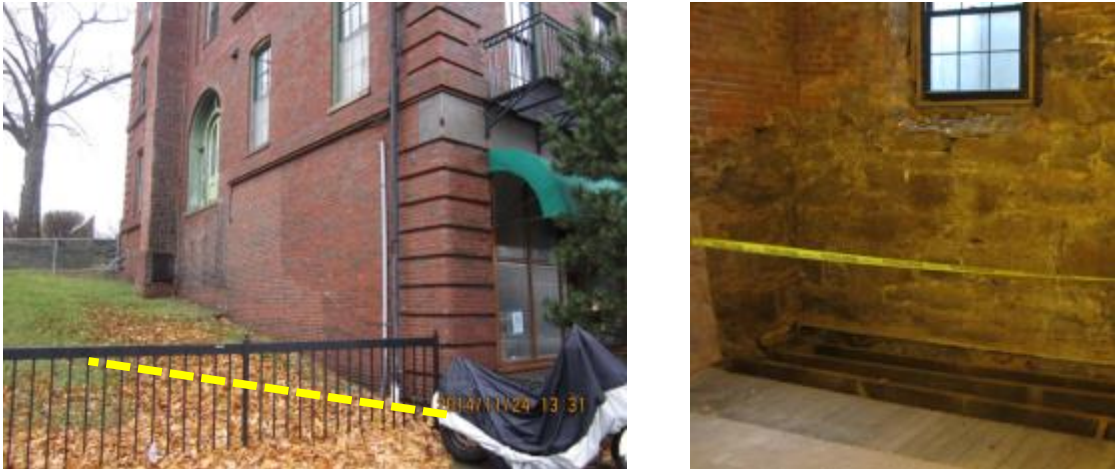
These risks are demonstrated in demolition at a circa 1850 brick building in the Boston area. The exterior grade rises at the sides of the building, which puts the floor framing below grade (Figure 11).

**Figure 11. Building exterior grade condition (left); beam interface to below-grade wall (right)**

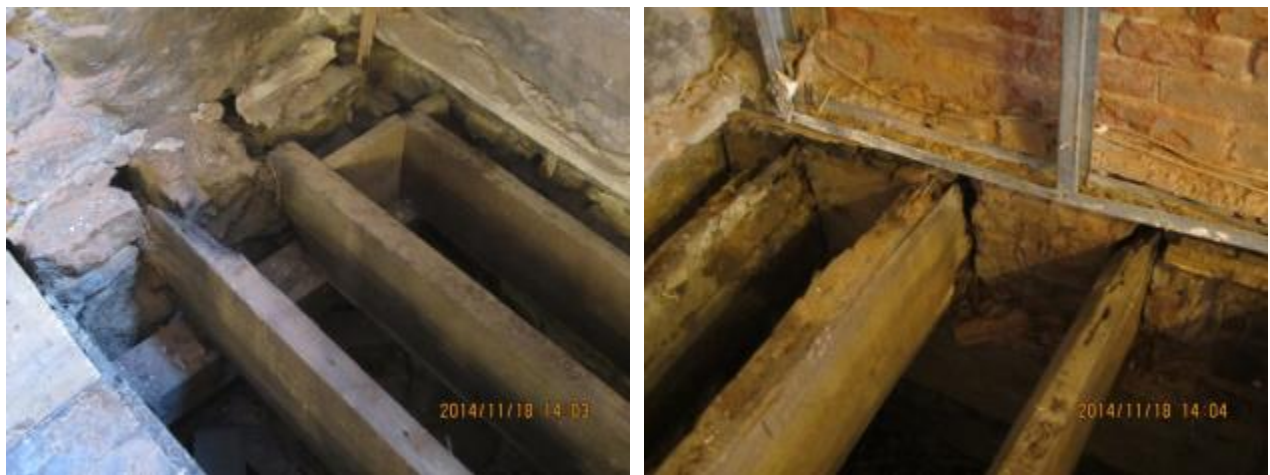
The floor framing had severely deteriorated at the beam pockets (Figure 12). This floor system had no insulation. This damage had likely been continuing for some time, but it postdates the circa 1980s–1990s renovation (which was being demolished here).

**Figure 12. Damage to embedded beams at walls**

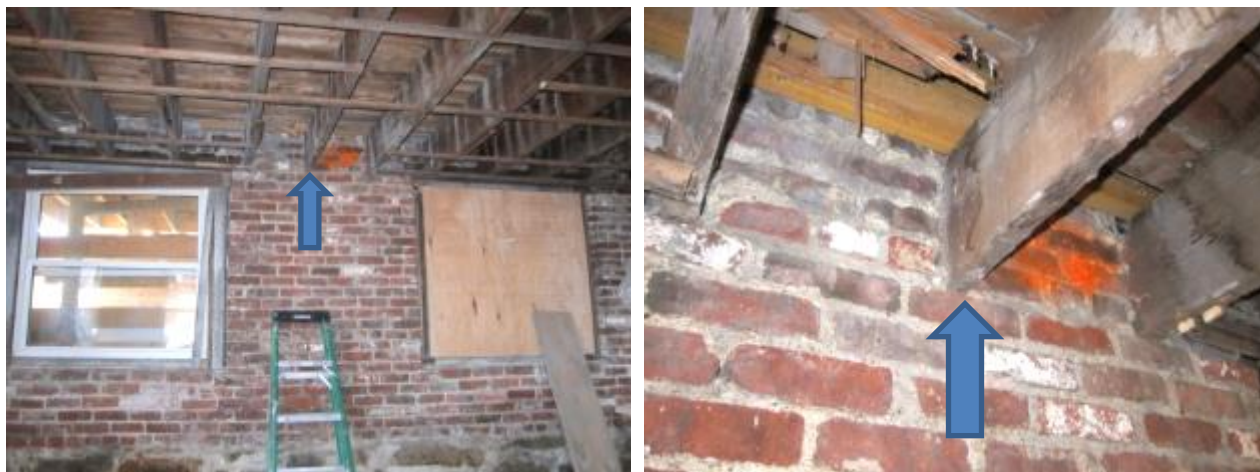
**Figure 25. BSMT-E2 joist, showing existing water staining**

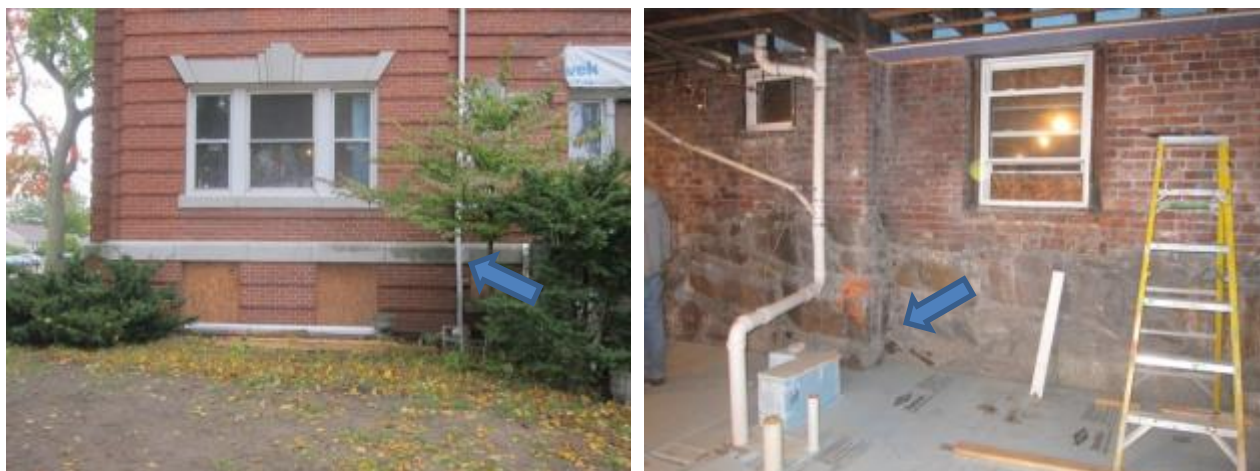
BSMT-W1 and BSMT-W2 are of interest because the site inspection revealed that rainwater was being deposited on the wall at the jog (see Figure 21). BSMT-W1 was set up to capture the mostly dry field of the wall; BSMT-W2 was located close to the jog to determine whether this bulk water was sufficient to cause issues with the embedded joist end moisture behavior. This cardinal orientation has low driving rain exposure (see Figure 15).

**Figure 26. BSMT-W1 and BSMT-W2 joists showing water deposition at wall jog**

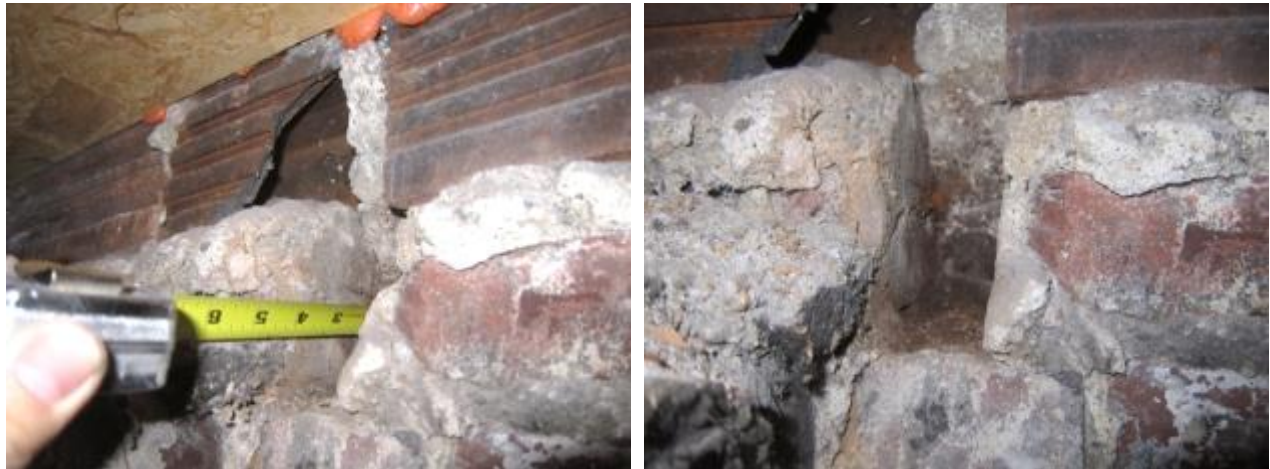
**Figure 35. Conditions in joist pocket at north-facing building at addition**

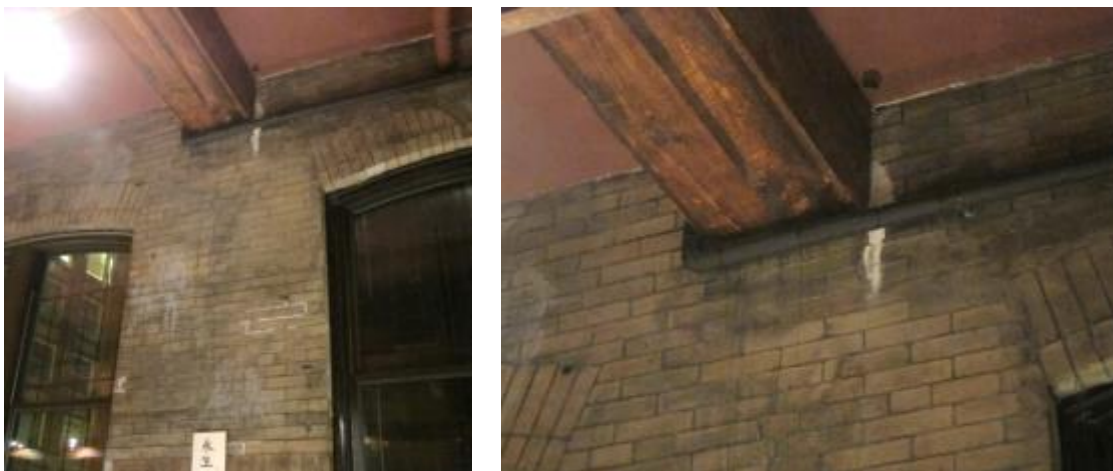
**Figure 67. Evidence of water penetration at embedded beam end in masonry**
