Field Testing of an Unvented Roof with Fibrous Insulation, Tiles, and Vapor Diffusion Venting

K. Ueno and J. W. Lstiburek
Building Science Corporation

February 2016

This report describes research about a test implementation of an unvented tile roof assembly in a hot-humid climate (Orlando, Florida; climate zone 2A); the roof was insulated with air-permeable insulation (netted and blown fiberglass). Given the localized moisture accumulation and failures seen in previous work, the U.S. Department of Energy's Building America research team Building Science Corporation theorized that installation of diffusion vents might allow for the wintertime release of moisture to safe levels. Diffusion vents are open slots at the roof's highest points (the ridge and hips) that are covered with a water-resistant but vapor-open (500+ perm) air barrier membrane.

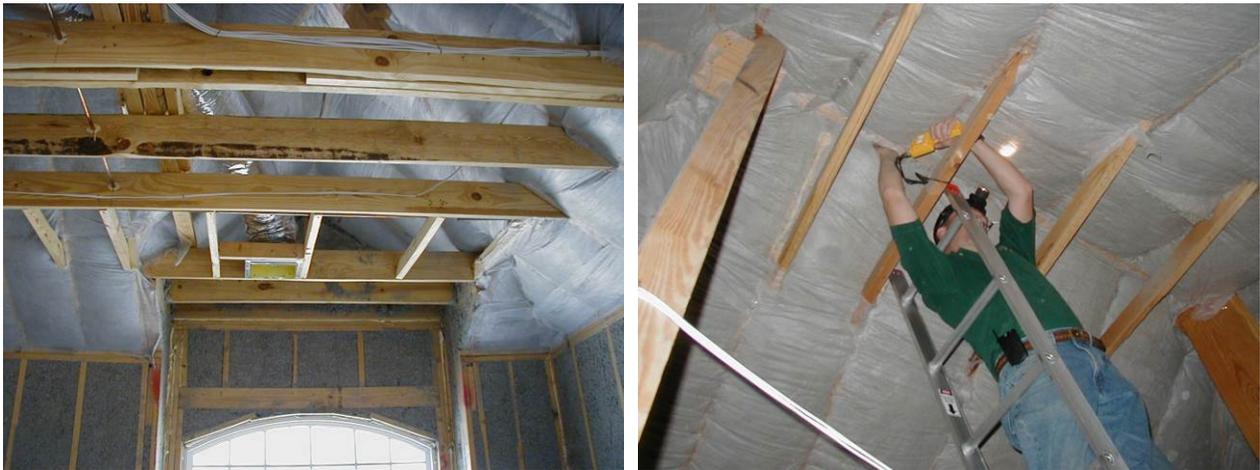
During the first fall of operation, the homeowner reported seeing reflections of moisture condensation and dripping from the ridge of the unvented attic from the interior. Site investigations (Figure 9, right) revealed elevated wood MCs at the ridge and evidence of previous condensation (such as rusted staples).

Figure 9. Netted and blown cellulose roof insulation in Houston (left); MC at the roof ridge (right)

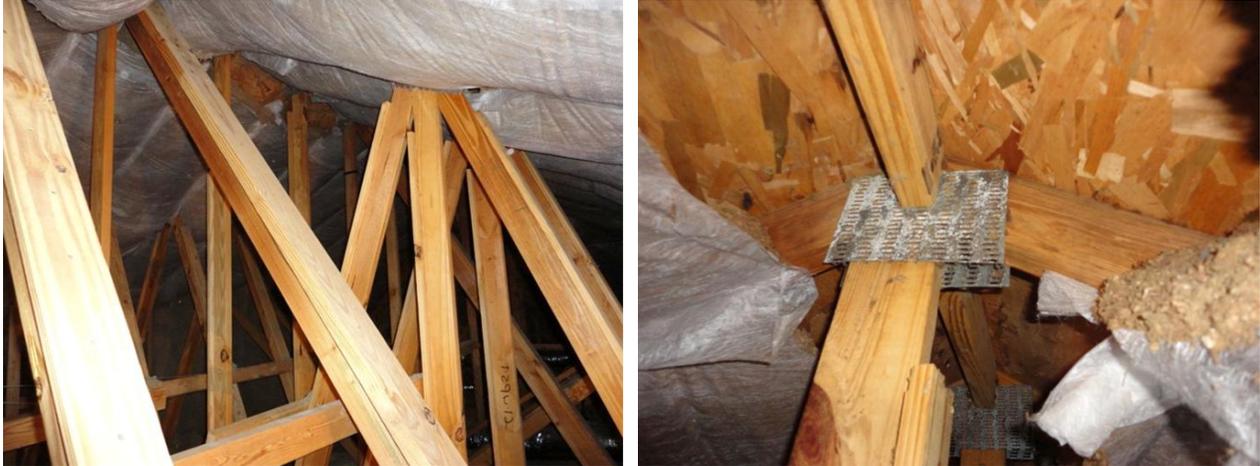
During a site visit, the cellulose and roof sheathing were wet to the touch, and the steel truss plate was corroded; however, the wood had not decayed. In response, the insulation was removed near the ridge (roughly 2 ft; Figure 10, right) to increase surface temperatures at the condensing roof sheathing surface. This roof has been rechecked over time (circa 2003 and as recently as March 2014); roof sheathing conditions remained dry with this assembly.

Figure 10. Cellulose roof insulation in Jacksonville (left); corrosion of ridge truss plate (right)

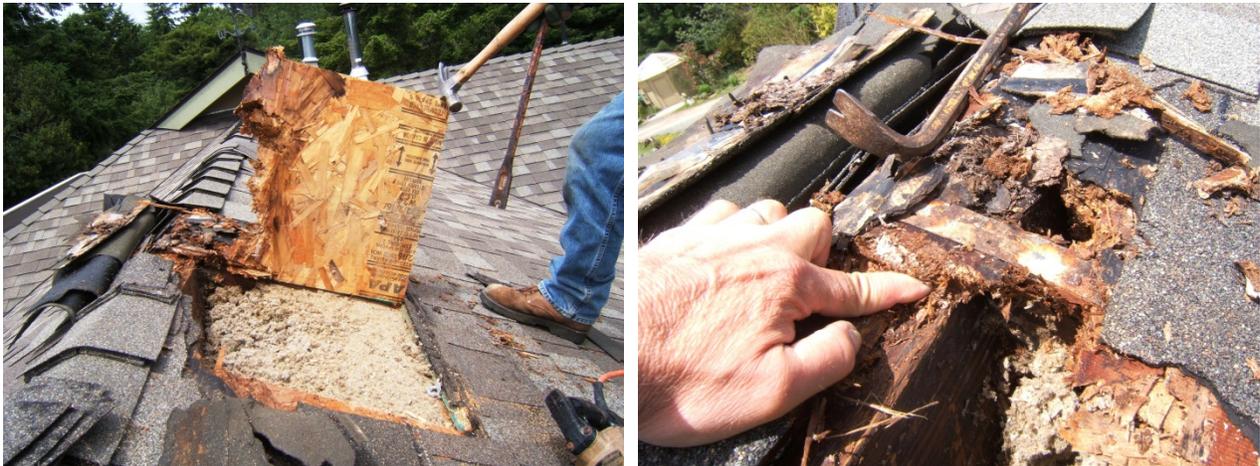
Moisture issues in unvented roof assemblies often manifest in the form of damage to the sheathing at the ridge of a sloped roof, colloquially known as *ridge rot*. An example is shown in Figure 11, which was a dense-pack cellulose roof in a northern California location (CZ 3C).

Figure 11. Ridge sheathing degradation with dense-pack cellulose in northern California

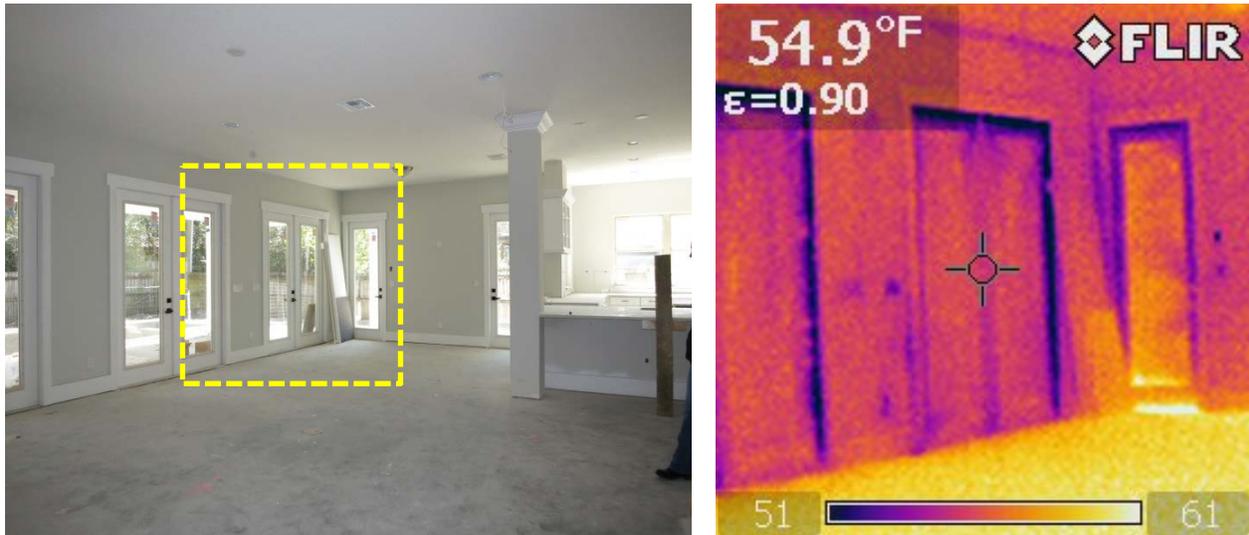
The overall air leakage results (6.7 to 7.6 ACH 50) are higher (worse) than typical goals for energy-efficient construction; they exceed the 5 ACH 50 target for CZ 2 (per 2012 International Energy Conservation Code ICC 2012, §R402.4.1.2 Testing). However, the house was still being completed; door gaskets (Figure 36) and finish floors were not installed (which would have provided some gasketing).

Figure 36. Visual (left) and infrared (right) image during depressurization testing, showing door leakage

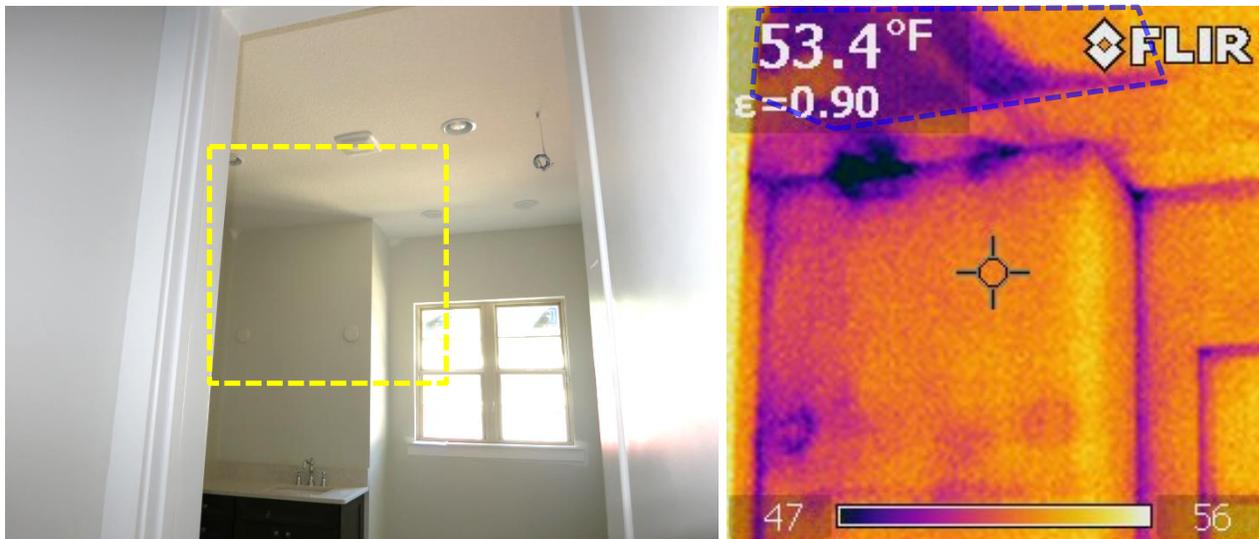
Figure 41. Bathroom ceiling air leakage at roof-wall interface; water leak in blue (Location A)

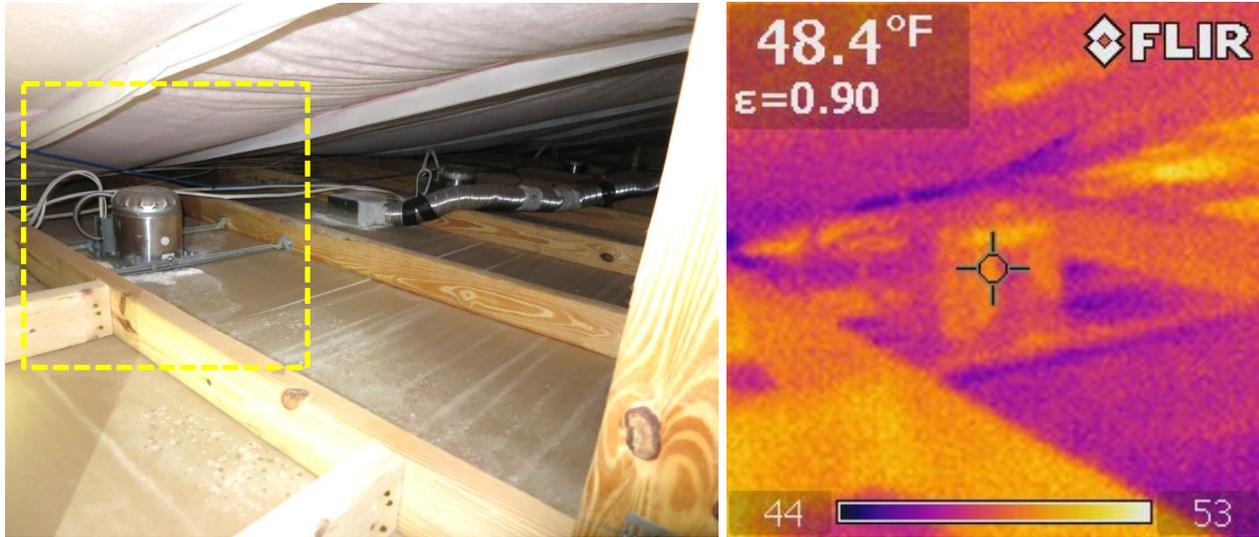
Figure 42. Roof-wall connection above bathroom; water damage at ceiling visible (Location A)

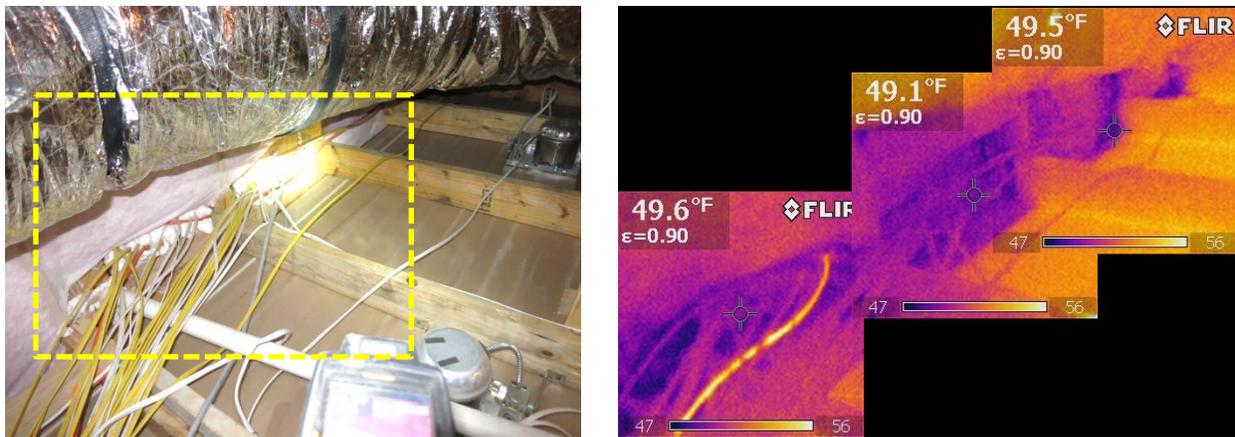
Figure 43. Air leakage at wiring penetrations at garage wall-top plate (Location B)

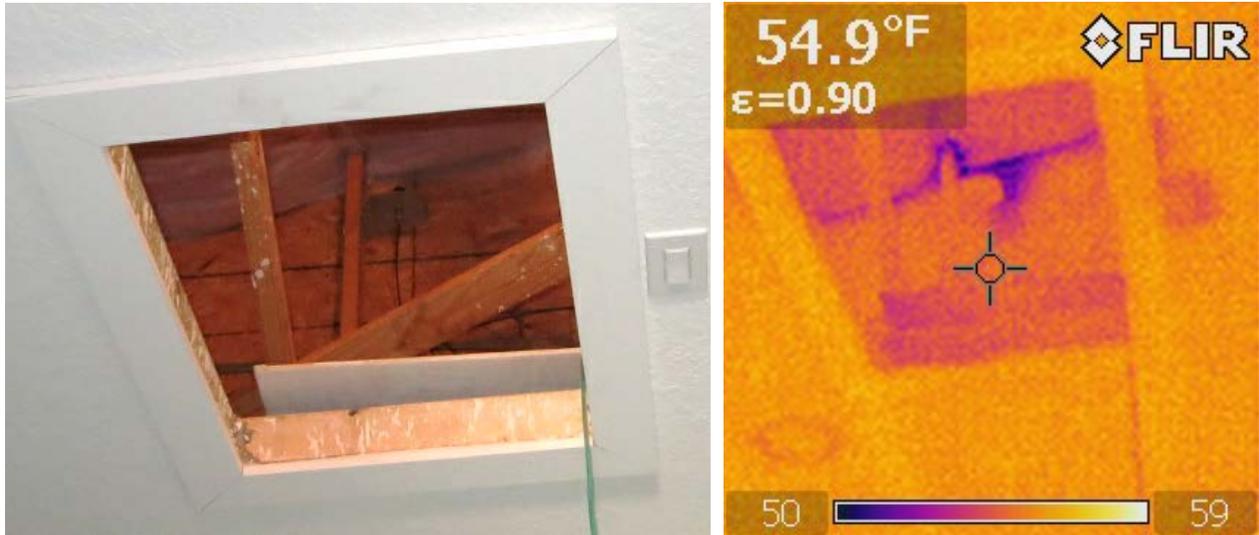
Figure 44. Air leakage at stud below roof-wall interface (Location C)

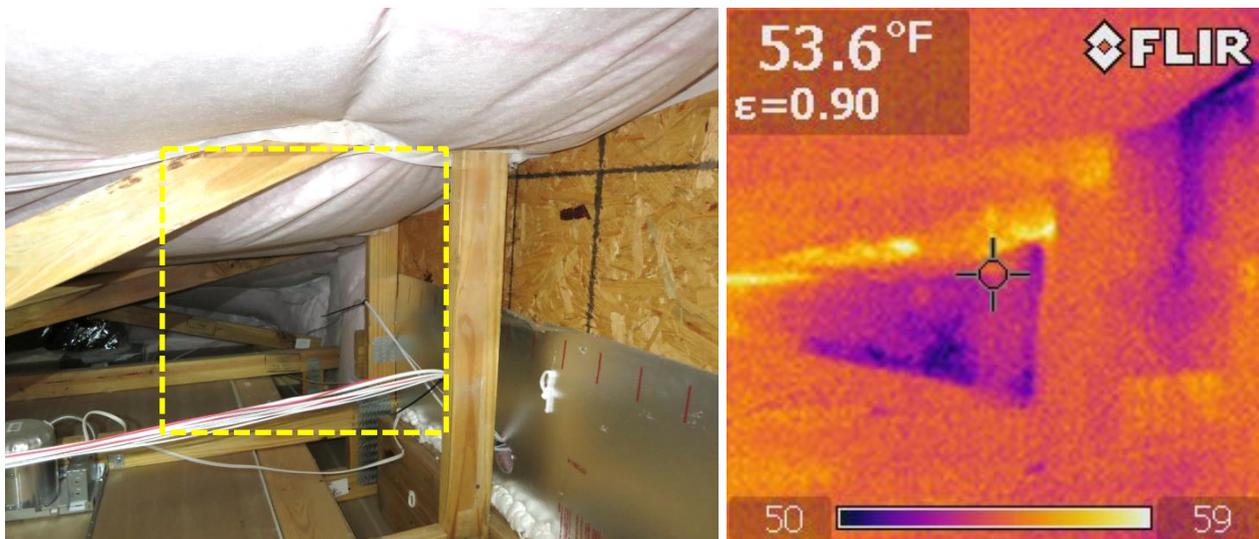
Figure 45. Air leakage at roof-wall interface, and at unconditioned porch attic (Location D)

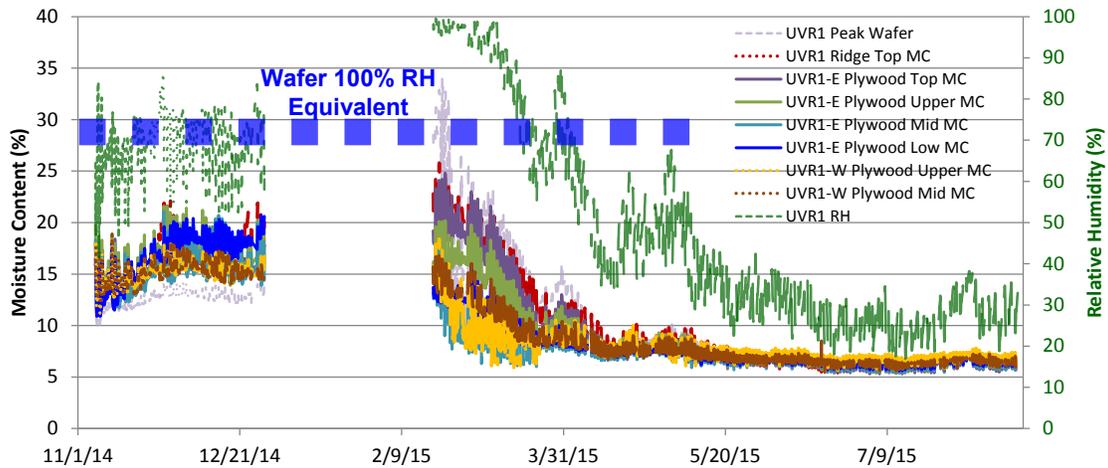
Figure 59. Unvented roof (UVR1) MC and RH measurements (second-floor attic)

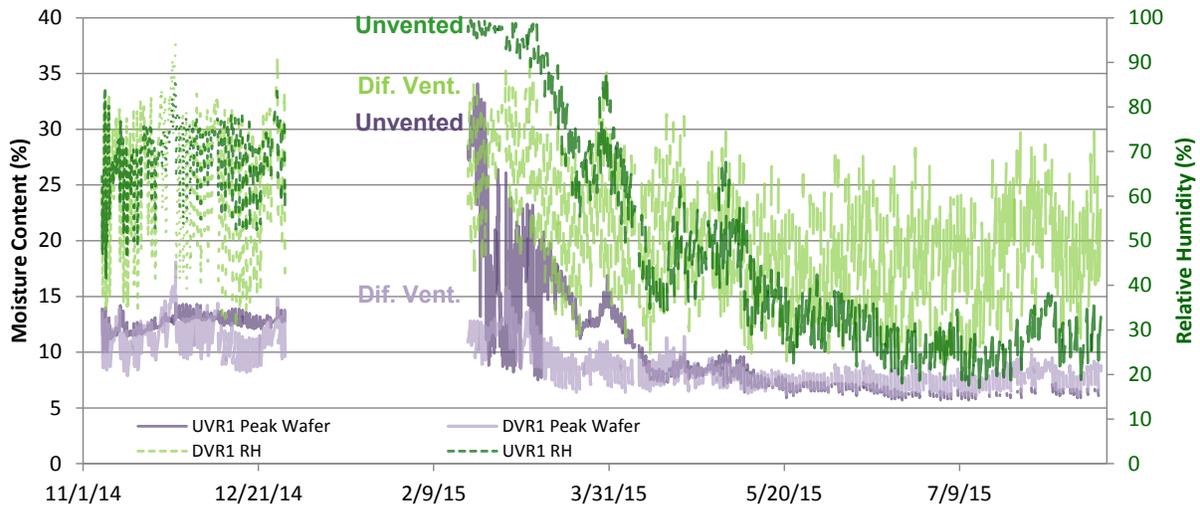
Figure 67. Comparison of unvented (UVR1) and diffusion vent (DVR1) ridge wafer MC and RH
