Public Housing: A Tailored Approach to Energy Retrofits

J. Dentz, F. Conlin, D. Podorson, K. Alaigh,
and T. Davis

February 2016

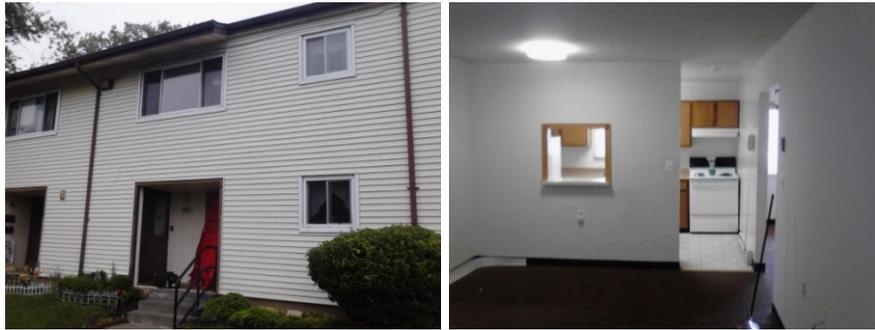
Figure 1. Typical IHA housing unit

IHA’s apartments are predominantly single-floor studios and one-bedroom apartments in two-story wood-frame buildings that contain about eight units each. Tenants pay their own utility bills and are given an allowance by IHA based on historical energy use for each unit size. Cooling energy is not reimbursed, and room air conditioners (ACs) (for the 330 electric units) are owned by the tenants. (About half of these residents own ACs). Of the 360 units, 330 have electric resistance heat, electric storage water heaters, and through-the-wall sleeves for resident-owned ACs. Table 1 summarizes the audit findings and recommendations. Southwind, a 30-unit site, was an anomaly in that it had gas-fired, forced-air heating, central AC, and a gas-fired water heater. In general, the units displayed significant air leakage; second-floor units were substantially worse than ground-floor units. Some apartments showed signs of earlier attempts at air sealing.

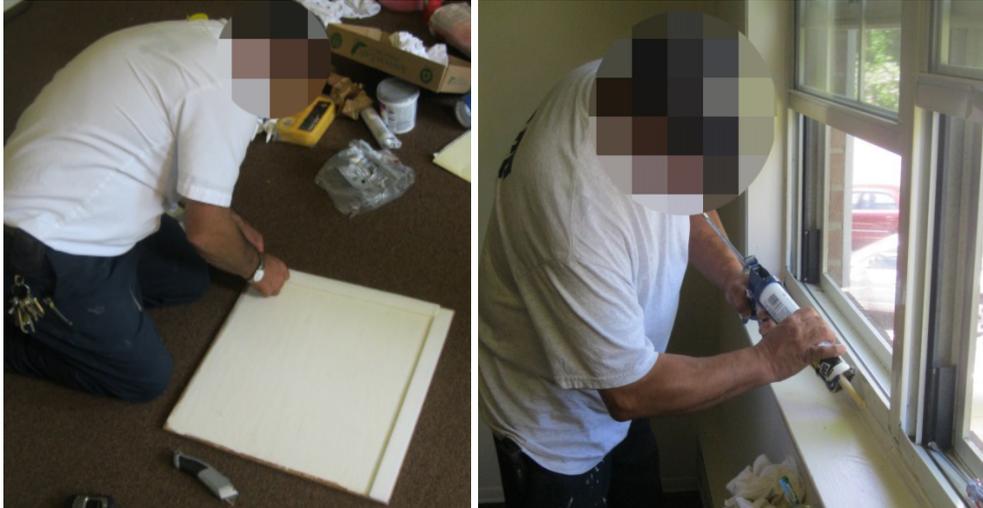
Figure 4. Installing gasket on attic hatch (left); caulking gap around window (right) at IHA

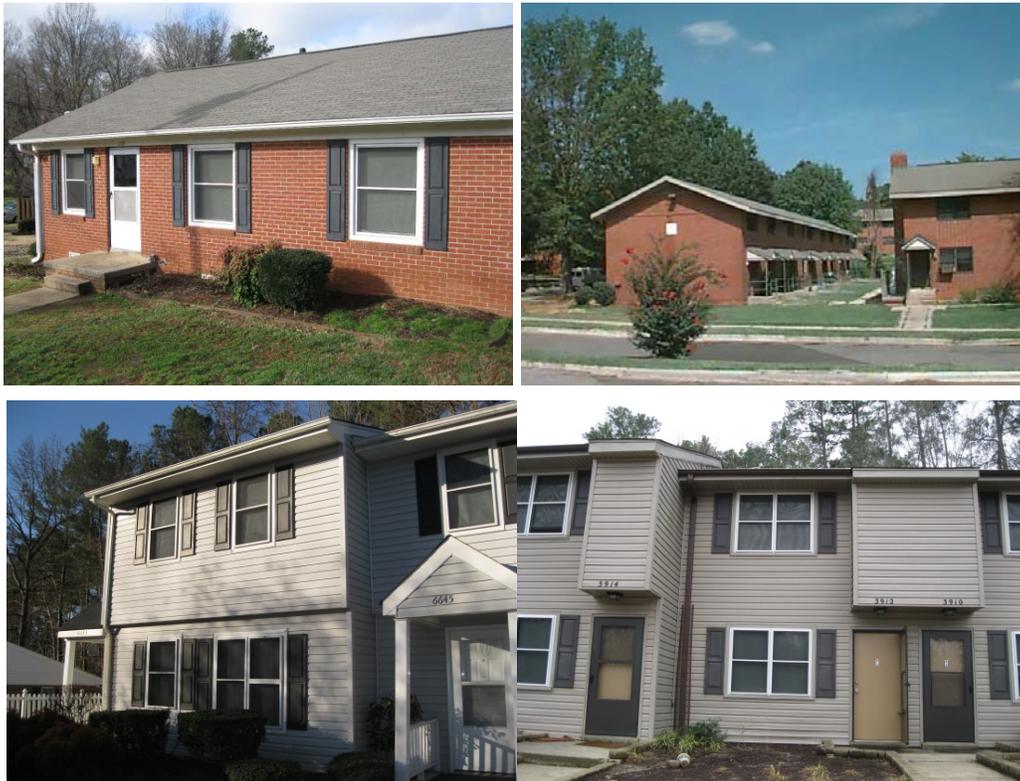
Figure 7. Typical RHA housing units

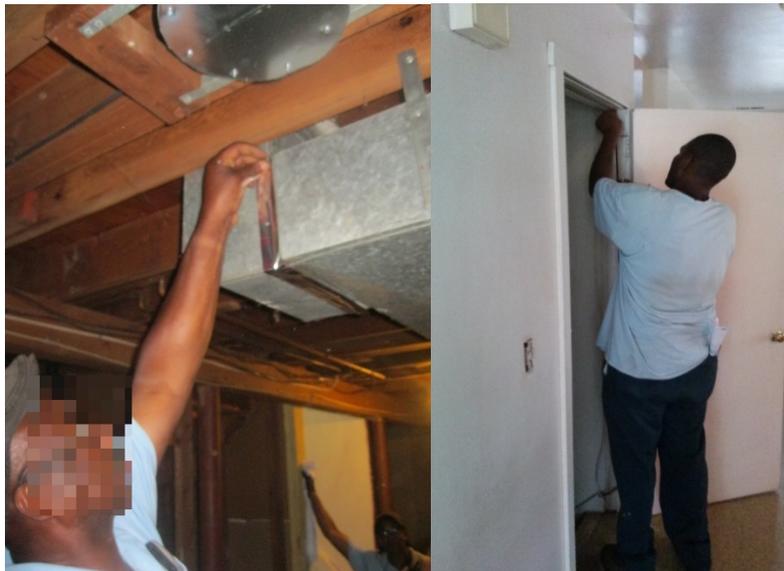
Figure 17. Sealing ductwork with Underwriters Laboratories-181 tape (left); installing weather stripping on door to unconditioned basement (right) at NHA
