# Report of the Condition of a General Electric Transportation Systems Gearbox

**Technical Report**  
NREL/TP-5000-76004  
Revised February 2022

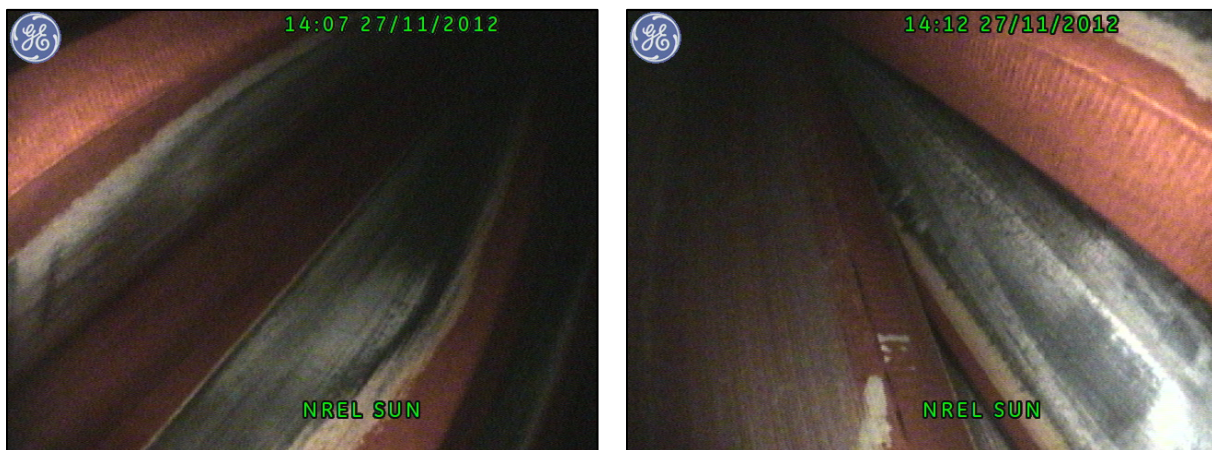
The first physical inspection of the gearing was conducted by GE personnel in November 2012 during an uptower borescope inspection. Although the focus of the inspection was to assess the condition of most of the bearings in the gearbox, several photos were taken of the gearing. At the time, and within the limits of borescope access, there was no sign of significant damage or bearing failure; no spalling, debris, or over-rolled indents; no significant scratching or abrasion of gears that would indicate appreciable bearing deterioration; and only minor marks and scratches observed on the cage of one of the bearings supporting the high-speed pinion [23]. Example borescope photos of the sun pinion are shown in Figure 3.

**Figure 3. Typical condition of the sun pinion teeth in 2012**  
*Photos from John T. Murphy, GE Renewables*

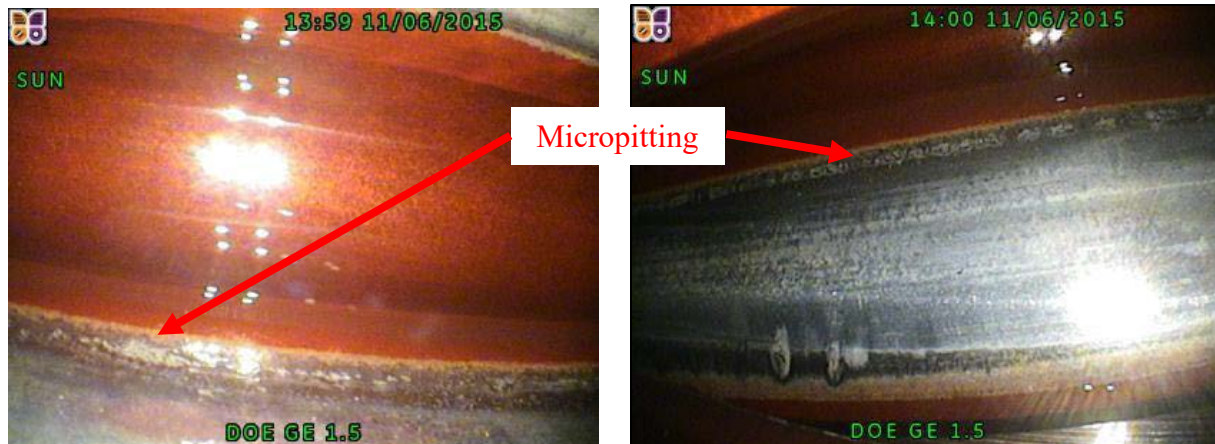
A second borescope inspection was conducted by Romax Technology personnel in November 2015. In this case, half of the sun pinion teeth and all of the mating planet gear teeth were inspected along with some of the other gearing and bearings. Some damage was documented on the sun pinion teeth that were inspected. The rotor- and generator-side flanks of several teeth showed hard contact lines. One tooth had isolated abrasive wear marks while another had an area of isolated micropitting. The roots of several teeth showed evidence of the onset of micropitting at the start of the active profile as shown in Figure 4. Only normal wear was noted on the planet gears and any of the accessible bearings [24]. Hereafter, the primary item of interest on this gearbox became the micropitting on the sun pinion.

**Figure 4. Micropitting of the sun pinion teeth in 2015**  
*Photos by Jesse Graeter, Onyx InSight, NREL 61223 and 61224*

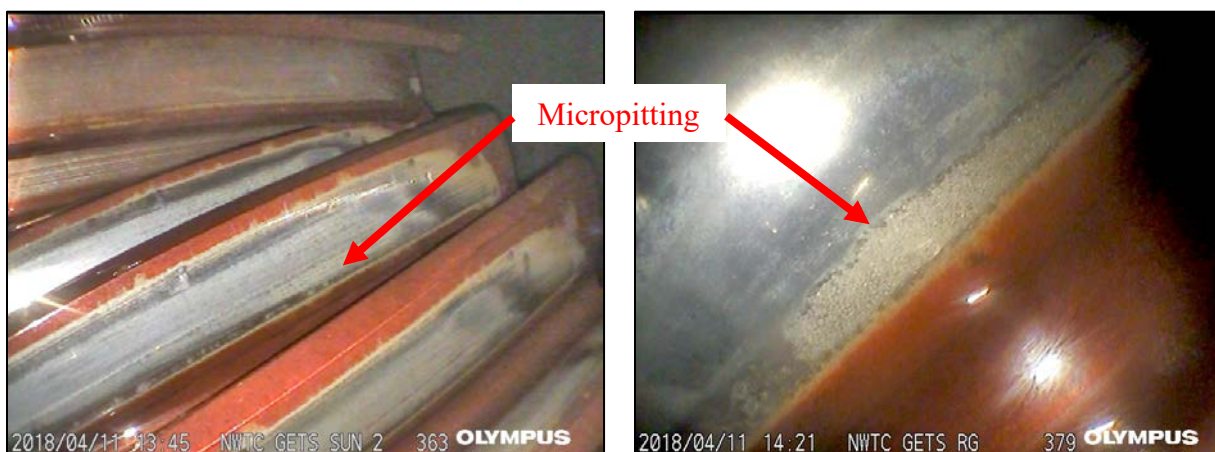
After the gearbox was removed from the turbine in December 2017, a third borescope inspection was performed in April 2018 by personnel from Wind Driven. By this time, it was clear that the sun pinion was the most heavily damaged component. Micropitting, occasional abrasion, and corrosion were observed on the sun pinion teeth. Micropitting was found in the roots of all teeth, an example of which is shown in Figure 5 [27].

**Figure 5. Micropitting of the sun pinion teeth in 2018**  
*Photos by Scott Eatherton, Wind Driven, NREL 61193 and 61194*

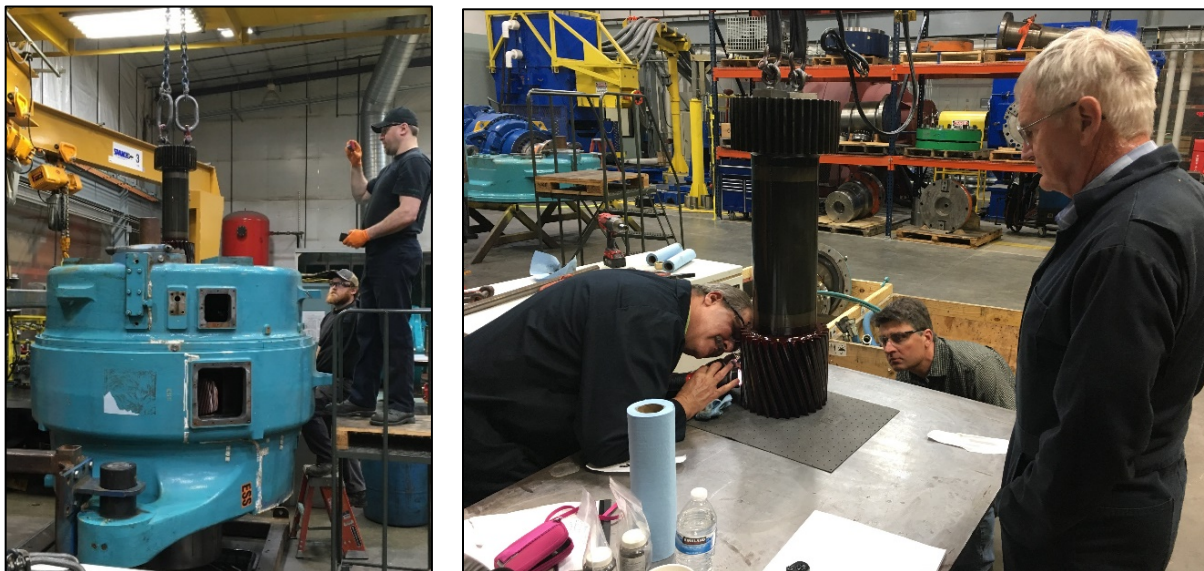
The gearbox was trucked to Renew Energy Maintenance facilities and disassembled in May 2019 as shown in Figure 6. During the disassembly process, particular attention was paid to the condition of the sun pinion (part number 84E901974 P2, revision D, serial number 0808010) and the mating planet gears (part number 84E901975 P3, revision E, serial numbers 0808002, 0808095, and 0808140). Additional technical details of each of these helical gears are listed in Table 1. During the disassembly, the condition of all gears was examined. In general, the gears showed no significant damage—no major foreign object damage, tooth chips, or tooth cracks were found.

**Figure 6. Gearbox disassembly (left) and sun pinion inspection (right)**

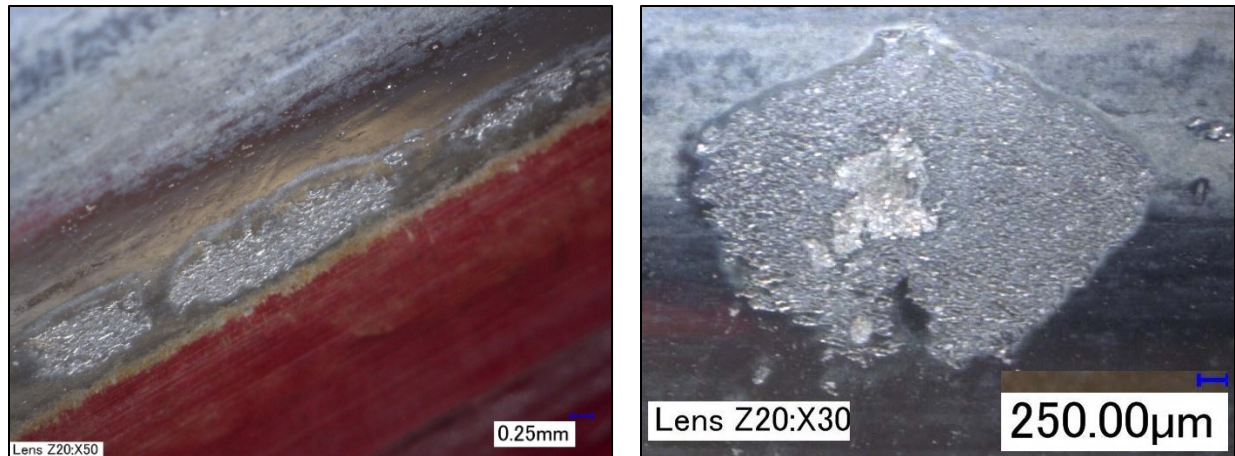
The gearing was shipped to REM Surface Engineering for profilometry measurements in July 2019. Additional photographic evidence of the drive-side root micropitting and localized damage on the sun pinion described above is shown in Figure 7. In the figure, the patches of micropitting had not yet coalesced across the tooth contact zone. This is considered early-onset micropitting. Roughness measurements were acquired away from the gear contact zone and away from any damage or micropitting on the gear teeth flanks of the sun pinion and mating planets to assess the as-manufactured surface roughness of the gears. The roughness measurement,  $R_a$ , was  $0.22\text{ }\mu\text{m}$

on the sun pinion and  $0.55\text{ }\mu\text{m}$  on the mating planets, yielding a composite roughness of approximately  $0.4\text{ }\mu\text{m}$ . The localized corrosion spot with micropitting on Tooth 1 was measured to be approximately 3-millimeters (mm) long and 2.5-mm wide. The damage in the center of the halo was approximately  $3.4\text{ }\mu\text{m}$ , or 1.4 ten-thousandth of an inch, deep, Rz. It was considered to be the most severe damage on the sun pinion.

**Figure 7. Sun pinion root micropitting (left) and localized corrosion spot with micropitting halo (right)**

Finally, after the profilometry measurements were completed, all of the gearing was refurbished by an isotropic superfinishing process [28]. All tooth-flank surface damage was repaired by removing approximately  $3.5\text{ }\mu\text{m}$  from each flank of all of the gearing. Before-and-after isotropic superfinishing photographs of the sun pinion are shown in Figure 8.

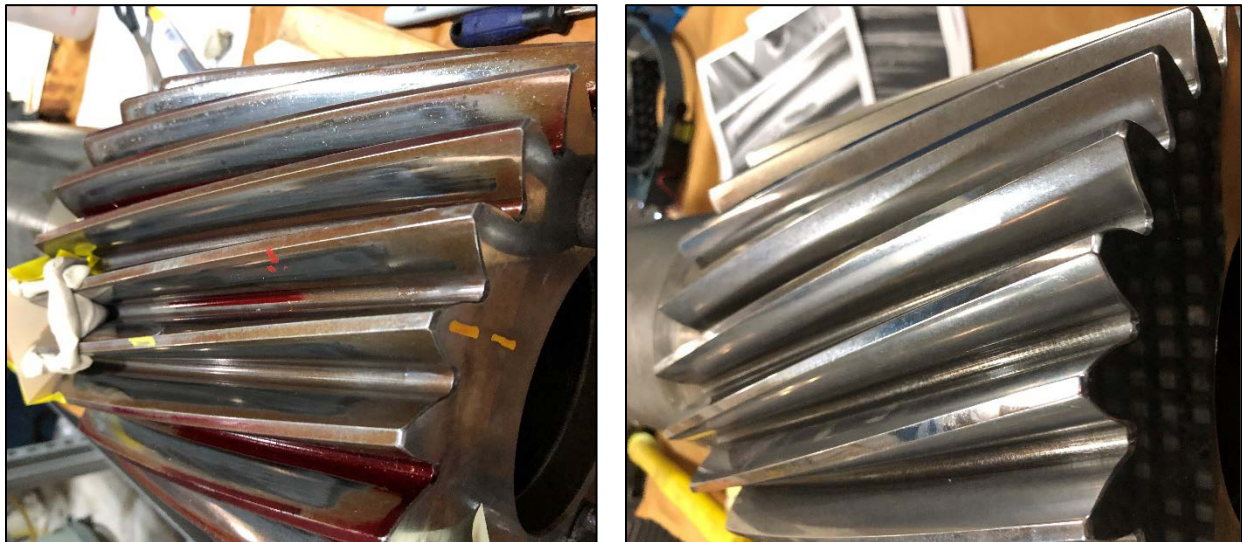
**Figure 8. Sun pinion before (left) and after (right) isotropic superfinishing**

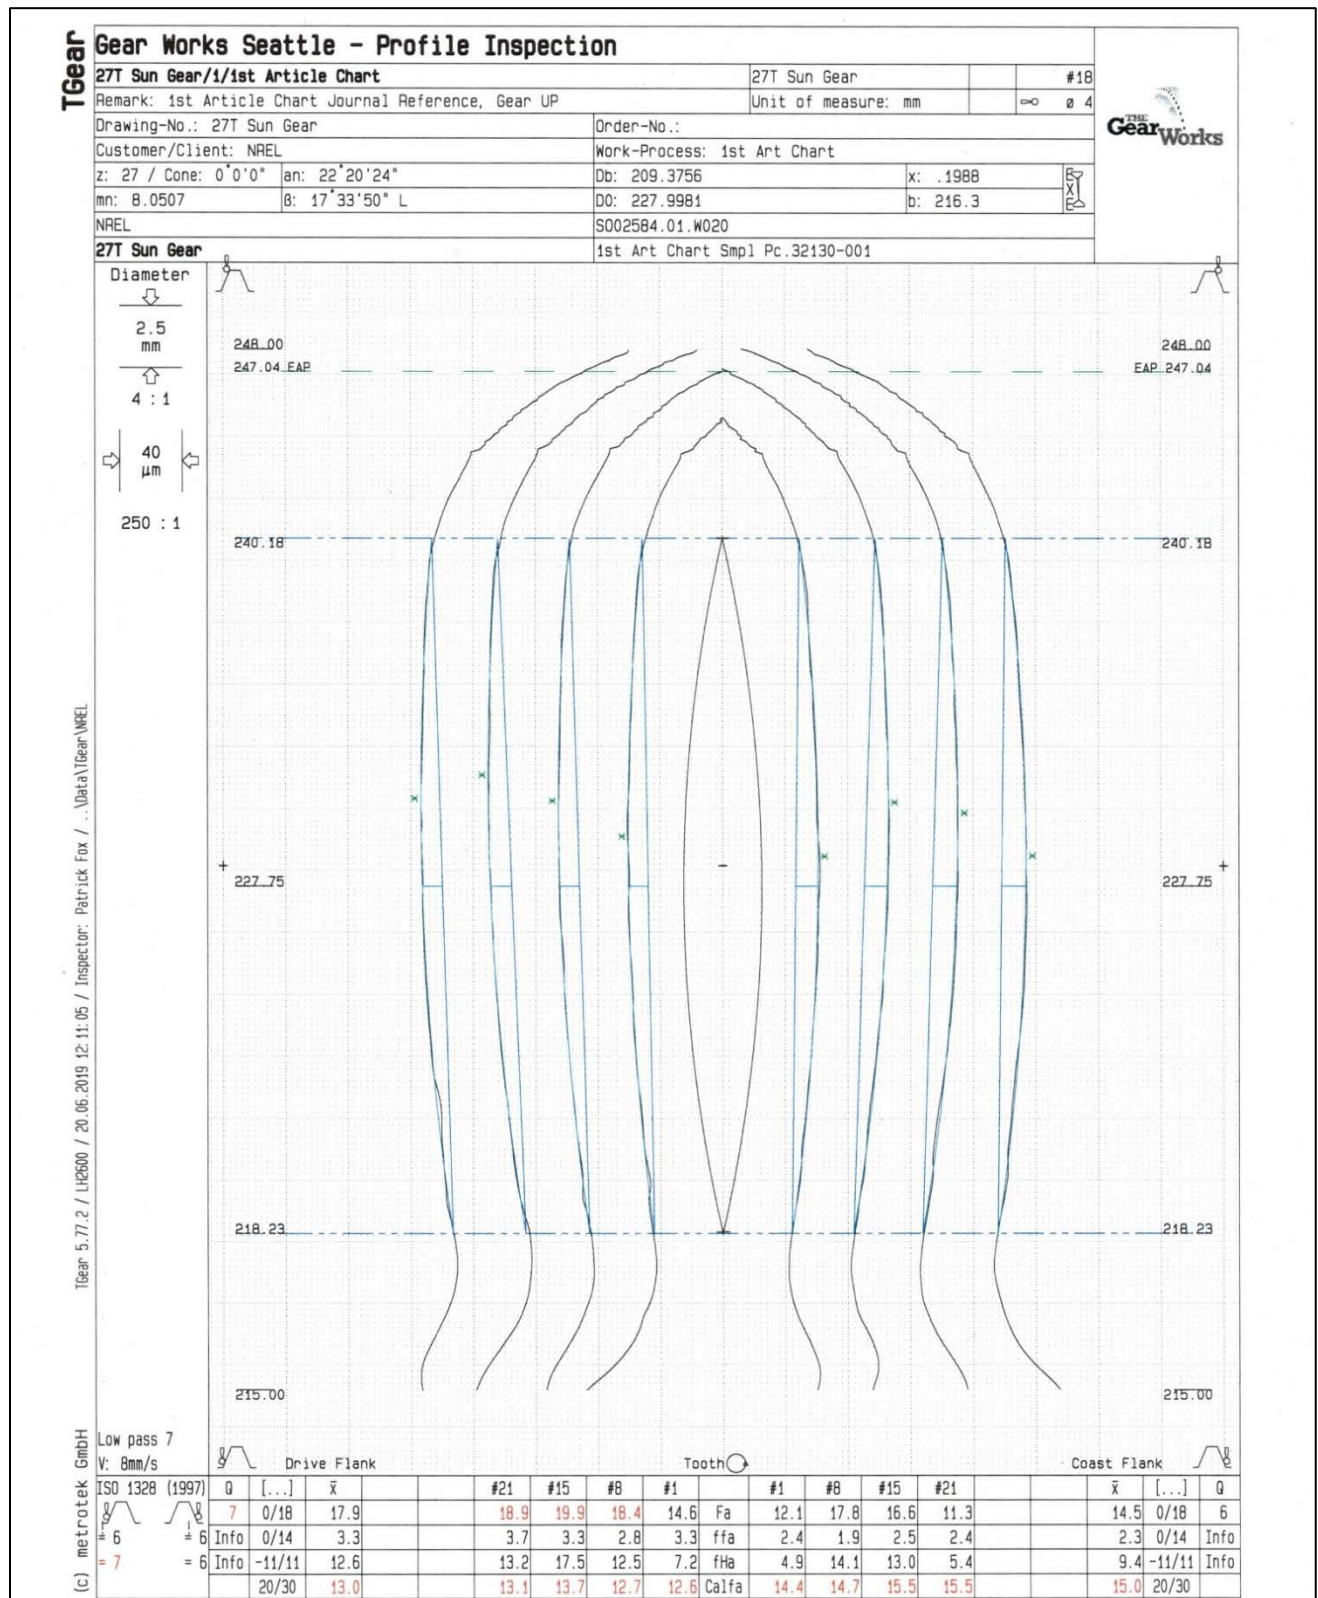
Figure A-1. Sun pinion profile inspection (250:1)

After disassembly, in June 2019, all of the gearing was shipped to Machinists Incorporated (formerly The Gear Works) for cleaning, inspection for accuracy, and measurement of the timing of the planetary pinions and gears. Inspection charts for the sun pinion are included in the Appendix. The inspections showed that the gear teeth profiles were still accurate and no significant wear was found. One localized spot of damage with a micropitting halo surrounding it was found on the drive-side flank of a tooth of the sun pinion, hereafter identified as Tooth 1. It likely originated from a spot of grind temper or corrosion and was measured in the lead profile chart in Figure A-2 in the Appendix.
