William Sekulic, Chris Deline, Byron McDanold, Josh Parker

Main goal, identify how damaged modules change over time.

2022 Photovoltaic Reliability Workshop (PVRW)

NREL/PR-5K00-82248

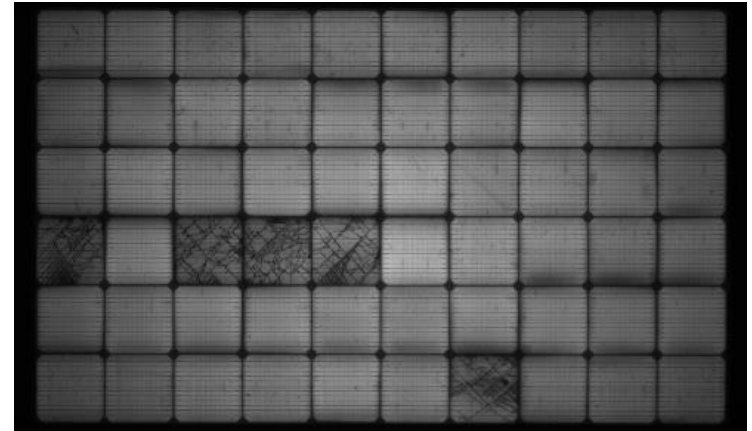
EL Image, Installation and Hail damage,
LG - M1806-0005

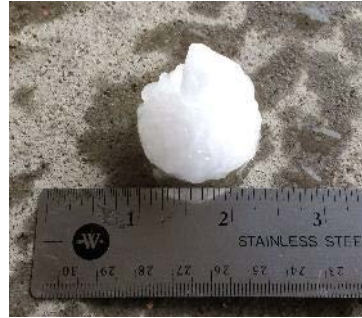
Large Hail (NREL 2017)

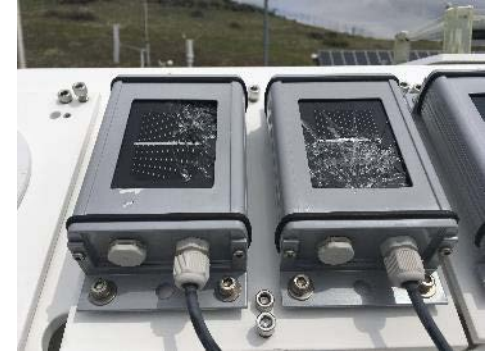
Hail Damage to Irradiance Sensor (NREL 2017)

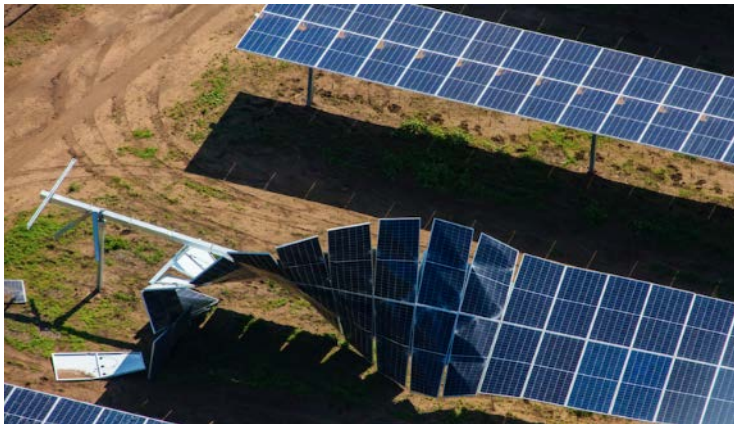
Wind Damage – Long read: What broke at Oakey –
pv magazine Australia (pv-magazine-australia.com)

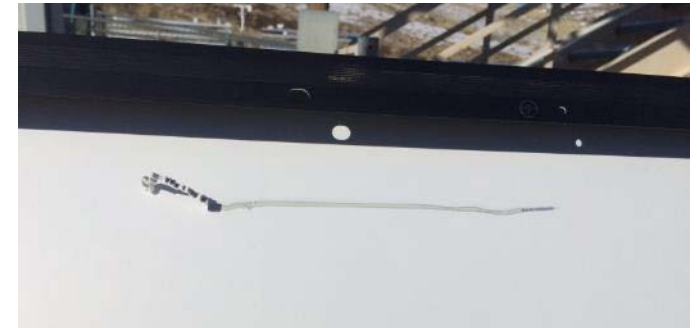
Shipping Damage – back sheet scratched during
unpacking (NREL 2016)

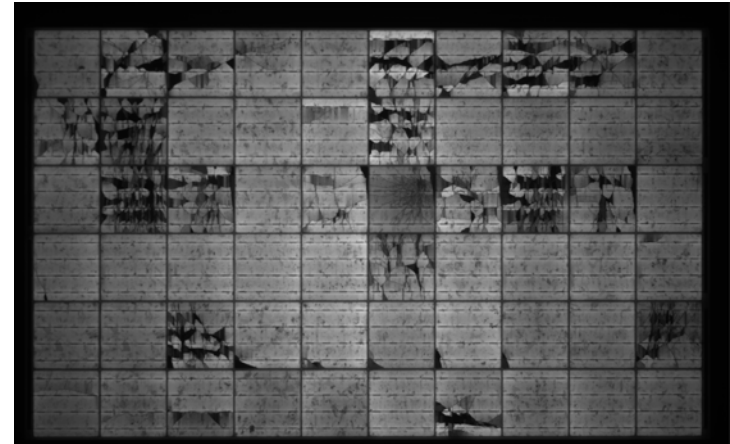
EL Image, Hail damage, Trina - M1610-0043

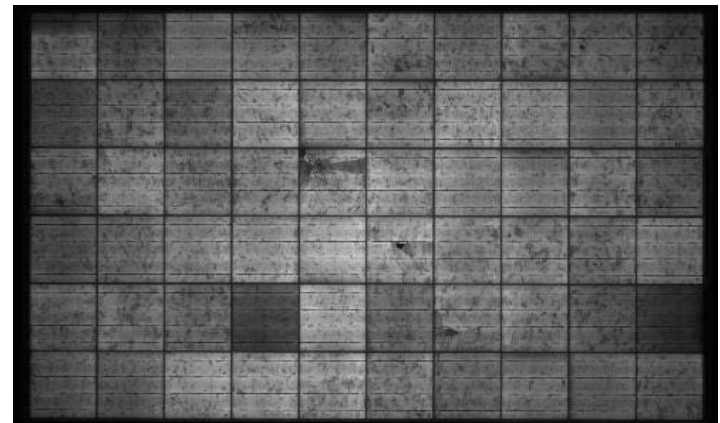
EL Image, Hail damage, Jinko - M1609-0059

- Module possibly damaged during shipping

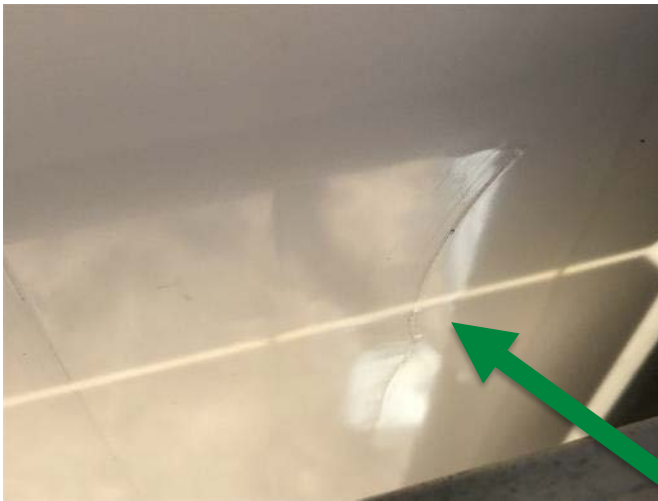
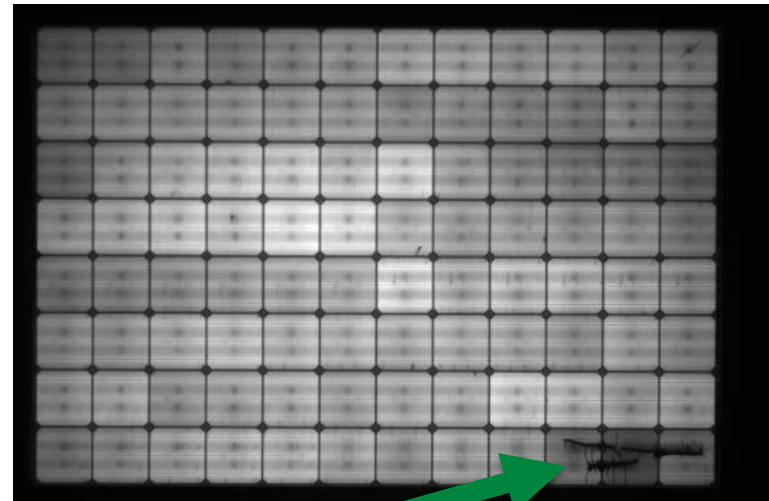
Shipping Damage, lower right 3 cells
(Visual Image and EL image)
