# **Polybutylene Pipe Freeze/Thaw Reliability Testing**

**Robert B. Farrington**

**April 1987**

## POLYBUTYLENE PIPE FREEZE/THAW RELIABILITY TESTING

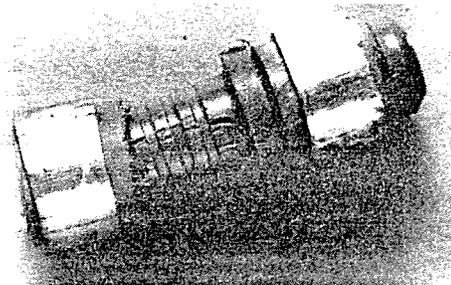
Fig. 3. Failure of Polymer Coupling

3. Catastrophic failure of all three original polymer couplings at 579 cycles. The failed joints used aluminum compression rings. Apparently the repeated freezing and thawing caused the polybutylene pipe to slowly work off the fitting. One coupling was deeply gouged (see Figure 3), showing the large stress on the fitting as the pipe was slowly worked off. It appears that the polymer coupling is too soft to maintain a good compression fit under severe freeze/thaw cycling. Since these three failures occurred at essentially the same time and for two orientations, this appears to be a fairly uniform process. These fittings were replaced and additional fittings installed.
