20-Year field exposed polycrystalline silicon PV modules: detailed visual inspection and analysis

Tony Sample and Alberto Pozza

European Commission, DG JRC, Institute for Energy and Transport, Ispra (VA), Italy

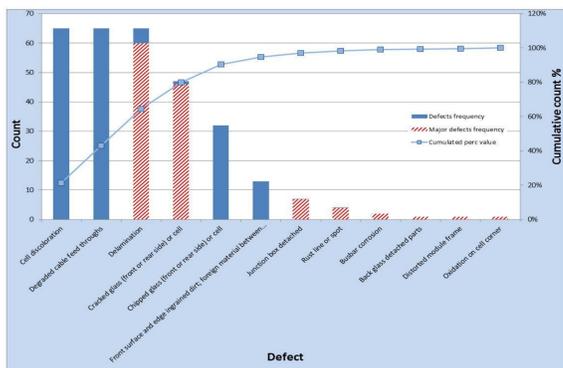
Fig.1: result of 2010 visual inspection

Visual inspection according to IEC 61215 was performed on the majority of modules in 2010. More than 90% of defects were due to 4 types:

- Cells discoloration
- Degraded cable feed through
- Delamination and bubbles formation
- Chipped or cracked glass (module front or back)

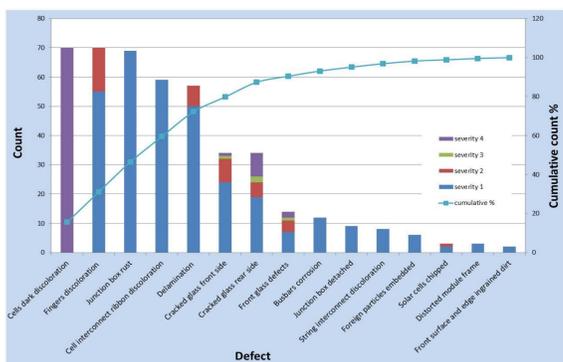
Fig.2: result of 2013 visual inspection

- Height of columns: occurrence of each defect as a percentage of the total number of defects found with the visual inspection in all modules.
- Each defect type is divided into four severity levels corresponding to protocol indications eg.:
 - "cells dark discoloration": severity 4 = 75% - 100% discolored area
 - "cracked glass": severity 1 = 1 crack; severity 2 = 2 cracks; severity 3 = 3 cracks

Figure 2 contains a selection of information useful to compare the results of the previous visual inspection.

Some defect types found in 2010 are not present in 2013 eg: "degraded cable feed throughs". This defect was not evident in 2013 as the cables were removed from modules in 2010 after visual inspection.

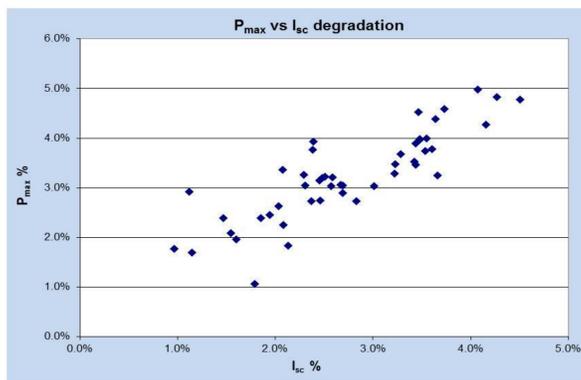
Fig.3: 1991-2010 P_{max} versus I_{sc} degradation

Direct correlation between visual defects and electrical degradation was not found even taking into consideration defect severity as a parameter. This is due to the low average degradation rate (-0.24% P_{max} per year)

- Data analysis showed correlation between degradation of P_{max} (-0.24% /y) and I_{sc} (-0.15% /y) (fig.3).

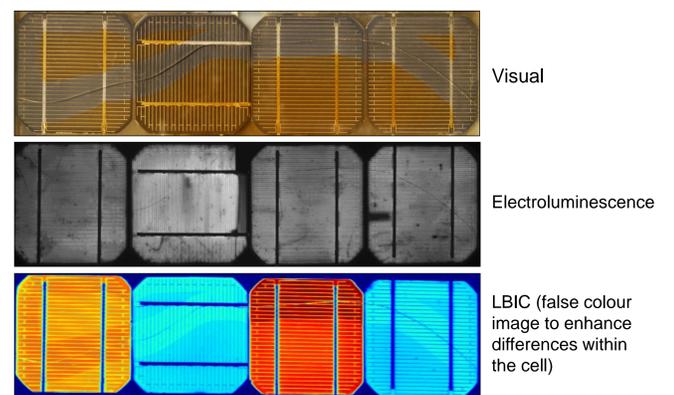
Fig.4: Visual, EL and LBIC images of the same module area

Visual: extensive EVA yellowing, extensive glass crack, no yellowing near cracked area (effect due to oxidative bleaching)

EL: several defects visible (cracked cell, finger interruptions, scratches). No difference between area with and without yellowing. Cells do not show damage by moisture ingress from glass crack.

LBIC: higher photogenerated current in the area without yellowing (optical coupling is limiting factor for current). With dark LBIC technique, only the difference of response inside a cell is to be considered. (Cell to cell comparison is not possible as the response is dependent on the complete string connection).

- Main degradation factor was found to be optical coupling degradation due to extensive yellowing, present in all modules, causing I_{sc} losses.
- Moisture ingress from glass crack did not cause cell degradation.
