Thin Film PID Field Failures and Root Cause Determination

N.A. Olsson, M. Propst, C Richardson, J. Hevelone*

Pearllaboratories
2649 E. Mulberry St, Unit 15
Fort Collins, CO 80512

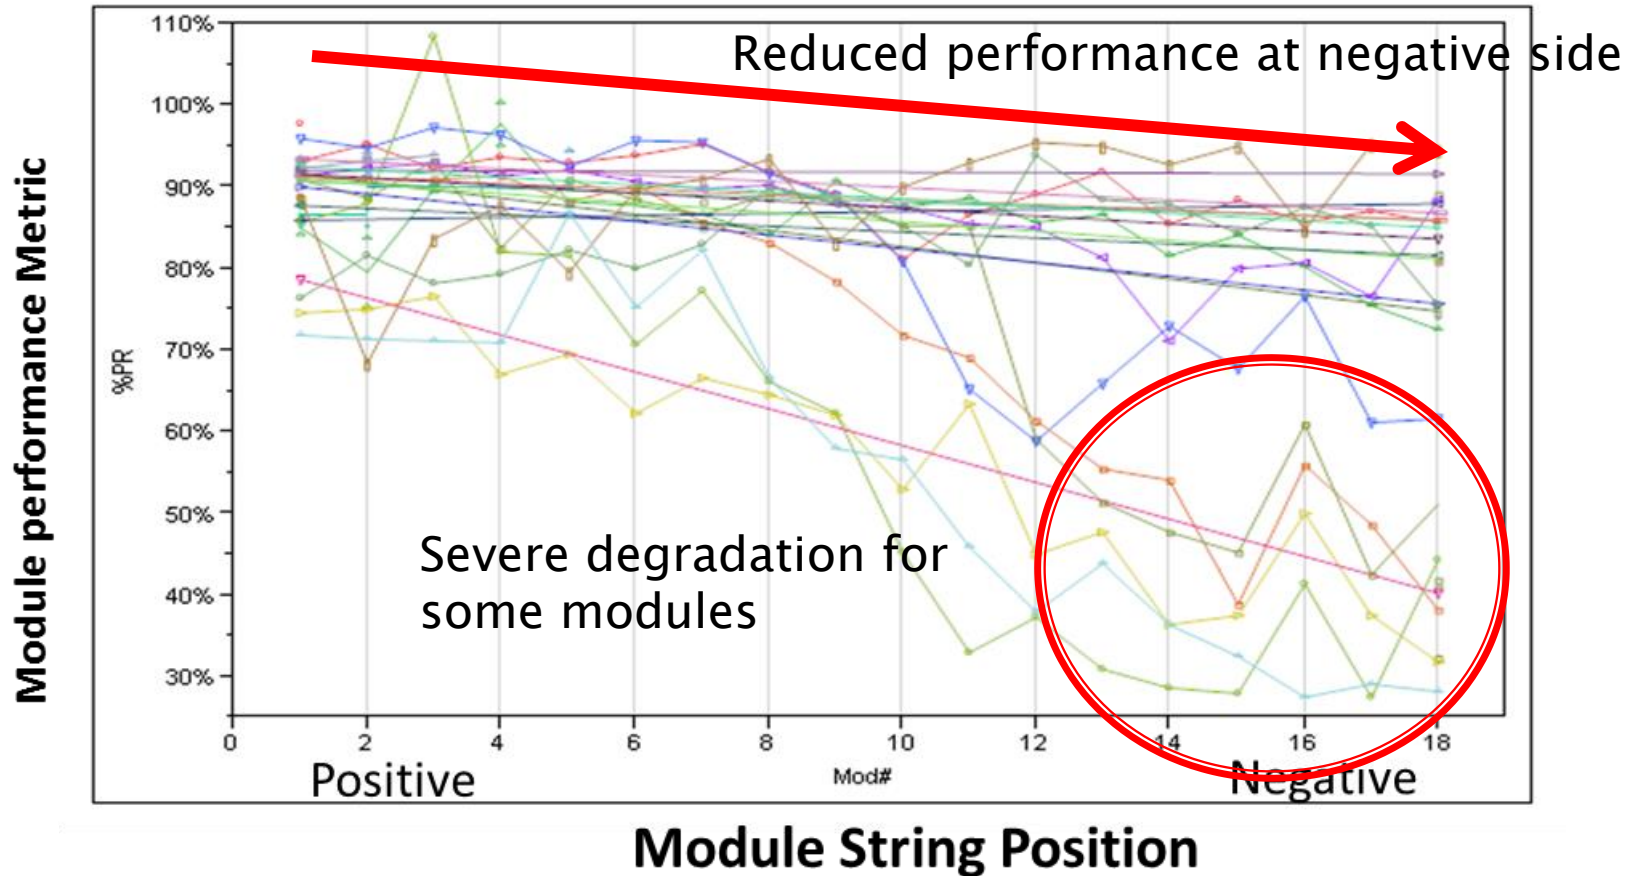
Field Measurements

- ▶ Location: Germany
 - ▶ Size: 3 MW
 - ▶ Inverter: Transformer less
 - ▶ Voltage: 1 000 V
 - ▶ Grounding: Ungrounded
 - ▶ Modules: Thin Film (CdTe)
-
- ▶ Issue: Substantial under performance after 1 year of operation

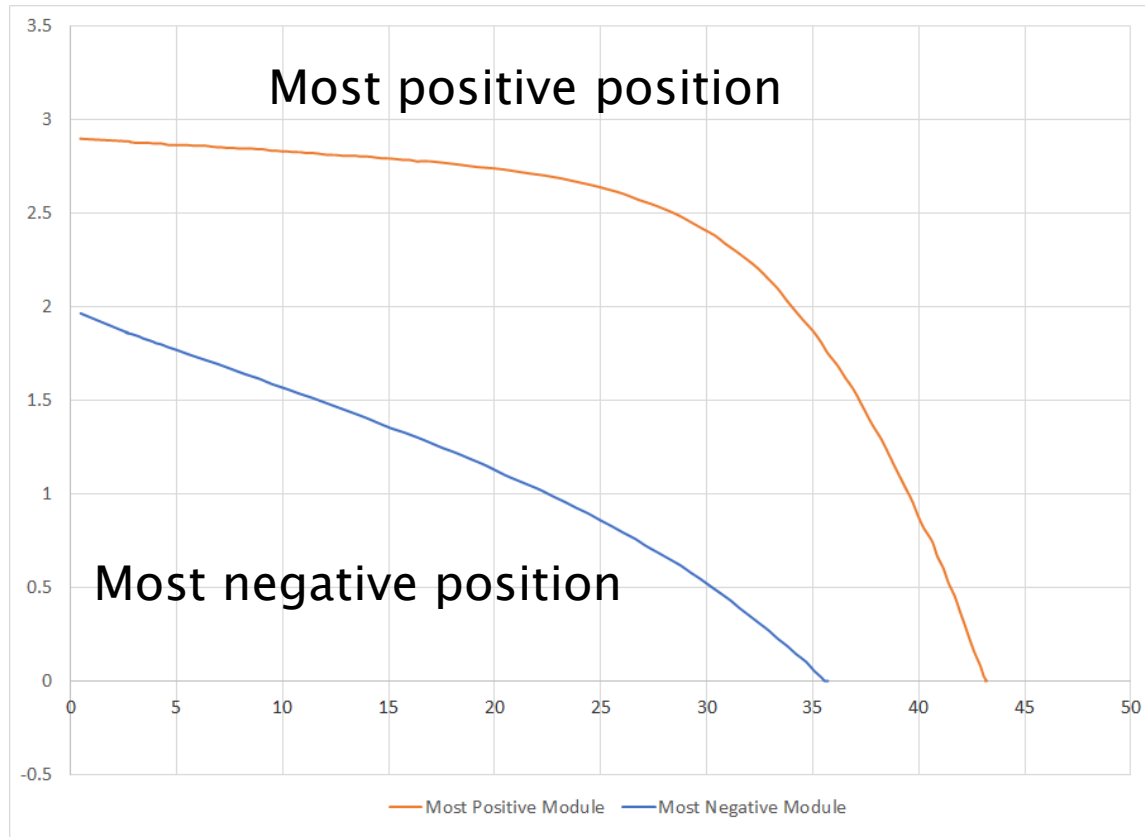
Return Module I-V

Severe degradation in Rsh is the issue

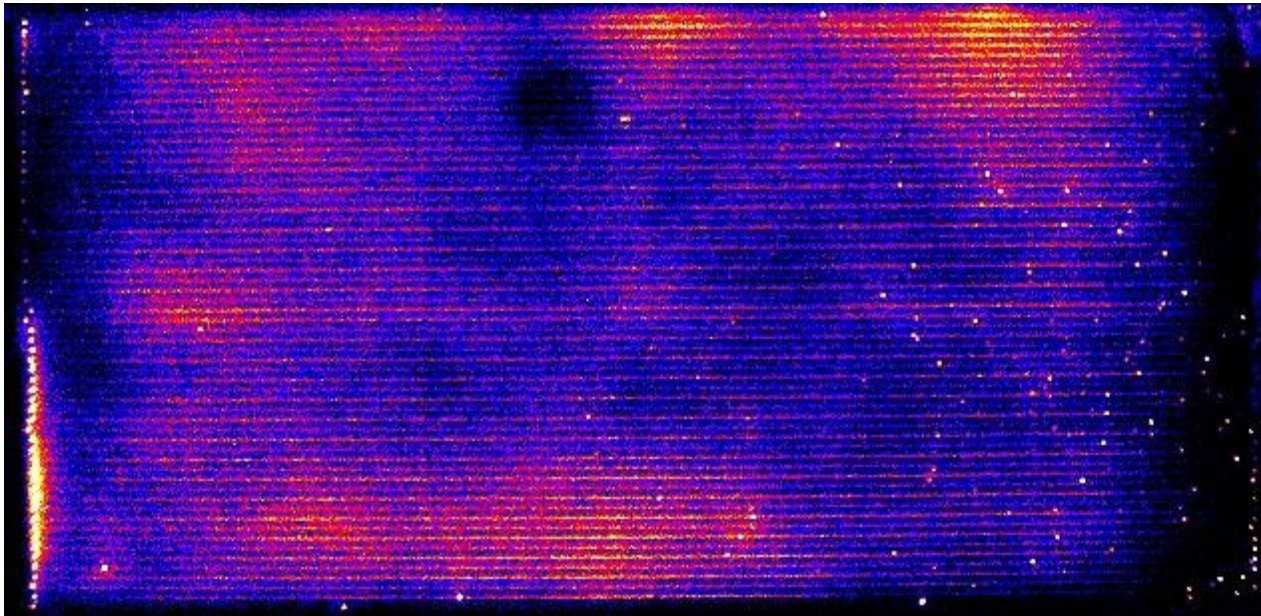
Lock-In thermography

Pinpointing the location of shunts

Severe scribe
shunts in degraded
module

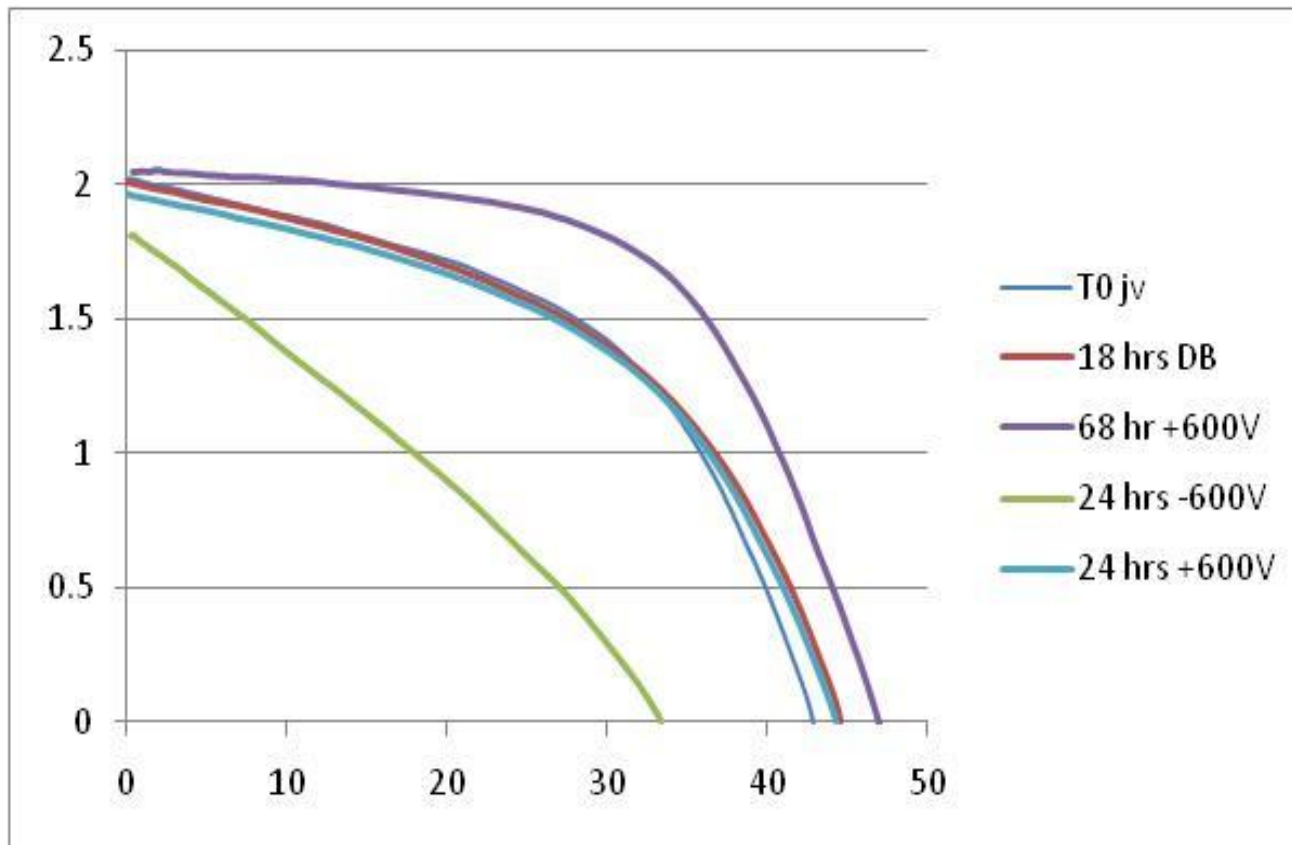
Reversibility of damage

Main degradation is in Rsh and it is a reversible PID type

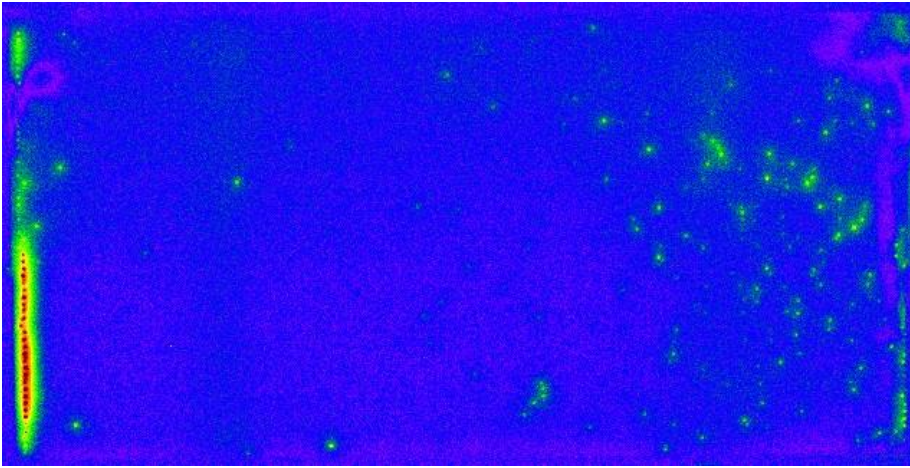
Lock-in thermography of healed module

After positive bias healing

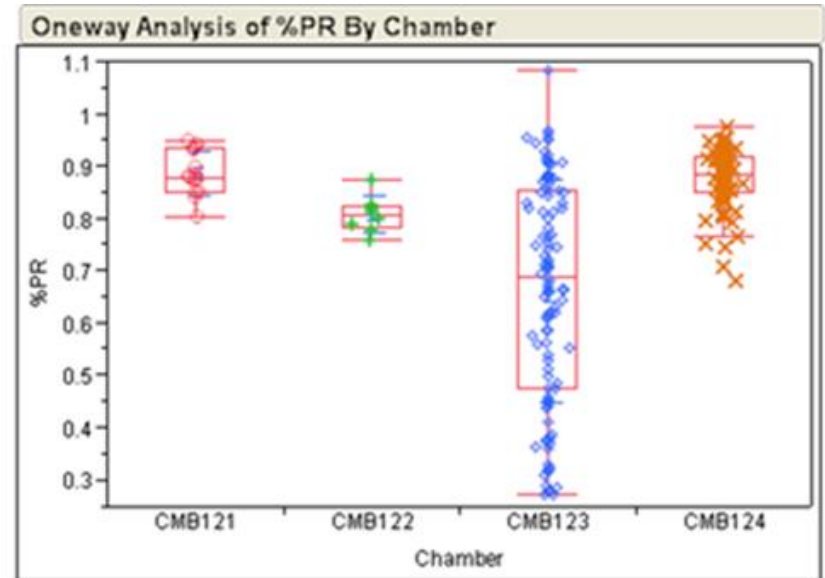
Severely Degraded Modules: manufacturing excursions

All the severely degraded modules came from only one of 4 production chambers and only from a specific time period.

Root cause:
Broken glass on top of heater coils in the deposition chamber: Excellent source of sodium.

- ▶ Corrective Action
 - Switch P1 scribe and semi deposition process order
 - Backfill P1 with inert material

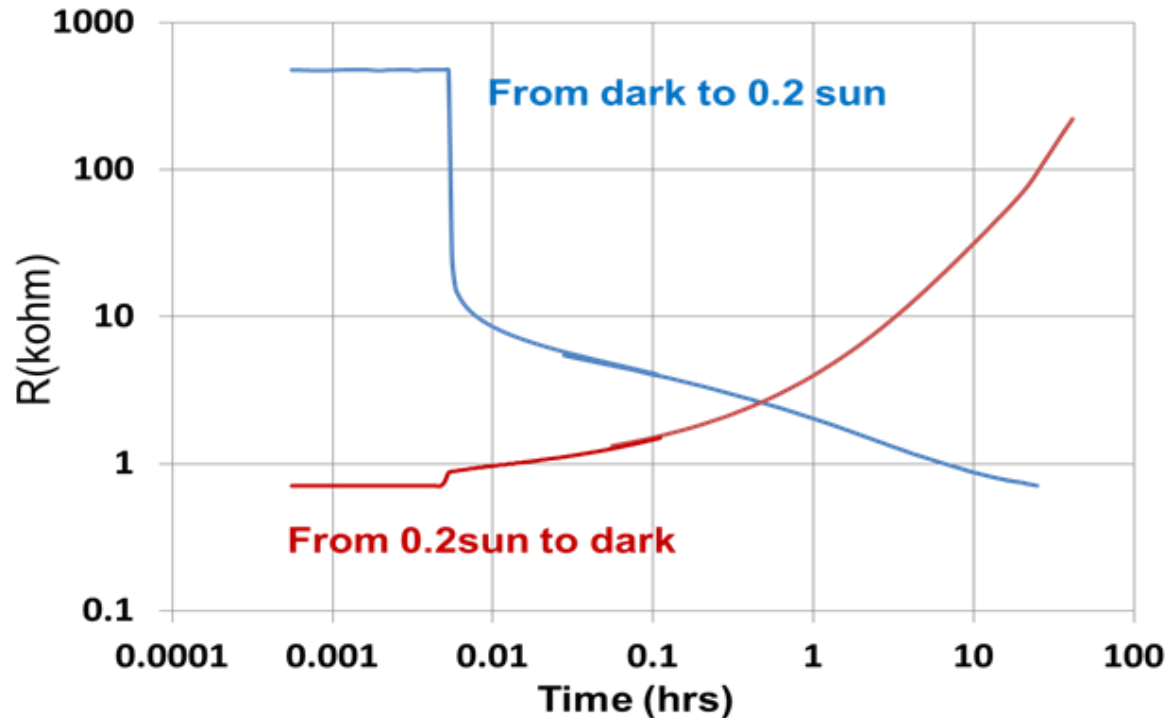
Photoconductivity in CdS

CdS photoconductivity is very dynamic and may take many Hrs to fully develop
