PERFORMANCE ANALYSIS OF CIGS THIN-FILM PHOTOVOLTAIC SYSTEM AFTER 10 YEARS IN THE HOT AND HUMID CLIMATE OF FLORIDA

Eric Schneller, Narendra Shiradkar and Neelkanth G. Dhere

Florida Solar Energy Center, 1679 Clearlake Road, Cocoa, FL 32922-5703 USA

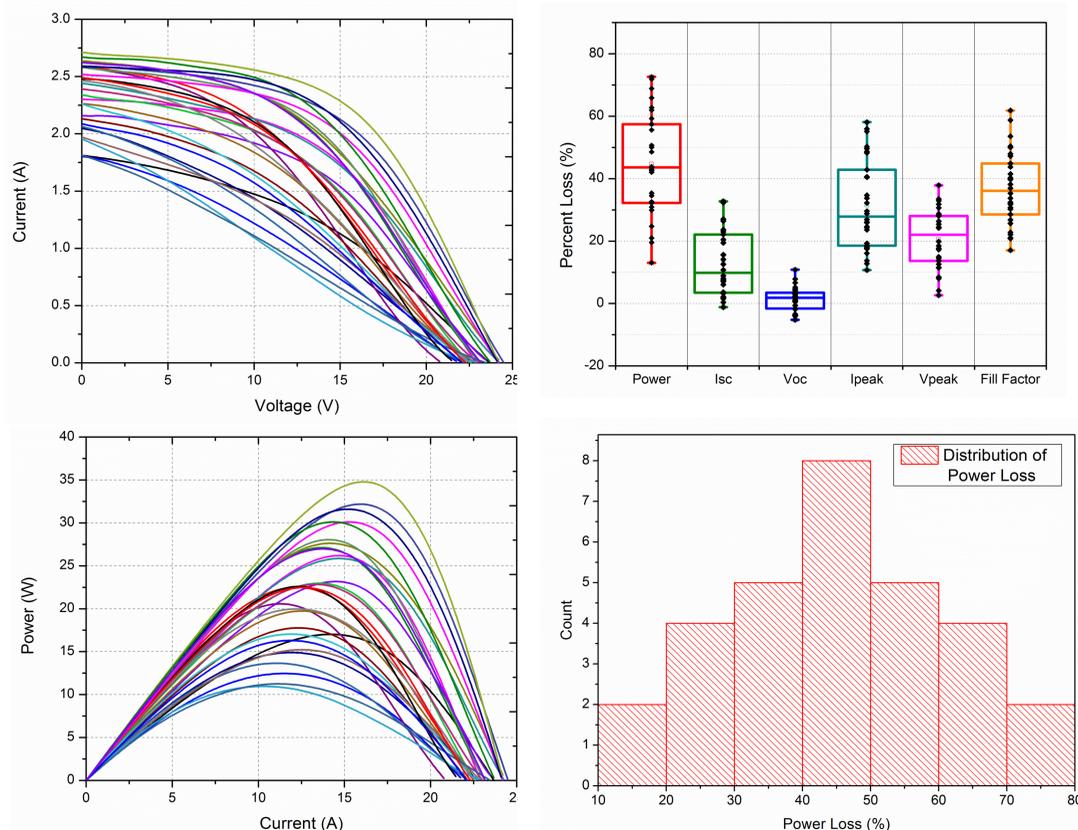
CURRENT-VOLTAGE CHARACTERISTICS

Outdoor I-V measurements were taken with a tolerance of $1000 \text{ W/m}^2 \pm 5\%$ and $25 \text{ }^\circ\text{C} \pm 1 \text{ }^\circ\text{C}$. The percentage loss of each parameter was calculated with reference to the nameplate ratings for the modules. The large variation in power loss among the modules exhibited a normal distribution with an average power loss of 44.6%. This loss was mainly a result of decrease in fill factor and more specifically the operating current.

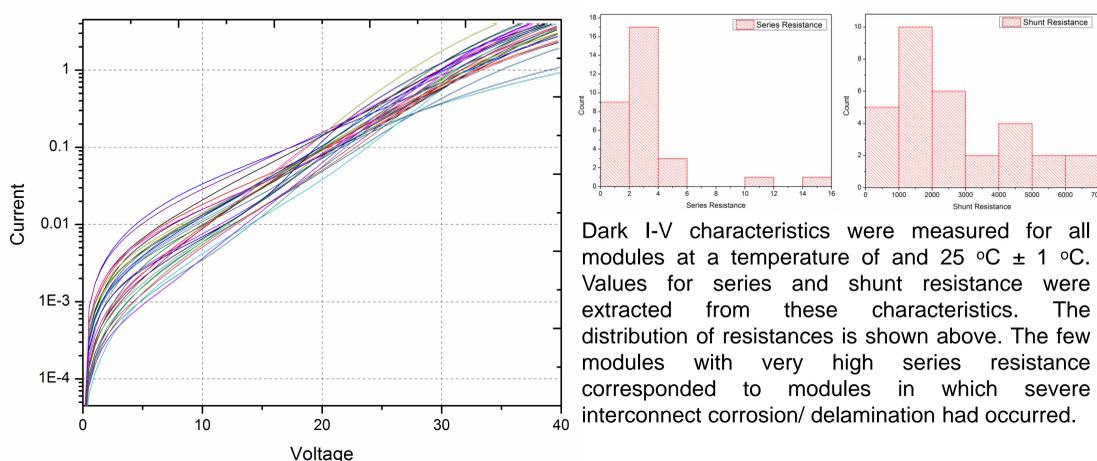
DARK I-V CHARACTERISTICS

Dark I-V characteristics were measured for all modules at a temperature of $25 \text{ }^\circ\text{C} \pm 1 \text{ }^\circ\text{C}$. Values for series and shunt resistance were extracted from these characteristics. The distribution of resistances is shown above. The few modules with very high series resistance corresponded to modules in which severe interconnect corrosion/delamination had occurred.

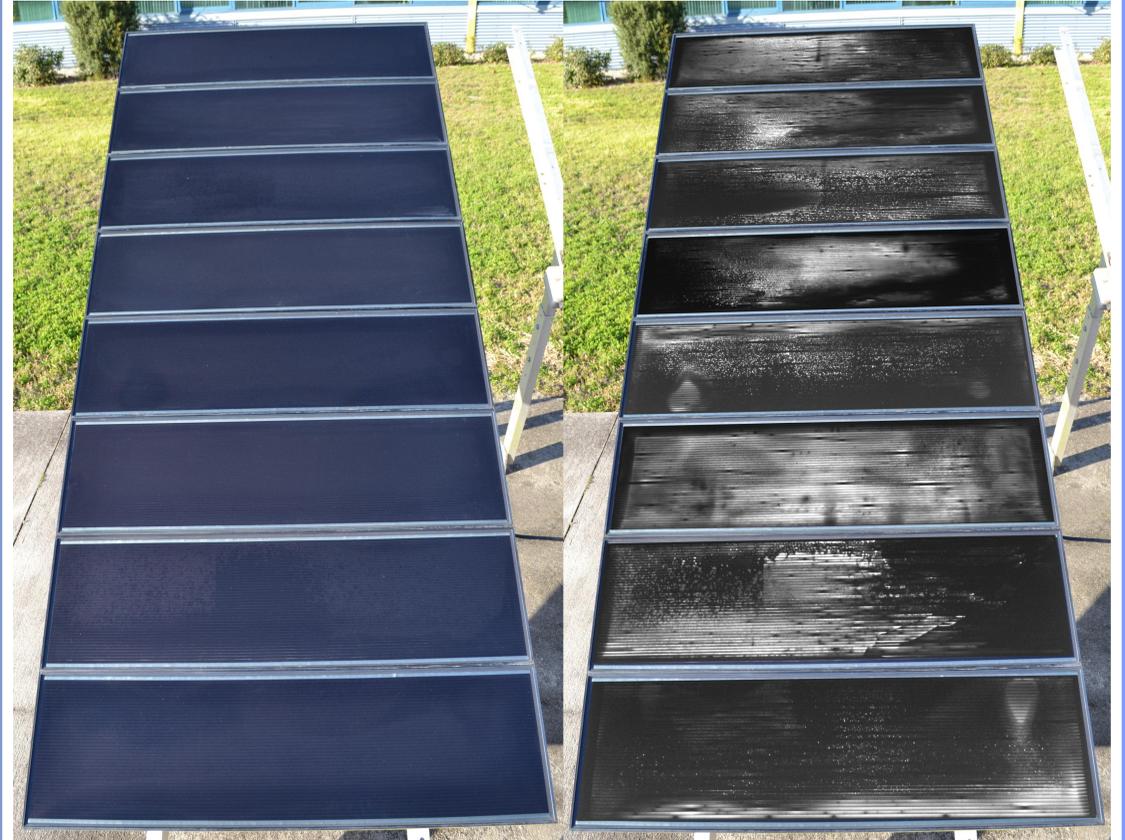
VISUAL DISCOLORATION

Visual image (left) and imposed electroluminescence images of corresponding modules (right). Distinct features and severe discoloration were observed on several modules. It was found that this directly correlated with underperforming regions of the device as shown in the EL images. This was attributed to issues within the front Transparent Conducting Oxide (TCO).

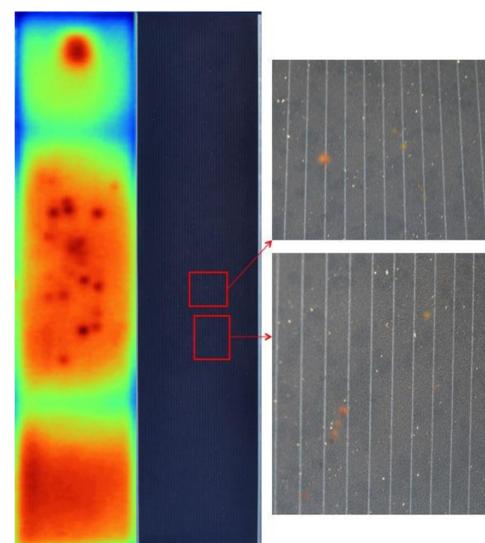
HOT SPOTS

Outdoor infrared image showing multiple hotspots within the module and corresponding visual image highlighting visible browning of the encapsulant.

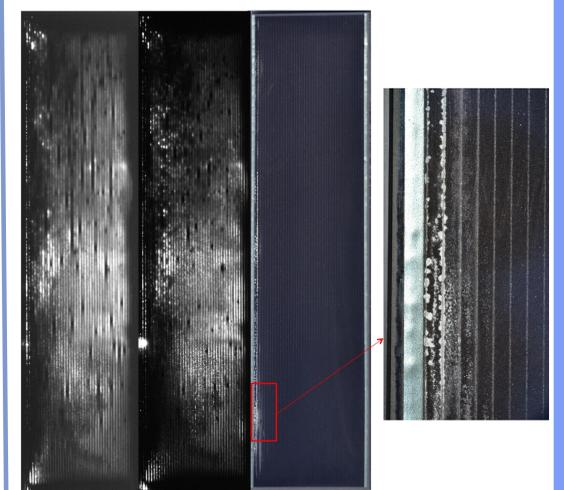
DELAMINATION AND INTERCONNECT CORROSION

Electroluminescence images and corresponding visual image highlighting corrosion of the interconnects along the bottom edge of the module.
