Current status of TG5 region Japan

Mitsui Chemicals, Inc.

Delamination

A 20y-field-aged PV module with delamination failure and induced corrosion

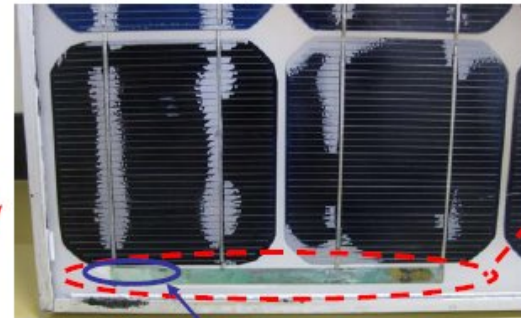
closeup picture

Patina

Severe degradation of copper

A solder layer disappeared.

A part of Copper ribbon disappeared.
= No electrical conduction

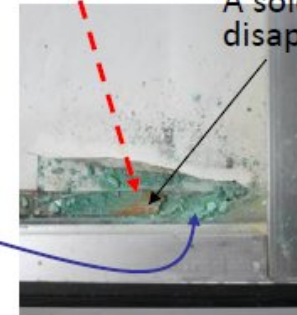
Backsheet/EVA were cut at the bus-bar portion.
We observed the corroded bus-bar.

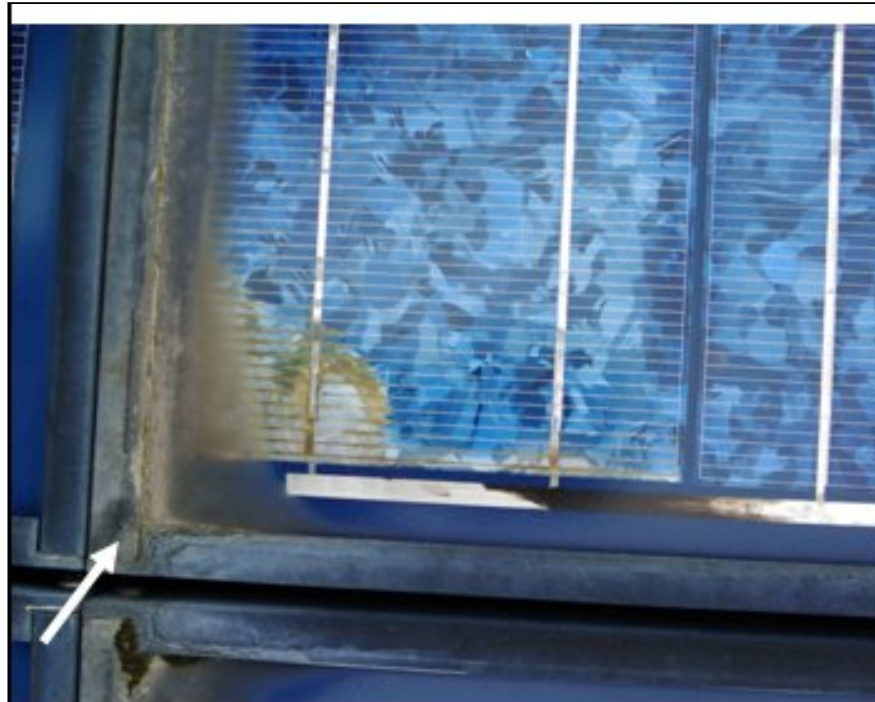
EL image

✓ Adhesion strength among inner layers of the backsheet "TAT" was extremely low.

Delamination at inner-layer or inter-layer of backsheet and penetration of water into front side of cell

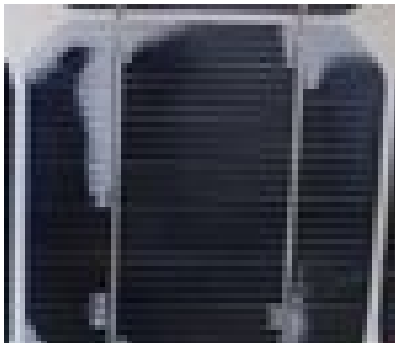
Category (A) Delamination at interface between EVA and cell / interconnector

This is considered to be **isolated** from liquid water penetration.

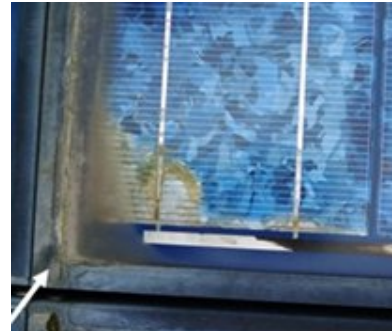
There is a pass for liquid water penetration.

Higher severity
High priority

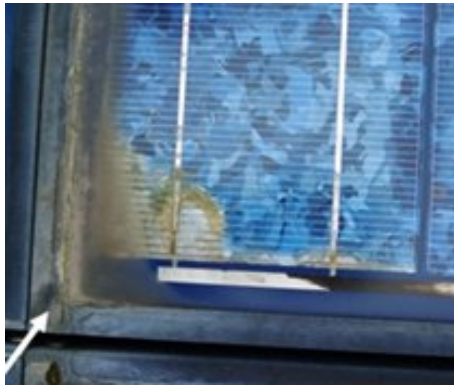
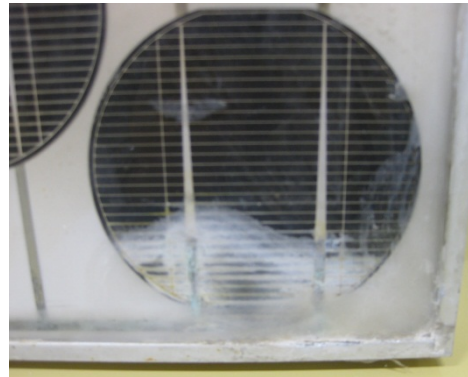
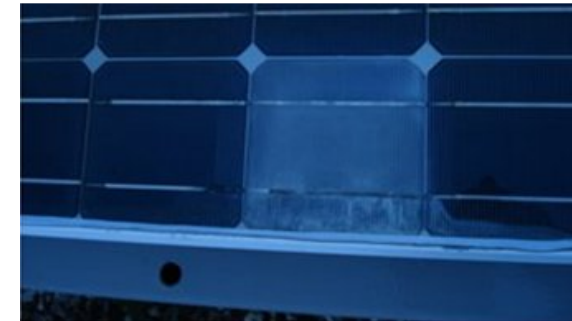
Category (B) Delamination at interface of inner-layer of BS / BS and EVA

Liquid water induces corrosion and delamination which leads to corrosion.

This failure is typically observed at corners of a PV module and lower side for deployment in field.

Adhesion of the interface between inner layers and BS/EVA would be important.

New test, such as dipping hot water, may be necessary for duplicate this delamination, instead of or after typical chamber tests such as UV, DH, TC and these sequence... We need some ideas and data. Of course, we still collect field failure information concerning delamination.

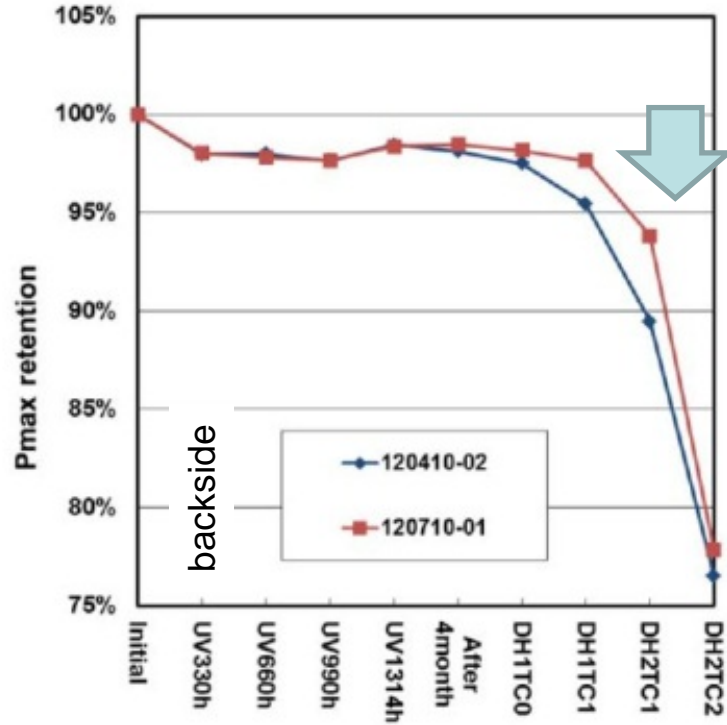
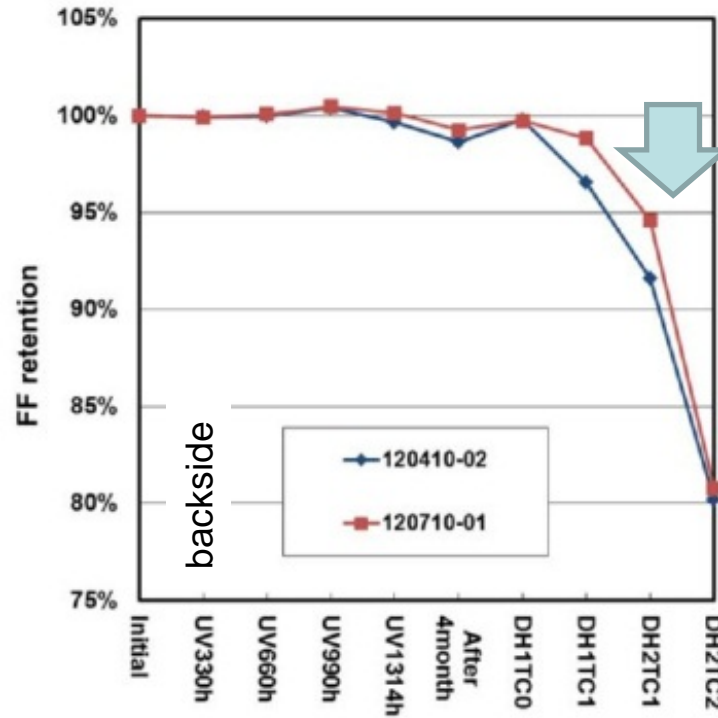
After 2nd DH500, TC100, Pmax, FF was dramatically reduced.
