# Field Evaluation of Photovoltaic Modules and Systems at GREEN-IPUC/PUC Minas, Brasil

Antonia Sônia A.C. Diniz,<sup>1</sup> Marcelo M. Viana,<sup>1</sup> Cristiana B. Maia,<sup>1</sup> Suellen C.S. Costa,<sup>1</sup> Thiago A. Silvério,<sup>1</sup> Marcio E.M. de Souza,<sup>1</sup> Denio A. Cassini,<sup>2</sup> Francisco H.A.F. Souza,<sup>2</sup> Lawrence L. Kazmerski<sup>3</sup>

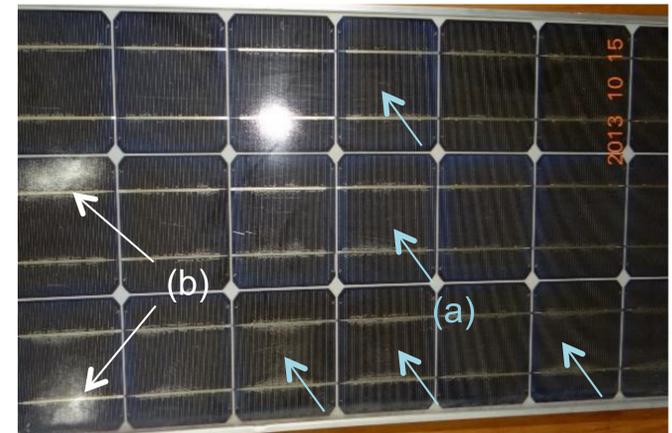
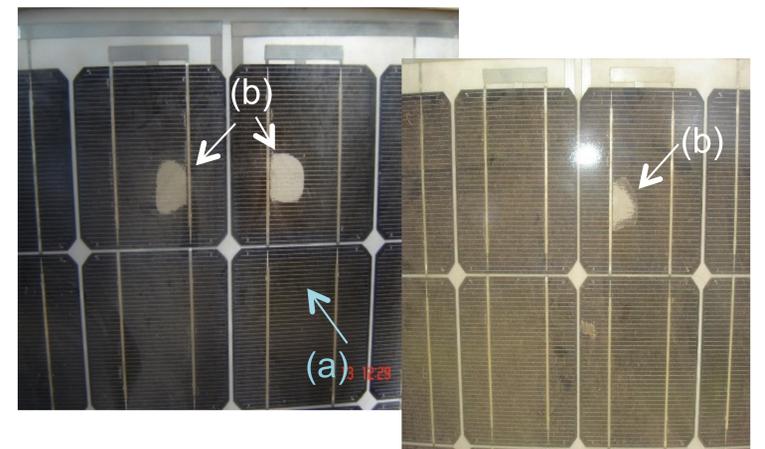
**Figure 1.** Examples of (a) browning and (b) encapsulant delamination for modules from stand-alone systems. Several areas of browning and delamination are highlighted by the arrows—although many such areas can be seen.

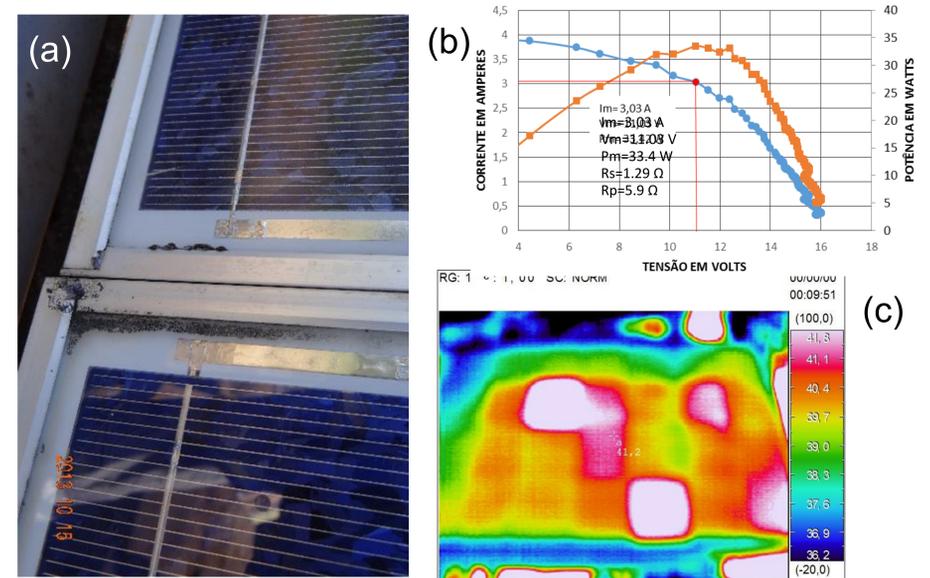
**Figure 2.** Reliability studies (a) Degraded modules; (b) Current-Voltage characteristic of lower module; and (c) Infrared image of lower module in (a).

Extensive corrosion at the interconnections, junction boxes, and system wiring was also discovered. In addition to major interconnect corrosion, extensive encapsulant discoloration, and prolonged inverter failures, some modules had fairly severe module soiling issues with up to 20% transmission obscuration.
