# Quality and Reliability - sometimes the customer wants more ...

Gerhard Kleiss<sup>1)</sup>, Johannes Kirchner<sup>2)</sup>, Karsten Reichart<sup>1)</sup>

<sup>1)</sup> SolarWorld AG, Martin-Luther-King-Straße 24, 53175 Bonn, Germany  
<sup>2)</sup> SolarWorld Innovations GmbH, Berthelsdorfer Straße 111, 09599 Freiberg

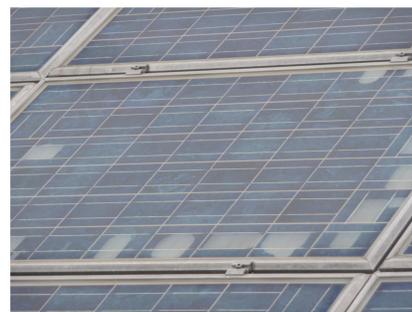
- **Type A:** „white spot“: highly visible, white discoloration stops at each cell perimeter (compare Fig. 1 and 2)
- **Type B:** delamination in the edge region that violates creepage path towards aluminum frame and may be hazardous (Fig. 3) - reject
- **General delamination:** as widely known. A very bad example (resulting in voids and cell crack) is given in Fig. 4.

- Production data for the modules under consideration are not available. However, a strong hypothesis could be established with two assumed factors:
1. ARC on solar cell is with TiO<sub>2</sub> which is known to be prone to hydrolytic distortion against the EVA. Typically, mechanical barriers like ribbons / bus bars or the cell's perimeter tend to stop the visible effect (comp. Figs. 1 / 2).
  2. poor control of lamination process. The laminate construction consists of front glass EVA (unknown brand), crane glass (most likely to support the lamination process) and a backsheet containing an Al barrier layer.

Fig. 1: Type A „white spot“ delamination. Center cells and edge cells affected

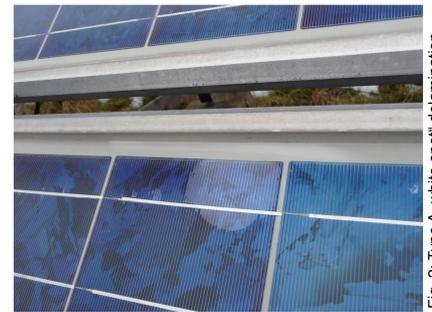
Fig. 2: Type A „white spot“ delamination. Delamination does not exceed perimeter of the cell

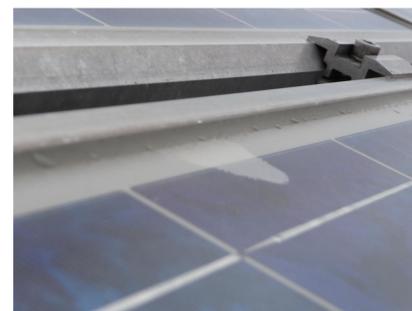
Fig. 3: delamination (bubble) extending to the aluminum frame. Creepage no longer given - reject

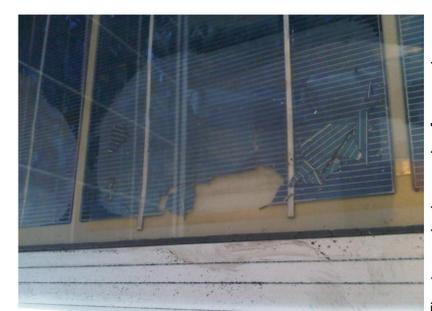
Fig. 4: very bad example of general delamination that results in voids and even cell breakage - clear reject

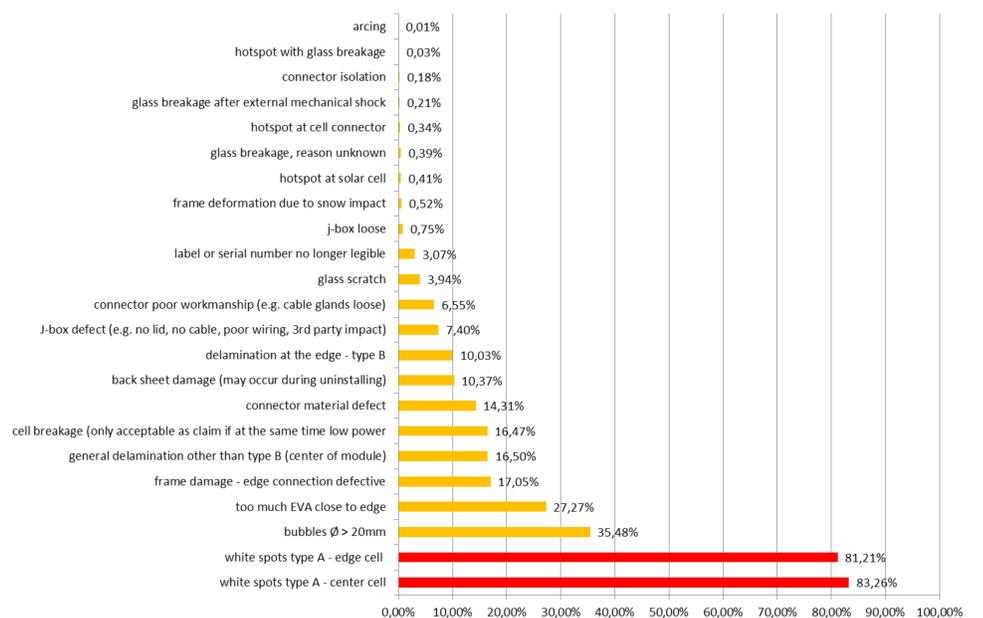
The dataset is based on 22,328 returned modules. All modules have been classified by multiple failure possibilities. More than 90% of the returned modules show “delamination”, whereas the overwhelming contribution is the “Type A” failure mode. A statistical lot of 2,838 of modules out of the 22,328 modules has been flash tested and **only 13% of the tested modules had a power less than promised in the warranty document.**

Fig. 5: failure pareto of 22,328 returned modules. Multiple failures are possible: total of all failure modes is > 100%
