Subcomponent Validation of Composite Joints for the Marine Energy Advanced Materials Project

Technical Report
NREL/TP-5700-84487
January 2023

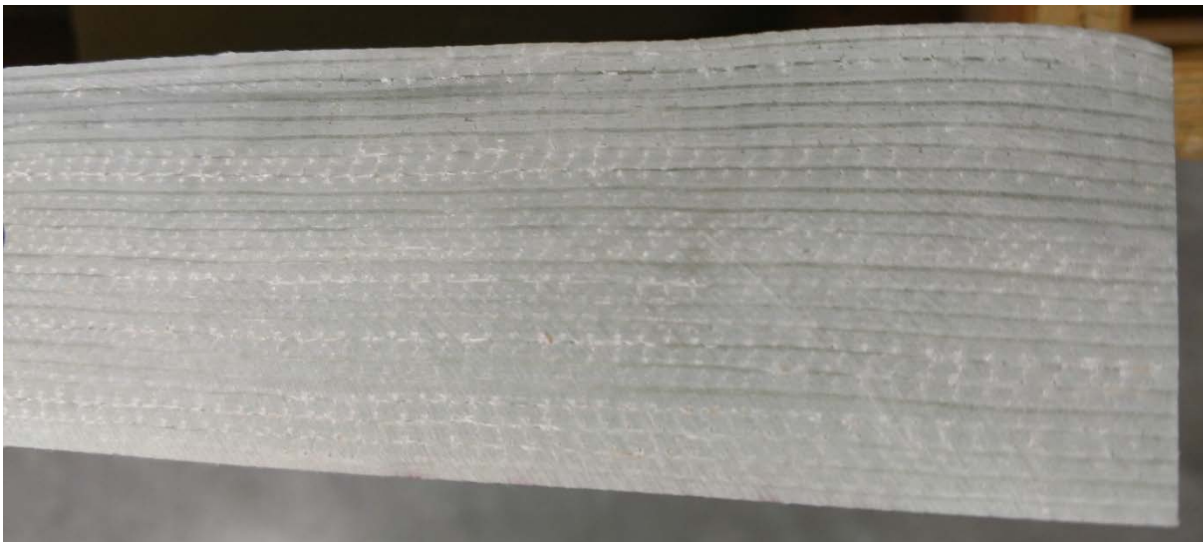
Figure 2. Cross-sectional view of a manufactured thick panel

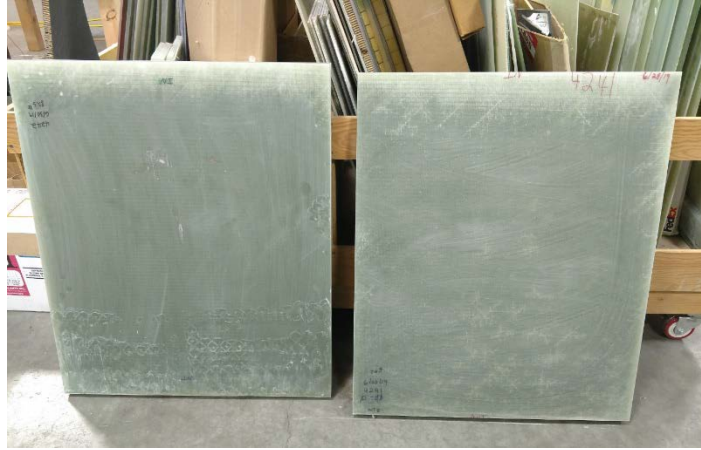
Figure 3. Two complete panels

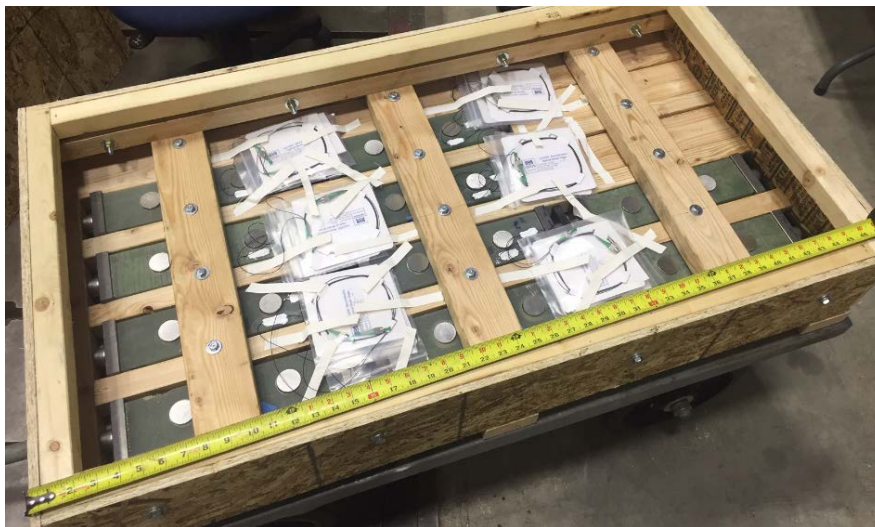
Figure 6. T-bolt specimens packaged and ready to be shipped to PNNL and FAU

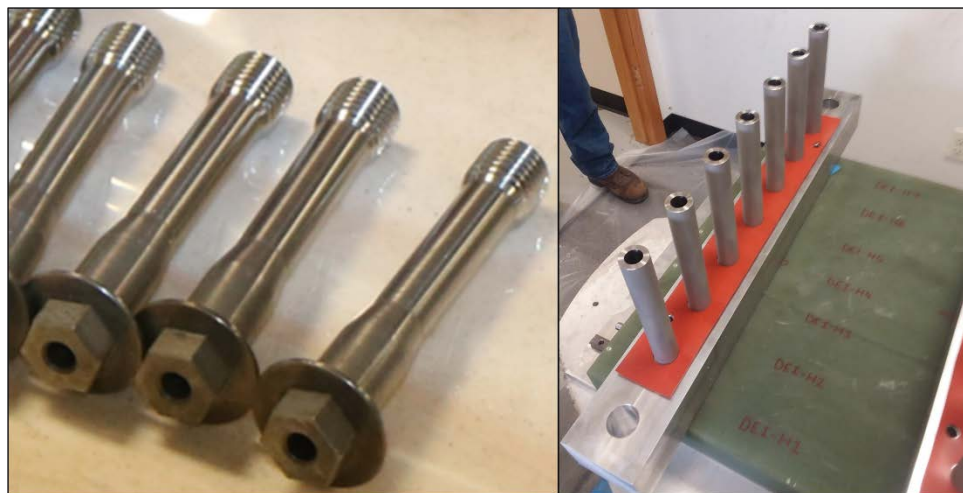
Figure 10. (left) An M20 injection bolt used to inject adhesive into the cavity between the inserts and the composite blank and (right) a photo of the inserts bolted to the end bars in preparation for bonding

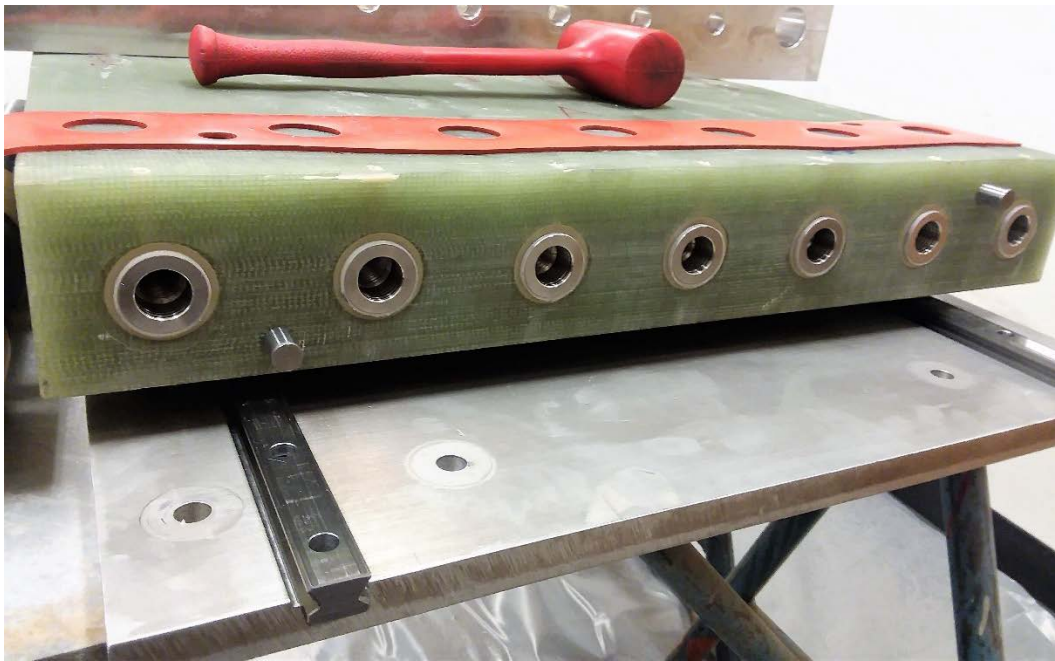
Figure 11. A composite blank with the adhesive bonding process complete

Once the steel inserts were assembled and ready for bonding, adhesive was injected through the injection bolts using a pneumatic dispensing gun with mixing nozzles to properly mix the two-part adhesives. Adhesive was injected until it squeezed out of the exit holes drilled on the surface of the composite panel, so the cavity between the steel inserts and the composite was filled with adhesive without any air bubbles or voids. The adhesive cartridges were weighed before and after each hole was filled for quality assurance purposes. The adhesive was left to cure before disassembly of the fixture (Figure 11).

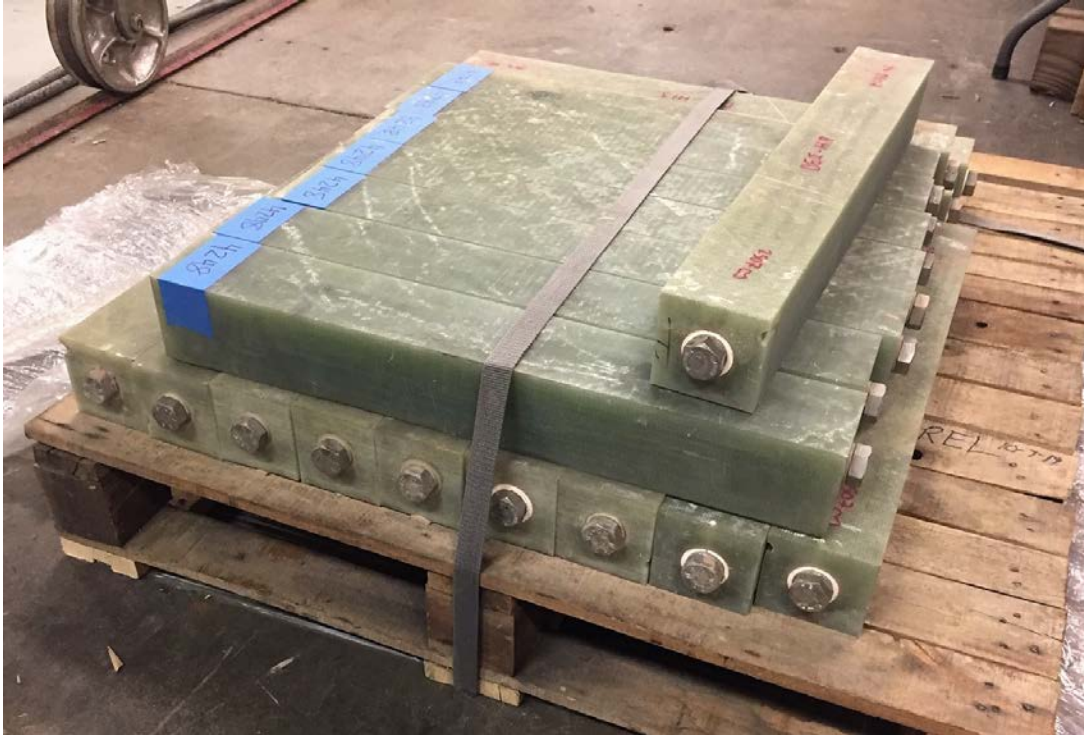
Figure 12. Complete DEI specimens ready to be shipped to FAU and PNNL

Finally, the large composite panels were waterjet cut to yield seven DEI specimens each (Figure 12). Prior to shipping to PNNL and FAU, M20 bolts with rubber gaskets were installed in both ends of the specimen to protect the insert threads from corrosion during saltwater conditioning. Table 3 provides a summary of the composite matrices, steel insert materials, and adhesives used for each DEI specimen for this study.

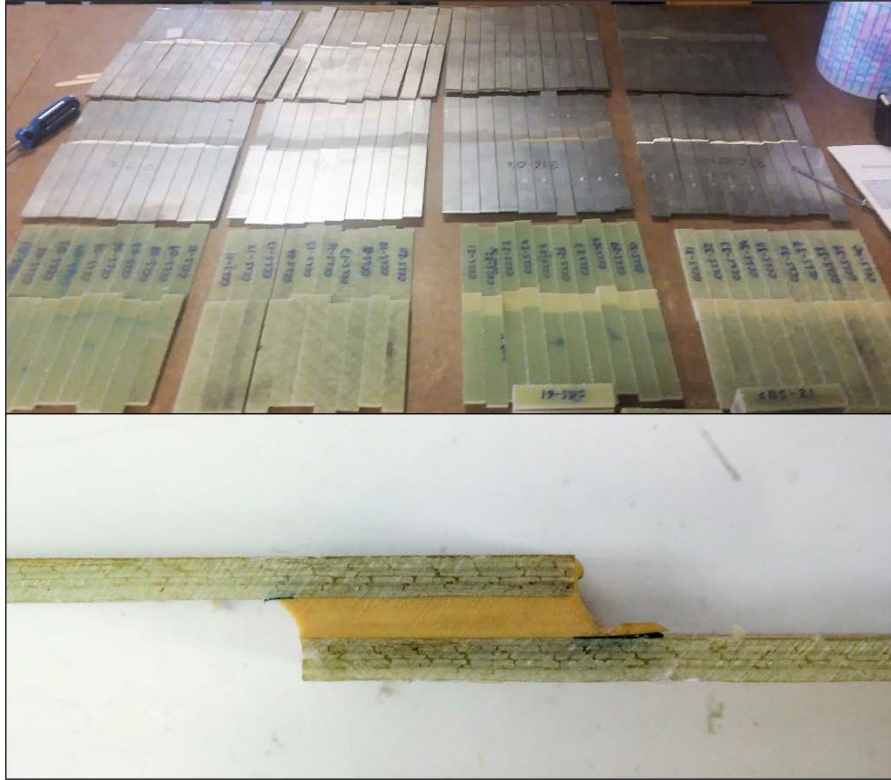
Figure 15. (top) The final manufactured MMLS and CCLS specimens and (bottom) a closer view of a CCLS bondline cross section

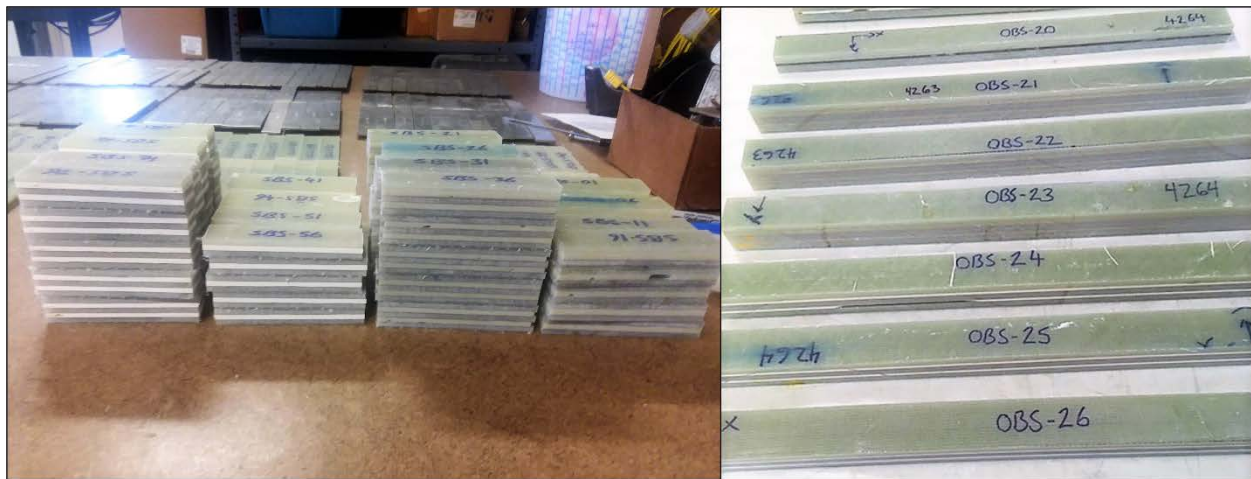
Figure 17. Some of the manufactured specimens: (left) SBS specimens; (right) OBS specimens

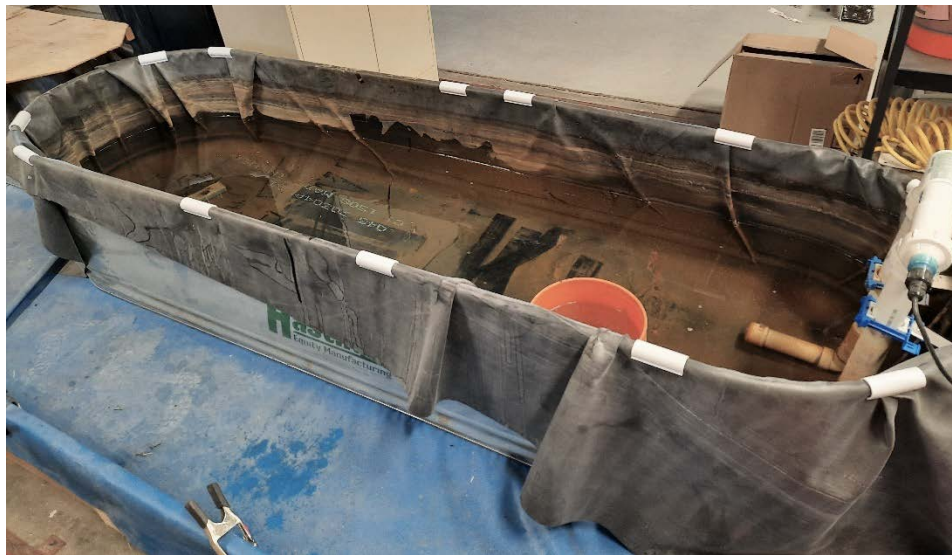
Figure 18. Cold-water storage tank used to maintain saturation conditions of specimens prior to mechanical testing

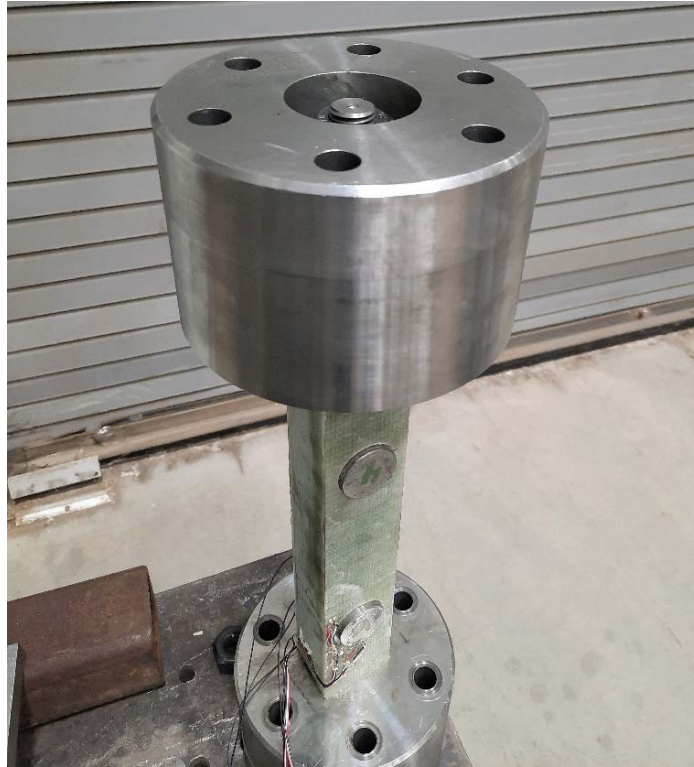
Figure 19. The fixture used to connect the T-bolt specimens to the 500-kN load frame

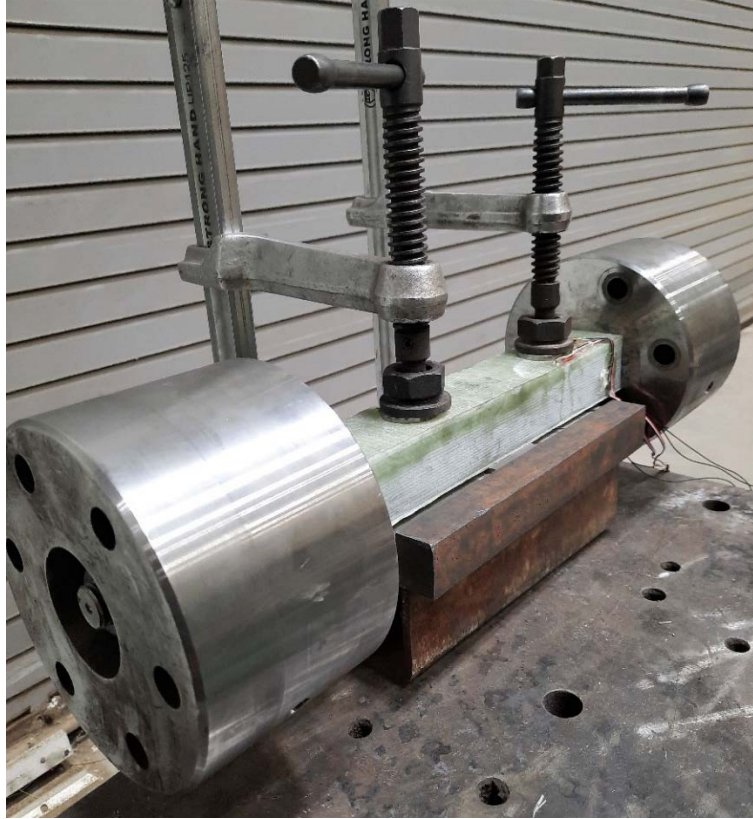
Figure 20. A T-bolt specimen being loaded into the test fixture using the alignment fixture

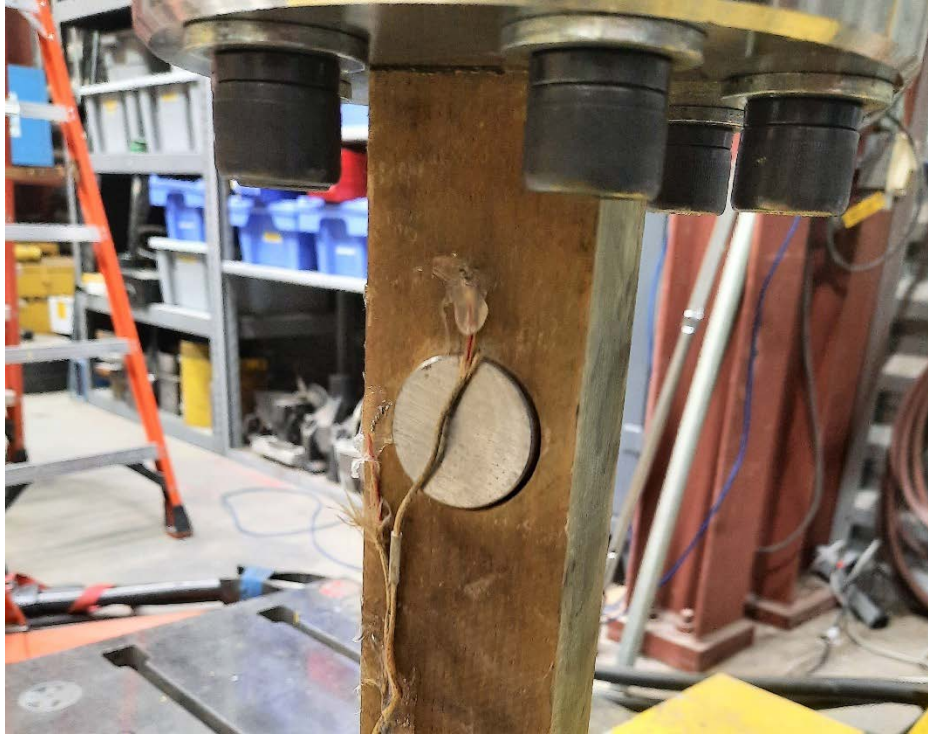
Figure 21. Thermocouples bonded to a T-bolt specimen for fatigue testing

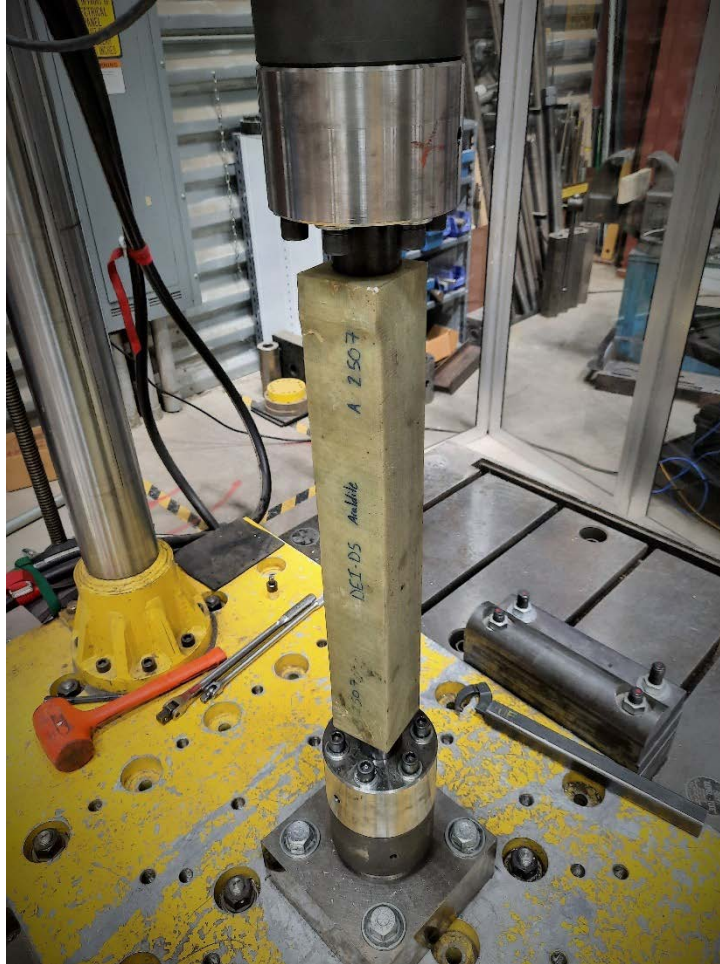
Figure 22. A DEI specimen set up in the load frame prior to testing to failure

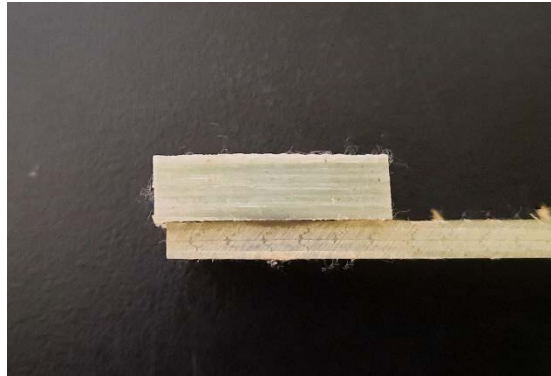
Figure 24. A fiberglass end tab bonded to a CCLS specimen to ensure good alignment in the load frame

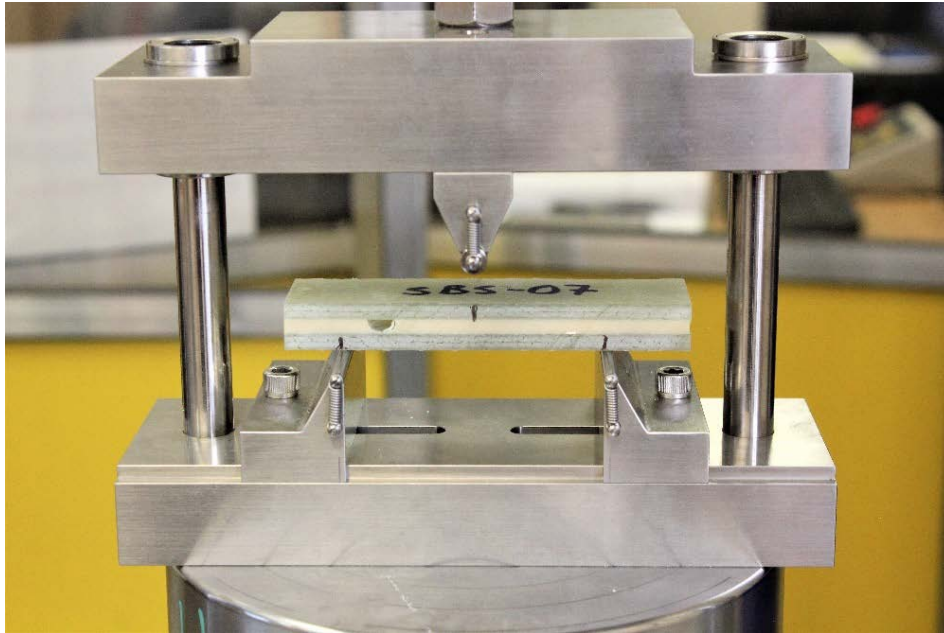
Figure 26. An SBS specimen prepared in the three-point bend fixture before loading to failure

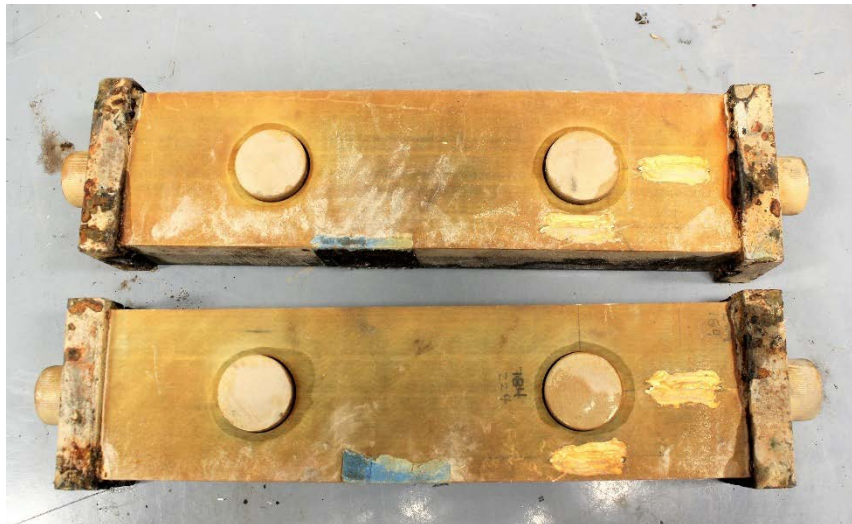
Figure 29. Extensive amounts of corrosion (iron oxide) stuck to the surface of T-bolt specimens with broken fiber optic gauges attached

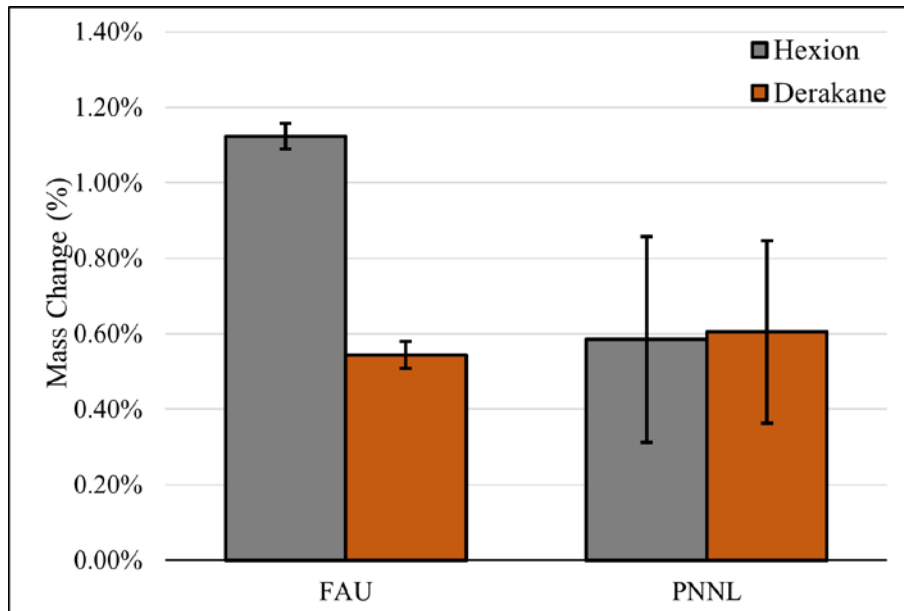
Figure 30. A comparison of percentage mass change of T-bolt specimens from FAU and PNNL (error bars represent standard deviation)

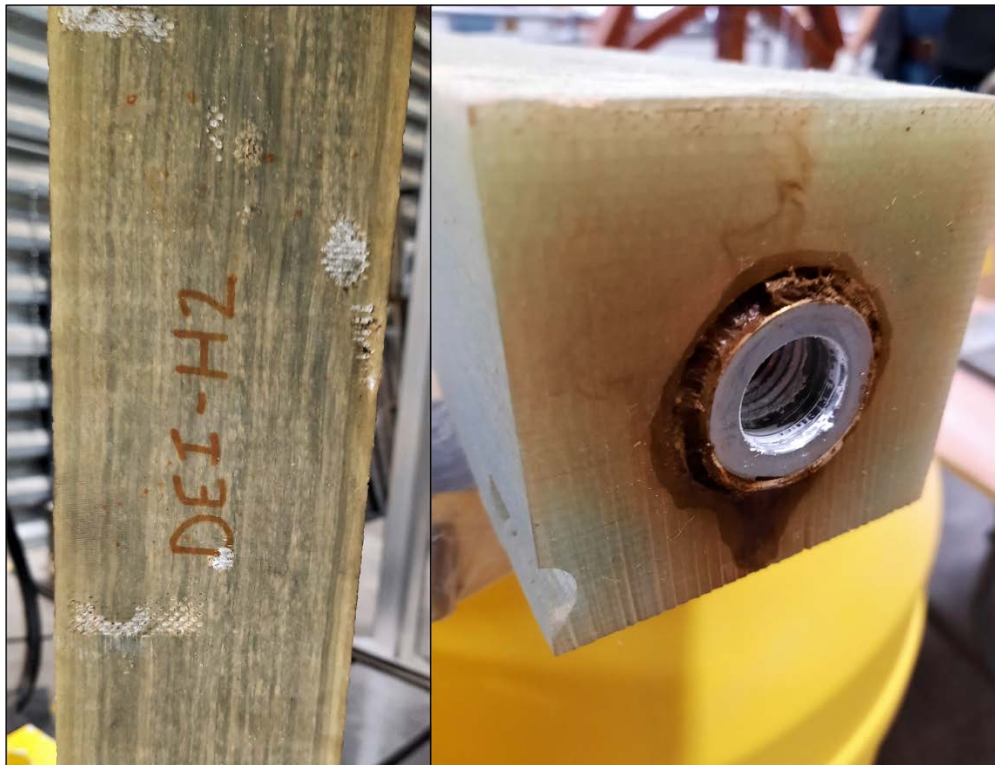
Figure 32. (left) Discoloration and streaking on the surface of a Hexion DEI specimen conditioned at FAU and (right) corrosion observed on a 316 steel insert of a DEI specimen conditioned at PNNL

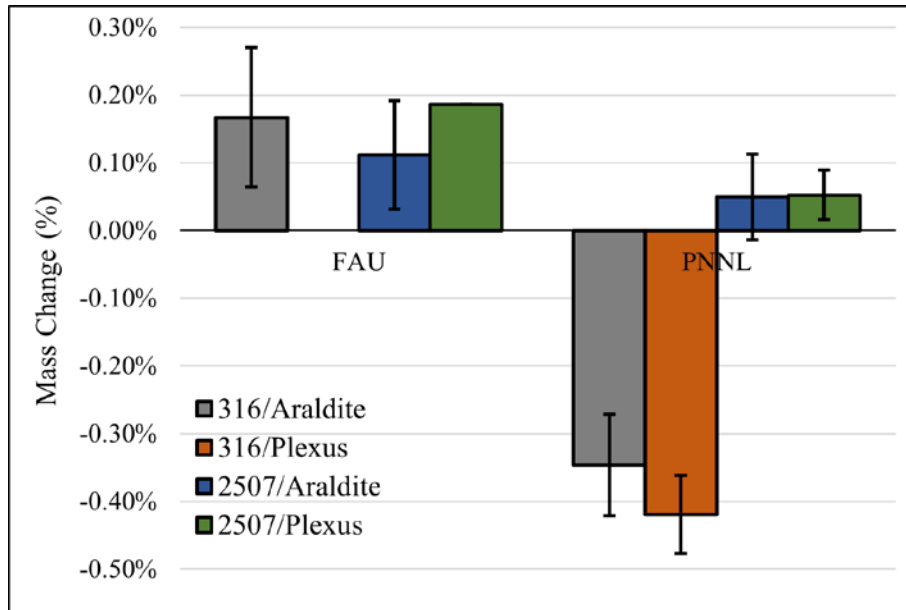
Figure 33. Mass change results for the MMLS specimens conditioned at FAU and PNNL based on the type of steels and adhesives used in their construction (note that the 316/Plexus specimens from FAU were lost in transit; error bars represent standard deviation)

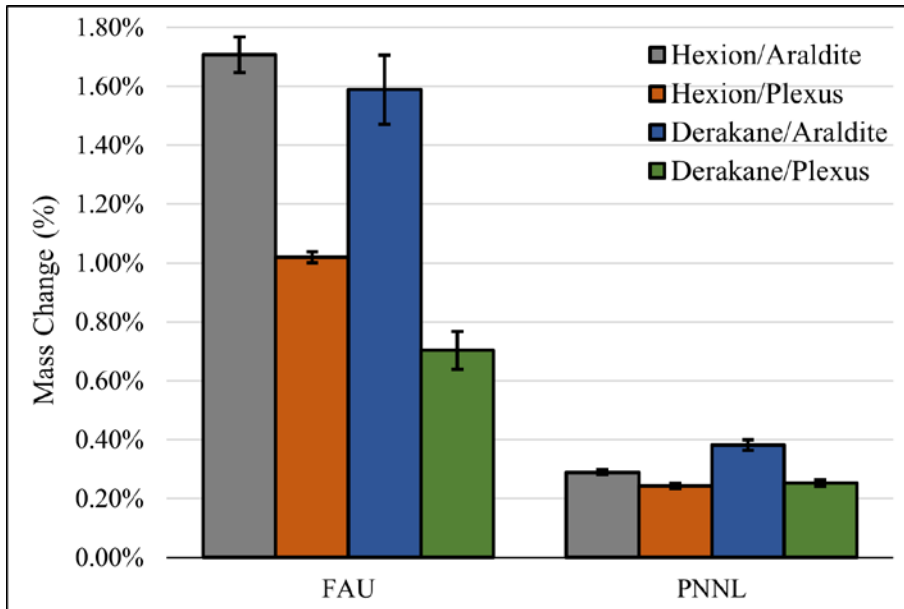
Figure 35. Mass change results for the SBS specimens conditioned at FAU and PNNL based on the composite matrix materials and adhesives used in their construction (error bars represent standard deviation)

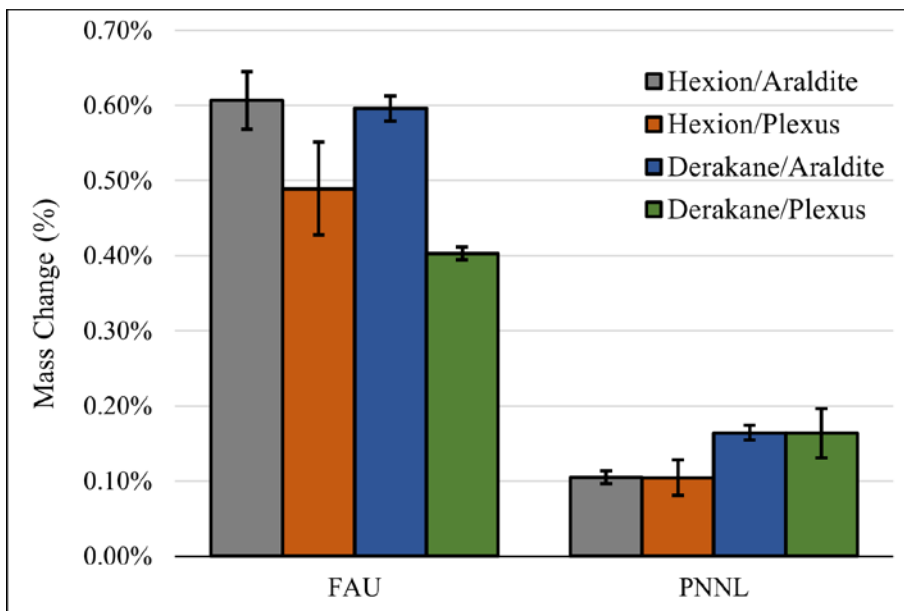
Figure 36. Mass change results for the OBS specimens conditioned at FAU and PNNL based on the composite matrix materials and adhesives used in their construction (error bars represent standard deviation)

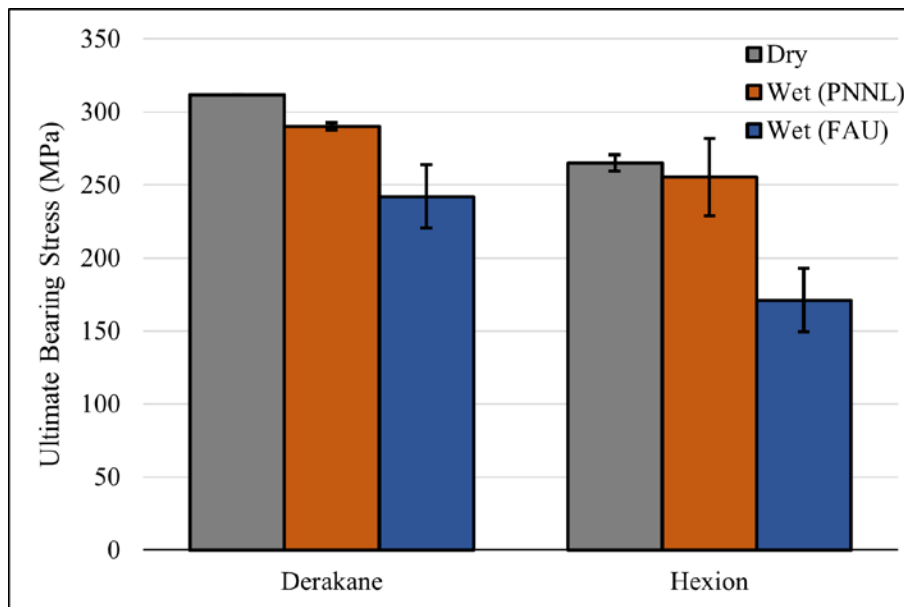
Figure 37. A comparison of ultimate bearing strengths of the T-bolt specimen through-holes under dry and wet conditions (error bars represent standard deviation)

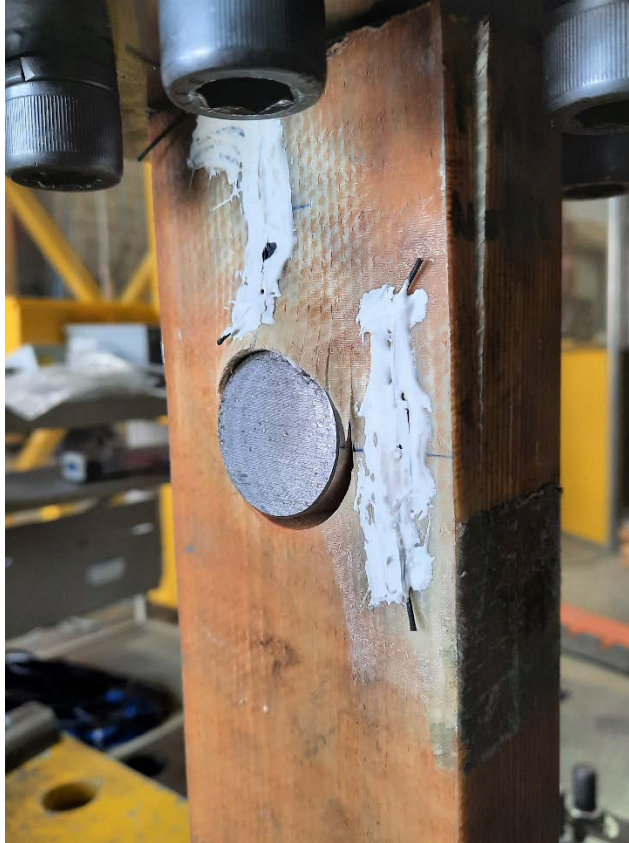
Figure 38. An example of a through-hole bearing failure exhibited by all the T-bolt specimens tested under static loading conditions

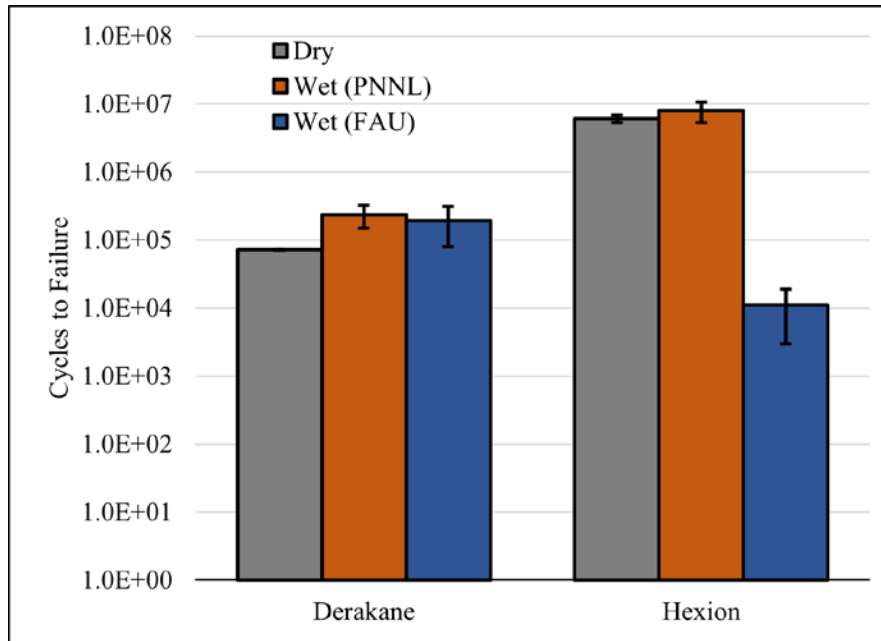
Figure 41. A comparison of fatigue lives for T-bolt specimens under constant-amplitude, tension-tension loading with a maximum tensile stress of 130 MPa for Derakane and Hexion specimens (error bars represent standard deviation)

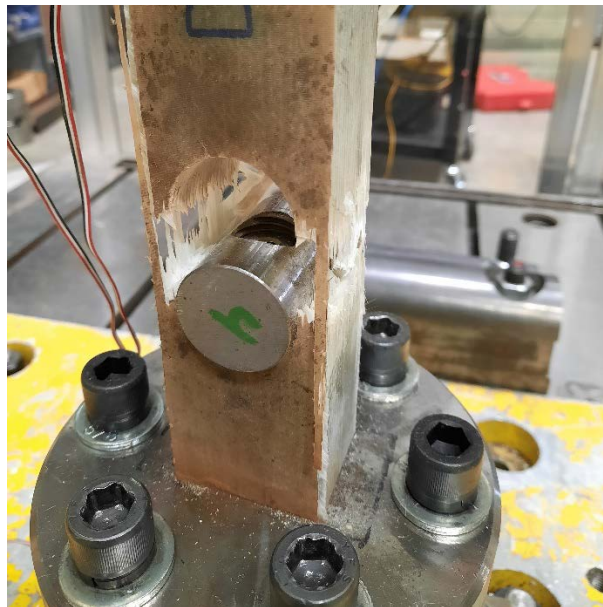
Figure 42. A typical through-hole tensile failure observed for all the T-bolt specimens tested under fatigue loading

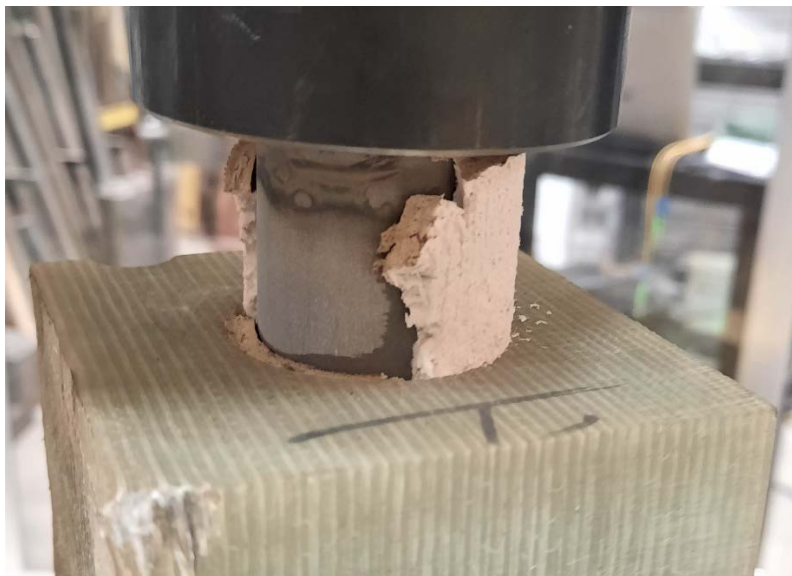
Figure 45. Moisture observed deep in the adhesive bondline of a DEI specimen with Plexus adhesive

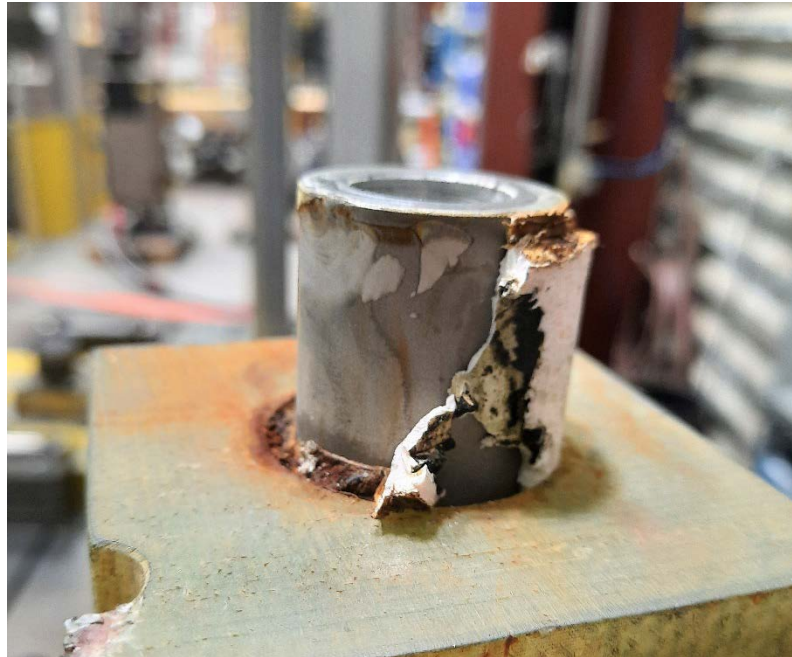
Figure 46. Corrosion observed in the adhesive bondline of a DEI specimen with 316 steel inserts that was conditioned at PNNL

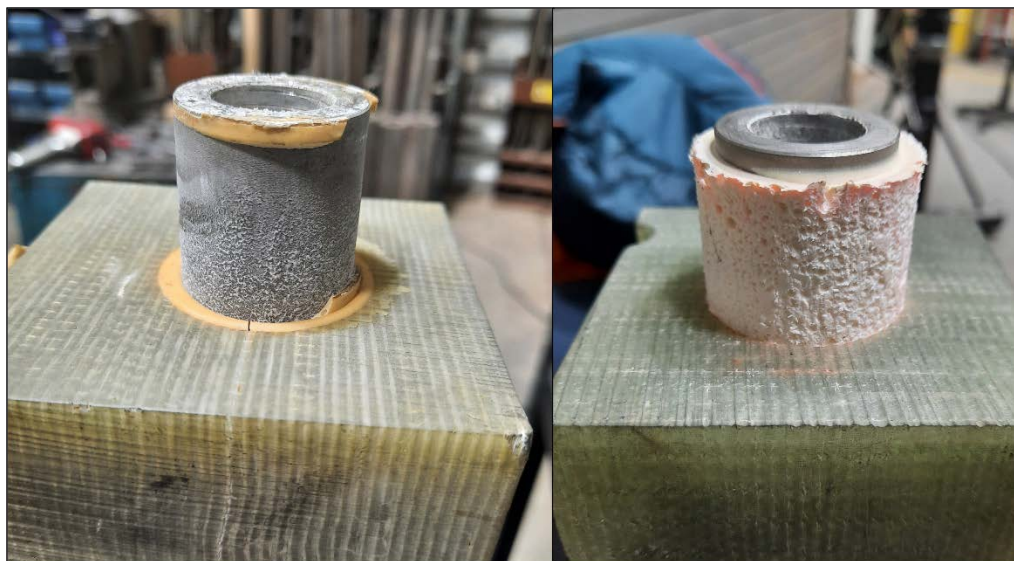
Figure 47. Photographs demonstrating the differences in failure modes observed between the (left) Araldite and (right) Plexus DEI specimens

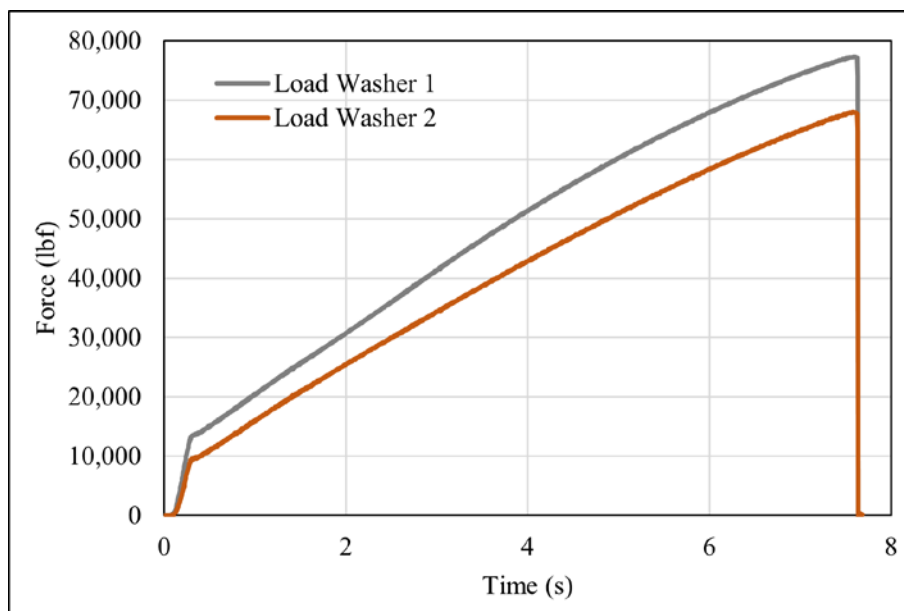
Figure 48. A comparison of measured loads between two load washers for a DEI specimen tested using the benchtop setup

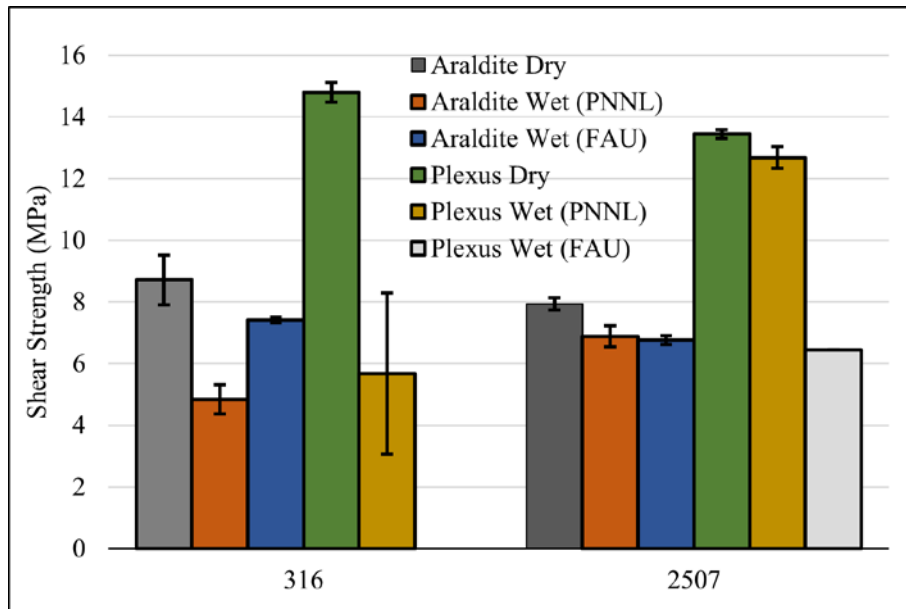
Figure 49. A comparison of ultimate shear strengths for the MMLS specimens (error bars represent standard deviation)

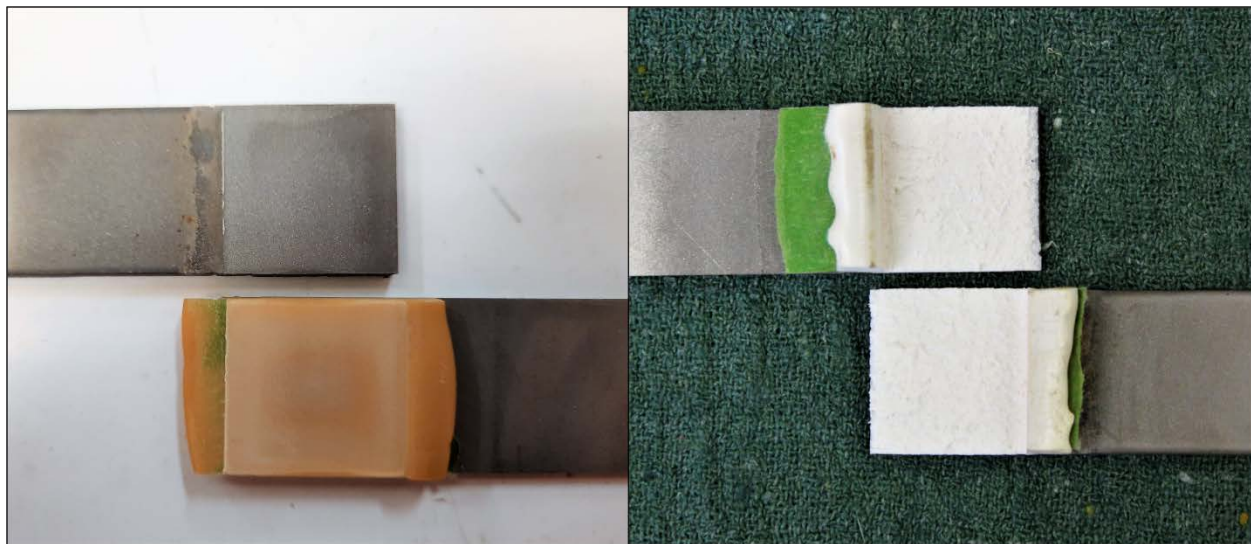
Figure 50. A comparison of failure modes observed in the (left) Araldite and (right) Plexus MMLS specimens

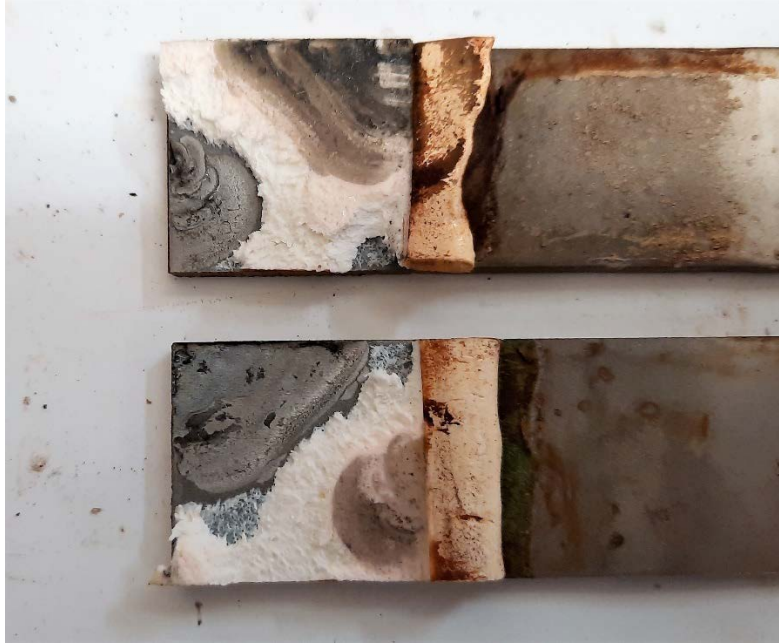
Figure 51. Corrosion observed deep in the bondlines of 316 steel MMLS specimens conditioned at PNNL

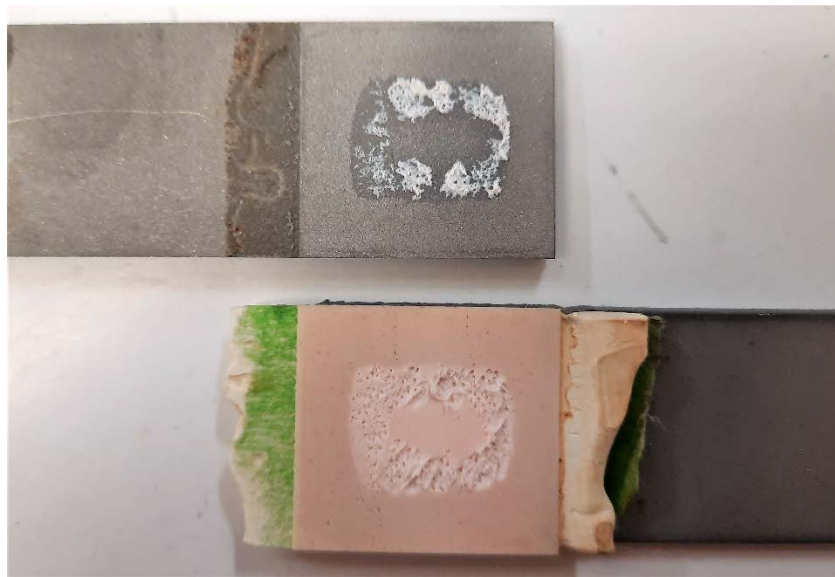
Figure 52. Mixed adhesive/cohesive failure of a Plexus MMLS specimen conditioned at FAU

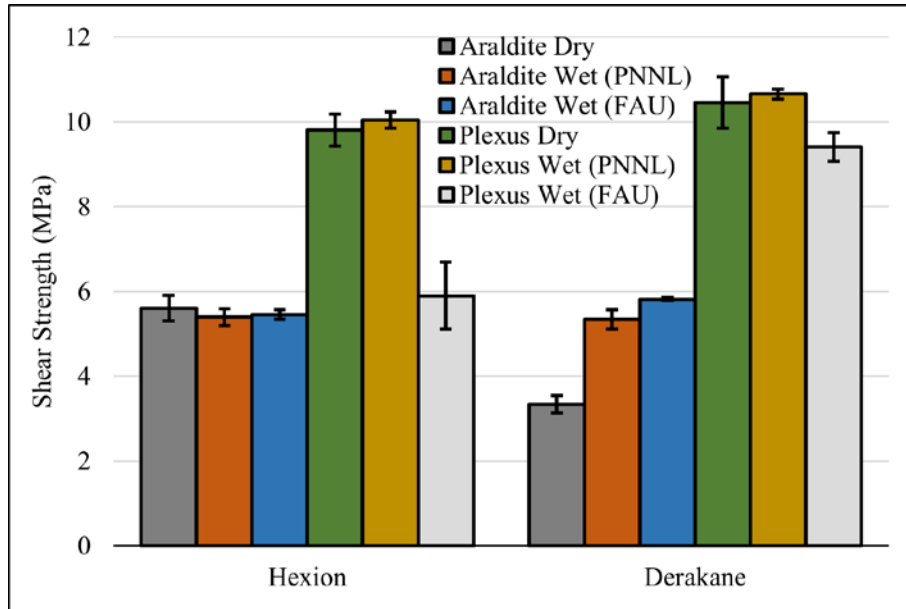
Figure 53. A comparison of shear strengths for the CCLS specimens (error bars represent standard deviation)
