Industrial Materials for the Future R&D Strategies: A Case Study of Boiler Materials for the Pulp and Paper Industry

**David R. Howell
Richard Silbergliitt
RAND
Arlington, Virginia**

**Douglas Norland
National Renewable Energy Laboratory
Washington, D.C.**

October 2002

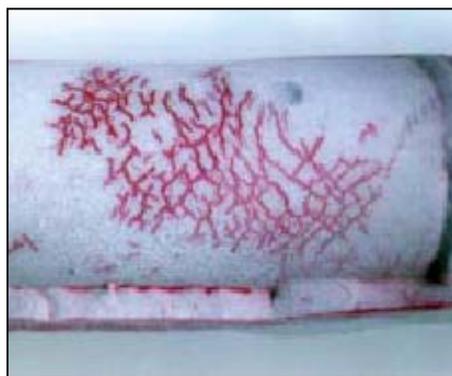
Figure 12b: Crazed Cracking

If a boiler tube cracks, it can cause an unplanned shutdown and additional damage to the boiler. Photographs of two types of cracking commonly found in recovery boiler floor tubes are shown in Figure 12 (this figure is described in more detail in Appendix A).³⁶ When cracks in the boiler tubes extend deep enough to allow water and steam to leak into the molten smelt environment of the recovery boiler, a large explosion can occur. In a 1998 review of recovery boiler accidents, David Parrish (P.E. of the Factory Mutual Research Corporation) noted that the instantaneous vaporization of one pound of

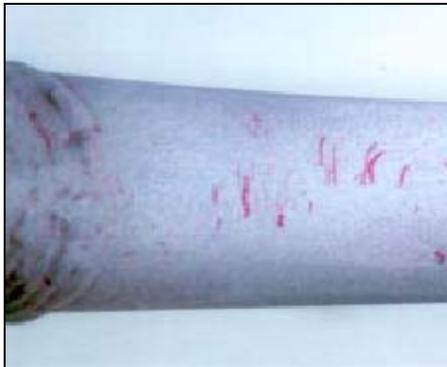
Figure A1a: Circumferential Cracking

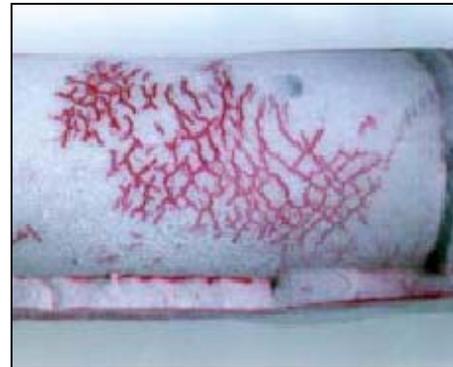
Figure A1b: Crazed Cracking

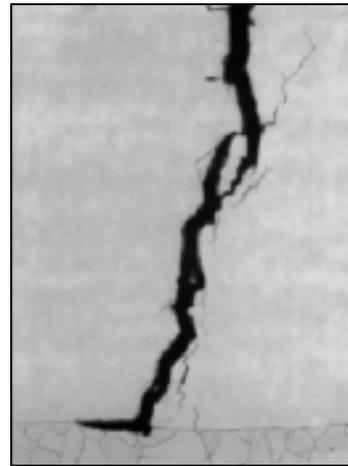
Figure A2b: Microscopic Photograph of Floor Tube Crack

The results of these studies defined the general characteristics of composite tube cracking.⁶⁸ These general characteristics suggested two potential cracking mechanisms. The first possibility is thermal fatigue. Thermal-fatigue cracking requires thermal variations that create stresses that exceed the yield strength of the composite tube. The second possibility is stress-corrosion cracking. This requires both a tensile stress and a liquid corrosive material to be present in the critical temperature range. Both of these mechanisms require tensile stresses to be present at the outer layer of the composite tube, which suggested the importance of residual stress measurements.⁶⁹
