BigHorn Home Improvement Center Energy Performance Preprint

*To be presented at the 2006 ASHRAE Annual Meeting
Quebec City, Quebec, Canada
June 24–28, 2006*

Conference Paper
NREL/CP-550-39533
April 2006

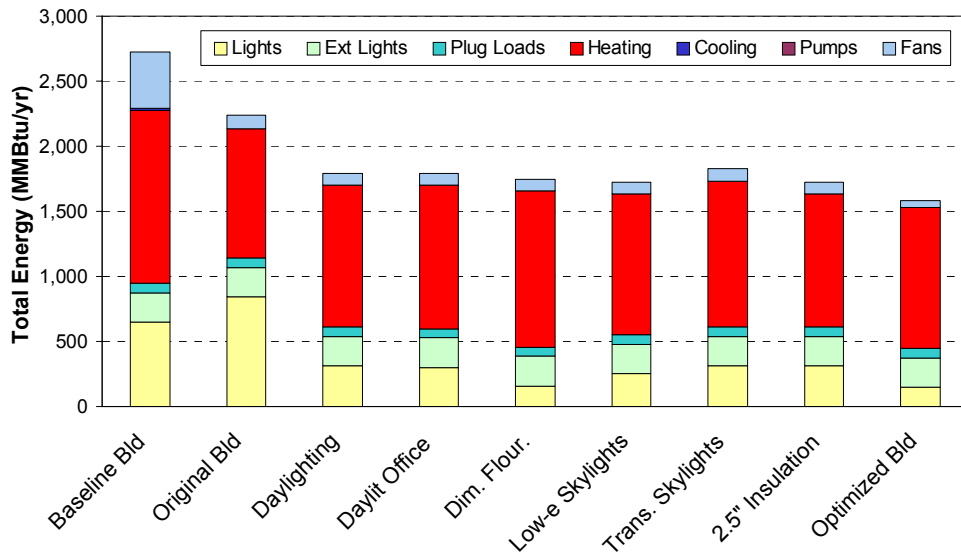
Figure 1. Total Energy Consumption for the Models Listed in Table 2

The predicted total energy consumption of all the simulations is listed in Table 2 and shown graphically with end uses in Figure 1. The most effective reduction in total energy comes from the Optimized Model, which shows a 42% energy saving compared to the Design Baseline Model.

The Optimized Model uses 77% less energy for lighting than the Design Baseline Model and 82% less lighting energy than the Original Model. The annual energy costs were calculated with expected utility rate structures for natural gas and electricity service. The Optimized Model produced a 41% energy cost saving compared to the code compliant Design Baseline Model, with annual cost for the Design Baseline at \$29,960 and the Optimized Model's at \$17,652.

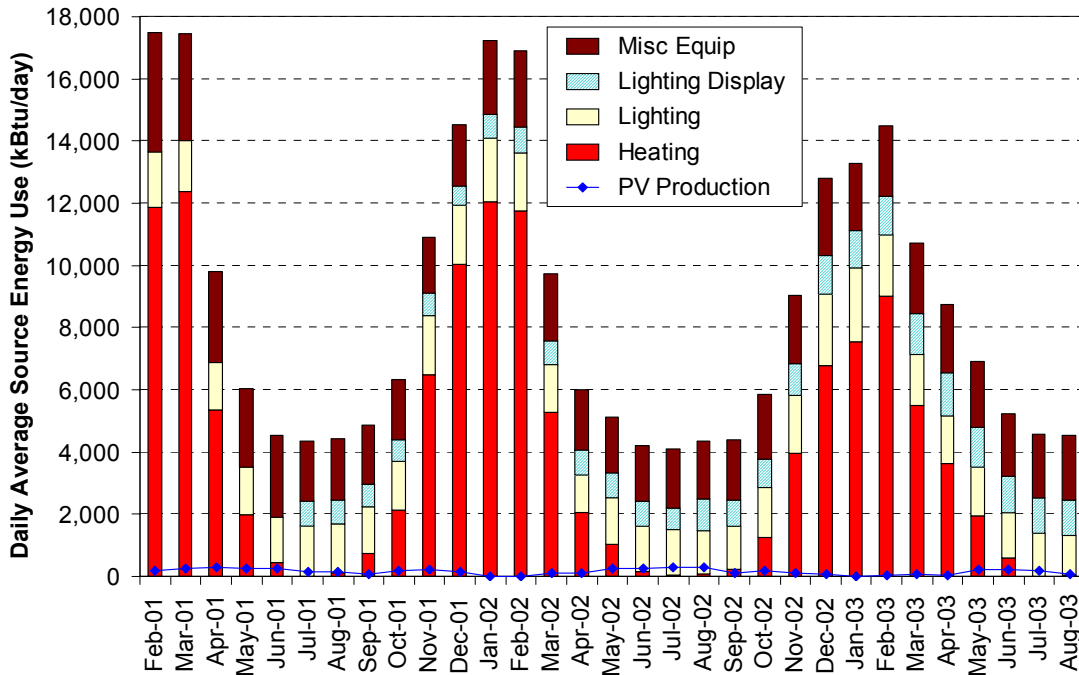
Figure 3. Daily average source energy consumption by end use for the BigHorn Center (monitoring of the lighting display began in July 2001)

The total energy consumption in Figure 3 shows a strong seasonal correlation. The increase in the winter is caused by the high heating loads, higher lighting loads caused by the reduced number of daylight hours, and the snow and ice melt systems. The heating energy consumption is a combination of the gas use taken from the utility bills plus pump energy for the hydronic heating system and fan energy for the transpired solar collector. The heating load approaches zero in summer months and has shown a general decrease over the monitoring period. Table 3 shows a 24% decrease in the gas energy use from the 2001–2002 winter to the 2002–2003 winter. This decrease is mostly due to the introduction of a dry fire-protection system in the warehouse in March 2002. Before this change, the warehouse was kept warmer than 40°F (4.4°C) to ensure that all pipes remained above freezing. A second reason for the reduced gas use was the reduced use of the sidewalk snowmelt system, which was not effective and was phased out during the 2001–2002 winter. Finally, the 2002–2003 winter was slightly warmer than the 2001–2002 winter, with 5% fewer HDDs.

The lighting loads in Figure 3 consist of all the interior ambient lights and exterior lights. The lighting display is monitored separately, and the limited accent lighting loads are monitored with the miscellaneous loads. There is a slight increase in the total lighting load from the first year to the second year. Table 3 shows that the retail/office area lighting energy decreased by 16.5 MMBtu because the daylighting controls were fine tuned, and a higher number of the light bulbs burned out after the first year of operation. The warehouse lighting energy increased by 16 MMBtu and the exterior lighting energy increased by 11.5 MMBtu. These increases are mainly due to the changes in the cleaning process that left more lights on for longer periods. The lighting display load increased by more than 50% from the first monitoring year to the second as more lighting fixtures were added to the display.

The miscellaneous loads include items noted in Table 3. The display lighting load was included in the miscellaneous loads from February 2001 to June 2001. The miscellaneous loads increased during the winter by approximately 20%, which is mainly due to the roof ice melt and the two electric space heaters. There has been a slight increase in the miscellaneous loads during the monitoring period because more plug loads and accent lighting were added.

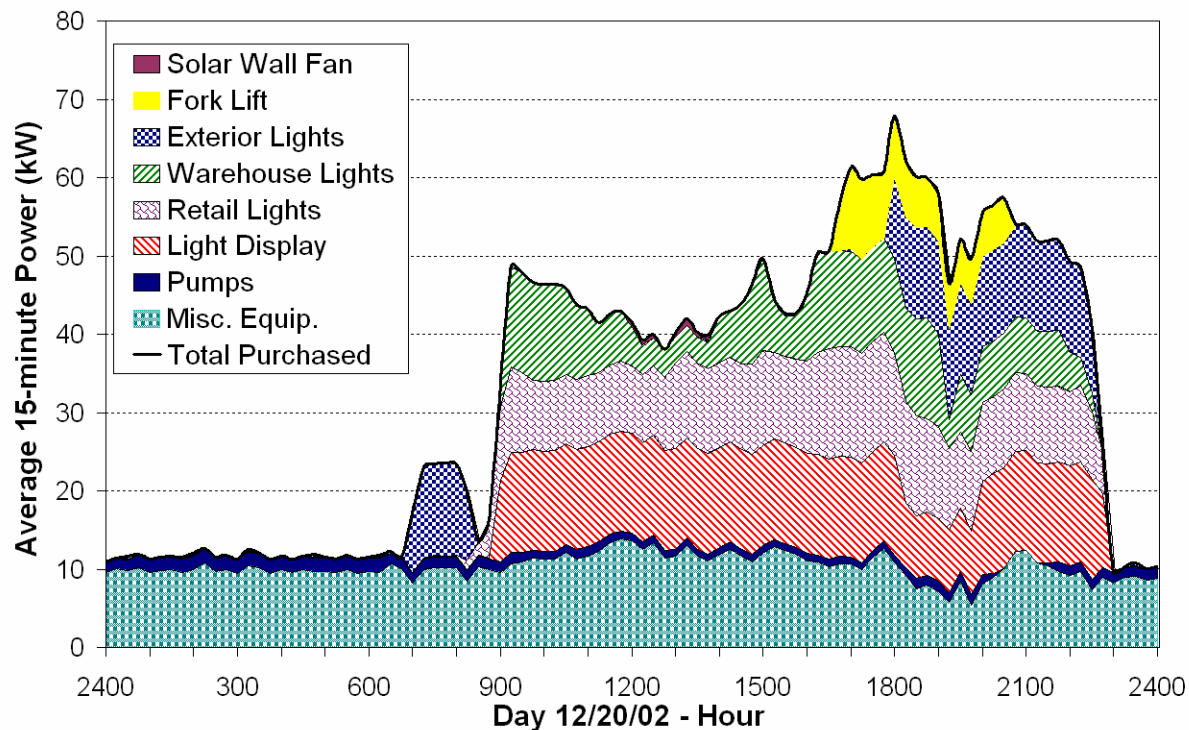
Figure 6. Electrical power profile on the peak demand day in December 2002

The electrical power profiles for typical peak demand days during the summer and winter are shown in Figure 5 and Figure 6. These figures show the average power drawn every 15 minutes. The heavy black line is the purchased electrical power. When this line is below the top of the graph, the PV system provided some of the building electrical load. In Figure 5, the PV system provided some power during the day; however, the PV system was operating on only one of three inverters on this day. In Figure 6, the PV system was not operational.
