Instrumentation for Evaluating PV System Performance Losses from Snow

Preprint

B. Marion, J. Rodriguez, and J. Pruet
National Renewable Energy Laboratory

Conference Paper
NREL/CP-550-45380
April 2009

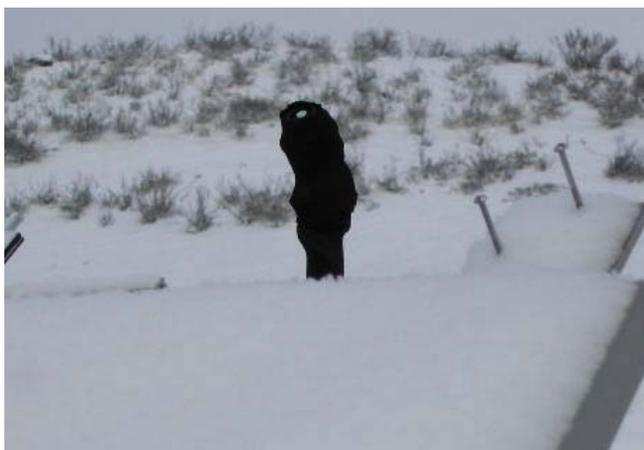
Fig. 2: Heated pyranometer demonstrating effectiveness in preventing snow and ice accumulation.

The controller is set to turn on the power to the heating cable if the temperature sensor is equal to or less than 35°F (1.7°C) and to turn off the power when the temperature sensor reaches 60°F (15.6°C). Raychem heat-shrinkable fabric tubing is used to cover the installed heating cable. The fully assembled unit is shown in Fig. 2.

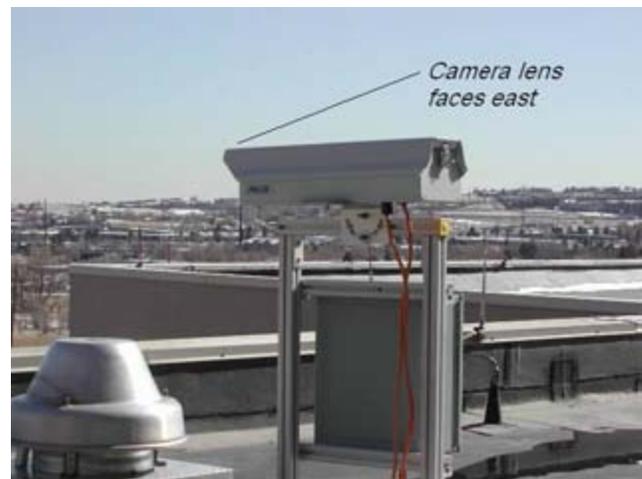
Fig. 3: CC640 digital camera from Campbell Scientific, Inc., located on building roof.

For this work, a CC640 digital camera from Campbell Scientific, Inc., was placed on the roof of the building to record images of the PV arrays being studied. This setup is shown in Fig. 3. The camera may be connected to a Campbell Scientific datalogger that is programmed to take images at required intervals and then transfer them from the camera to the data logger. Any of the available Campbell Scientific communication protocols may be used to retrieve images from the datalogger.

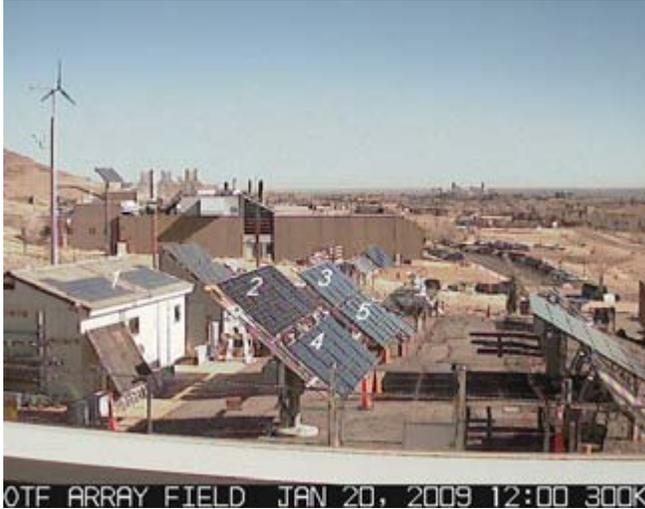
Fig. 4: PV arrays, identified by numbers, for evaluating performance losses from snow.

For the five PV arrays shown in Fig. 4, the heated pyranometer and digital camera were used to determine PV system performance losses associated with a snowfall beginning about 7 a.m. on the morning of January 26, 2009.

The five PV arrays use crystalline PV modules and are grid-connected. PV array number 1 is building-integrated (BIPV) with a PV module tilt angle of 15° from horizontal. The other PV arrays are open-rack mounted with a PV module tilt angle of 40° from horizontal.

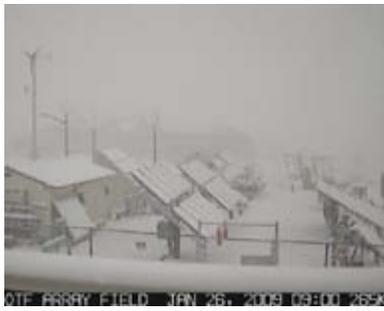
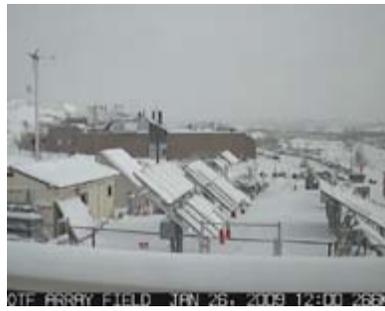
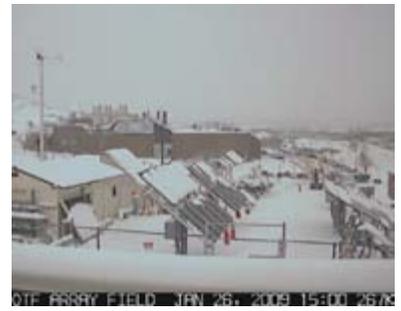
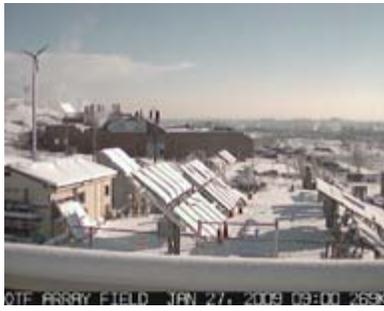
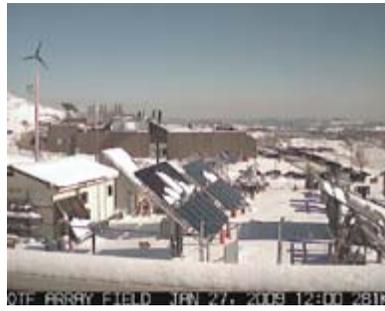
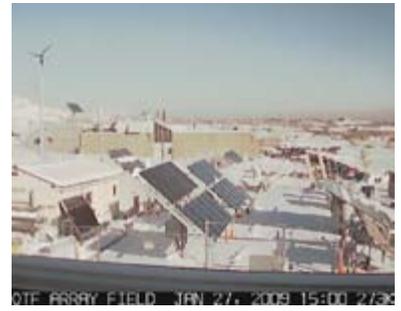
Fig. 5: Digital images for January 26–30, 2009, for 9 a.m., 12 p.m., and 3 p.m.

The snowfall ended at about 11:00 a.m. on the morning of January 26, with a total accumulation of about eight inches. Figure 5 shows the digital images for January 26–30 for 9:00 a.m., 12:00 p.m., and 3:00 p.m. PV arrays 3, 4, and 5 began shedding snow in the afternoon of January 26th, but wind during the night re-covered the PV modules with snow and drifting also occurred on the roof of the shed where PV array 1 was installed. By noon on the 27th, the snow had been shed from PV arrays 4 and 5; and by 3 p.m., the snow was also gone from PV array 2, and only a small amount remained on PV array 3. Beginning in the morning of the 28th, no snow remained on the rack-mounted PV arrays 2, 3, 4, and 5.

Snow remained the longest on PV array 1, with one module retaining snow until the morning of the 29th. Interestingly, the east side of PV array was free of snow about 1 day before the west side. To better understand the thermal characteristics of BIPV arrays, two different mounting methods had been used. The west side was mounted directly on the roof sheathing, but the east side was raised about an inch using battens to promote air flow. Apparently, the increased air flow promoted snow removal.
