Low Wind Speed Turbine Developments in Convoloid Gearing

Final Technical Report
June 2005 – October 2008

*Genesis Partners, LP
Montgomeryville, Pennsylvania*

Subcontract Report
NREL/SR-500-45103
August 2010

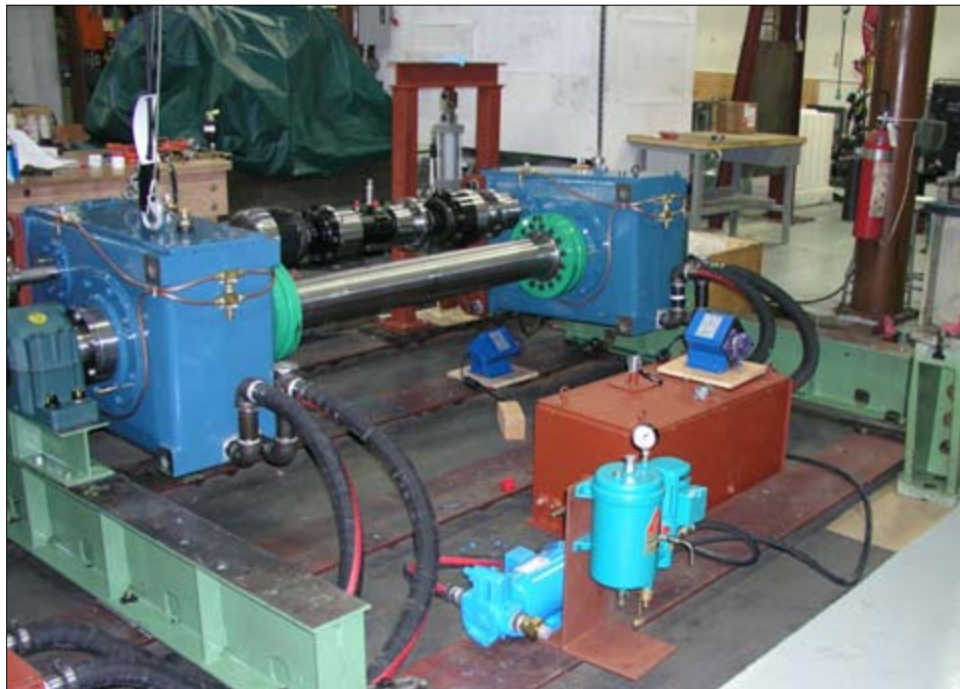
Figure 2.2. Micon 108 test fixture, involute gearbox on the left and Convoloid gearbox on the right

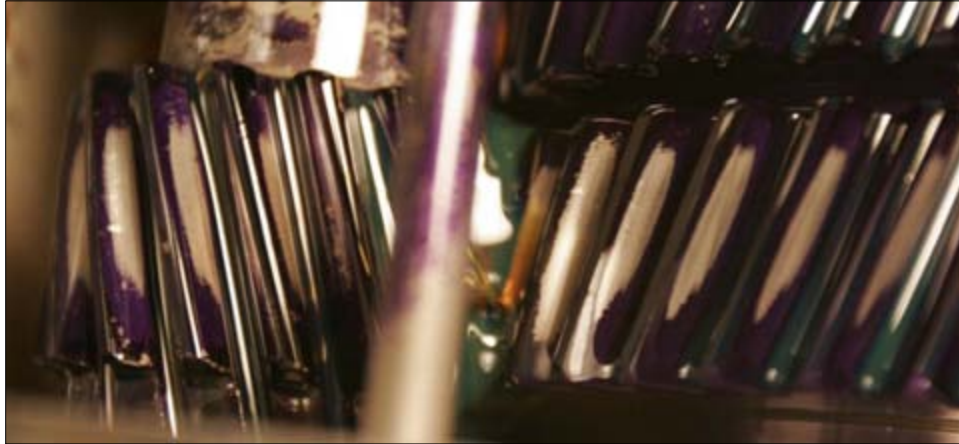
Figure 2.5. Example of contact pattern for lightly loaded involute gearing in the 3-Hole Test

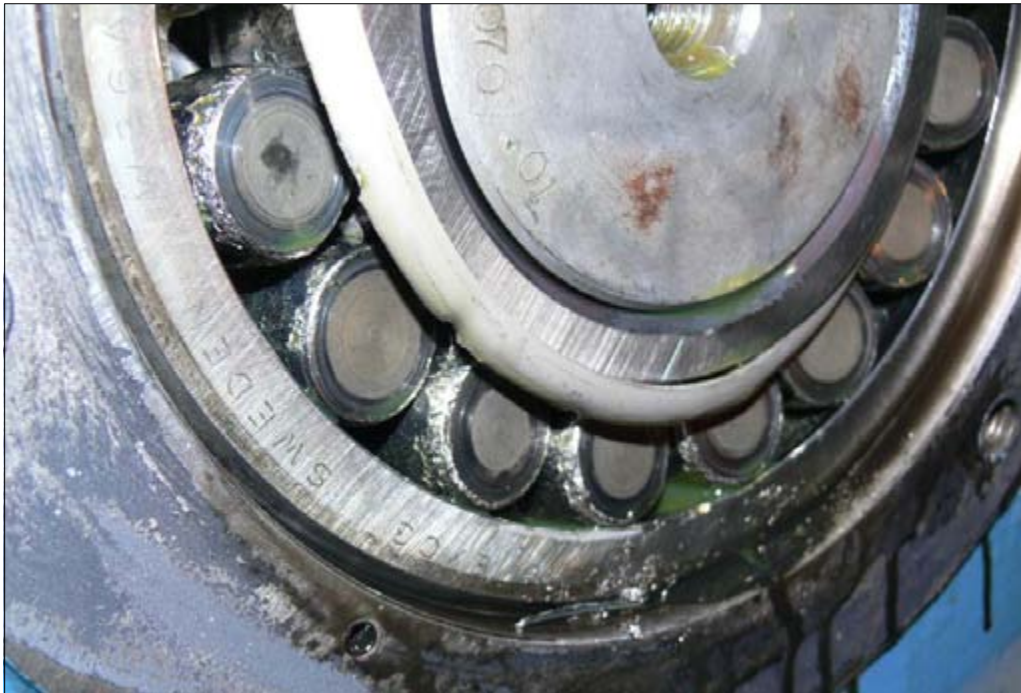
Figure 4.11. Failed spherical roller bearing in Convoloid gearbox after 763 total test hours; note pitted edges of the rollers and deformation of the cage; metallic particles are present at the bottom of the housing bore

On March 1, 2006, noise levels and unexplained fluctuations in an intermediate shaft bearing temperature in the Convoloid gearbox prompted the test monitor to shut down the test. Significant damage was present on the rollers and cage (Figure 4.11). Pieces of the cage and roller material passed through gear meshes and other bearings (Figure 4.12). Significant quantities of metal were recovered in the gearbox sump, oil reservoir, and primary filter. A day prior to the bearing failure, a magnet inspection of both gearbox sumps revealed no metal particles. After the failure, extensive quantities were found inside the gearbox housing.

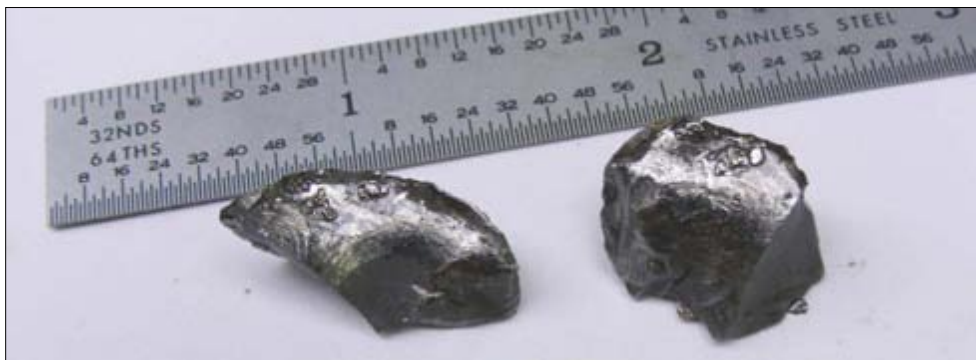
Figure 4.12. Pieces of the failed bearing

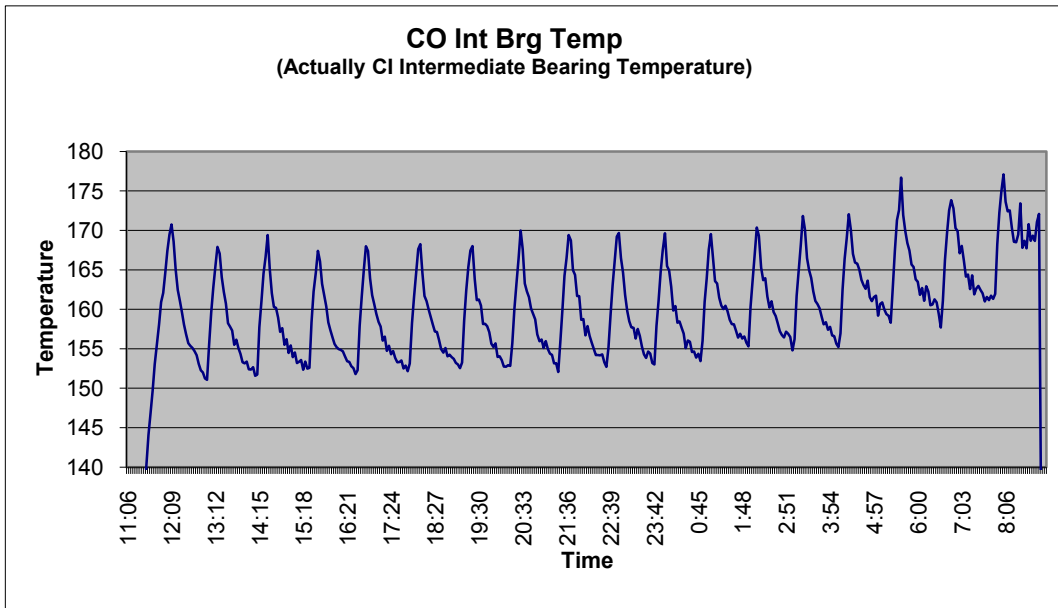
Figure 4.13. Bearing temperature chart for the failed Convoloid intermediate bearing; note the rise in temperature after 2:18 a.m.; the jagged “saw-tooth” shape is due to cycling of the heat exchanger fan

Analysis of temperature and vibration data taken during the final day of operation, show a distinct increase in vibration levels about 8 hours before shutdown (Figure 4.13, Figure 4.14). An observation by the operator that was written in the test log at the time of the increased vibration indicates that there was “a change in the sound” of the Convoloid gearbox. However, testing continued until a more dramatic failure occurred.

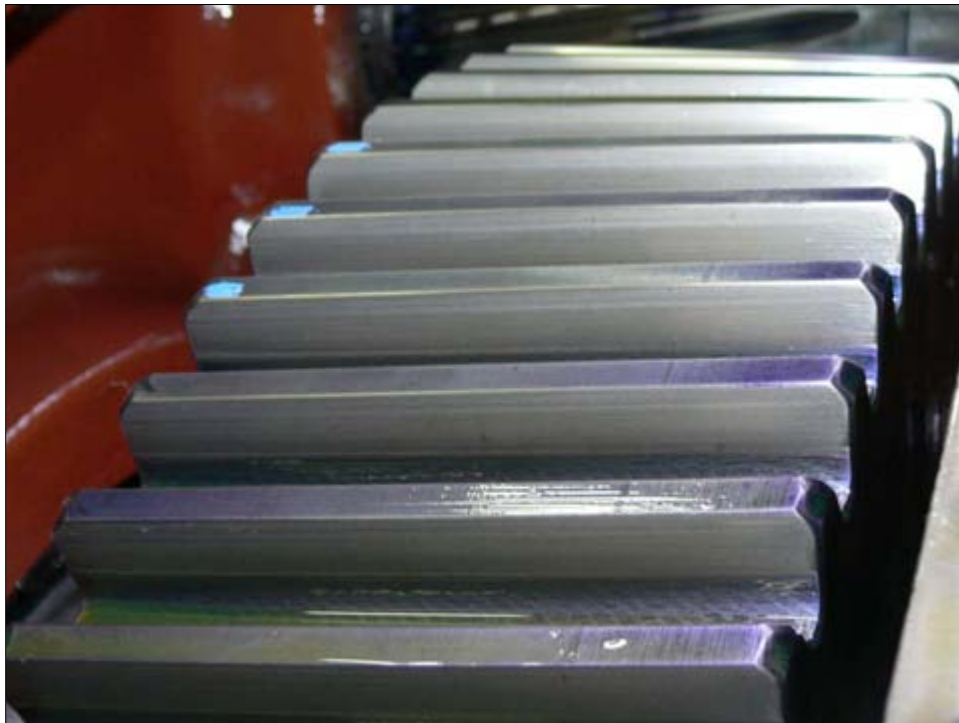
Figure 4.21. Involute LS gear at the end of test; no wear is visible (235 hours at 200% load; 528 hours at 240% load)

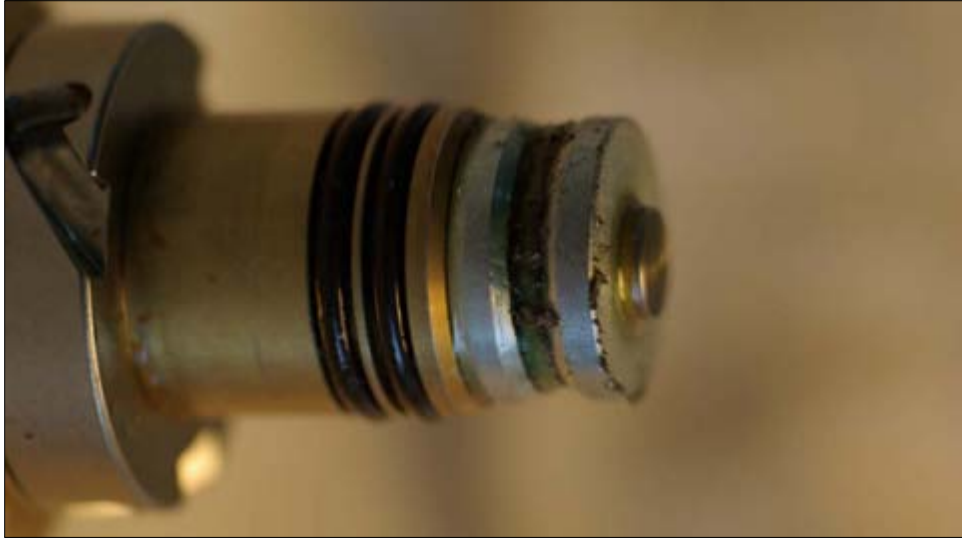
Figure 6.6. One of the chip detectors after a surface fatigue failure

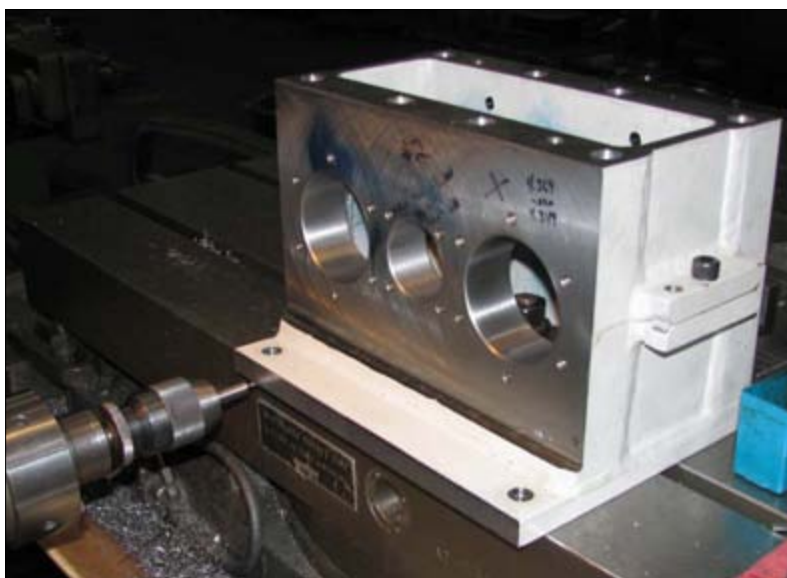
Figure 6.9. The 3-Hole Test gearbox during final machining

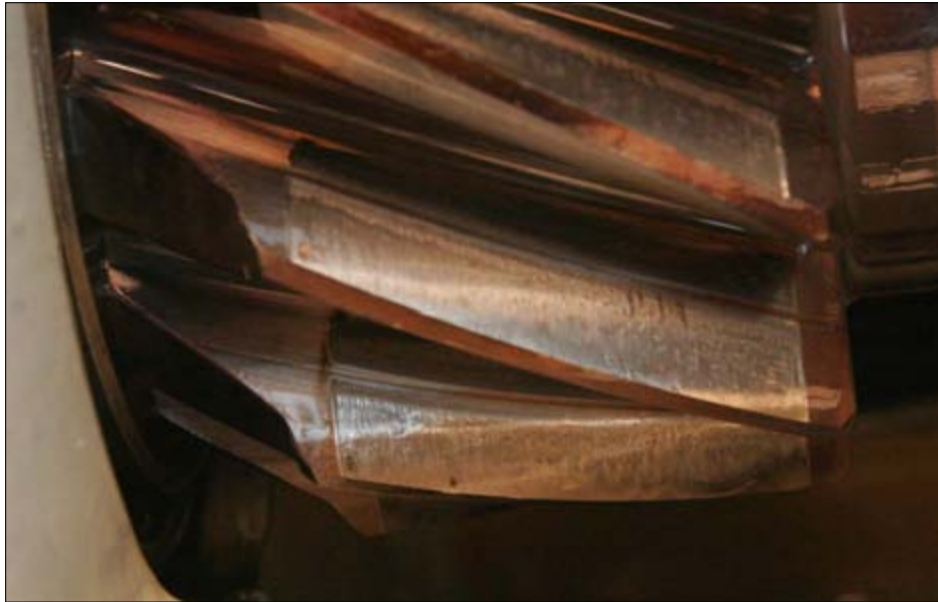
Figure 7.1. Severe scuffing failure due to loss of lubricant

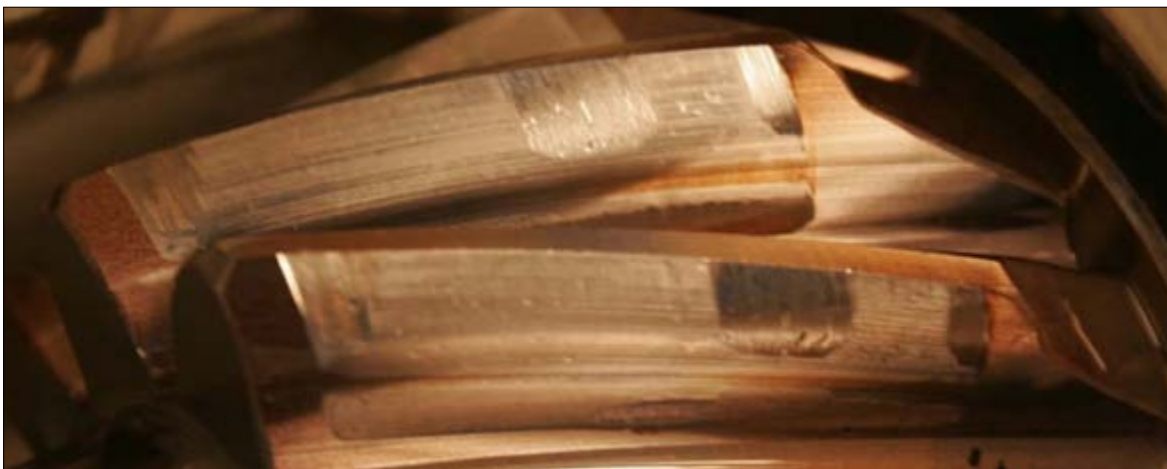
Figure 7.3. Close-up of Convoloid gear tooth with no micropitting and partial scuffing damage due to loss of lubrication

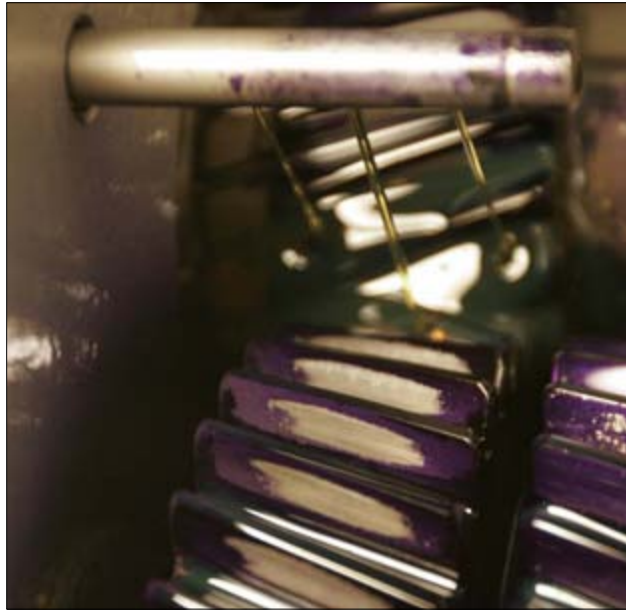
Figure 7.5. No-load contact pattern—involute gear; lube nozzle

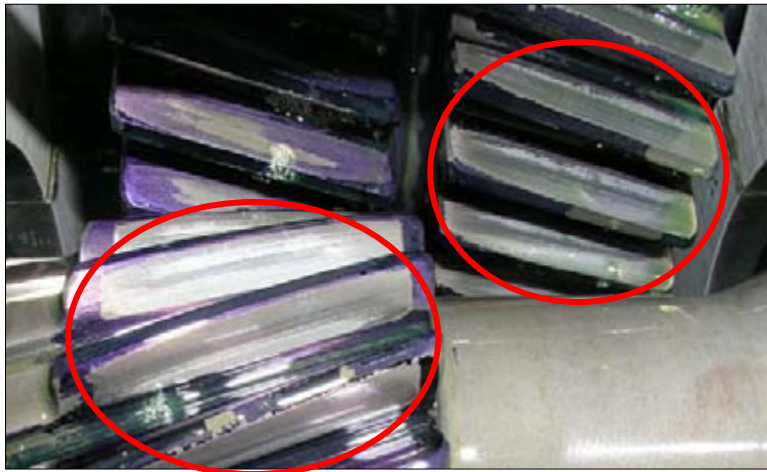
Figure 7.7. Involute gearing showing early micropitting; both parts (circled) drive their respective mates

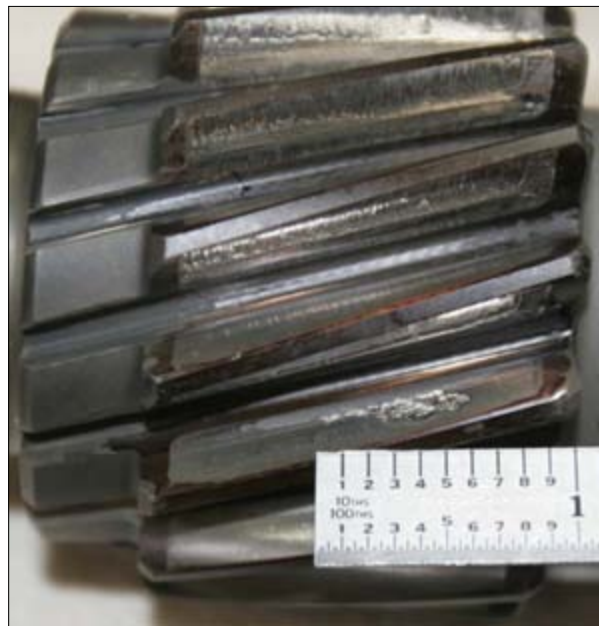
Figure 7.10. Further pitting and opposite flank scuffing damage from Test 2

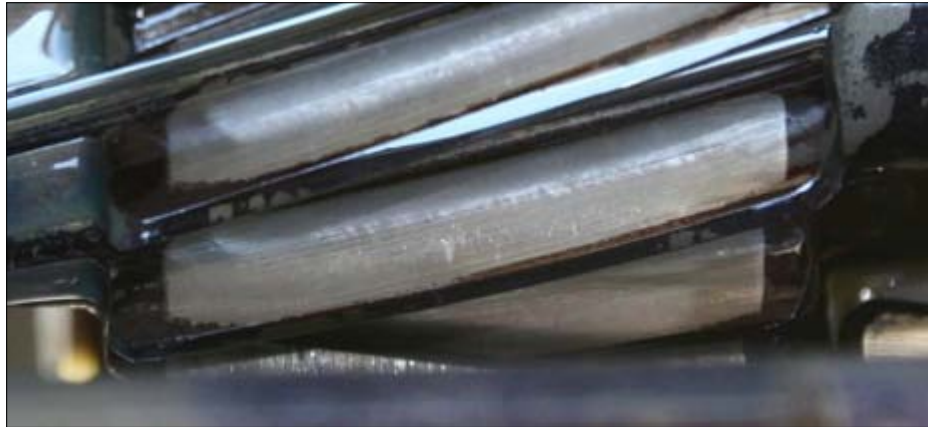
Figure 7.13. The other pinion in the same gearbox loaded as a speed increaser and showing minimal wear

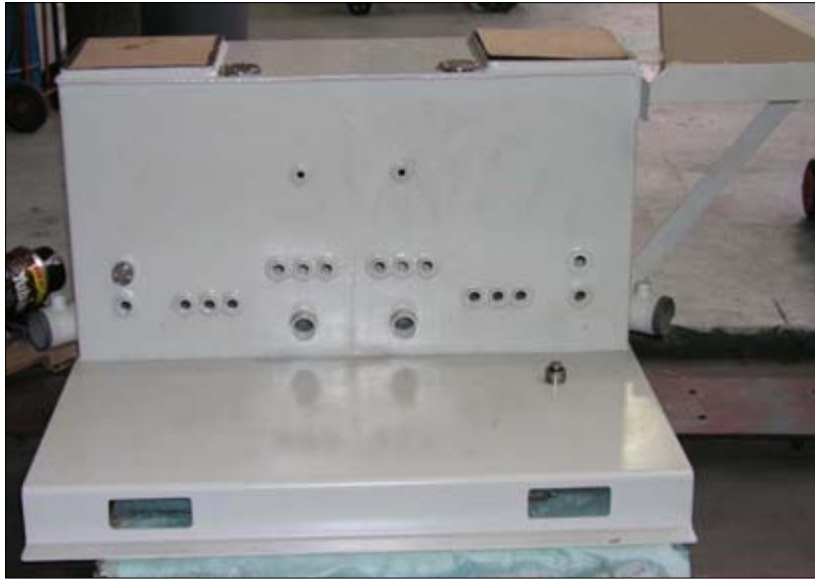
Figure A.2. The 3-Hole Test fixture after paint and initial top milling

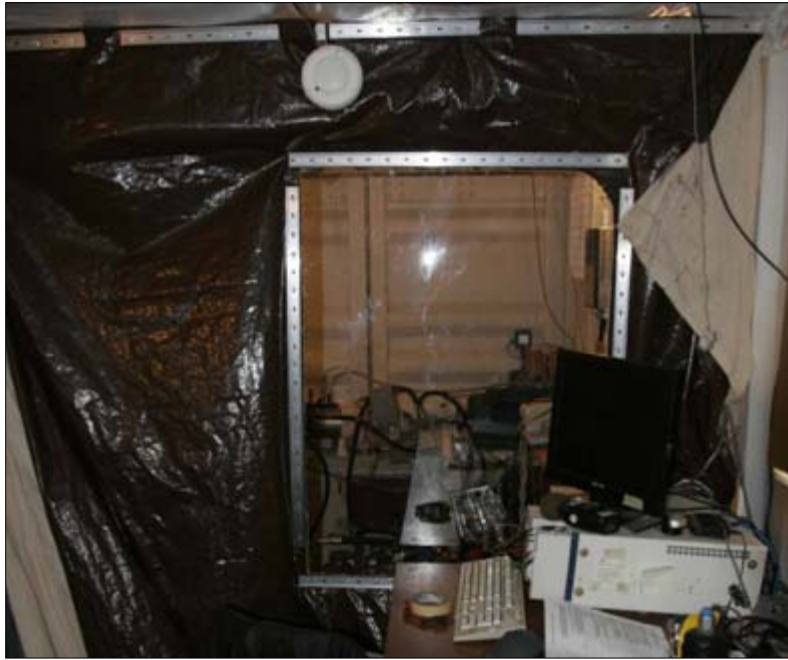
Figure A.5. View inside the test container showing the computer monitoring system and polycarbonate view window

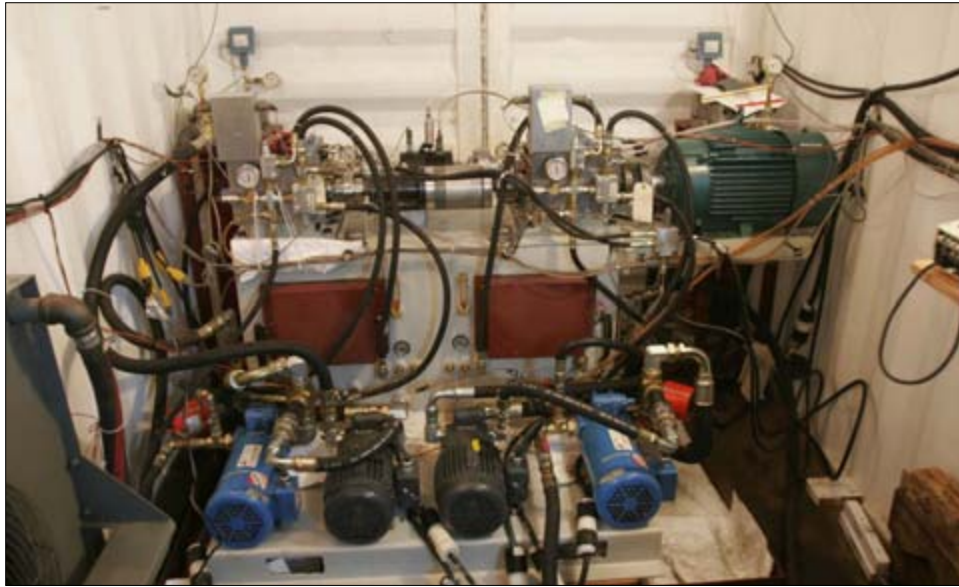
Figure A.14. Operational configuration of the 3-Hole Test fixture

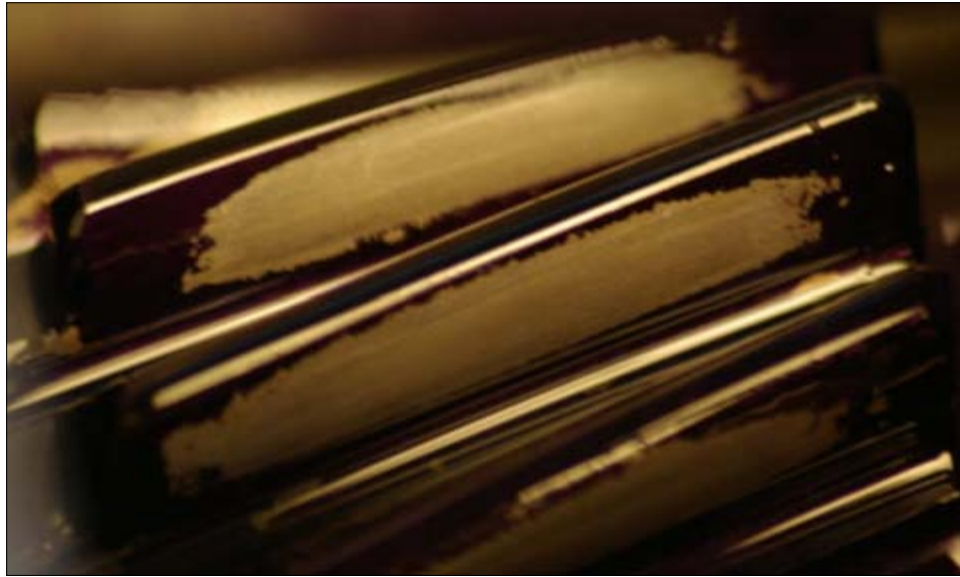
Figure A.18. Representative involute no-load contact

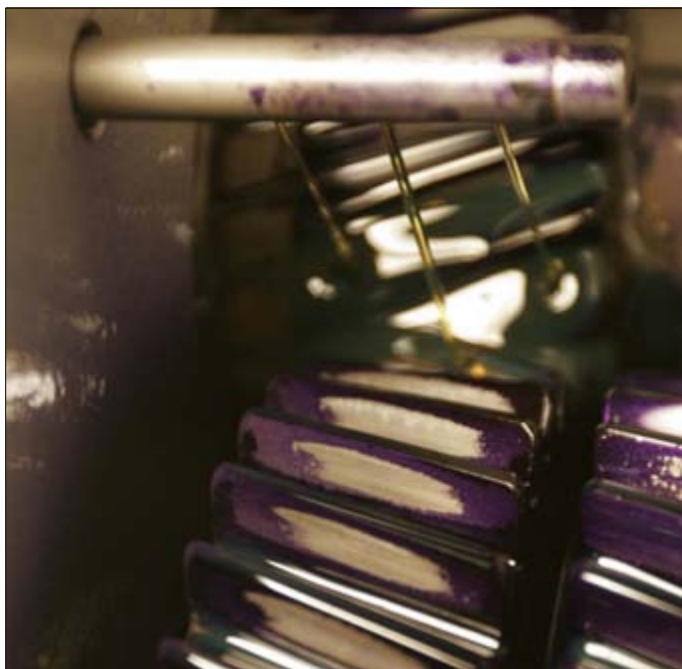
Figure A.20. No-load contact pattern—involute gear; lube nozzle

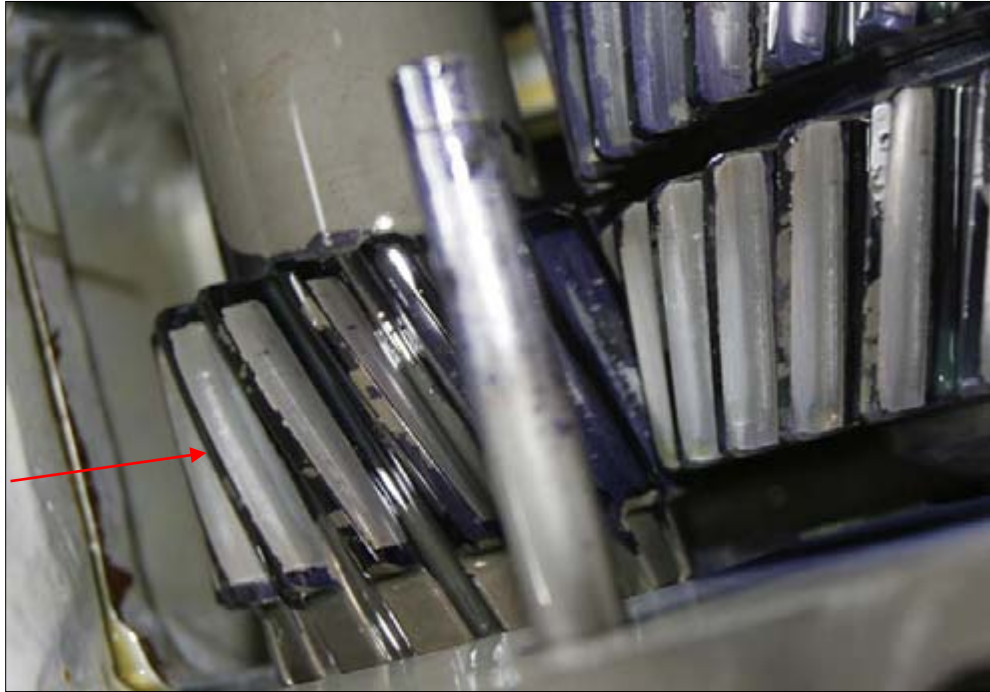
Figure A.23. Involute pinion 2—increaser operation (gear drives pinion)—shows a smaller amount of micropitting on the pinion (arrow) as well as on the mating gear

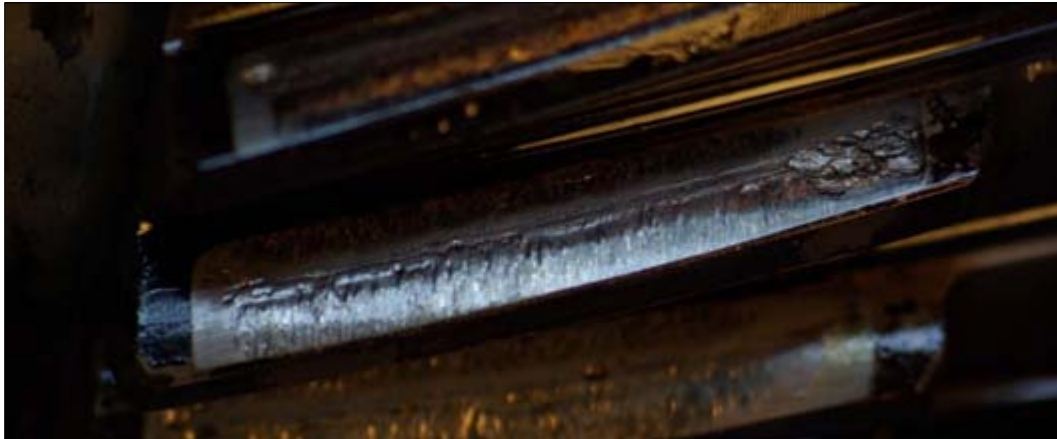
Figure A.24. Involute (1) reducer pinion surface wear (Test 2)

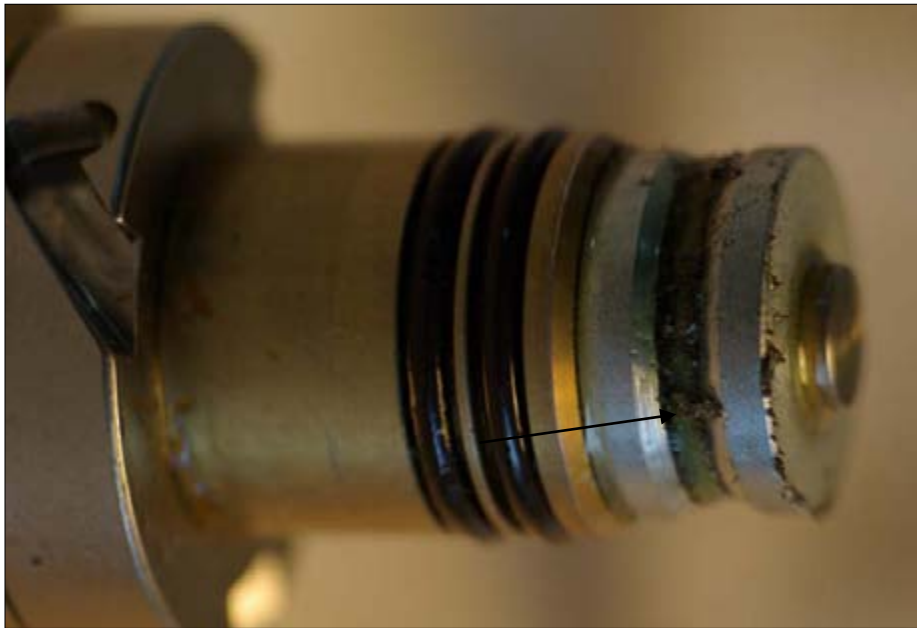
Figure A.25. Gearbox 1 chip detector after gearing failure; note material crossing the gap

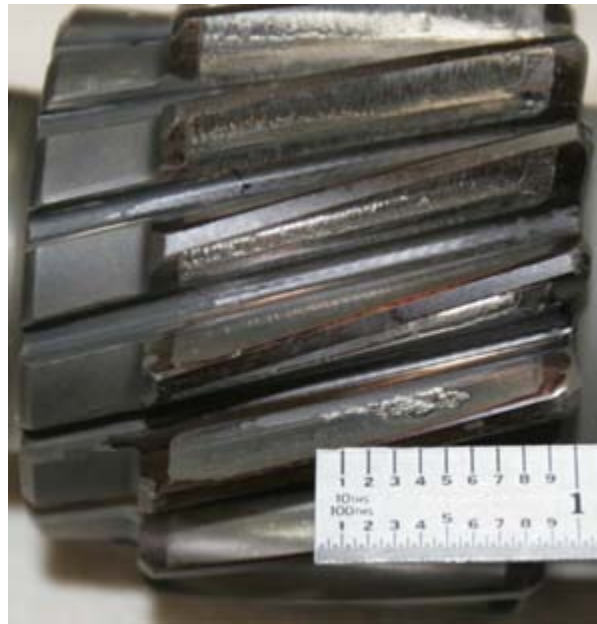
Figure A.28. Further pitting and opposite flank scuffing damage from Test 2

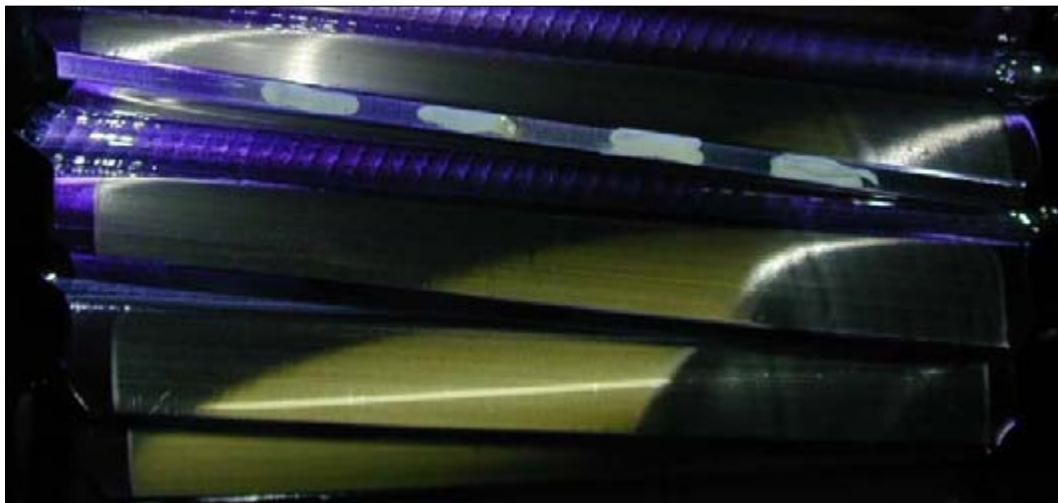
Figure O.7. Involute low speed pinion at 200% shakedown; the contact patch reveals a consistent contact pattern across the contact flank; note paint marks on teeth tips for inspection purposes

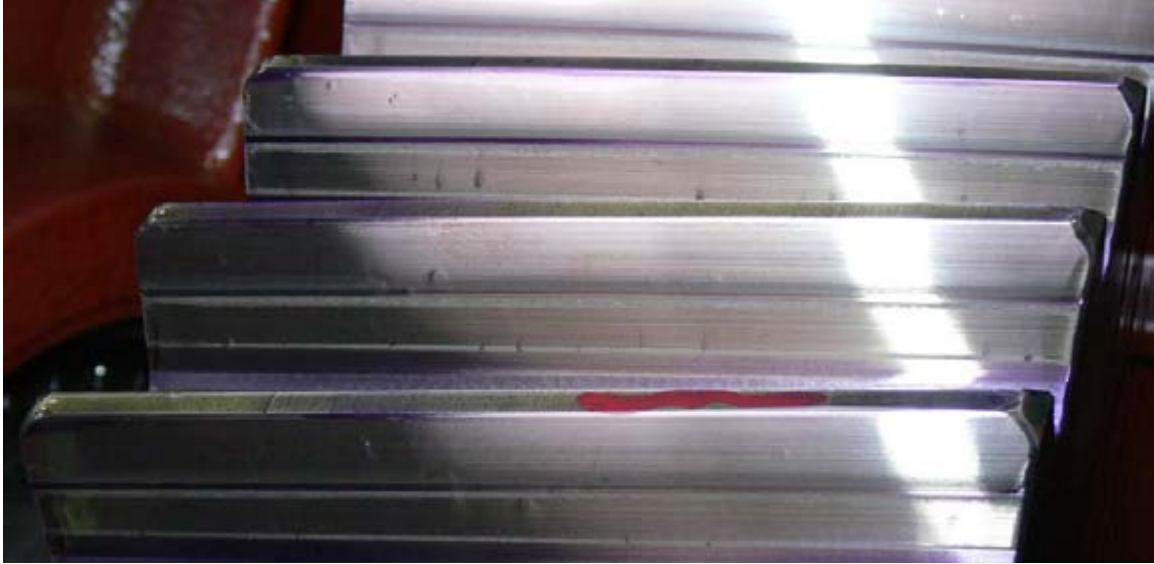
Figure O.23. Convoloid low speed gear after 763 total test hours; light micropitting is visible at the edges of the dedendum side of the transition zone; no micropitting is evident at the tip, nor is there much bluing

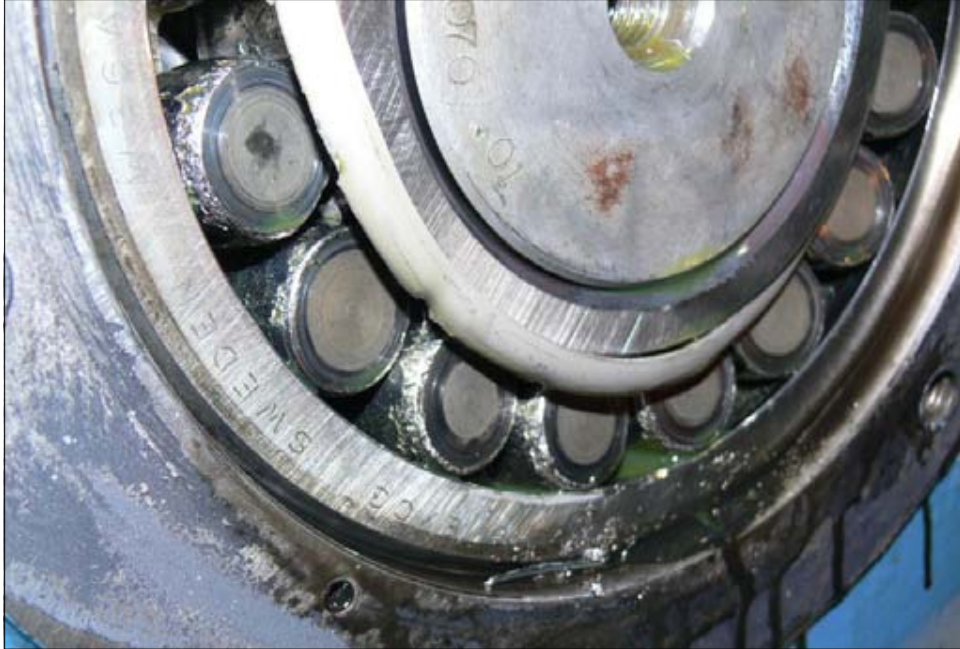
Figure O.24. Failed spherical roller bearing in Convoloid gearbox after 763 total test hours; note pitted edges of the rollers and deformation of the cage; metallic particles are present at the bottom of the housing bore

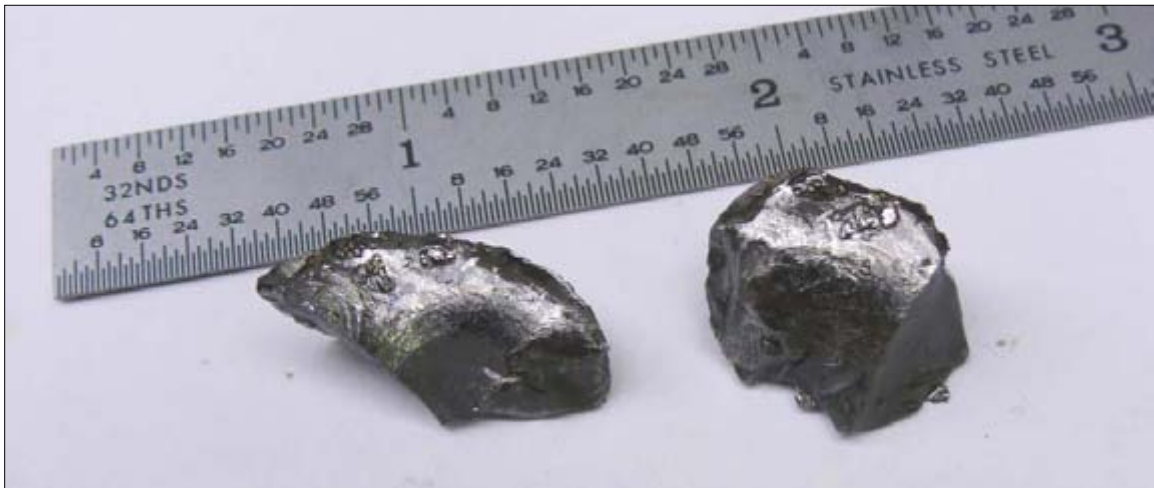
Figure O.25. Pieces of the failed bearing

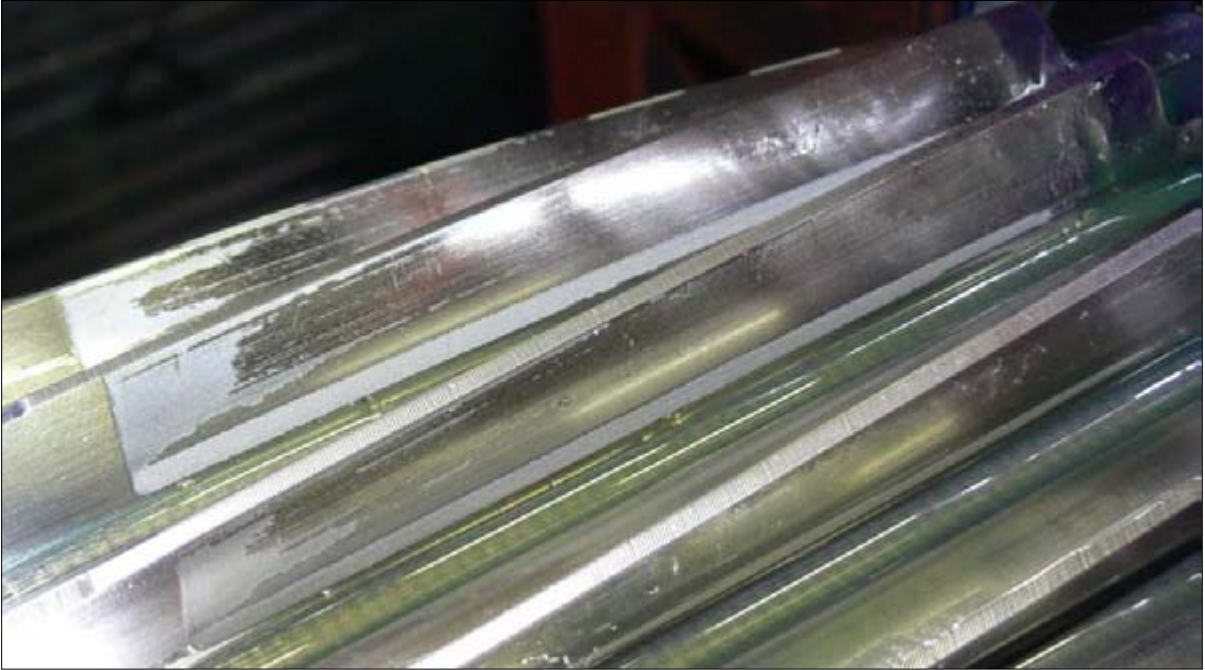
Figure P.37. Involute HS pinion at the end of test; wear due to micropitting is extensive along one side (235 hours at 200% load; 528 hours at 240% load)

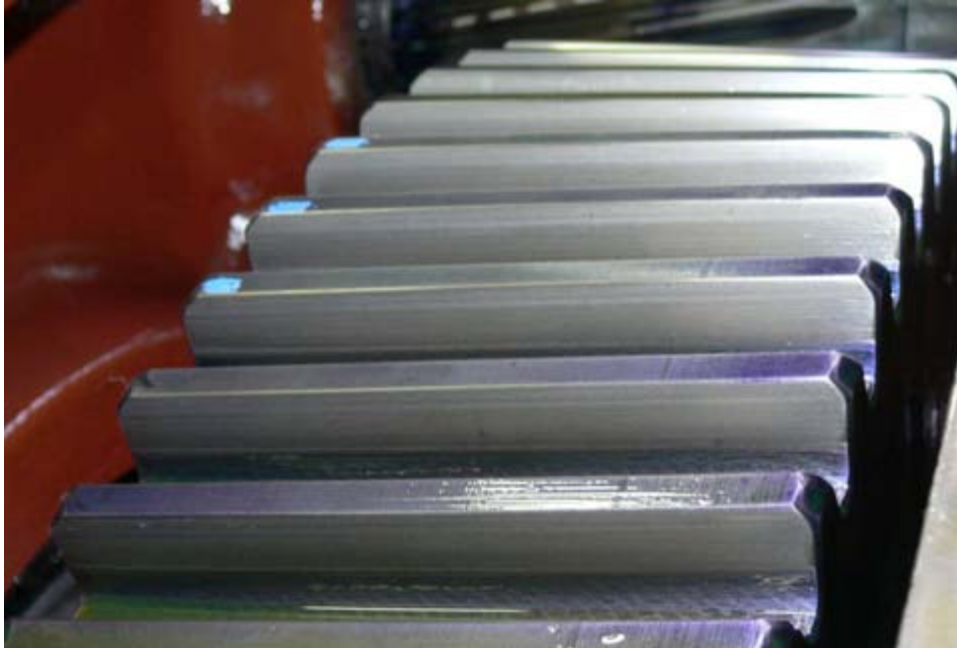
Figure P.43. Involute LS gear at the end of test; no wear is visible (235 hours at 200% load; 528 hours at 240% load)
