Wind Turbine Safety and Function Test Report for the Gaia-Wind 11-kW Wind Turbine

Technical Report

NREL/TP-500-46724

January 2010

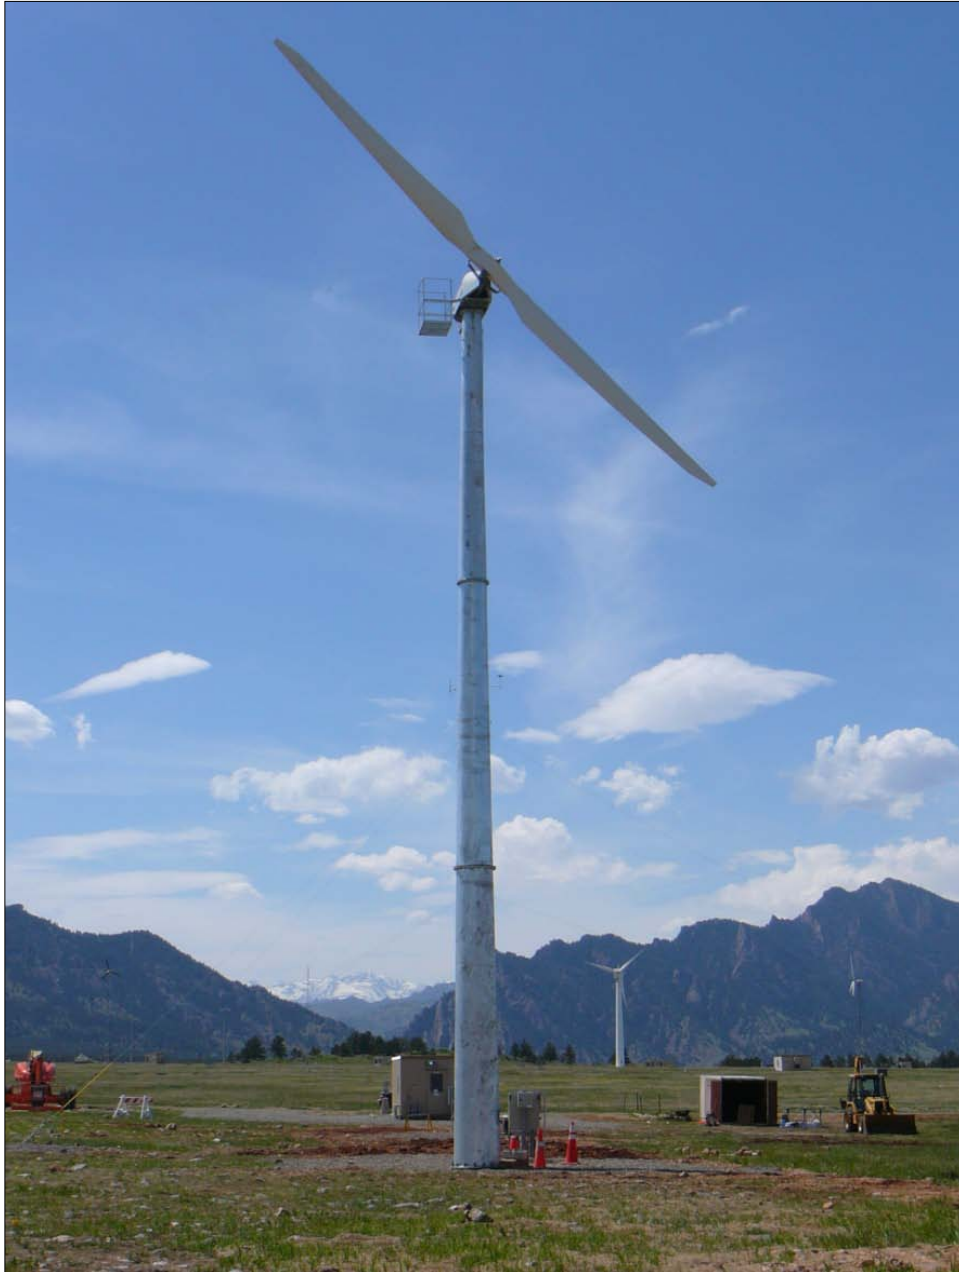
Figure 1. Gaia-Wind 11-kW wind turbine at the National Wind Technology Center test site

The test turbine was a Gaia-Wind 11-kW wind turbine. This turbine is a downwind, two-bladed, constant-speed, turbine with a rated power of 11-kW. Figure 1 shows the test turbine installed at the National Wind Technology Center. Table 1 provides the key descriptive information of the test turbine.

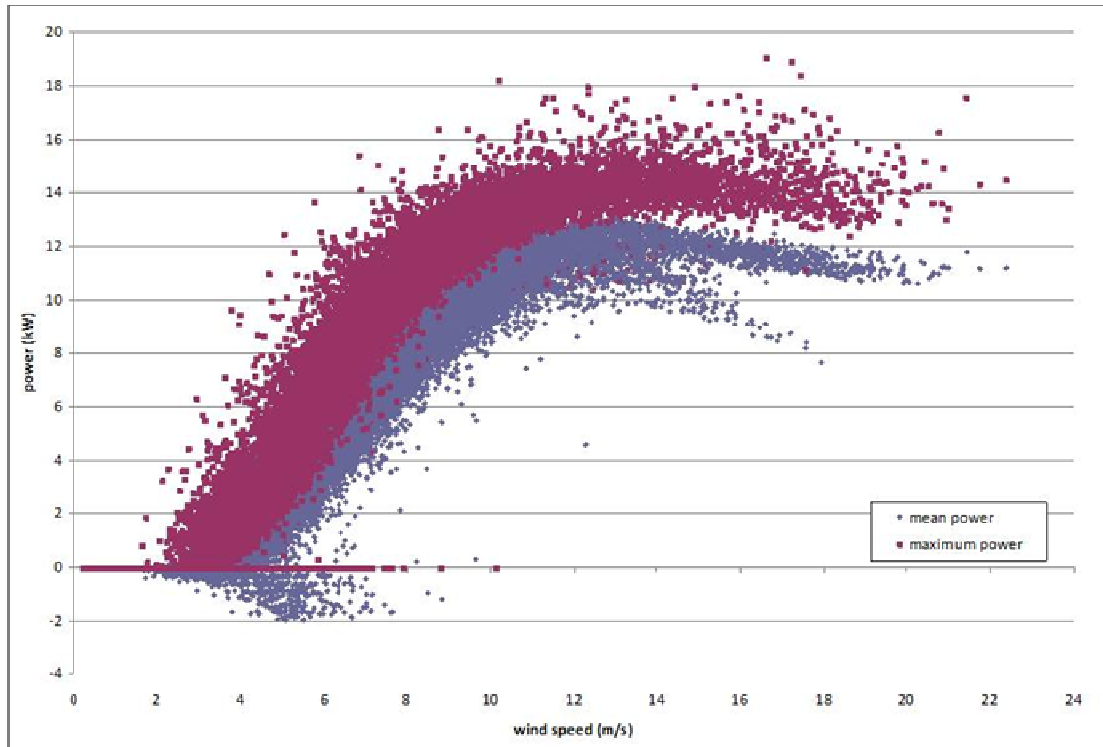
Figure 3. Power response to wind speed

Power measurements over the test period indicate that the turbine system exhibited control over power production in response to high winds. Both 1-minute average power data and 1-second maximum power data in Figure 3 show a leveling in wind speeds greater than about 12 m/s to 13 m/s. Furthermore, the turbine automatically shuts down if the average wind speed over 10 minutes is at least 20 m/s, and on occurrence of an instantaneous reading of at least 25 m/s.

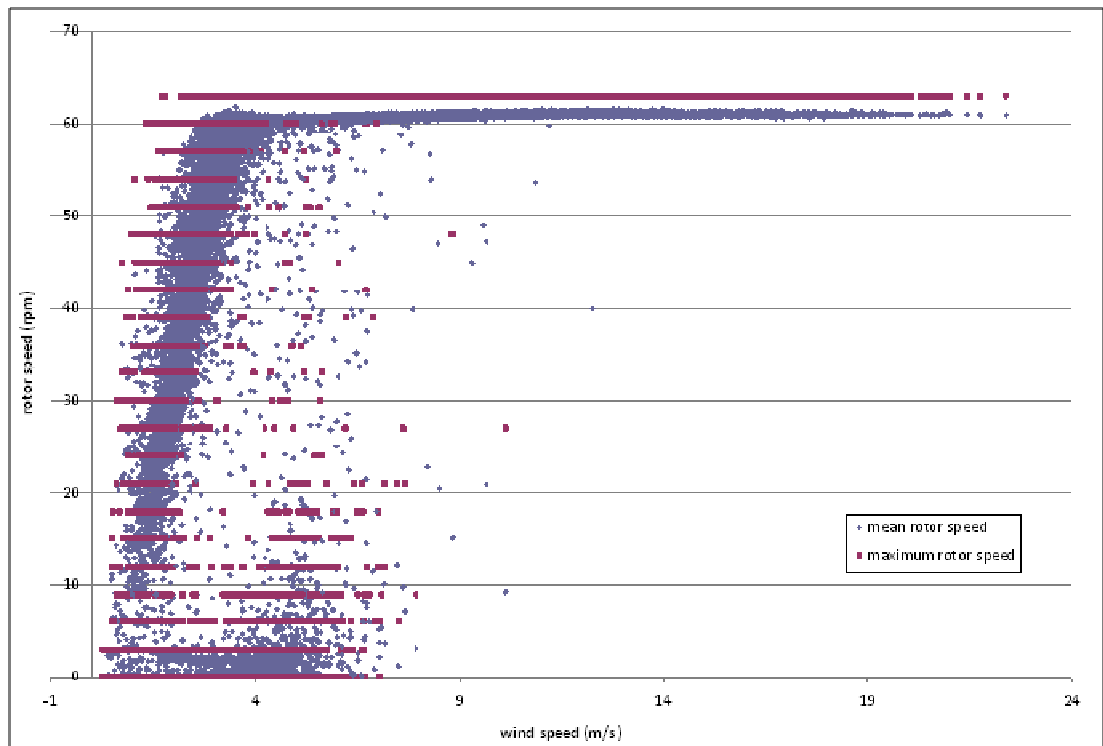
Figure 4. Rotor-speed response to wind speed

Rotor-speed measurements over the test period indicate that the turbine system exhibits control over rotor speed in response to high winds. Figure 4 shows both 1-minute average and 1-second maximum rotor speed. The maxima level off and hold at about 63 rpm. The manufacturer’s rated rotor speed is 60 rpm and a rotor over speed occurs at 66 rpm. The data shows the rotor speed was held at less than 66 rpm.

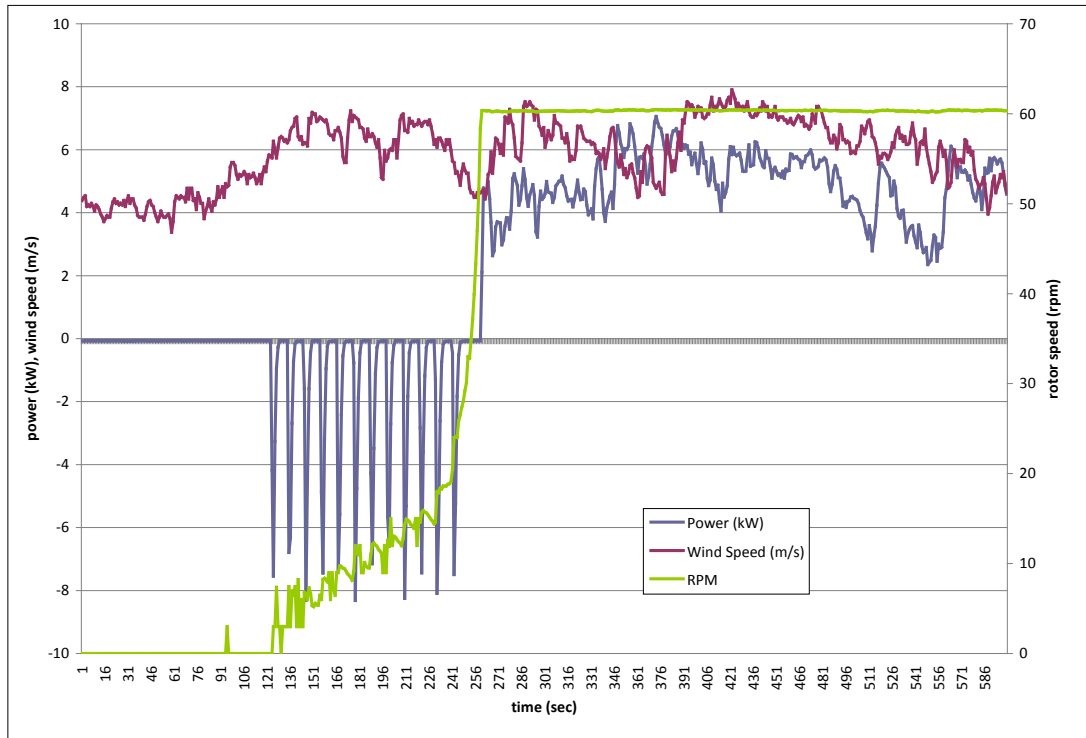
Figure 5. Normal start-up

Normal Operation—Wind Speed Greater Than Cut-In. This event was captured in January 2009. As shown in Figure 5, the wind speeds were slightly greater than the cut-in wind speed,

so the turbine started from the “soft starter.” This is indicated by the negative power spikes that occurred before starting. During the turbine motoring pulses, the rotor speed increased and the turbine began producing power in wind speeds of approximately 4 m/s. NREL staff observed similar smooth cut-ins when the turbine was returned to service after shutdown.

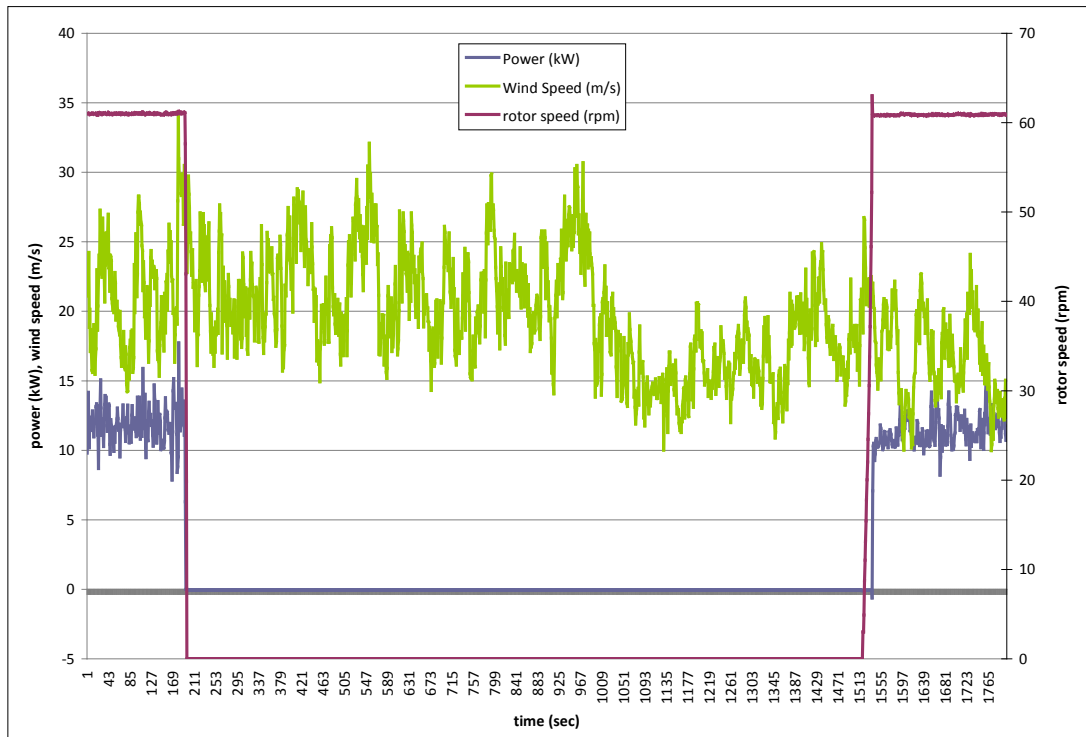
Figure 6. Turbine shutdown and auto-start after high-wind shutdown

Normal Operation—Wind Speed Decreasing to Less Than Cut-Out. This event was documented in November 2008. Figure 6 shows the turbine shutting down due to an instantaneous wind-speed reading of more than 25 m/s as the rotor speed and power fall to zero. After approximately 20 minutes the wind speeds decreased and turbine auto-started without error.

Normal Operation—Wind Speed Increasing to Greater Than Cut-Out. Instantaneous Reading: This event was documented in November 2008. Figure 6 shows the turbine shutting down for an instantaneous wind speed reading of more than 25 m/s as the rotor speed and power fall to zero. After approximately 20 minutes, the wind speed slowed and turbine auto-started without error. **Behavior upon Average Reading:** This event was captured in January 2009. The parameter for allowed wind speed averaged over 10 minutes before shutdown was changed from 20 m/s to 10 m/s. The setting was changed while the turbine was operating and the wind speeds were greater than 10 m/s. The turbine came to a stop and the controller read, “wind > max.”

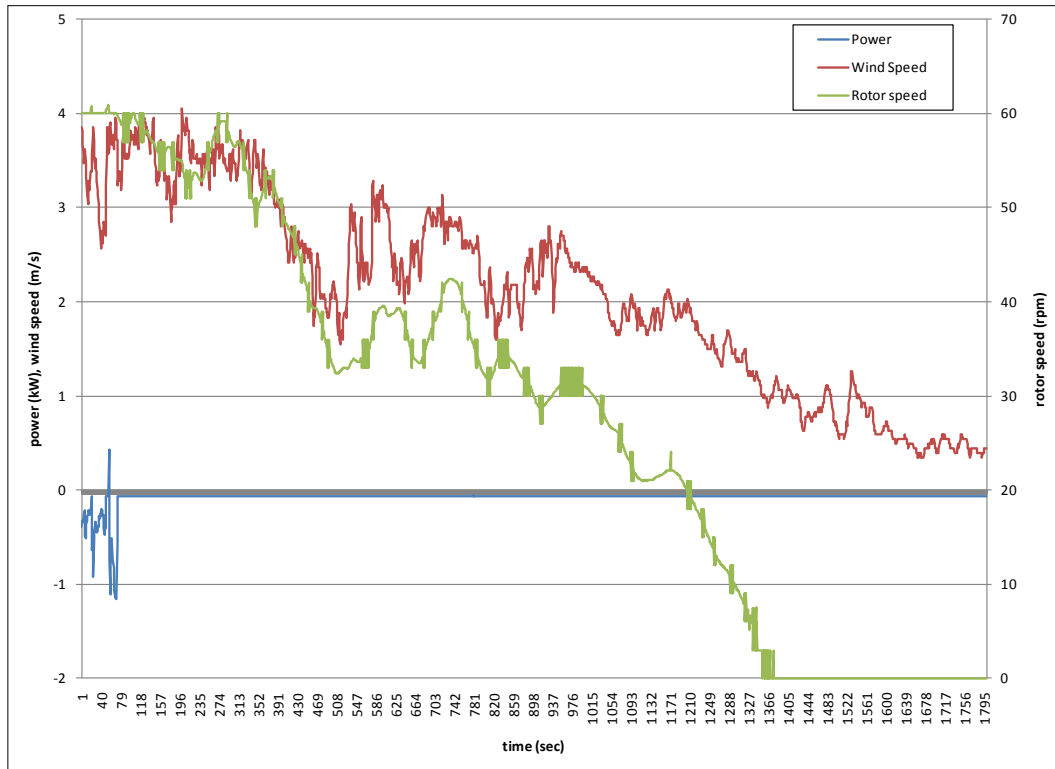
Figure 7. Normal shutdown in wind speeds decreasing to less than cut-in

Normal Operation—Wind Speed Decreasing to Less Than Cut-In. This event was captured in January 2009. When the wind speed decreases to less than cut-in the turbine stops producing power—with no significant change in sound or behavior. The turbine allows the rotor to freewheel in wind speeds less than cut-in. Figure 7 shows that the turbine stopped producing power and slowed to a stop as the wind speed decreased.

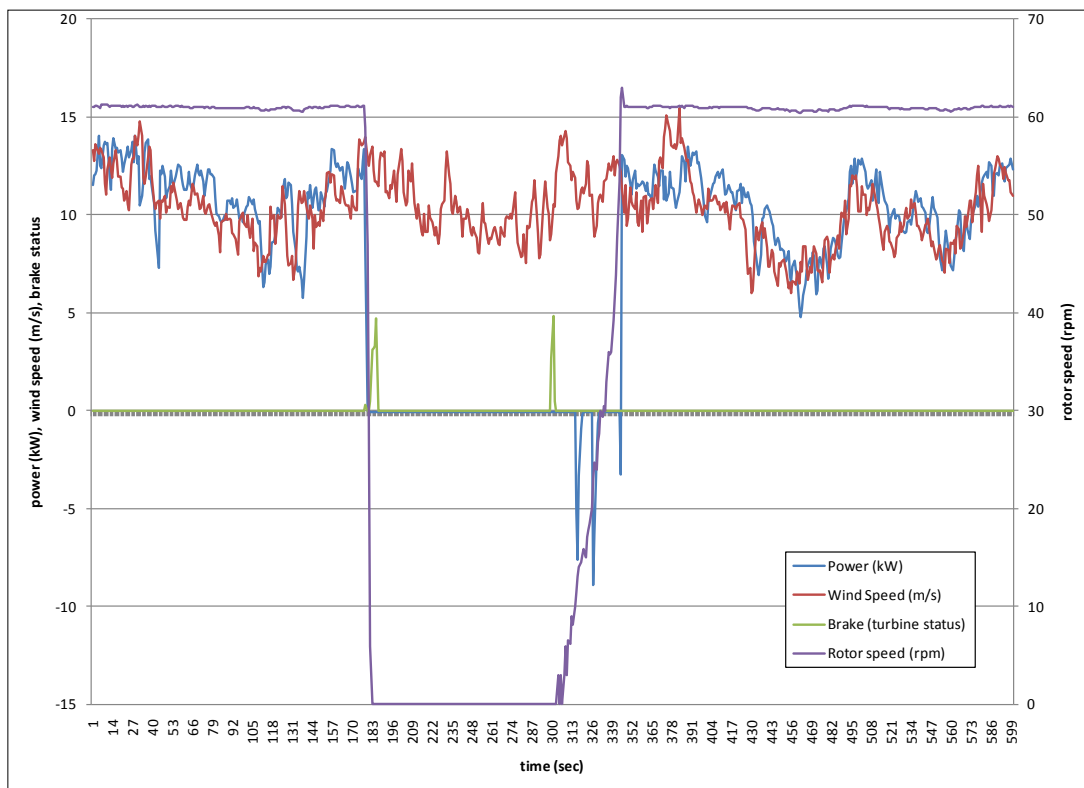
Figure 8. Automatic shutdown from over speed at design wind speed or greater

Behavior Upon Automatic Shutdown from Over Speed at Design Wind Speed or Greater. This event was observed in January 2009. While the turbine was operating, the setting for maximum rotor speed temporarily was changed to 59 rpm (normally 66 rpm). As soon as the setting was changed, the mechanical brake brought the wind turbine to a stop and the controller read, “rotor over speed.” The wind speeds were between 7 m/s and 15 m/s.

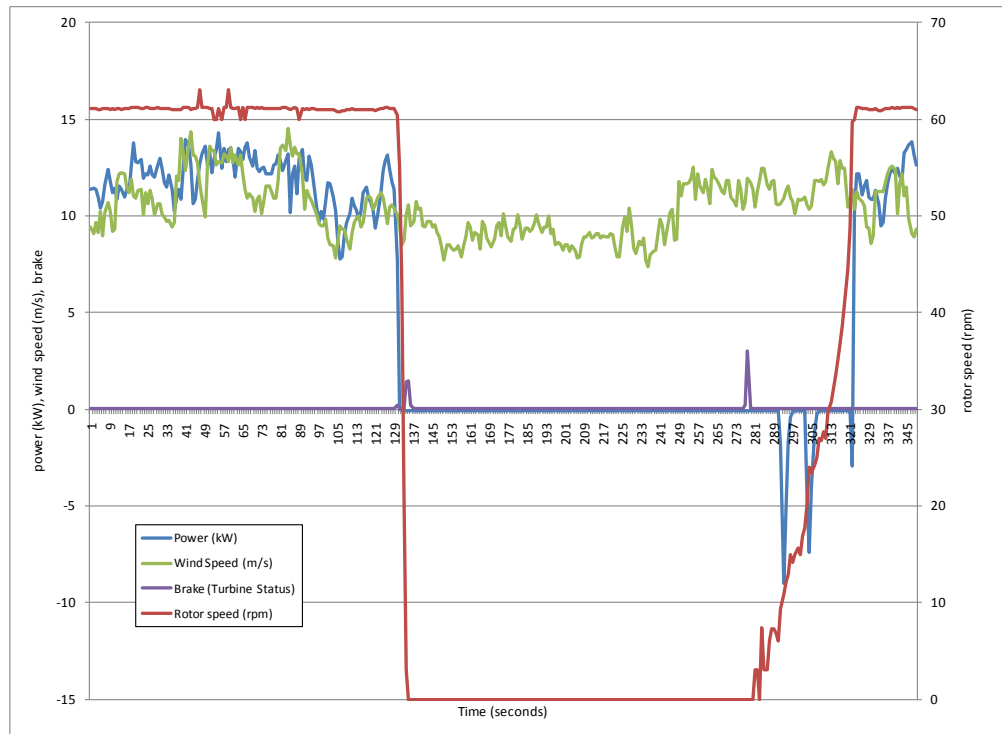
Figure 9. Normal start-up after fault clearance at design wind speed or greater

After Maintenance or Fault Clearance at Design Wind Speed (10.5 m/s) or Greater. This event occurred in January 2009. The “emergency-stop” button on the side of the controller box was pressed, activating the mechanical brake to stop the turbine. The error was cleared manually and the turbine started without problem. Figure 9 shows a time series of the events.

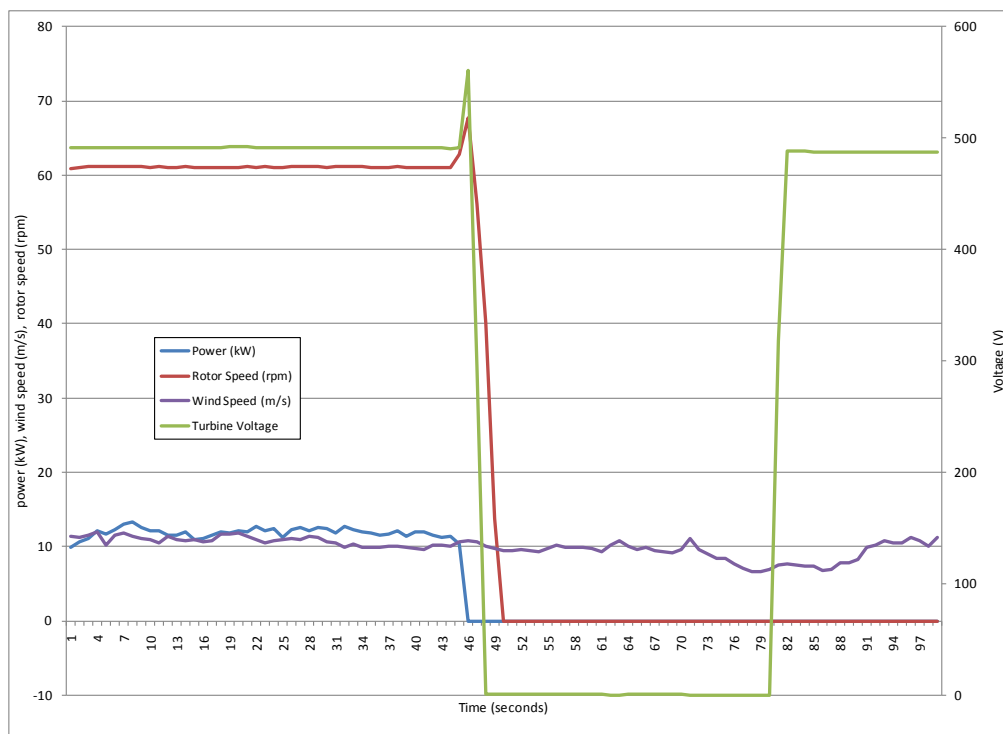
Figure 10. Automatic shutdown due to a grid outage

Response to Grid Outage. This event was observed in January 2009. The disconnect switch in the data shed was opened to simulate a grid outage and the turbine stopped within 2 to 3 seconds. After the switch was opened, the turbine voltage increased to 560 V before dropping to 0 V. The wind speed was between 9 m/s and 10 m/s and the turbine was producing approximately 11 kW. Figure 10 shows a time series of the event.

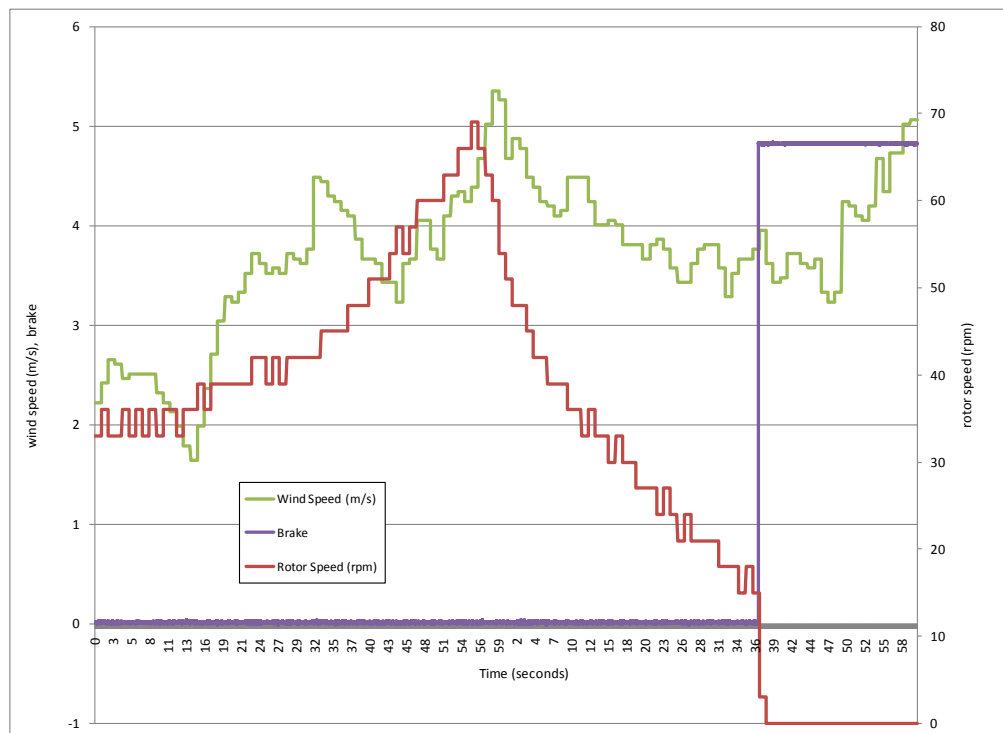
Figure 12. Shutdown using tip brakes due to 15% over speed

Behavior Upon Rotor Over speed 15%. This event was captured in May 2008. In case of a mechanical brake failure, the increased centripetal force causes the tip brakes to deploy at a rotor speed of approximately 15% greater than the nominal rotations per minute—or 69 rpm—to aerodynamically stop the turbine. The rotor over speed 10% setting was increased to allow the tip brakes to deploy. One tip brake was deployed less than 1 second after the turbine reached 69 rpm. Figure 12 shows that the turbine came to a complete stop approximately 42 seconds after the tip brake was deployed. The wind speeds were between 2 m/s and 6 m/s.

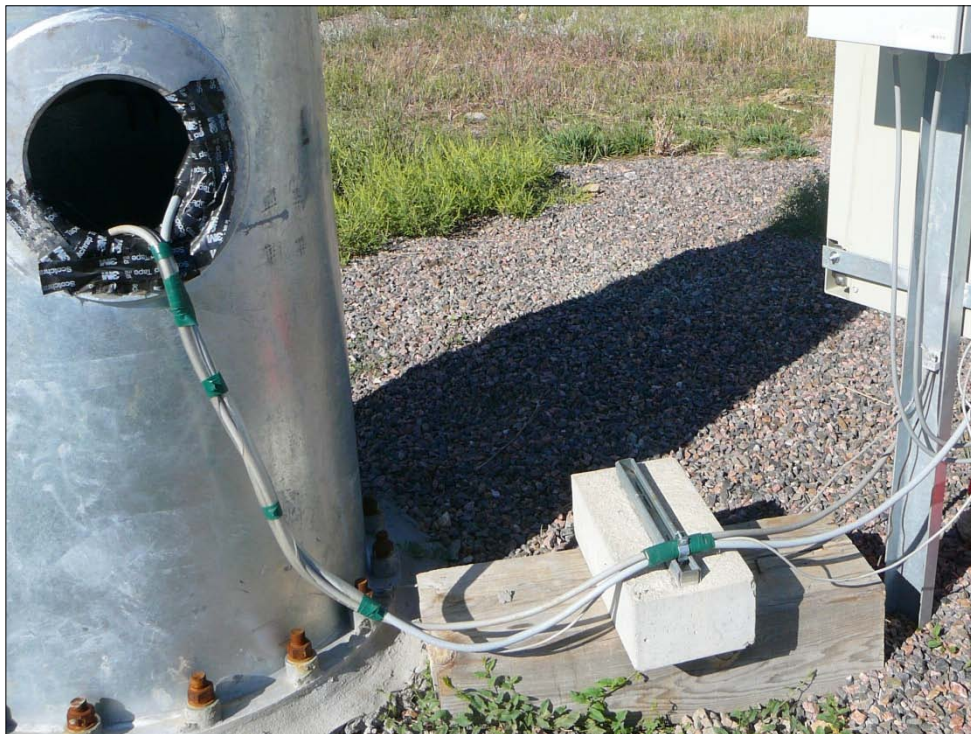
Figure 16. Power and instrumentation cables from turbine to controller

The power cables are exposed from the turbine tower to the controller where they terminate at a socket. The exposed cable presents a potential trip hazard, as shown in Figure 16. The socket termination shown in Figure 17 presents a potential safety hazard because it can be unplugged while the turbine is running. The grounding system consists of four ground rods embedded in the foundation and connected with a ground wire. The ground wire is connected to the tower and the turbine controller.
