Wind Turbine Safety and Function Test Report for the Mariah Windspire Wind Turbine

Technical Report
NREL/TP-500-47496
July 2010

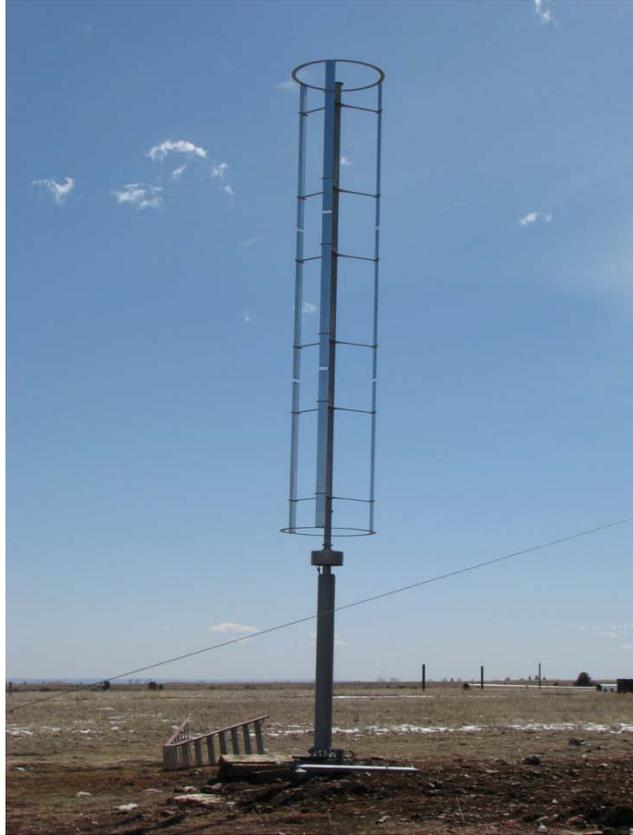
Figure 1. Windspire wind turbine at the NWTC test site

The test turbine was a Mariah Power Windspire wind turbine. This turbine is a vertical axis, three-bladed, variable-speed, turbine with a rated power of 1-kW. Figure 1 shows the test

turbine installed at the NWTC. Table 1 provides the key descriptive information of the test turbine.

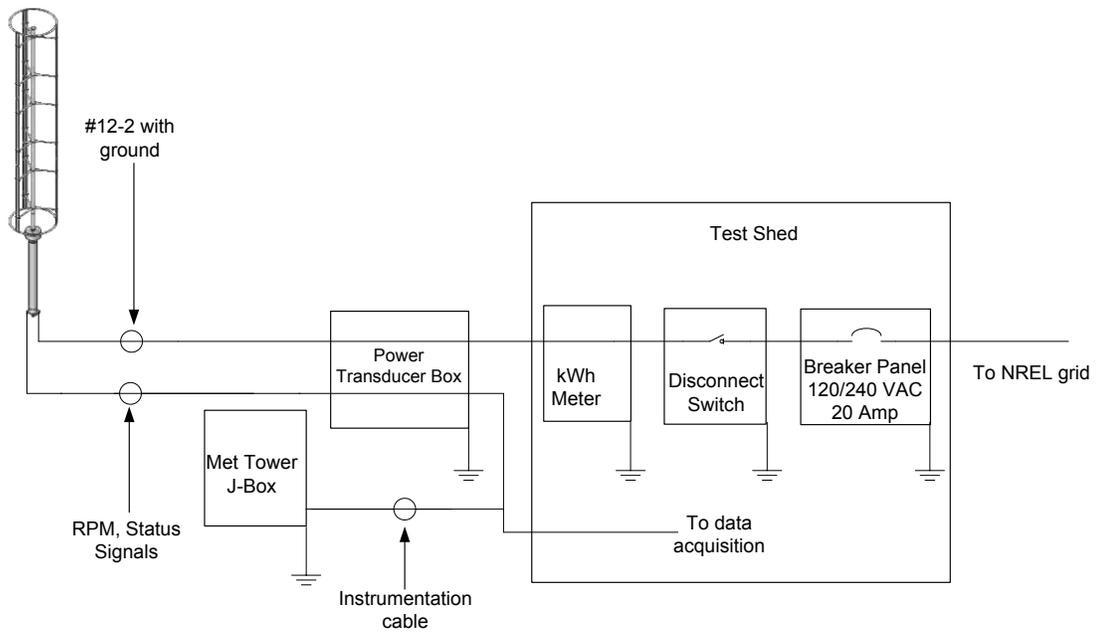
Figure 2. Electrical drawing

Figure 2 shows the general electrical arrangement. The wire run from the base of the tower to the data shed is approximately 54 meters of #12-2 American Wire Gauge (AWG) wire. Inside the data shed, on the turbine side of the transformer, the wire run is connected to a disconnect switch and a dedicated breaker in a breaker panel.

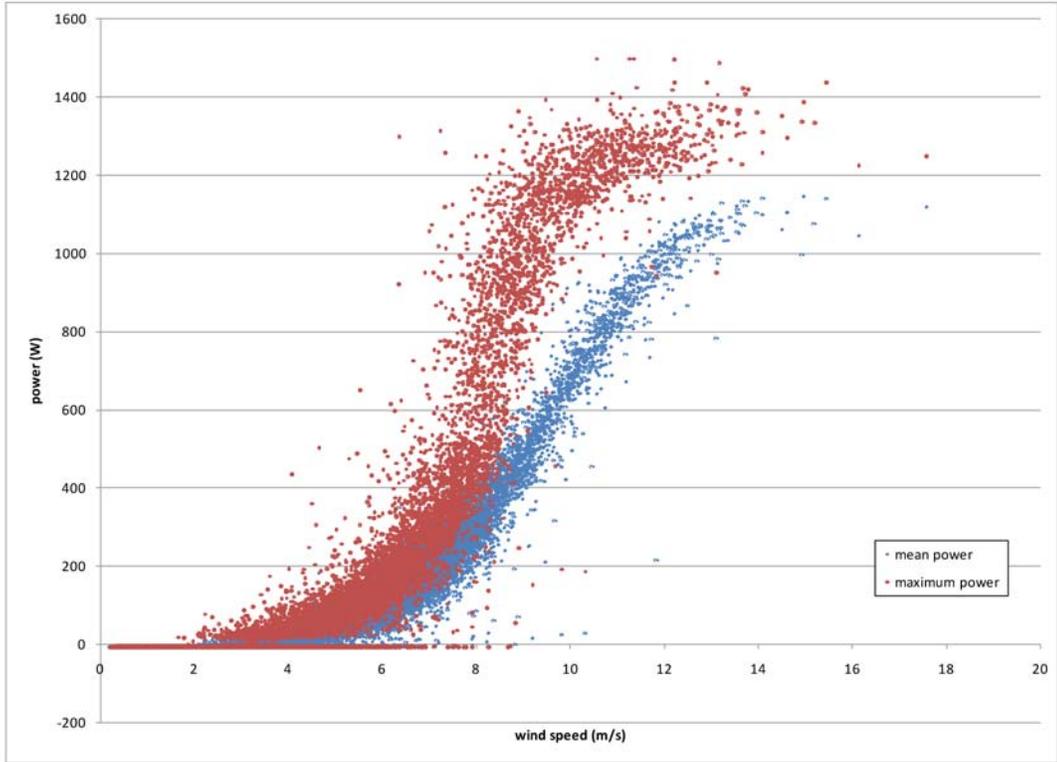
Figure 3. Power response to wind speed

Figure 3 shows the 1-minute mean power data and 1-second maximum power data for the inverter configured for standard power production. For the data collected, both the mean and maximum power values appear to begin leveling off at wind speeds greater than 14 m/s. However, there are not enough data points at these wind speeds to conclude that the turbine exhibits power control.

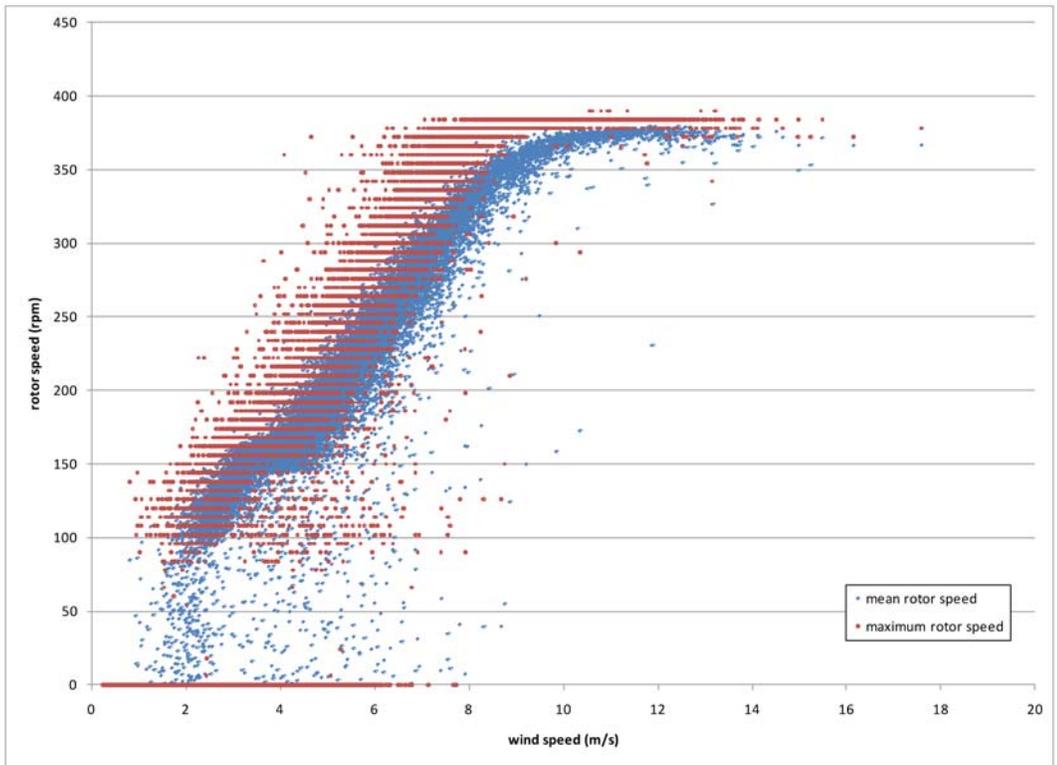
Figure 4. Rotor-speed response to wind speed

Rotor-speed measurements over the test period indicate that the turbine system exhibits control over rotor speed in response to winds below about 18 m/s. Figure 4 shows both 1-minute average and 1-second maximum rotor speed for the inverter configured for standard power production. The maxima level off and hold at about 390 rpm. The manufacturer's rated rotor speed is 380 rpm and a rotor overspeed occurs at 430 rpm. The data shows the rotor speed was held at less than 430 rpm.

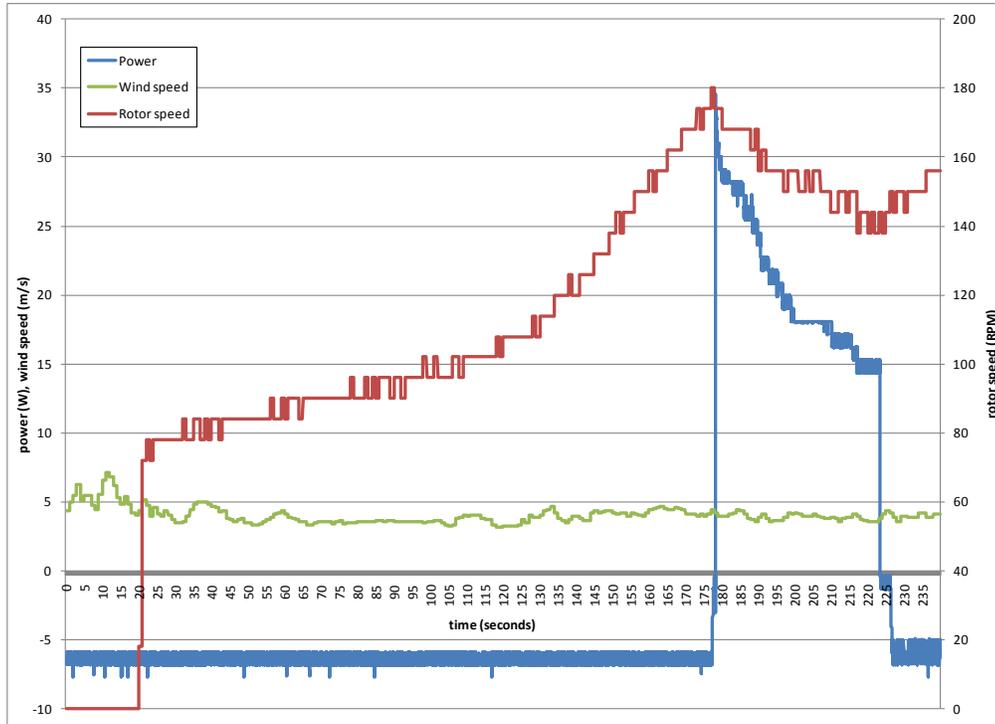
Figure 5. Normal start-up, wind speeds greater than cut-in

Normal Operation—Wind Speed Greater Than Cut-In (4 m/s). This event was captured in June 2008 on the inverter configured for optimized power production. As shown in Figure 5, the wind speeds were slightly greater than the cut-in wind speed when the turbine started. The rotor speed gradually increased as the wind speeds remained constant at approximately 4 m/s. The turbine began producing power at a wind speed of about 4 m/s and a rotor speed of about 180 RPM.

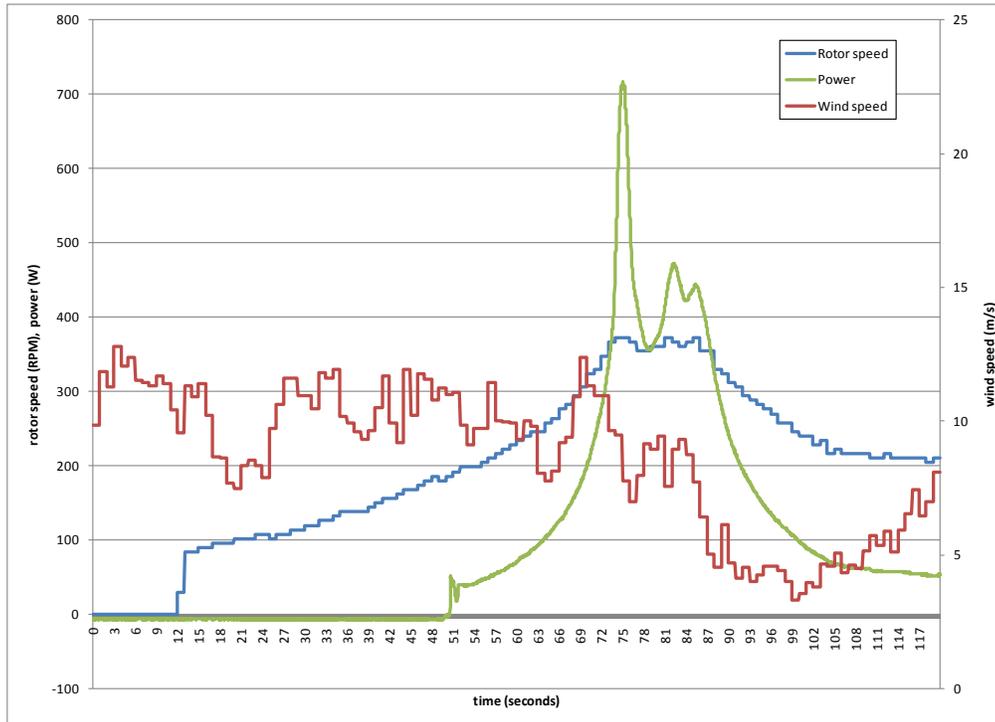
Figure 6. Normal start-up after maintenance

After Maintenance or Fault Clearance at Design Wind Speed (8.4 m/s) or Greater. This event occurred in June 2008 on the inverter configured for optimized power production. The turbine was stopped through the communication software for maintenance. After the turbine was enabled through the communication software, it started in winds between 9 and 13 m/s and began producing power. Figure 6 shows a time series of the events.

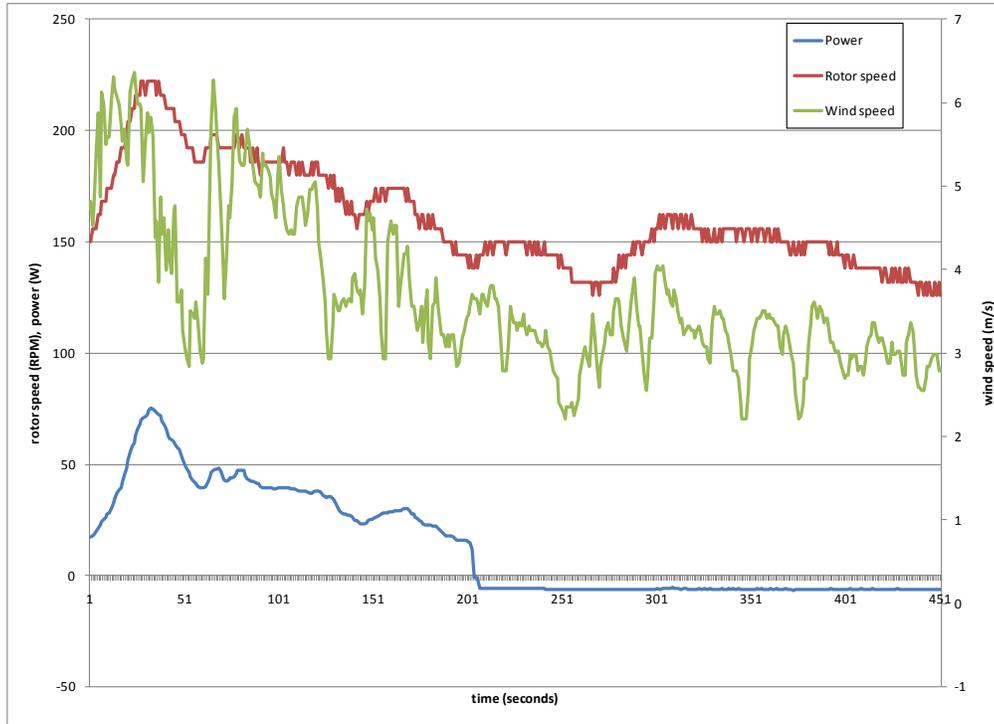
Figure 7. Normal shut down, winds decreasing below cut in

Normal Operation—Wind Speed Decreasing to Less Than Cut-In (4 m/s). This event was recorded in September 2008 on the inverter configured for optimized power production. When the wind speed decreases to less than cut-in the turbine stops producing power and then free wheels. A time series of the event is shown in Figure 7.

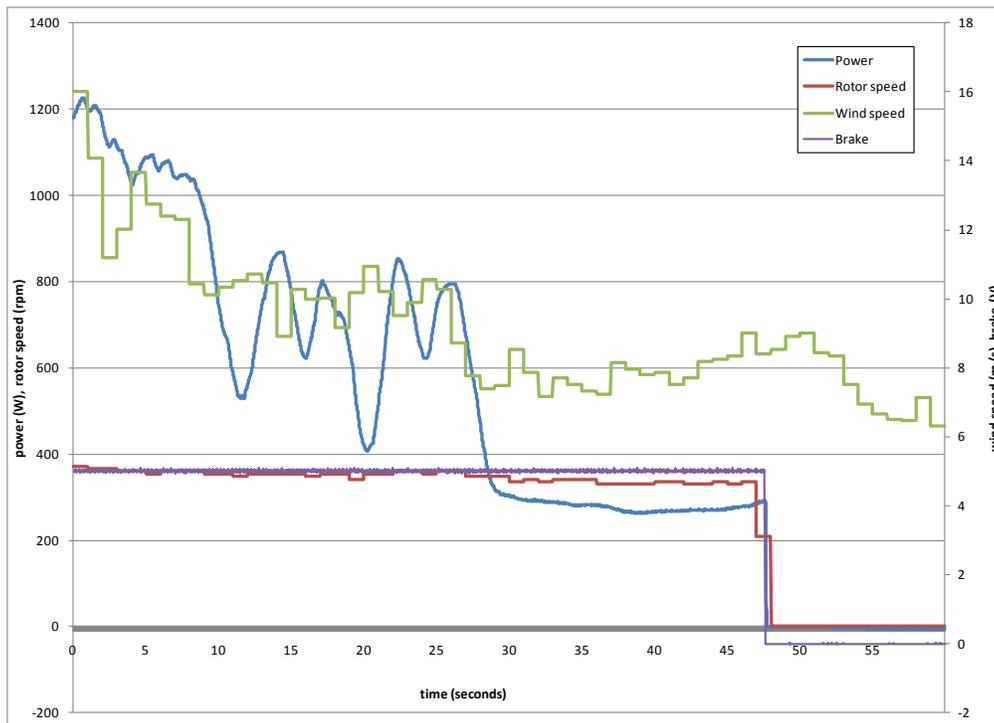
Figure 8. Normal shut down, maintenance at design wind speed or greater

Maintenance or Fault Conditions at Design Wind Speed (8.4 m/s) or Greater. This event was recorded in June 2008 on the inverter configured for optimized power production. The turbine was stopped through the communication software for maintenance. The wind speed was between 8.4 m/s and 9.0 m/s at the time the turbine was stopped. The brake was applied and both the detectable rotor speed and power dropped to zero within 2 seconds. Figure 8 shows a time series of the event.

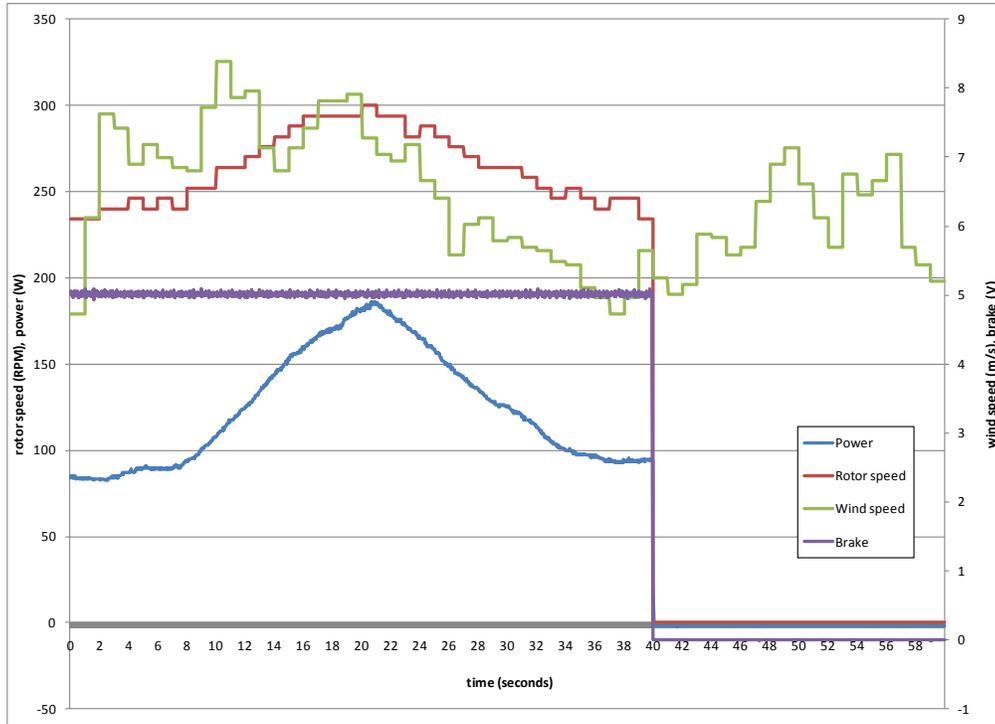
Figure 9. Emergency stop at wind speeds less than the design wind speed

Emergency Stop in Wind Speeds Less Than Design Wind Speed (8.4 m/s). The owner's manual indicates that the owner should disconnect power to the turbine to stop it in high winds. Thus, the emergency shutdown capability was tested by opening the dedicated disconnect switch that NREL installed. This event was recorded in June 2008 on the inverter configured for optimized power production. The wind speeds were between 4 m/s and 6 m/s when the disconnect switch for the turbine was opened. The brake stopped the wind turbine within 2 seconds. Figure 9 shows a time series of the event.

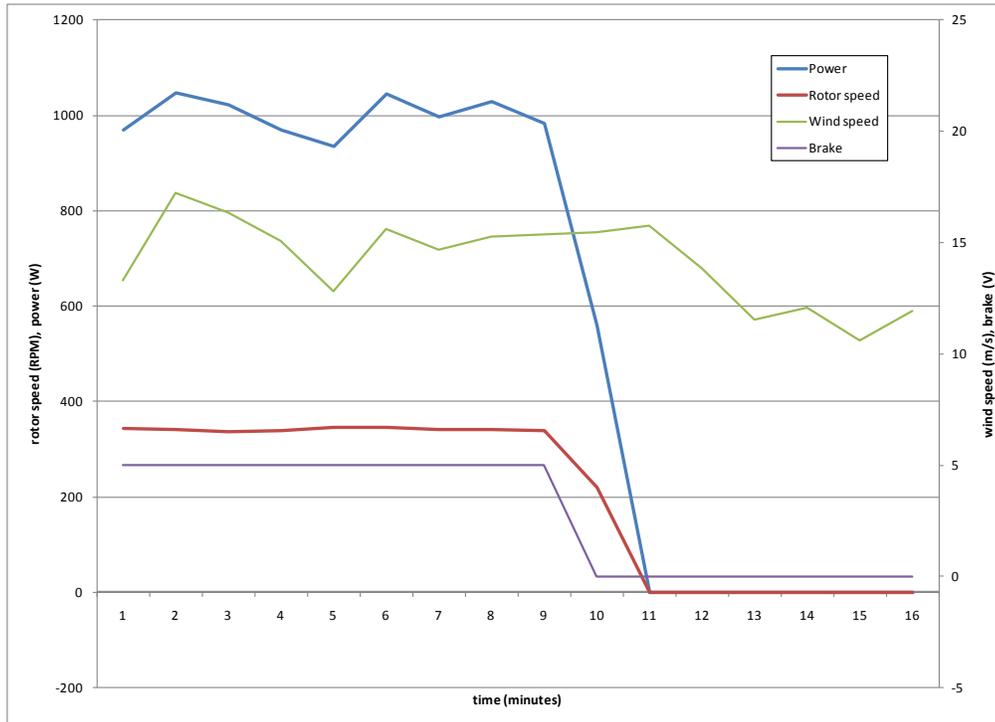
Figure 10. Emergency stop at design wind speed or greater

Emergency Stop at Design Wind Speed (8.4 m/s) or Greater. This event was recorded in October 2008 on the inverter configured for standard power production in a data file containing one minute averages. The wind speed was between 10 m/s and 19 m/s during the one minute period when the disconnect switch was opened to shut the turbine down at the request of the manufacturer for high winds. Figure 10 shows the one minute time series of the event.
