Small Wind Turbine Testing Results from the National Renewable Energy Laboratory

*Presented at the International Small Wind Conference
Glasgow, Scotland
April 27-28, 2010*

Conference Paper
NREL/CP-500-48089
April 2010

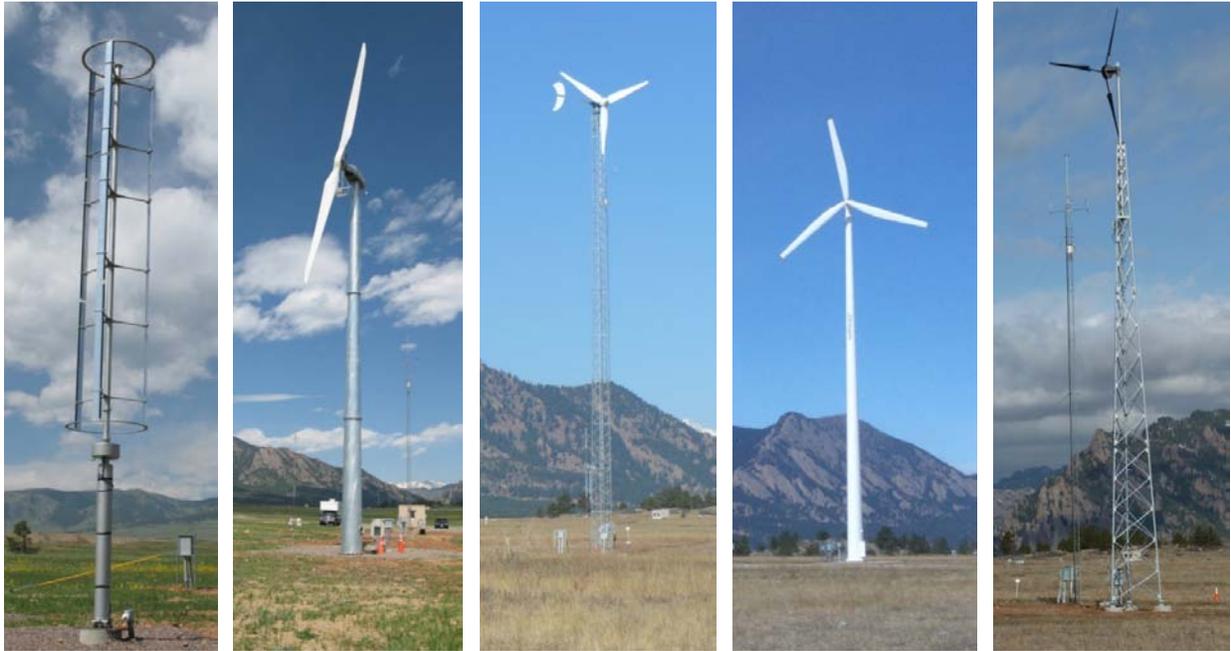
Figure 1. From left to right: Windspire, Gaia-Wind 11 kW, ARE 442, EW50, and VT10. PIX numbers left to right: 15705, 15733, 16390, 15704, 16948

The Mariah Power Windspire was installed on May 5, 2008. It is a vertical-axis turbine mounted on a monopole tower, and has a rotor height of 6.1 m and a rotor area of 1.2 m by 6.1 m. The Windspire uses a 120 VAC, single-phase, grid-connected, permanent-magnet generator wind turbine rated at 1 kW. Testing on the Windspire was terminated on January 14, 2009 after repeated turbine problems.

The Gaia-Wind 11 kW turbine was installed on May 13, 2008. It is a downwind, two-bladed, horizontal-axis turbine. The Gaia-Wind 11 kW has a 133 m² swept area and is mounted on an 18.2 m monopole tower. Its three-phase 11-kW induction generator delivers 480 VAC to the grid. At the time of this writing, data collection is complete with the exception of a post duration test inspection.

The Abundant Renewable Energy ARE 442 was installed on June 11, 2008. It is a horizontal-axis, three-bladed turbine with a swept area of 41 m². It operates upwind and uses a furling mechanism for power control. The ARE 442 is mounted on a 30.5 m lattice tower. The turbine uses a single-phase, grid-connected, permanent-magnet generator that is rated at 10 kW at 240 VAC. Testing is complete.

The Entegrity EW50 was installed on March 3, 2009. It is a horizontal-axis, downwind machine. It has a swept area is 177 m² and is mounted on a 30.5 m monopole tower. The EW50's three-phase induction generator produces 50 kW at 480 VAC. At the time of this writing, data collection for power performance and acoustic noise is complete and undergoing analysis. Data collection continues for duration testing, safety and function, and power quality.

The Ventera VT10 completed installation on March 23, 2010. It is a downwind, horizontal-axis, three-blade turbine. Its swept area is 35 m², and it is mounted on a 24.7 m lattice tower. The VT10 uses a single-phase, grid-connected, permanent-magnet generator that is rated at 10 kW at 240 VAC. Pitchable tips govern the rotor speed. At the time of this writing, data collection is in progress for all tests.

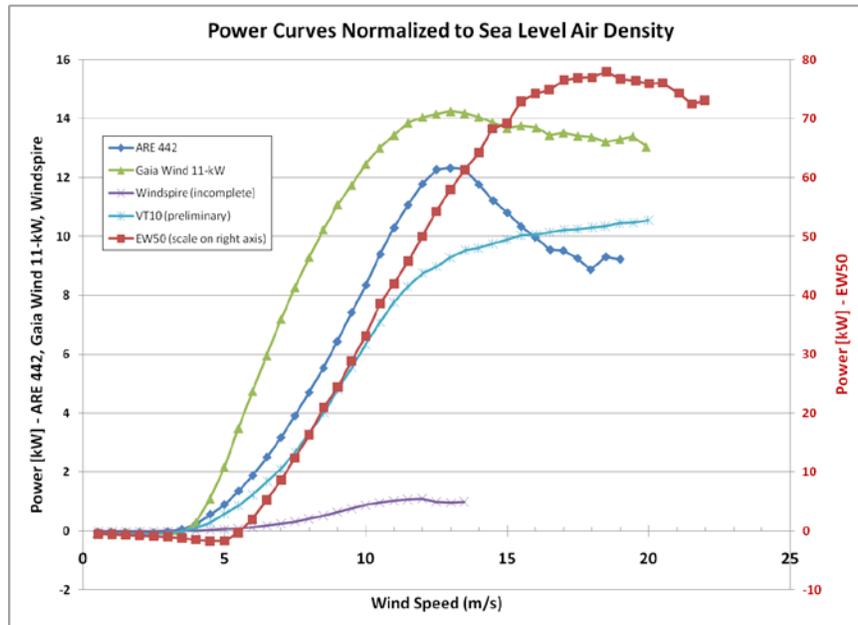
Figure 2 shows the power curve for all five small turbines tested. The EW50 is scaled on the right axis, the rest are scaled on the left axis. The Gaia-Wind 11 kW and ARE 442 are the final curves. The EW50, VT10 curves are preliminary. The original inverter on the Windspire was optimized for power performance and failed after several months of operation. After the failure, a production model inverter was installed and operated until testing on the Windspire was suspended. The required amount of data was not collected on either inverter due to failures. Figure 2 shows the incomplete power curve for the second, production model inverter.

Figure 2. Power Curves of the Five Turbines Tested

Annual energy production (AEP) is estimated by applying the power curve generated from power performance testing to a Rayleigh distributed wind resource. The AEP is calculated for annual average wind speeds at hub height for 4 m/s to 11 m/s. In Table 3 below, the measurements reported assume no energy production beyond the highest filled bin in the power performance test. The AEP for the EW50 has not been published, and the AEP for the VT10 is preliminary. The AEP is not reported for the Windspire because the required amount of data was not collected.

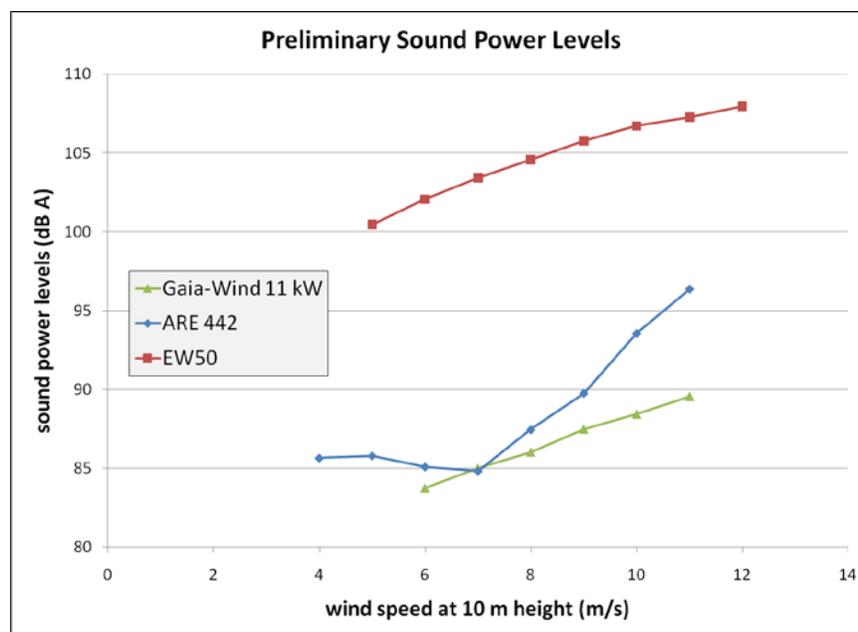
Figure 7. Preliminary Sound Power level for Gaia-Wind 11 kW, ARE 442, and EW50

IEC standard 61400-11, Acoustic Noise Measurement Techniques, does not contain information specific to small wind turbines, however noise will be addressed specifically in the next revision of this standard. One result of the noise test is to characterize emissions from a turbine in terms of sound power level. For small wind turbines, the IEC standard is followed with some modifications. Ten-second averages are used instead of 1-minute averages to better characterize the more-dynamic nature of small wind turbines. Also, to determine the sound power levels at the integer wind speeds, binning data is used instead of regression analysis. Figure 7 shows the sound power levels for the Gaia-Wind 11 kW, ARE 442, and EW50. Testing on the Windspire was not completed, and testing on the VT10 has not begun.
