SAE J2579 Validation Testing Program

Powertech Final Report

Mark McDougall
Powertech Labs Inc.
Surrey, B.C., Canada

Subcontract Report
NREL/SR-5600-49867
December, 2010

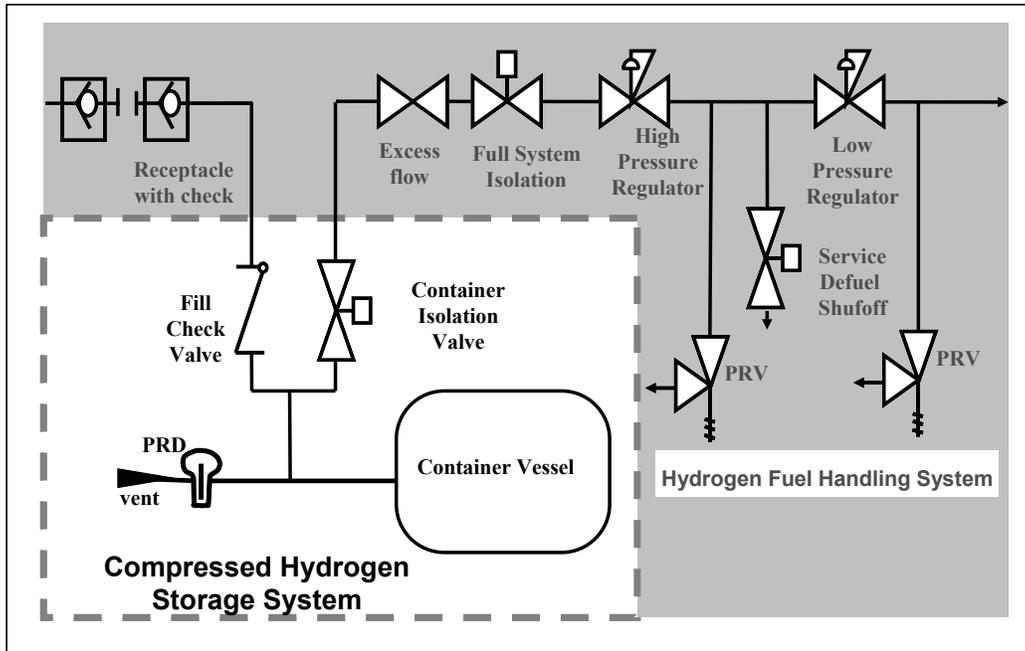
Figure 1.1: High-pressure envelope as defined in SAE TIR J2579

The Safety Working Group at the Society of Automotive Engineers (SAE) has developed a new “systems-level” document for hydrogen vehicles. This document, SAE TIR J2579, is a new approach to certification standards for components. The document eliminates the need for dozens of test samples, tested in isolation from each other. SAE TIR J2579 describes the components which create the “high-pressure envelope”, the components whose primary function is the containment of the high-pressure hydrogen on-board the vehicle, and has created a sequential test based on those specific components. The high-pressure envelope is shown in Figure 1.1 below.

A single 70MPa Type 3 tank, with in-tank solenoid valve, PRD and check valve (per the high-pressure envelope in Figure 1.1), was tested according to the Extended Service Life Verification Test as shown in Figure 1.1.2.

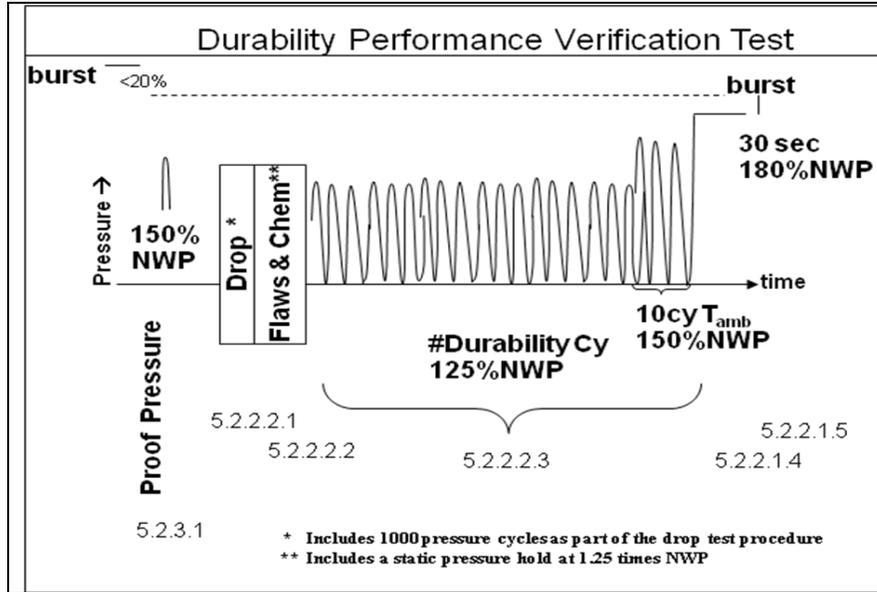
Figure 1.1.1: Durability Performance Verification Test sequence

The Durability Performance Verification Test is designed to verify that the hydrogen storage system shall have sufficient durability to survive extreme conditions and extended usage without failure. This test sequence is intended to be performed on the storage tank(s) only. The test sequence is shown in Figure 1.1.1 below and is performed hydraulically.

The sequence consists of 6 steps. The first is the Routine Production Quality Tests, which consist of a hydrostatic proof test to 150% of nominal working pressure (NWP), and expansion measurements. The second test is the Drop Test, which is an installation damage test derived from previous test standards (NGV2, etc.). The third test is the Surface Damage and Chemical Exposure, designed to simulate the types of fiber damage which may occur in service. Gravel and pendulum impacts, as well as 5 different chemical exposure pads, occur along the sidewall of the tank. The damage is performed unpressurized, although a 48 hour hold at 125% of NWP immediately follows. The fourth test is the Ambient Temperature Pressure Cycling Test, which is designed to expose the tank to cyclic fatigue stresses. The number of cycles is defined as 3 times the number of expected cycles (determined by a range and lifetime calculation) but not less than 5,500 cycles, which should allow for a significant safety margin on the total number of cycles. The cycles are performed at 125% NWP, similar to other test standards. However, 10 additional cycles at 150% NWP have been added to the end of the cycling test, to allow for the possibility of station over-pressurization of the fuel system. The final two tests are a Proof Pressure Test to 180% NWP and a Residual Strength Burst Test, both designed to determine the amount of strength reduction caused by the sequential testing.

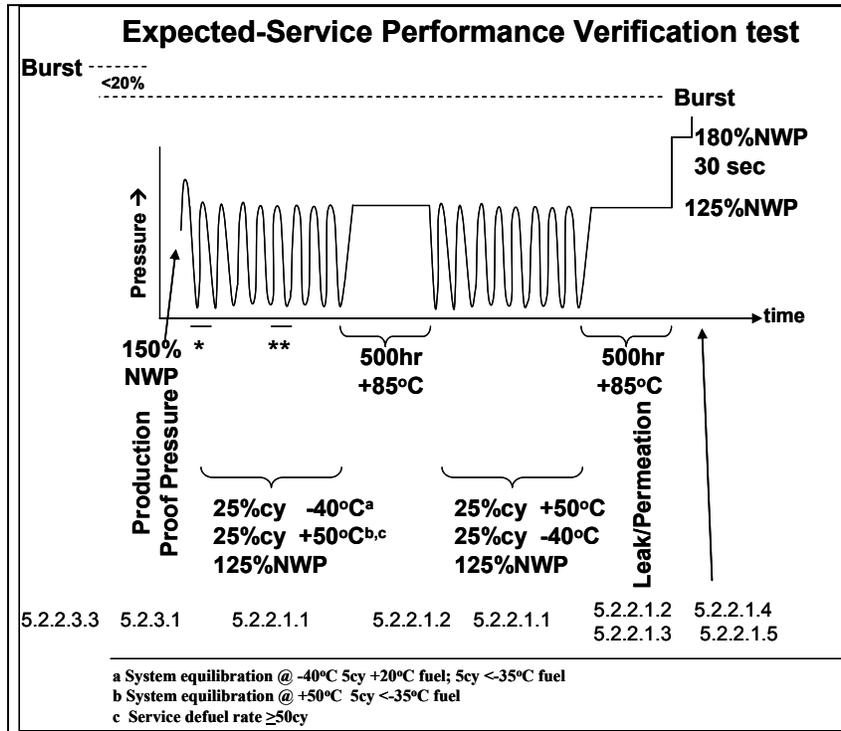
Figure 1.2.1: Expected-Service Performance Verification Test sequence

cumulative exposures associated with worst-case conditions of fueling and de-fueling and parking. The test sequence is shown in Figure 1.2.1 below and is performed pneumatically on the complete high-pressure system as defined in Figure 1.1.

The test sequence consists of 8 steps as shown above. The first test is the Routine Production Quality Tests, performed on the individual components by their respective manufacturers. The second test is the Extreme-Temperature Gas Cycling (Fueling Performance), which is essentially a gas cycle test at -40°C and +50°C. The number of total cycles to be performed is based on a range and lifetime calculation, but not less than 500 cycles, 50% in this step. The third test is an Extended Static High Pressure Gas Test (Parking Performance) which is an elevated temperature hold at 125% NWP for 500 hours. The fourth test is a repeat of the Extreme-Temperature Gas Cycling, to complete the number of total required cycles. The fifth test is another Extended Static High Pressure Gas Test (Parking Performance) which is an elevated temperature hold at 125% NWP for 500 hours. The sixth test is a Gas Leak (Permeation) test to evaluate the performance of the system following the exposures of the previous tests. The final two tests are a Proof Pressure Test to 180% NWP and a Residual Strength Burst Test, both designed to determine the amount of strength reduction caused by the sequential testing.

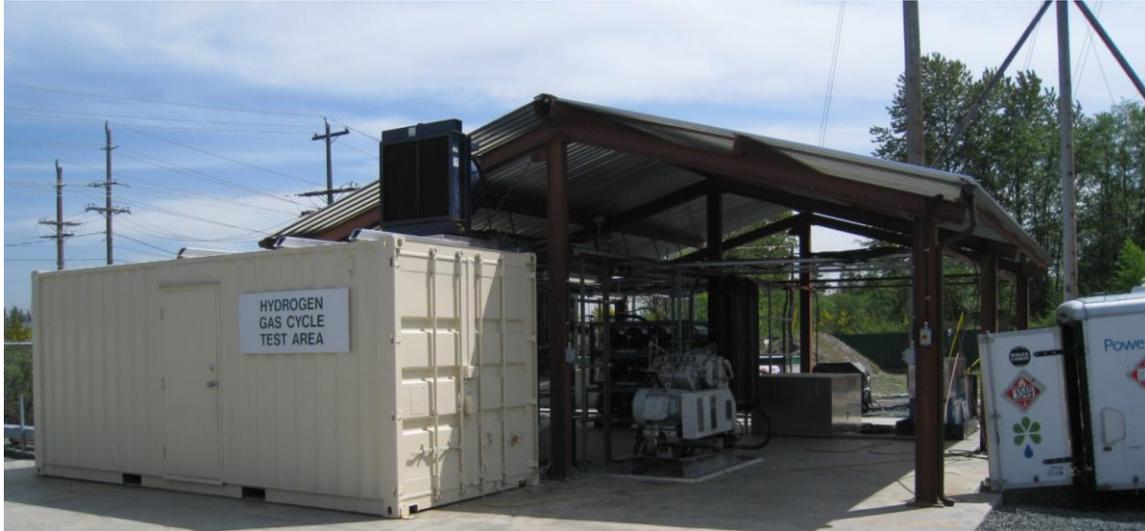
Figure 3.2.1: Powertech Hydrogen Gas Cycle Test Facility

Powertech Labs has designed and constructed two parallel gas cycle systems capable of performing the SAE TIR J2579 pneumatic test sequence. These two test systems, part of the Hydrogen Gas Cycle Test Facility (shown below), have similar equipment with slightly different capacities. For very high capacity tests, the two systems can be connected to increase the overall capacity of a single test system.

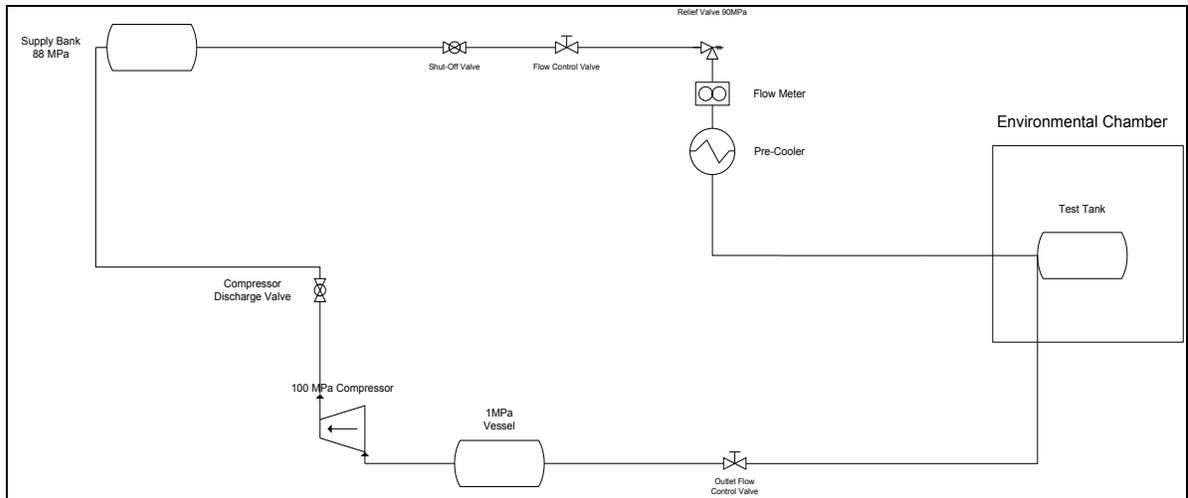
Figure 3.2.2: Schematic of Powertech Labs SAE TIR J2579 Test Setup

The major pieces of equipment required are all commercially available, with the exception of the hydrogen gas pre-cooler. Powertech uses their proprietary design for the two pre-coolers in the Gas Cycle Test Facility. Below is a schematic of one of the Powertech SAE TIR J2579 test setups.

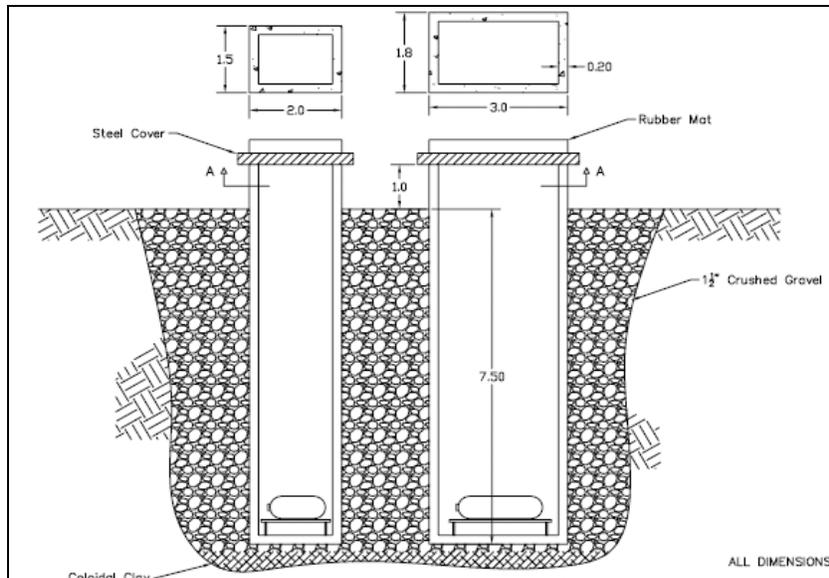
Figure 3.3.1: Hydrogen Gas Cycle Test Facility bunkers

To account for these safety concerns, Powertech has designed the test facility and applicable procedures such that at all times the safety of the test facility staff and test equipment is maintained. To this end, the Hydrogen Gas Cycle Test Facility is located such that additional containment or exclusion areas can be maintained. Also, as shown in Figure 3.3.1 below, the testing will occur underground in two concrete bunkers. In addition to the bunkers, concrete block walls have been erected to deflect any blast force away from the test facility and towards an unoccupied area (shown in Figure 3.3.2).

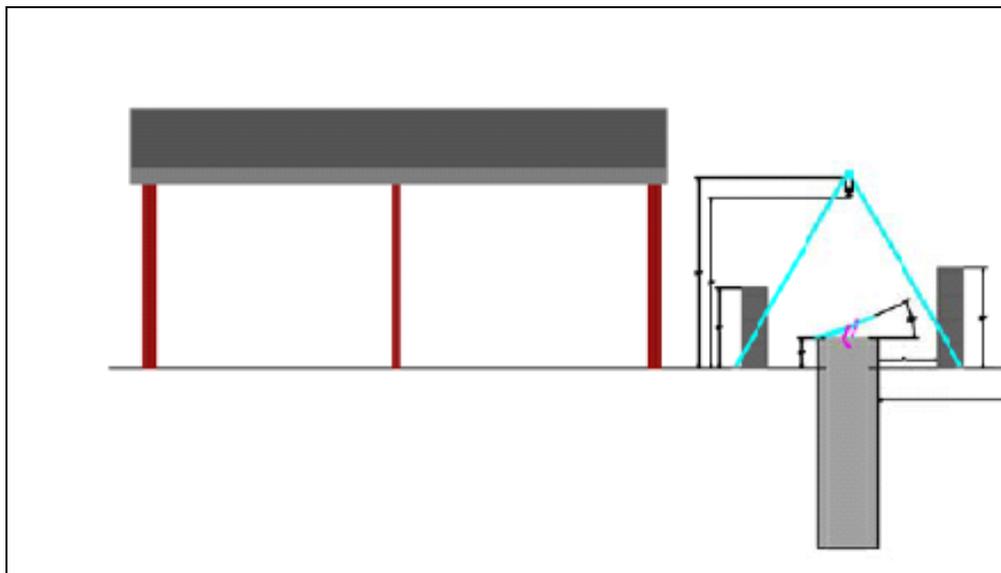
Figure 3.3.2: Hydrogen Gas Cycle Test Facility block walls

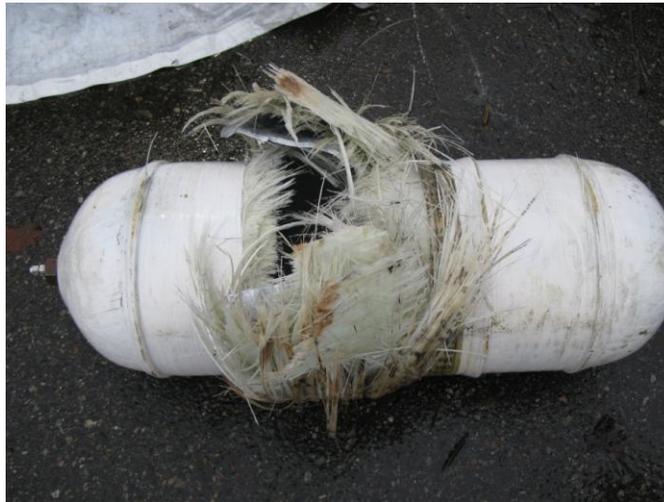
Figure 4.1.1: Comdyne tank #1 failure during hydraulic test sequence

The Comdyne tank was subjected to the Durability Performance Verification Test. The tank underwent the drop test, the surface damage and chemical exposure test, and was followed by a 48 hour hold unpressurized. The tank was then subjected to 5,500 hydraulic ambient pressure cycles to 125% of NWP. No tank failure or leakage occurred. The tank was then subjected to 10 hydraulic ambient pressure cycles to 150% of NWP. The tank failed on the fourth cycle at 150% of NWP, shown in Figure 4.1.1 below. The failure occurred much closer to the end of the test than expected from previous testing experience. An error in the test procedure specified in SAE TIR J2579 was found. The original wording did not require the 48 hour hold (during the chemical exposure) to be performed pressurized. However, the intent was for the hold period to be at 125% of NWP. The document was changed, and the test restarted with a second Comdyne tank.

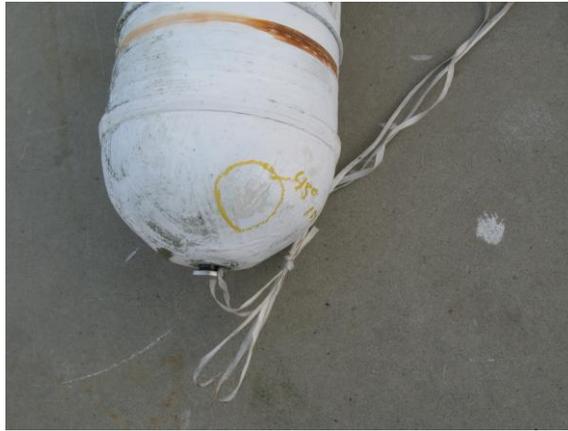
Figure 4.1.2: Comdyne tank #2 following the drop test

The second Comdyne tank was subjected to the drop test (Figure 4.1.2), the surface damage and chemical exposure (Figure 4.1.3), followed by a 48 hour hold at 125% NWP. The second Comdyne tank failed after 42 hours of pressure hold following chemical exposure. The failure was determined to be stress corrosion cracking of the glass fibers in the location of the sulfuric acid application. A photo of the failure of the second Comdyne tank is shown in Figure 4.1.4.

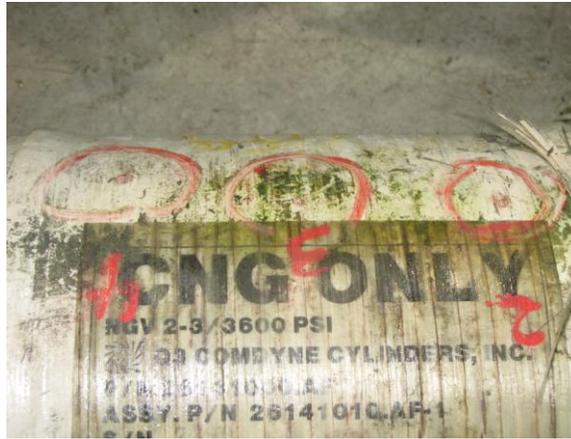
Figure 4.1.3: Comdyne tank #2 following the surface damage and chemical exposure

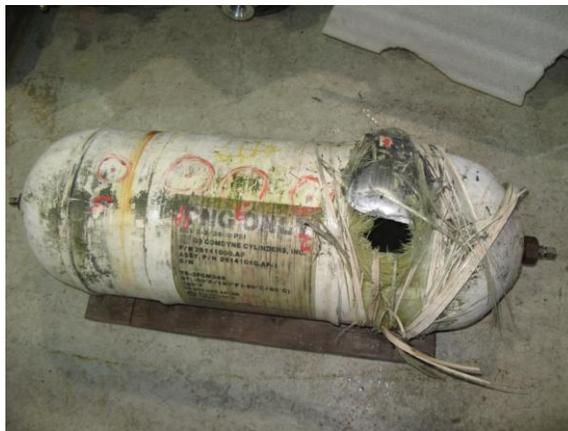
Figure 4.1.4: Comdyne tank #2 failure during 48 hour pressure hold at 125% of NWP

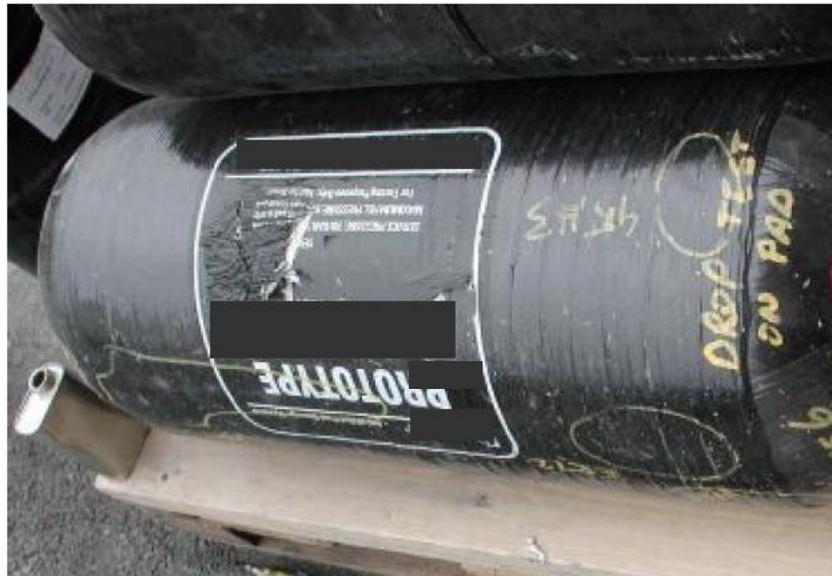
Figure 5.1.1.1: 70MPa Type 3 tank following the drop test

A single 70MPa Type 3 tank was tested according to the Durability Performance Verification Test as shown in Figure 1.1.1. The tank was subjected to the drop test (Figure 5.1.1.1), the surface damage and chemical exposure (Figure 5.1.1.2), followed by a 48 hour pressure hold at 125% of NWP. The tank was hydraulically cycled 5,500 times to 125% NWP and 10 times to 150% NWP. No failure or leakage was found.

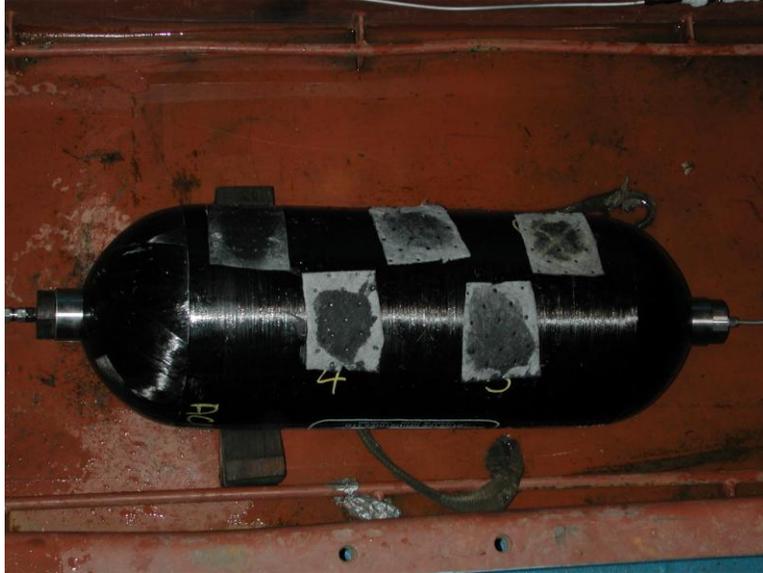
Figure 5.1.1.2: 70MPa Type 3 tank following the surface damage test

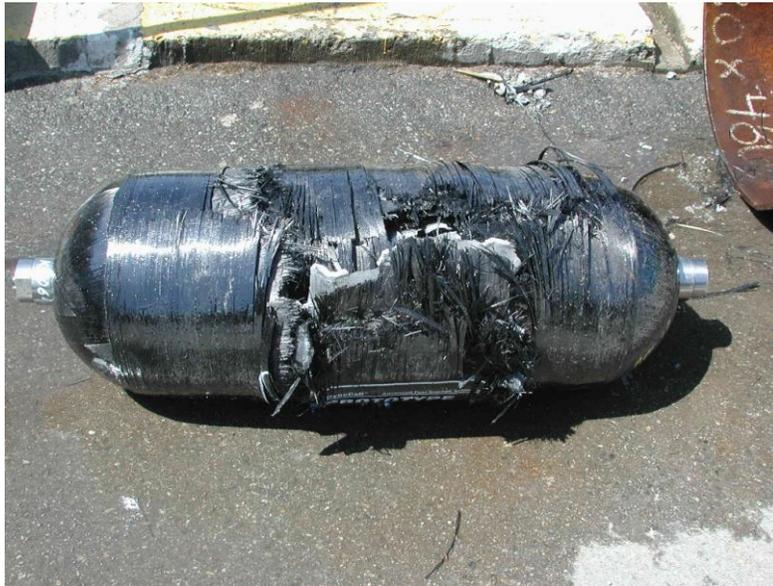
Figure 5.1.1.3: 70MPa Type 3 tank after residual strength burst test

The 70MPa Type 3 tank was subjected to a hydraulic proof test at 180% of NWP with no failure, followed by a residual strength burst test. The burst pressure was approximately 7MPa above the recorded virgin burst value. A photo of the burst tank is shown in Figure 5.1.1.3 below.

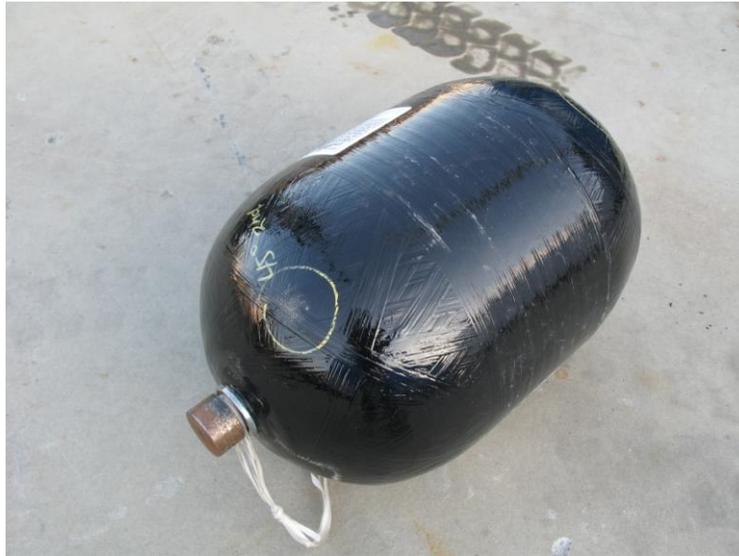
Figure 5.1.2.1: 70MPa Type 4 tank following the drop test

A single 70MPa Type 4 tank was tested according to the Durability Performance Verification Test as shown in Figure 1.1.1. The tank was subjected to the drop test (Figure 5.1.2.1), the surface damage and chemical exposure (Figure 5.1.2.2), followed by a 48 hour pressure hold at 125% of NWP. The tank was hydraulically cycled 5,500 times to 125% NWP and 10 times to 150% NWP. No failure or leakage was found.

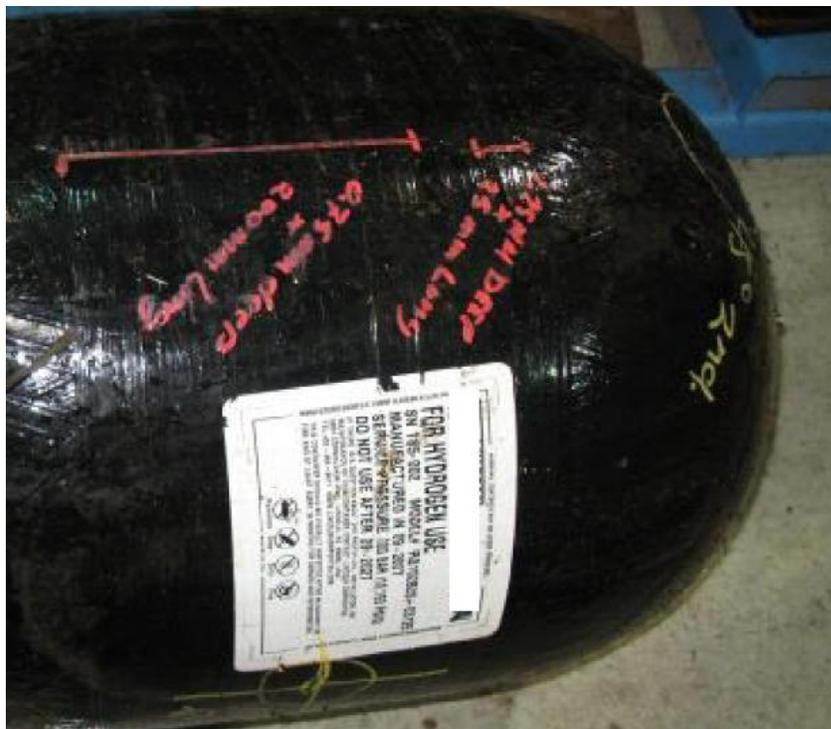
Figure 5.1.2.2: 70MPa Type 4 tank following the surface damage test

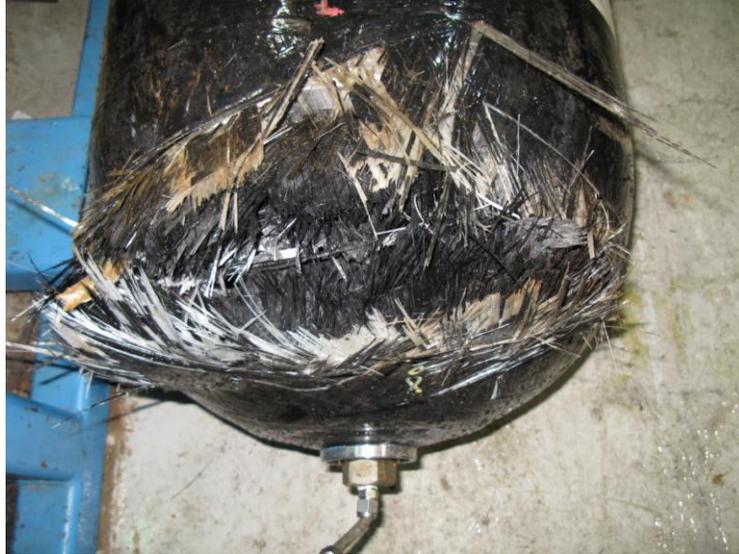
Figure 5.1.1.3: 70MPa Type 4 tank after residual strength burst test

The 70MPa Type 4 tank was subjected to a hydraulic proof test at 180% of NWP with no failure, followed by a residual strength burst test. The burst pressure was approximately 10MPa above the recorded virgin burst value. A photo of the burst tank is shown in Figure 5.1.2.3 below.

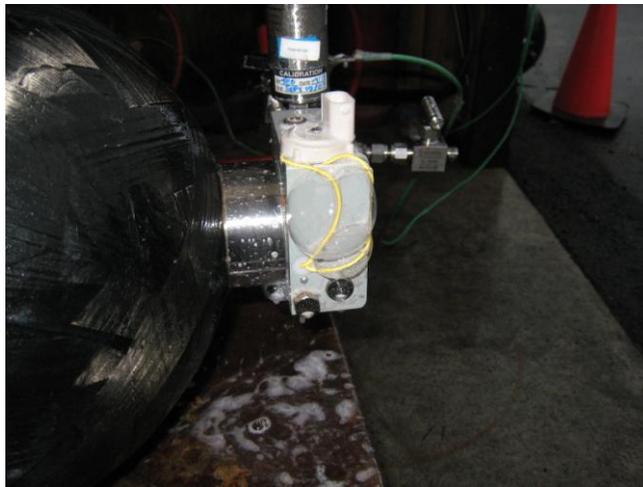
Figure 5.2.3.1: Leak at the tank valve on the 70MPa Type 3 system

During the initial cool-down to reach the starting conditions for the -40°C pneumatic cycling, leakage was noted on the hydrogen sensor installed in the test chamber. Upon further inspection, it was determined that there was external leakage from a fitting on the tank valve. The cause was likely failure of the o-ring due to extreme low temperatures. It was also noted that the leak was continuous, indicating that the valve was also leaking internally to continually supply the external leak point. The system was removed and the valve returned to the manufacturer for repair. The failure was identified as an internal seal failure. See Figure 5.2.3.1 for a photo of the leak.

The cause of both failures appears to be extreme cold temperature. The systems that failed were certified to -40°C ambient, with no mention of process temperature limitations. SAE TIR J2579 allows fuel systems with temperature control systems in place to be tested only within those temperature limits.

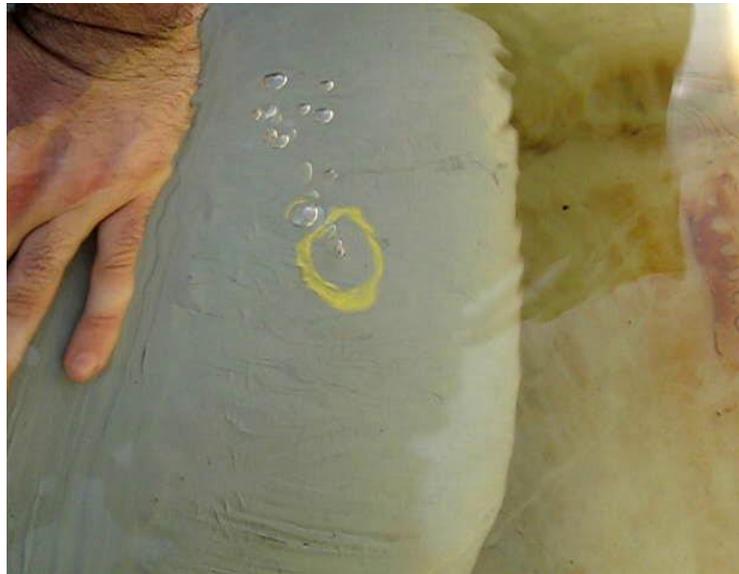
Figure 5.2.4.1: Photo of leak from 35MPa Type 4 system

The overall permeation rate of the 35MPa Type 4 system was 168 cc/hr, which is above the allowable limit. It was discovered there was a continuous stream of bubbles from a single location on the tank (see Figure 5.2.4.1). The constant stream of bubbles was determined to be of a sufficient rate to sustain a flame, indicating a failure according to the criteria of SAE TIR J2579.

The failure mode appears to have been caused due to liner damage in the back-end (end furthest from the gas inlet) on the tank. This failure mode has not been experienced in the limited service of this tank, but is realistic of future service. The manufacturer is aware of the failure.
