Measured Performance of a Low Temperature Air Source Heat Pump

R.K. Johnson

Consortium for Advanced Residential Buildings

September 2013

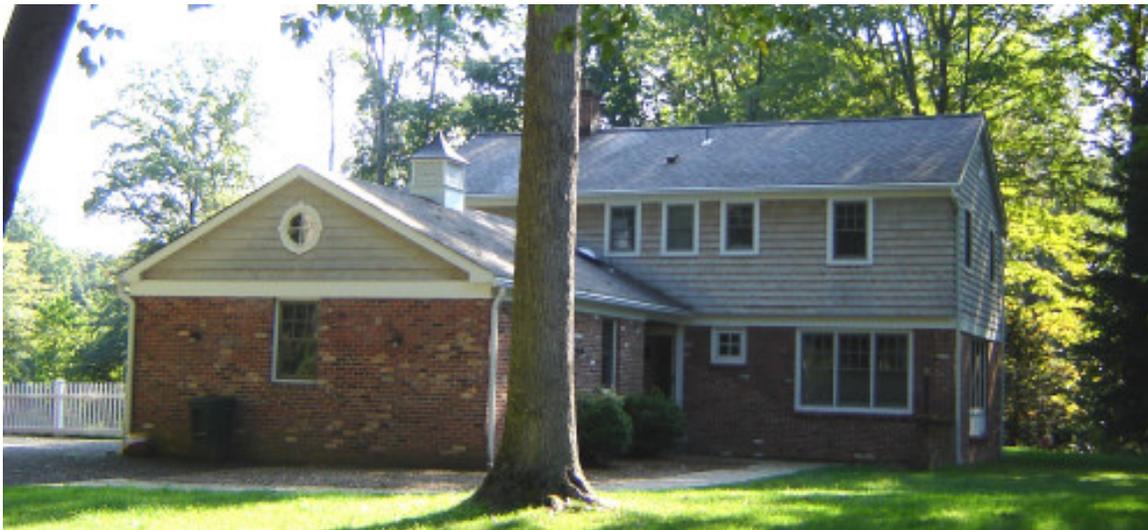
The test site is a two-story colonial style house in south-central Connecticut. The house has an attached garage and a full, unheated basement. The house was built in 1962. There are 2,010 ft² of heated floor area. Figure 1 shows the house. There is a pond at the bottom end of the backyard.

Figure 1. The test site. The heat pump is located at the back of the house.

The Acadia heat pump was installed in April 2009. The outdoor unit is located at the back of the house; the air handling unit (AHU) is in the attic.

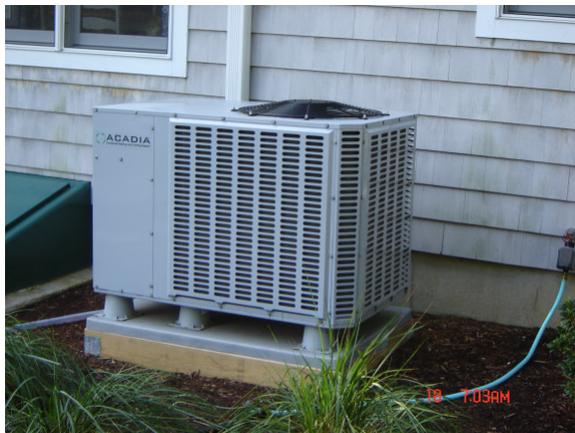
Figure 2 Acadia heat pump ODU

Figure 2 shows the ODU. This is the part of the heat pump that extracts heat energy from the outdoor air. It contains a wraparound coil, two compressors, a fan, a proprietary heat exchanger, and the system’s controls. The legs are intended to keep the ODU above snow and to allow space for defrost condensate to drain away. The legs can be as much as 2 ft longer in snowier climates.

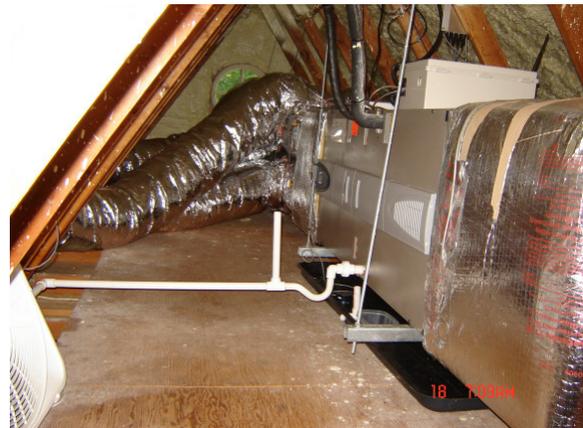
Figure 3 Acadia heat pump indoor unit

Figure 3 shows the AHU. The AHU receives hot refrigerant gas from the ODU and delivers its heat via ducts into the living spaces in the house. It contains a blower (fan), a heating coil or A-coil (named for its shape) through which hot refrigerant gas flows, and electric heater elements typically of 10–24 kW. This system uses two electric resistance coils of 5 kW and 7.5 kW for a total of 12.5 kW.

A data recorder enclosure sits atop the AHU in the white box. The horizontal white tube carries condensate from air conditioning dehumidification to the outdoors.
