Wind Turbine Generator System Safety and Function Test Report for the Ventera VT10 Wind Turbine

Technical Report
NREL/TP-5000-56586
November 2012

12 June 2012

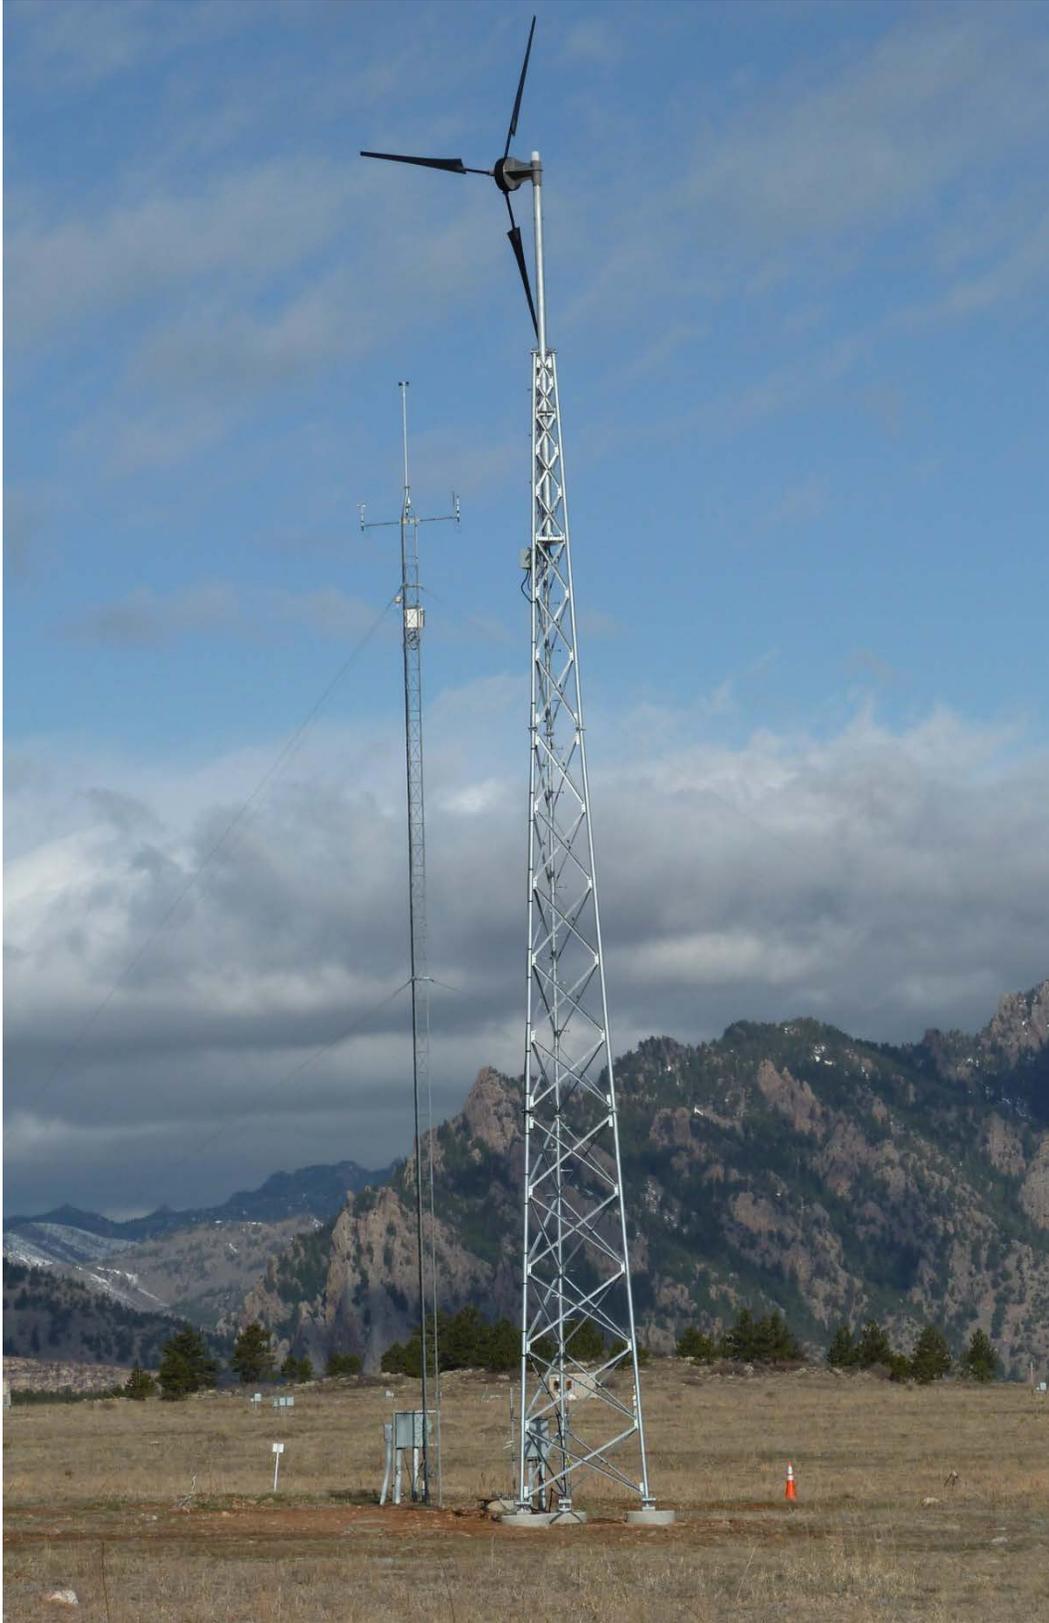
Figure 1. Ventera VT10 test turbine at the NWTC (PIX# 22251)

The test turbine was a Ventera VT10 wind turbine. The VT10 is a downwind, 3-blade, passive yaw, permanent magnet, horizontal-axis wind turbine. It is manufactured by Ventera Energy Corporation. It uses a Diversified Technology, Inc. GALE-12 inverter to deliver electrical energy to the a 60-Hz grid. To control rotor speed, each blade has a tip that begins to pitch at its rated rotor speed. It was mounted on a 60-ft Rohn SSV self-supporting lattice tower.

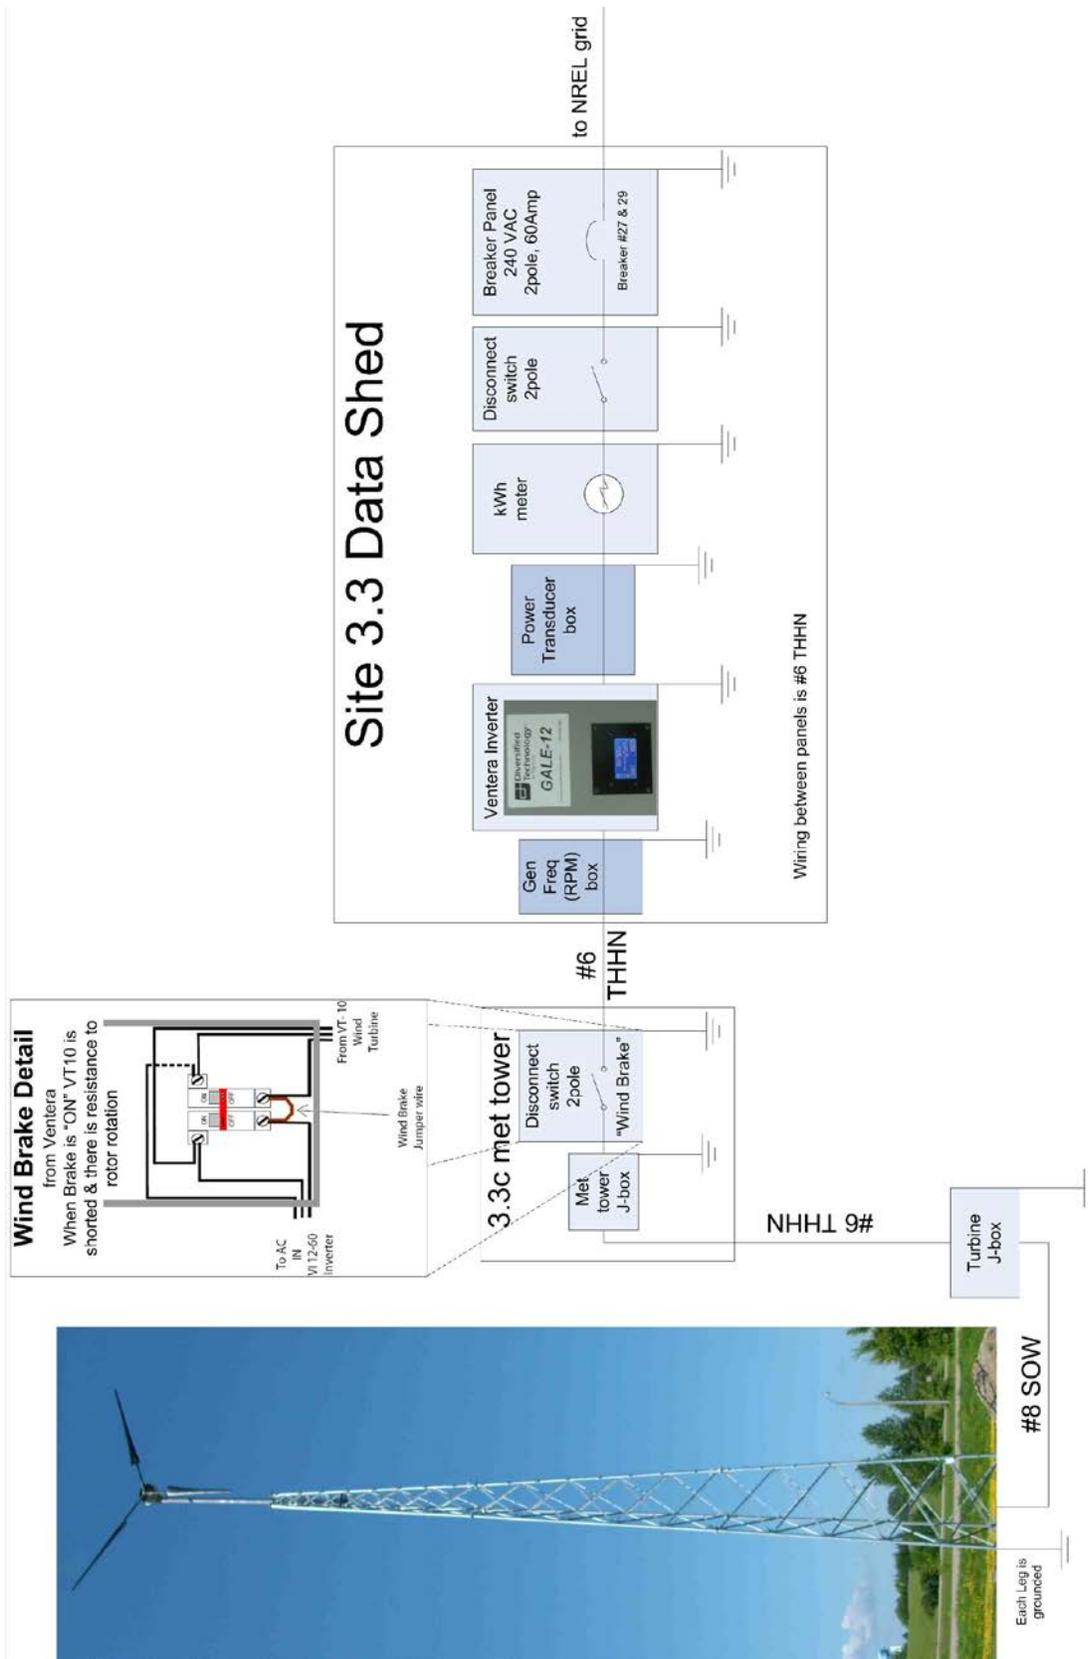
Figure 2. Electrical single-line drawing of VT10 installation

Figure 2 shows the general electrical arrangement. The wire run from the base of the tower to the met tower junction box is approximately 15 m of #6 American Wire Gauge (AWG) wire. The

wire run from the met tower junction box and wind brake¹ to the data shed is approximately 75 m of #6 AWG wire. The data shed houses the inverter, instrumentation, disconnect switch, and a breaker panel. Outside and adjacent to the data shed is a transformer that steps up the voltage to 13.2 kV for the NREL grid.

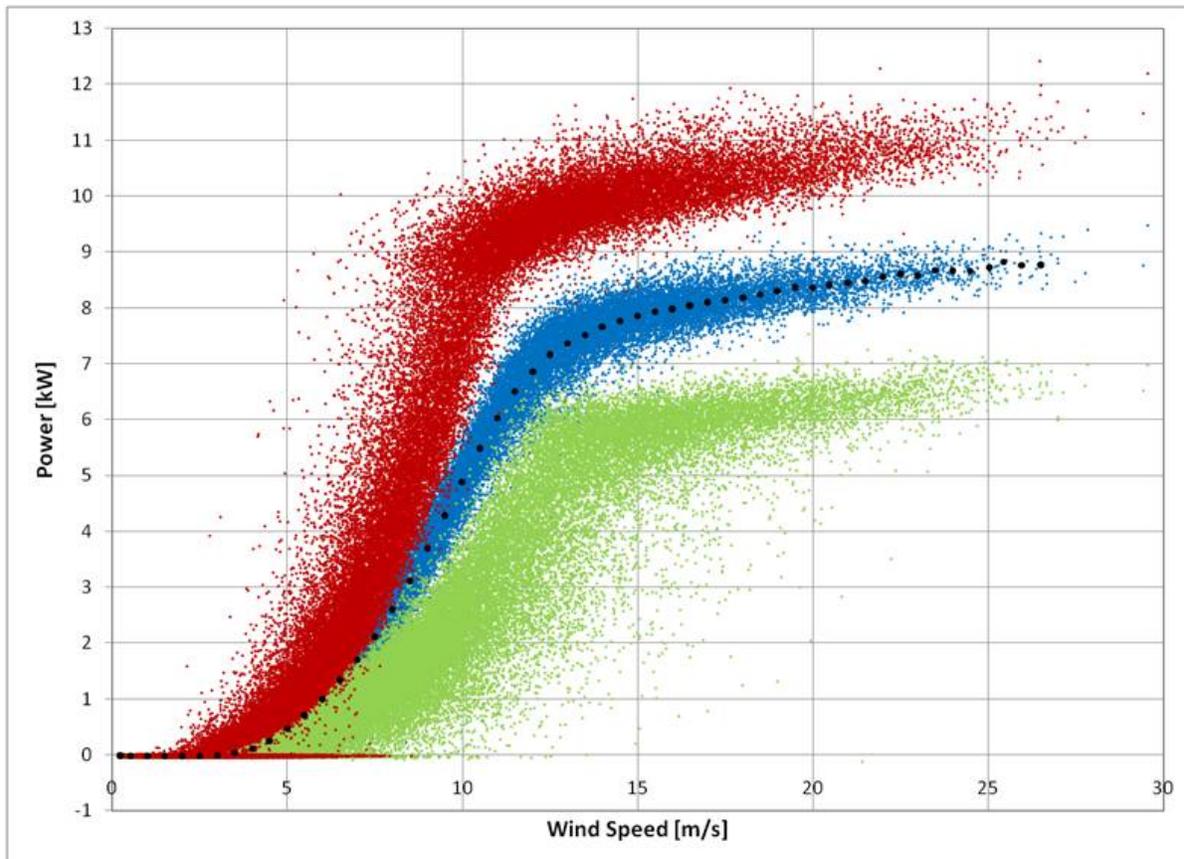
Figure 3 shows that the power output of the turbine system is regulated, however it does not reach a maximum peak, above which power would decrease in higher winds. Two methods of control are used. The inverter is programmed with a look-up table for loading the rotor and extracting more power when it is available, i.e. higher winds. If the wind contains too much power for the inverter, the rotor speed increases, and this causes each blade independently to pitch at the tip toward stall. With the blades in a stall condition, less power is extracted from the wind.

Figure 3. Power response to wind speed, 1-minute data (Red–maxima, Green–minima, Blue–average, Black–bin average)

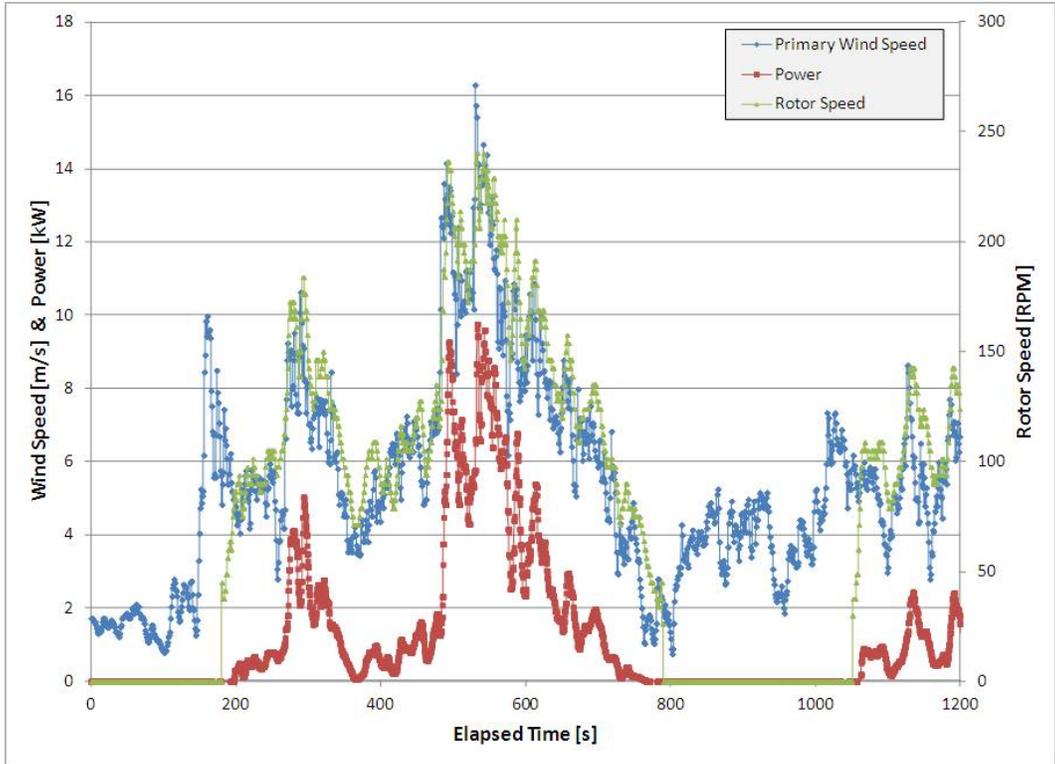
NREL observed that the turbine rotor starts spinning when winds increase to about 5.5 m/s. The inverter is always on, and when the rotor reaches approximately 60 rpm, it begins loading the generator and putting out electrical power. Figure 4 shows normal operation, including two normal startups over a period of 20 minutes. NREL has observed the turbine starting up over a wide range of wind speeds and has not observed any abnormal behavior during any of the startups. NREL observed similar smooth cut-ins when the turbine was returned to service after using the “wind brake” to stop the rotor.

Figure 4. Normal operation including startup and shutdown, 10-Hz data

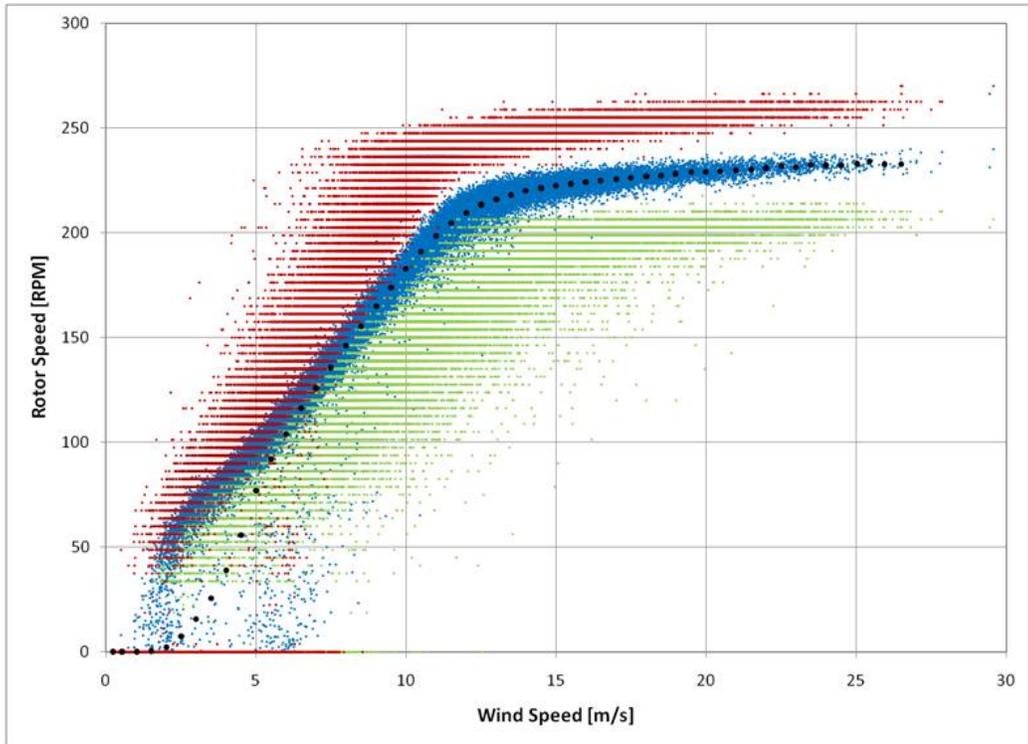
The Ventera VT10 control systems performed as designed, with the minor exception that rotor speed governing occurred at a lower speed than expected. The tests showed that in high winds the rotor speed was held between 240 and 260 rpm, whereas it was designed to hold at 260 to 280 rpm. Figure 5 shows that rotor speed was controlled in normal operation. When the turbine was loaded (inverter active, i.e., normal operation), governing occurred in wind speeds greater than approximately 13 m/s. When the turbine was unloaded (inverter stopped or off), governing occurred in wind speeds greater than 7 m/s. During unloaded conditions rotor speed was controlled entirely by mechanical blade-tip pitching. Figure 6 shows the rotor speed for loaded and unloaded conditions.

As with the power, the rotor speed is controlled; however, the data does not show a peak.

Figure 5. Rotor-speed response to wind speed, 1-minute data; (Red–maxima, Green–minima, Blue–average, Black–bin average)

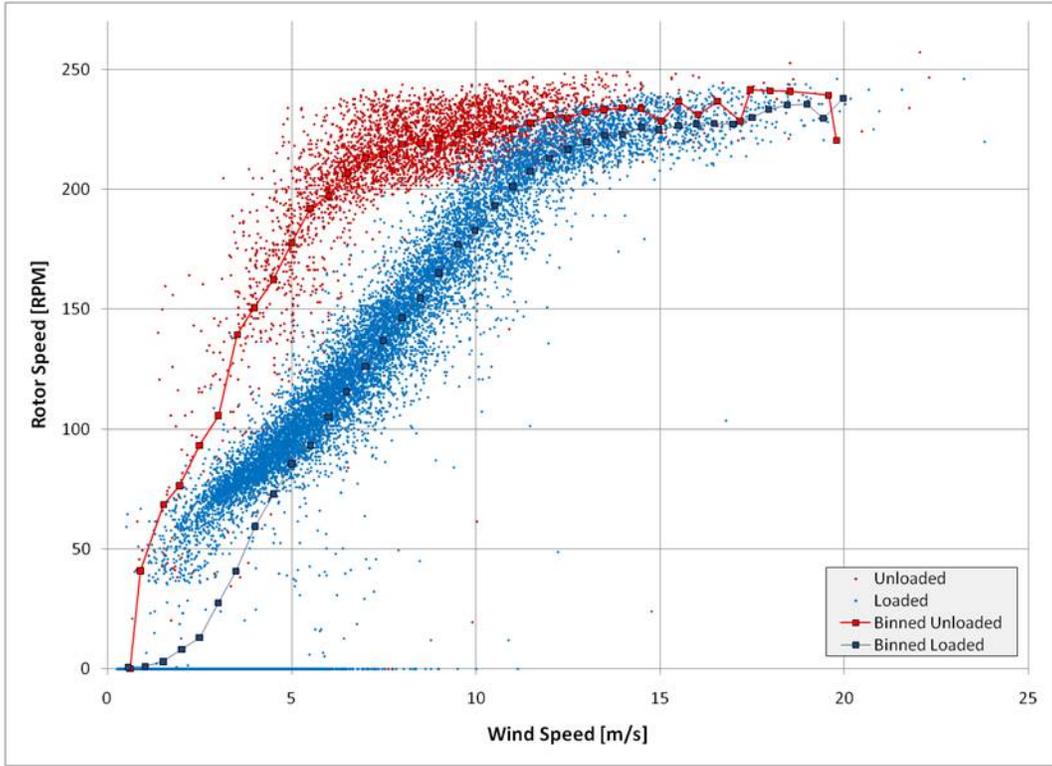
Figure 6. Rotor speed, loaded vs. unloaded, 5-second data

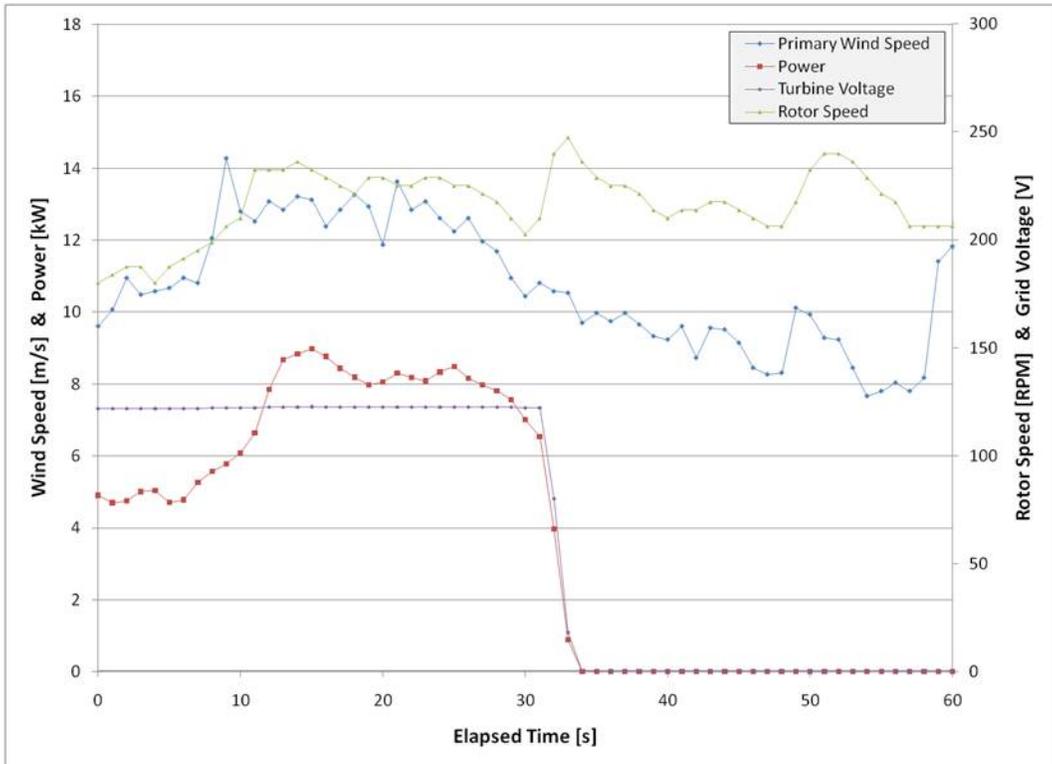
When the inverter senses a grid fault or large fluctuation, it disconnects from the grid. NREL tested for this by opening the disconnect switch between the VT10 subpanel and NREL grid. The results were as expected. In winds between 7 and 13 m/s the rotor speed increases to the mechanical governing speed. Figure 7 shows a simulated grid outage, at 1-Hz data resolution, around 10 m/s, and the rotor speed was observed to increase. In wind speeds greater than 13 m/s the rotor is already mechanically governing, so the loss of load does not affect rotor speed, as can be seen in Figure 8, again, in 1-Hz resolution.

Figure 7. Grid outage, winds near 13 m/s; (Note: Voltage measurement is only for one leg of 240-Vac connection)

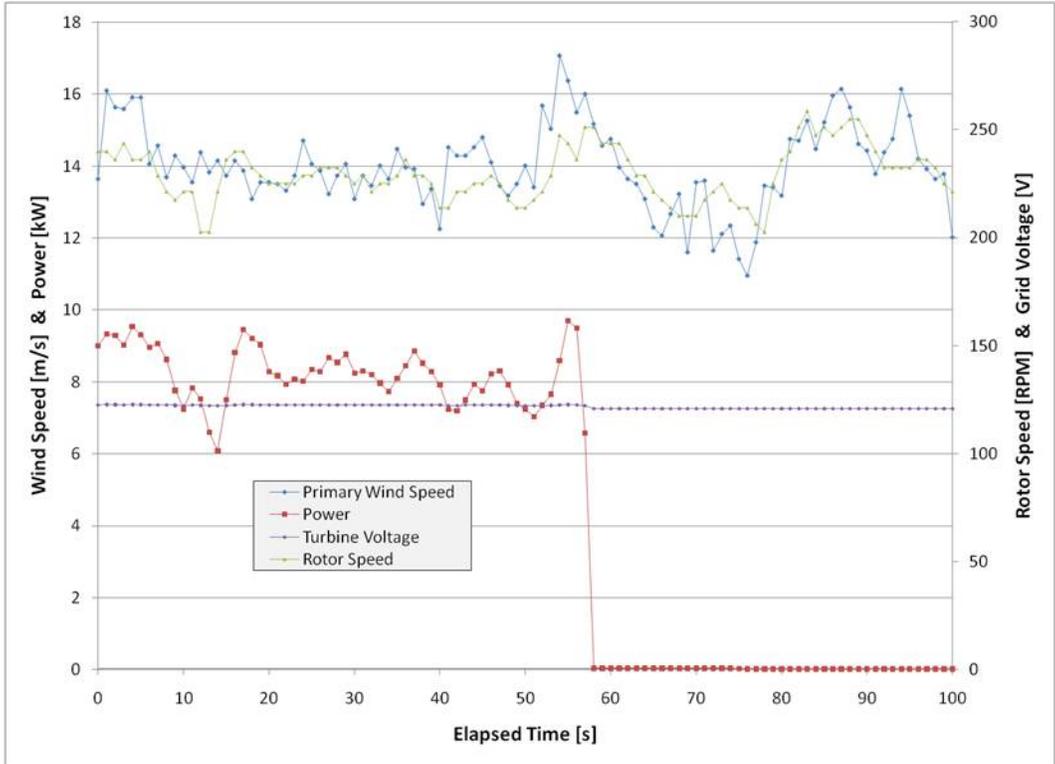
The inverter has a stop button on its LCD screen. This commands the inverter to disconnect from the turbine and grid contactors. It was observed to function as designed. This stop button applies only to the inverter, and does not stop the rotor. Figure 8 shows the effect of the inverter stop button when the inverter was operating at peak output. Because the winds were above 13 m/s the rotor was already mechanically governing, and there was no detectable difference in the rotor speed as it went into an unloaded condition.

Figure 8. Inverter stop, wind above 13 m/s; rotor speed unchanged; (Note: No increase in rotor speed when the inverter goes offline since the rotor is already regulating)

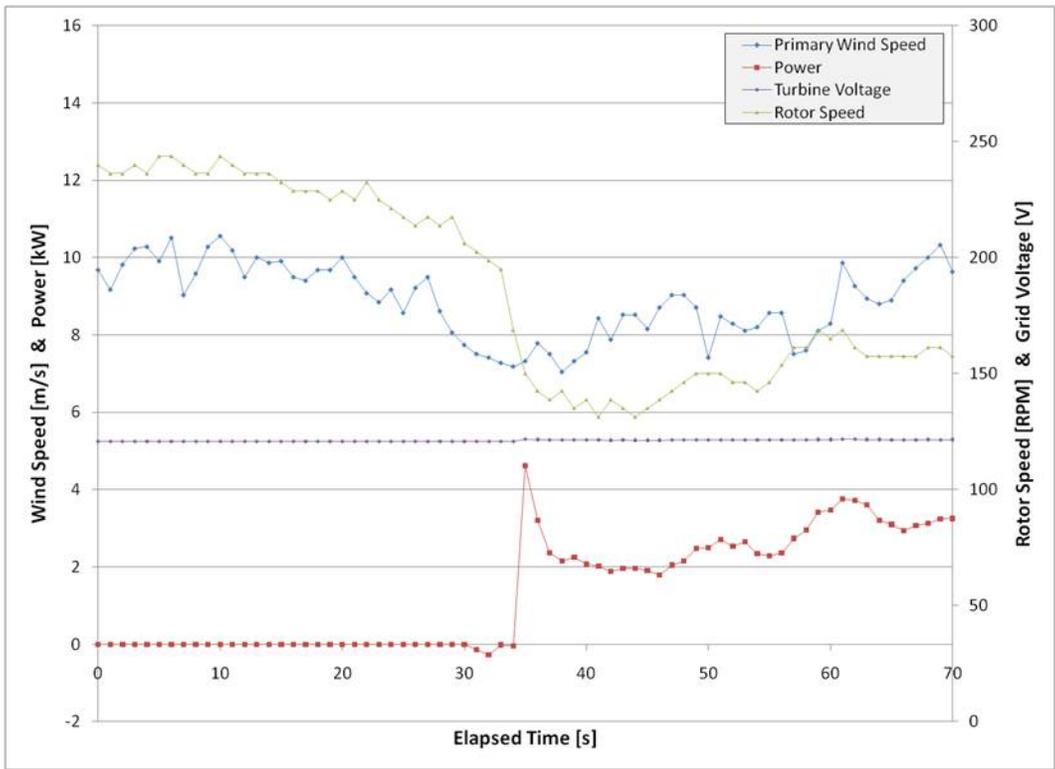
Figure 9. Inverter restart, wind below 13 m/s; rotor speed slows, 1-Hz data

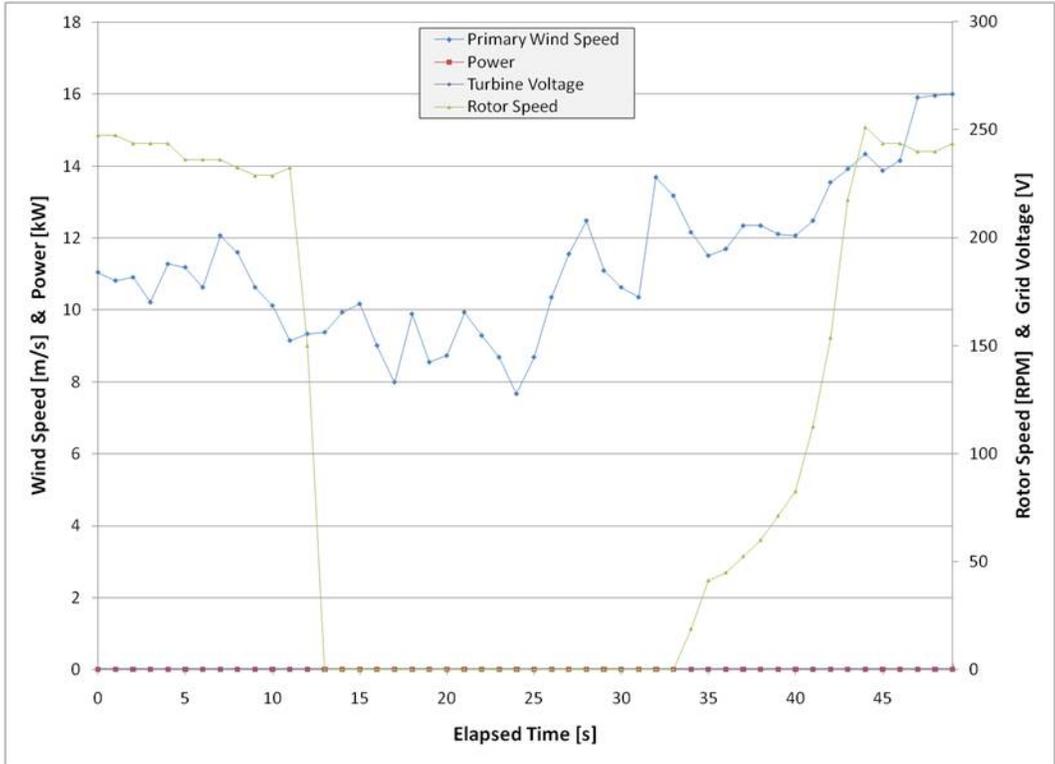
In wind speeds greater than 13 m/s the rotor cannot be stopped. In winds below 13 m/s the wind brake can be applied to bring the rotor to a stop. The wind brake shorts the 3-phase terminals of the generator, and this generates enough torque to bring the moving rotor to a stop and prevents a stopped rotor from spinning. Shorting the generator output terminals causes electrical energy to dissipate as heat inside the generator. Therefore it should not be applied for more than a few seconds at a time. NREL procedure was to apply the wind brake for no more than 10 seconds at a time, which was less than Ventera’s recommended maximum time of 1 minute. In winds below 13 m/s, application of the wind brake brings the rotor to a stop in a few seconds. Figure 10 shows the application of the wind brake in an unloaded condition (e.g., grid outage) for 15 seconds, which brought the rotor to a stop in winds around 10 m/s. (Note: The rotor speed signal in Figure 10 can be misleading. Because the rotor speed signal is measured from the wild-AC generator output, when the generator is shorted there is no signal, and the rotor appears to come to a stop in 1 second, but it was observed to take between 5 and 10 seconds to come to a stop.)

Test of the wind brake showed expected results, which were covered in loss of load and shown in Figure 10.

Figure 10. Wind brake for 15 seconds during grid outage in winds below 13 m/s, then released, 1-Hz data; (Note: The rpm signal is not available while the wind brake is applied, see section 6.1)

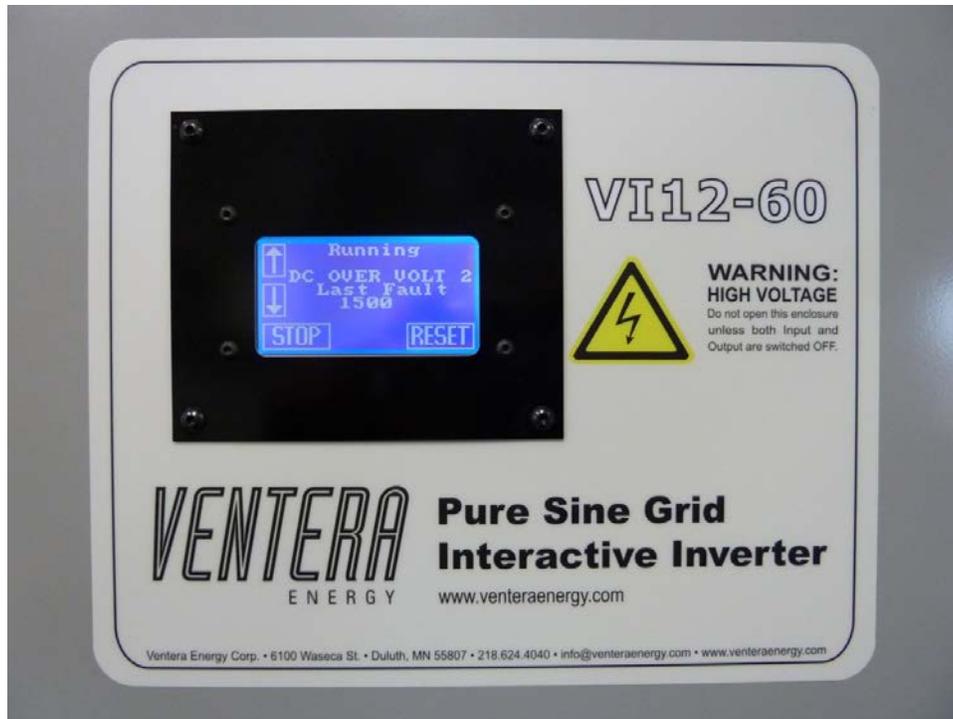
The turbine does not have an emergency stop button. It has an inverter stop button, which is shown in Figure 11. As noted previously, when the inverter is stopped, the rotor becomes unloaded, and its speed will increase to the governing speed of 240 to 260 rpm, in wind speeds greater than 7 m/s.

1. There is a warning not to open the inverter “enclosure unless input and output switches are off,” see Figure 11.
2. NREL added labels indicating the voltage levels on all enclosures, electrical panels, and disconnects, see Figure 12.

Figure 11. Inverter front panel, showing a “STOP” button on the touch screen display (PIX# 22252)

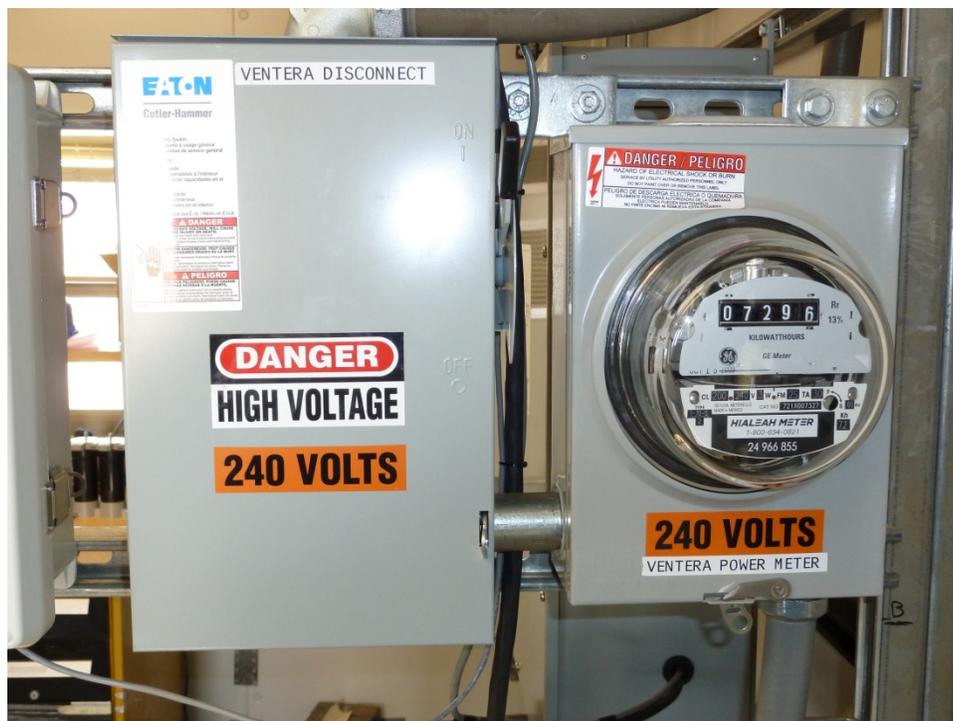
Ventura provided a lockable disconnect switch between the grid and the inverter. The electrical disconnect is shown in Figure 12.

Figure 12. VT10 lockable disconnect switch and power meter, both provided by Ventera (PIX# 22253)

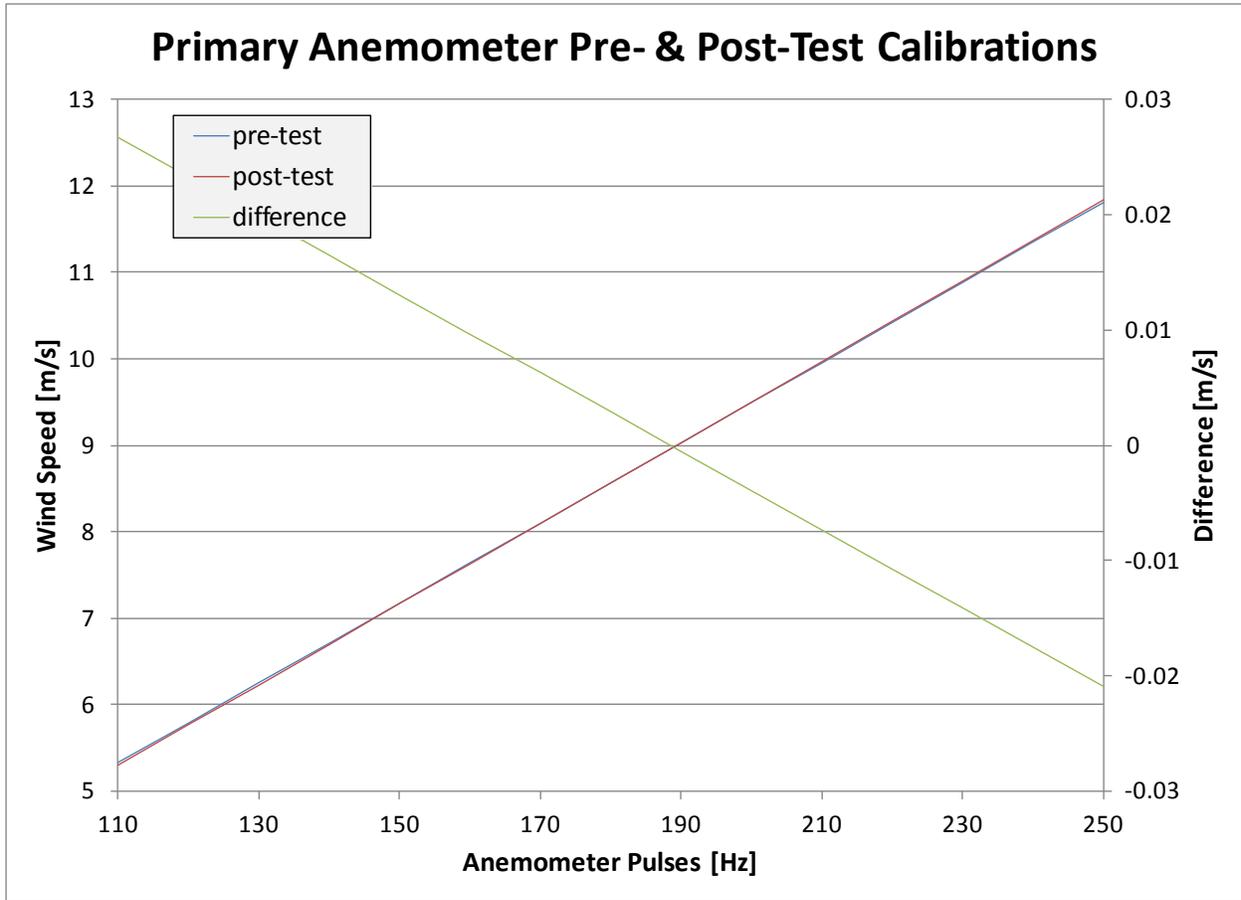
The anemometer was post-test calibrated and found to have held its calibration for the test period, within 0.02 m/s for the range of 6 to 12 m/s. The calibration sheets and analysis results are shown in Appendix A.

Figure A.3. Primary anemometer pre-test and post-test calibration comparison; the difference is less than 0.1 m/s for the range of 6 to 12 m/s

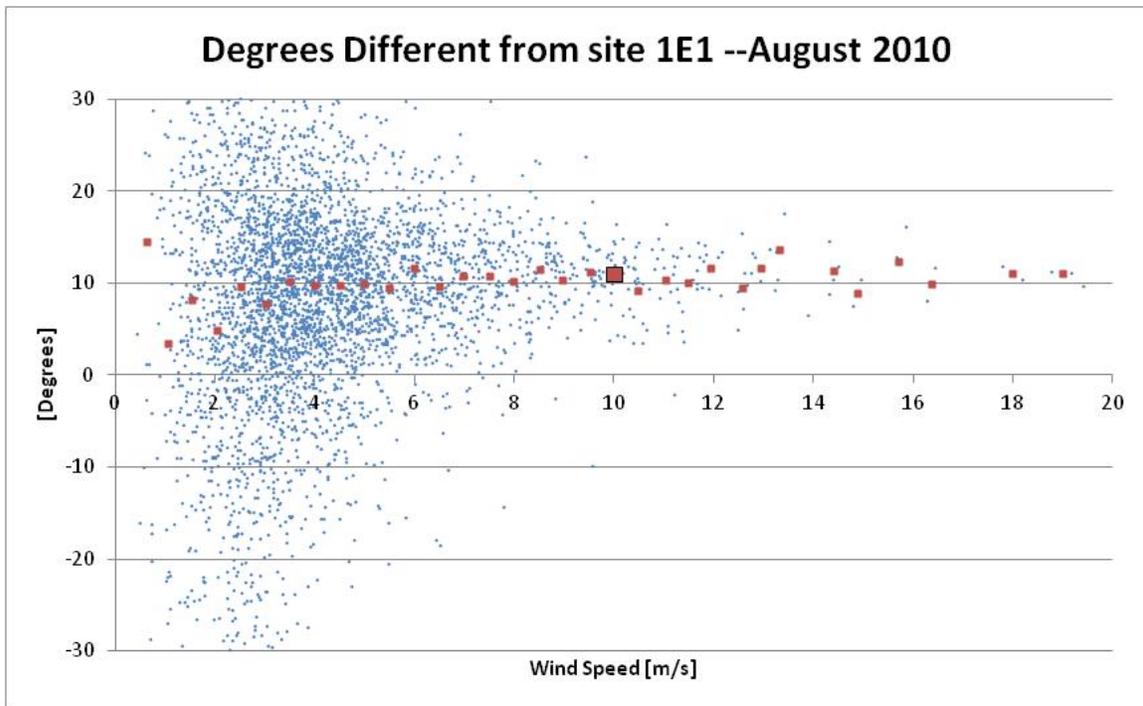
The wind vane was slightly damaged during high winds during the final days of October 2010; it was repaired on 1 November 2010. Comparisons with other wind vanes at the NWTC show that the vane's performance was consistent before and after damage and repair. Additional comparisons show that the repaired vane was consistent with a neighboring test site's measurements until the end of the test. Results of these in situ comparisons are in Appendix A.

Figure A.7. Wind vane in situ comparison with NWTC site 1E1, August 2010. (+10.9° at 10m/s)

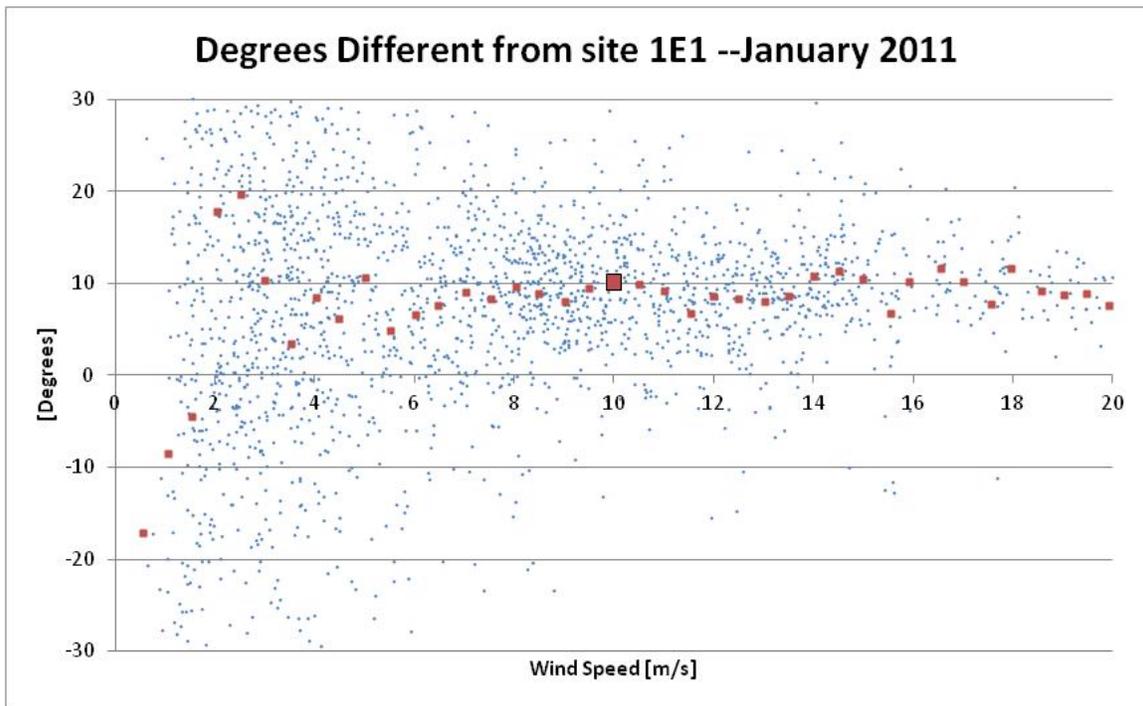
Figure A.8. Wind vane in situ comparison with NWTC site 1E1, January 2011. (+10.1° at 10m/s)

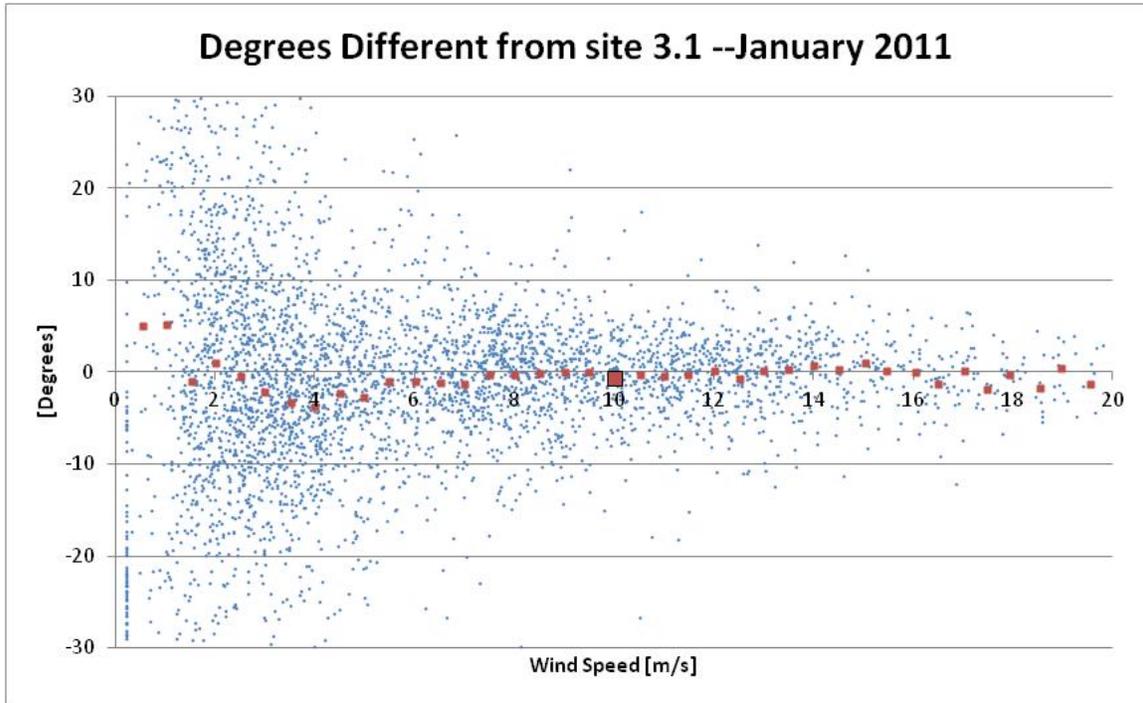
Figure A.9. Wind vane in situ comparison with NWTC site 3.1, January 2011. (-0.7° at 10m/s)

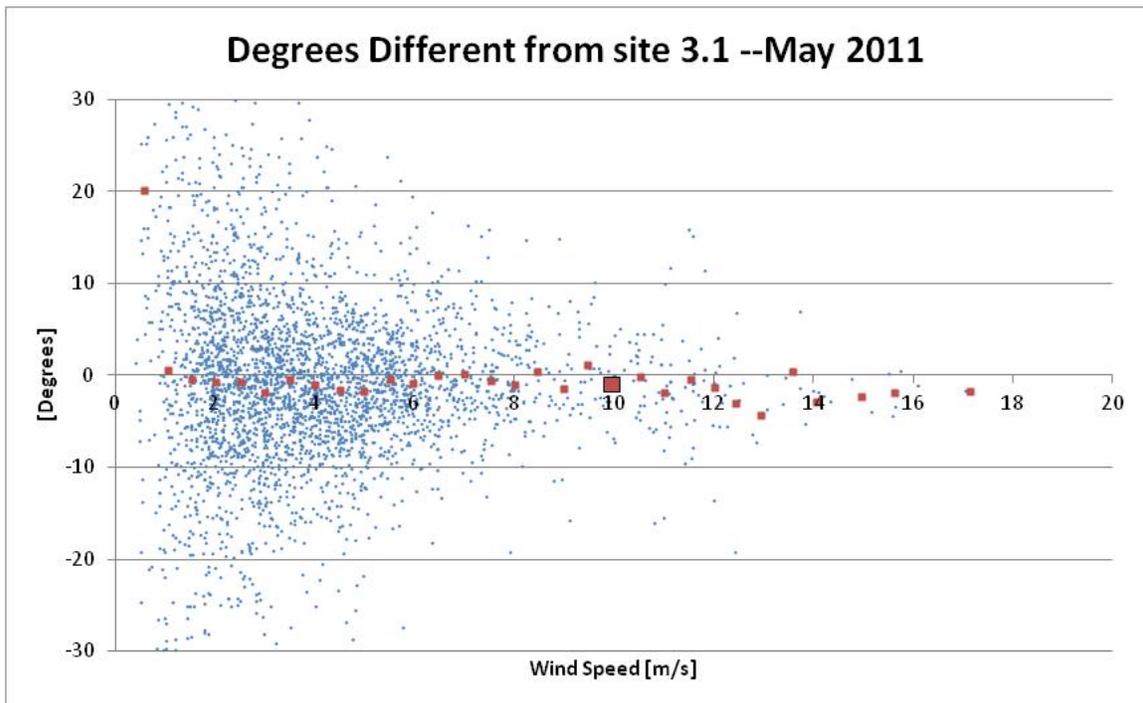
Figure A.10. Wind vane in situ comparison with NWTC site 3.1, May 2011. (-1.0° at 10m/s)
