# Safety and Function Test Report for the SWIFT Wind Turbine

**Technical Report**  
NREL/TP-5000-57125  
January 2013

**Safety and Function Test Report**  
**for the**  
**SWIFT Wind Turbine**

**Cascade Engineering**  
**4855 Thirty-Seventh St. SE**  
**Grand Rapids, MI 49512**

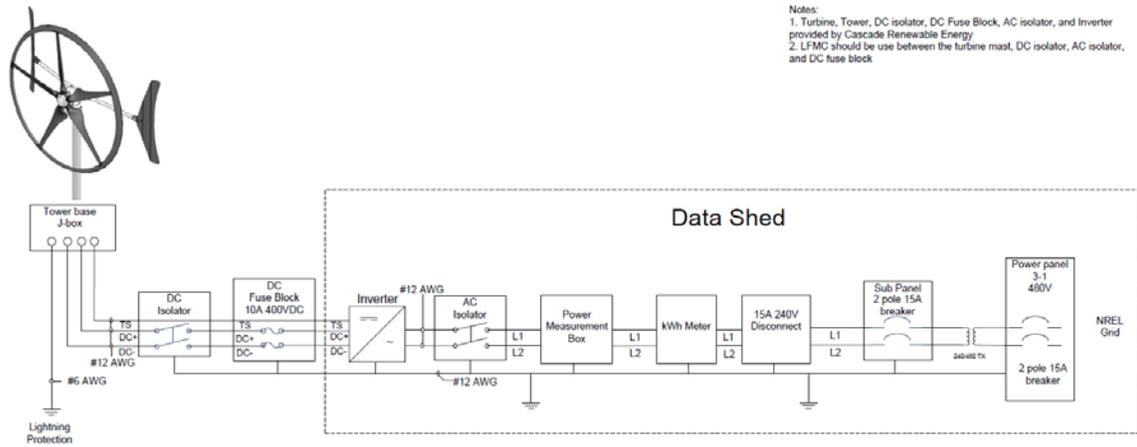
**Figure 2: Electrical single-line drawing of SWIFT installation (NREL 2012)**

Figure 2 shows the general electrical arrangement. The wire run from the nacelle at the top of the tower to the point of grid connection at the data shed was approximately 46 meters. The connection was made using #12 American Wire Gauge (AWG) wire for the two power lines and turbine signal, and #6 AWG for ground. The data shed housed the inverter, power instrumentation, disconnect switch, and data acquisition system. The 240 VAC power output from the turbine was connected to a series of insulating step-up transformers that raised the voltage to 13.2 kilovolts, allowing the system to tie to the NWTC grid.

The turbine was not equipped with a dedicated emergency stop button. The AC or DC disconnect rotary switches were used to turn off the turbine in case of an emergency (see Figure 10 and Figure 11). Turning any of the rotary switches to the off position immediately disconnected the turbine from the grid and applied the dynamic break by shorting the generator, decreasing the rotor speed to less than 16 RPM in about 9 seconds under any wind conditions. This behavior was consistent with the manual's statement that the system could be shut down at any wind speed. The turbine behavior during the activation of the AC isolation switch can be seen in Figure 6 during the mimic outage performed by NREL. Once the isolator was turned to the off position, the voltage immediately dropped to zero. The grid voltage monitoring also provided another source of turbine availability. The primary source of the availability was based on a controller voltage signal. The signal triggered the dynamic break relay that shorted the generator. Figure 12 illustrates the turbine behavior during the activation of the DC isolation switch. The dynamic break signal had a high reading (5 V) in the DC isolation exercise because the DC isolation switch was hooked up directly to the turbine as seen in Figure 2.

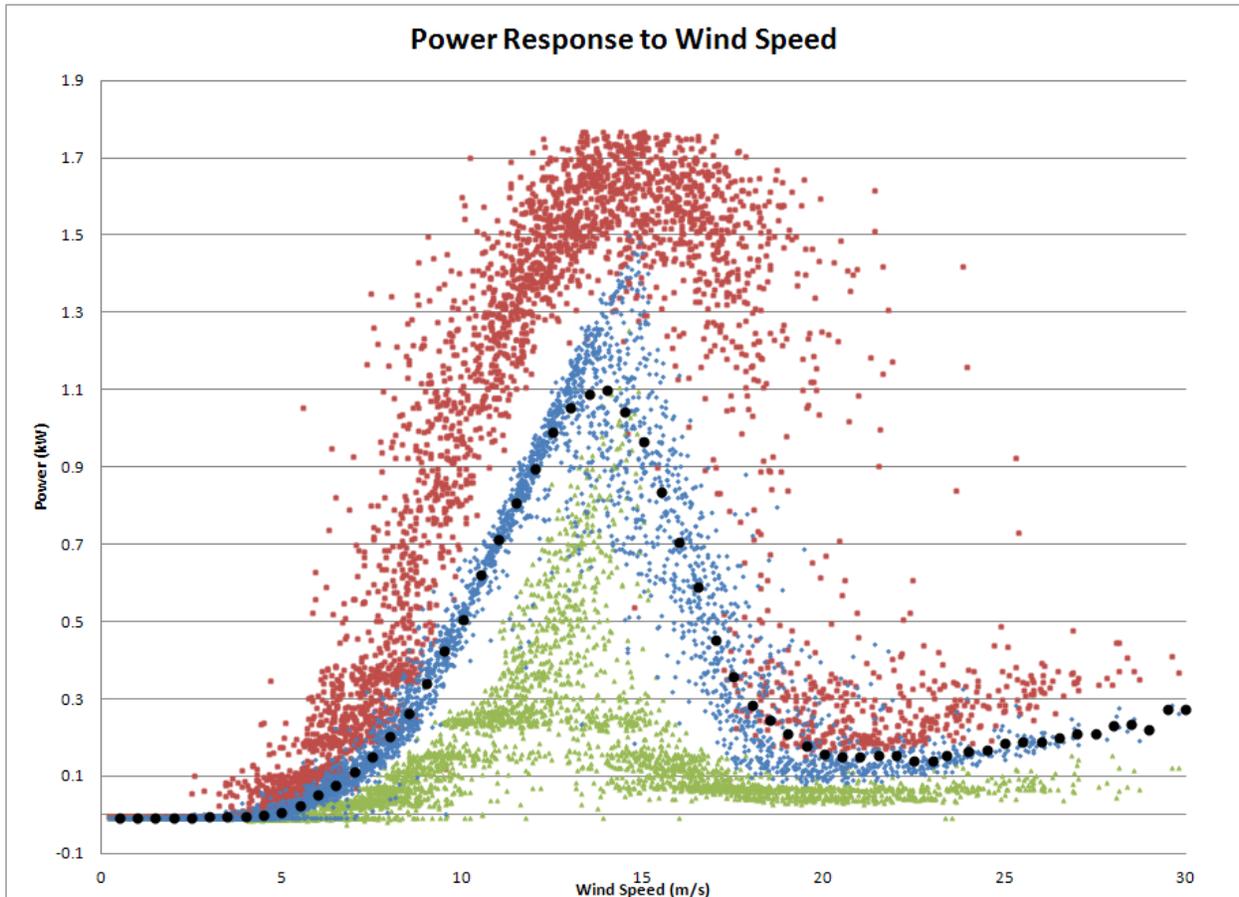
**Figure 3: Power response to wind speed, 1-min data  
(red–maxima, green–minima, blue–average, black–bin average)**

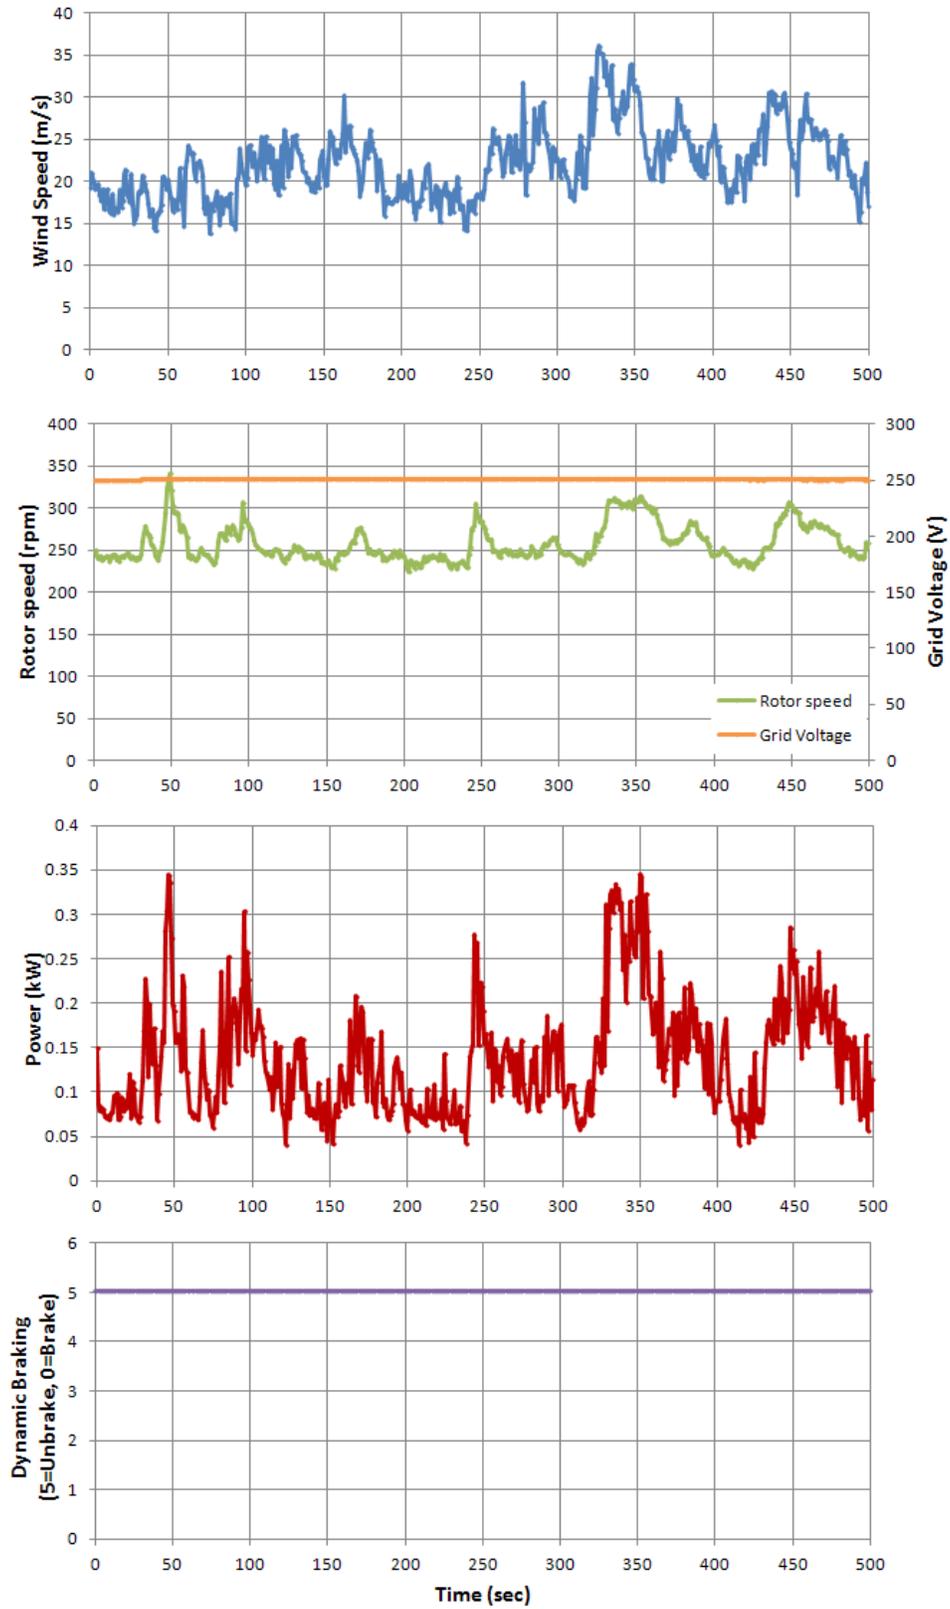
**Figure 4: Turbine response during a high-wind event**

A high-wind event and variable wind direction was observed on 16 December 2010 that caused excessive vibration, forcing the turbine to lock down. The turbine immediately disconnected from the grid and applied its dynamic break bringing the rotor to a safe idling speed. The turbine had to be manually reset in order to fully return to a normal operational state, indicating it had locked out for excessive vibration as stated in the owner's manual. The turbine controller did not show any indication when the turbine locked down. The owner's manual instructed the user to observe if there was no change in rotor speed at power-producing wind speeds, thus indicating a lock up. Subsequently, the user was instructed to perform a turbine reset in order to bring the turbine back to normal operation.

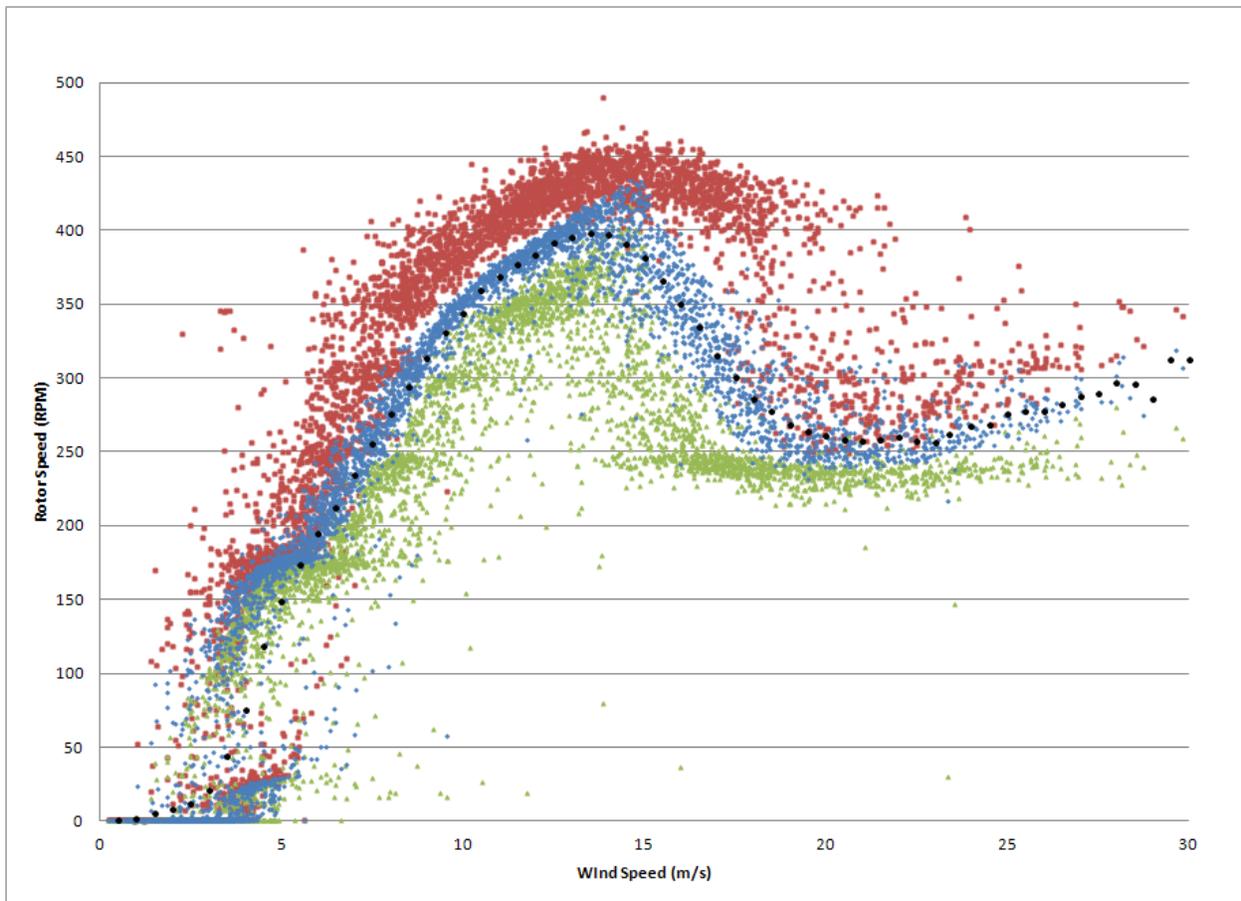
Rotor speed measurements were taken in January 2012. Figure 5 illustrates how the rotor speed was regulated by the furling system starting at around 10 m/s. The Figure 5 scatter plot also contains the wind speed bin average, 1-minute average, and 1-second maximum and minimum rotor speeds. The rotor average speed always stayed below its operating range maximum of 450 RPMs. The dynamic brake was automatically applied if the rotor speed exceeded the instantaneous safe operating level of 480 RPMs. On 5 January 2012 a high RPM event was recorded, as seen in Figure 5. *As noted in the log book: "The rotor reached a maximum of 489 RPM then immediately applied the break, reducing the rotor speed back to 80 RPMs in 5 seconds."* Figure 4 illustrates a time series of the turbine behavior and how the rotor speed was regulated during a high-wind event. When the turbine was turned off, or experienced a fault or a grid outage, the rotor speed reduced to an idling speed less than 16 RPMs. The idling speed was verified to stay below 16 RPMs even at high-wind speed as seen in Figure 6. Extra precaution needed to be taken when approaching the rotor because it did not stop.

**Figure 5: Rotor speed as a function of wind speed, 1-min data (red–maxima, green–minima, blue–average, black–bin average)**

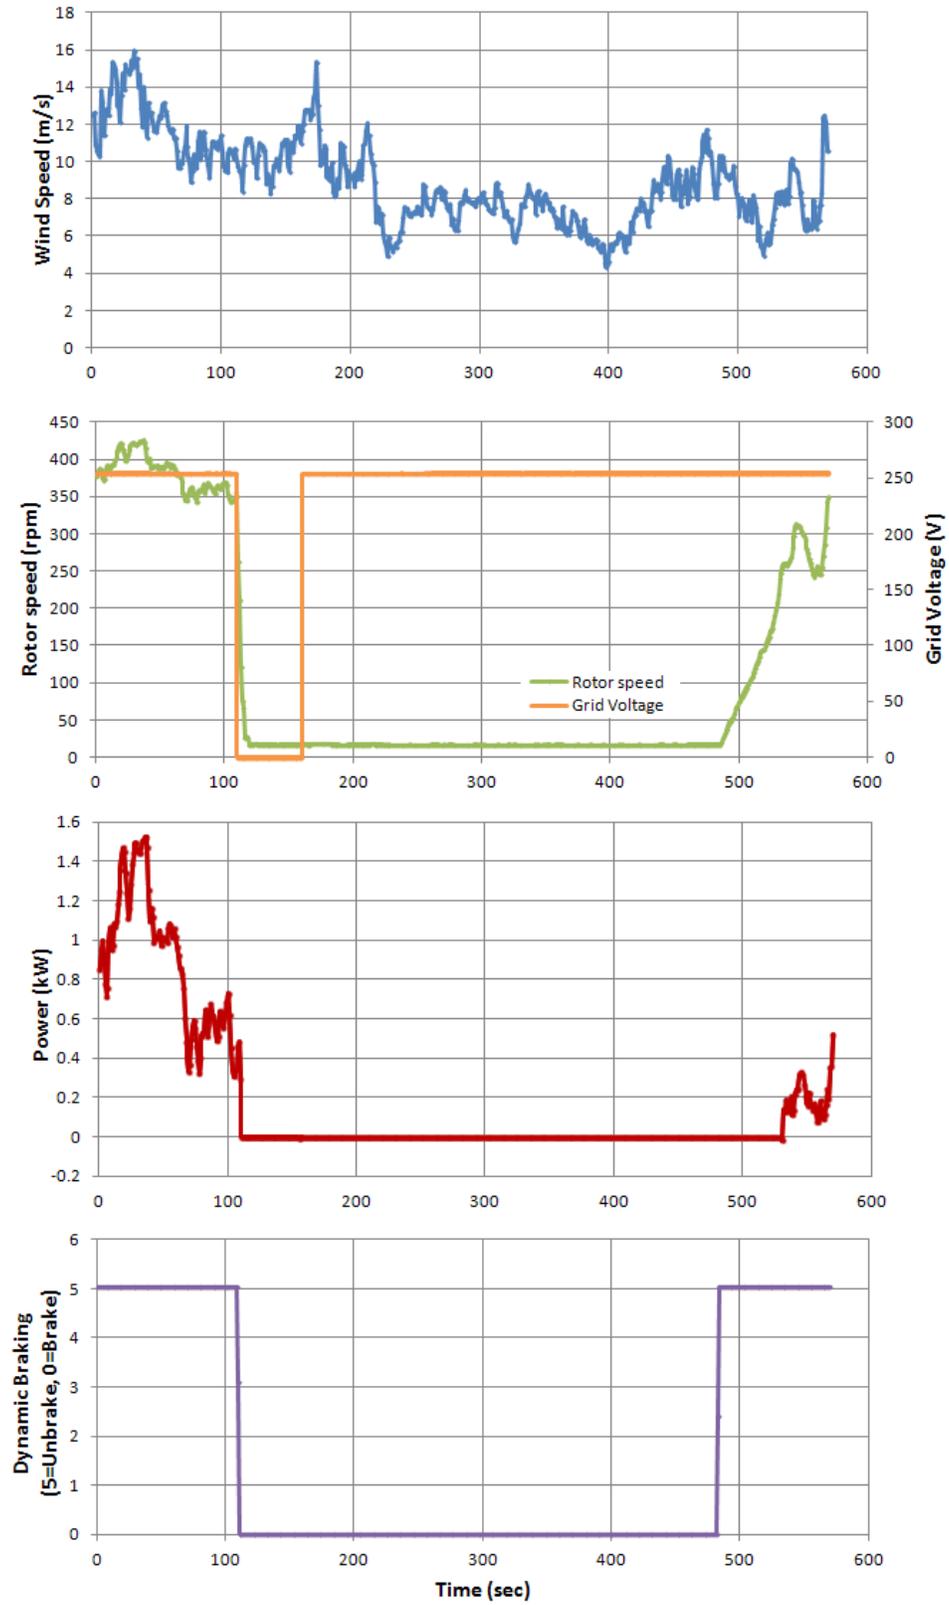
**Figure 6: Turbine response during a simulated grid outage**

In the event of a grid outage or large fluctuations, the SWIFT immediately disconnected from the grid in order to prevent any electric hazards. The controller shorted the generator, reducing the

rotor speed to an idling speed less than 16 RPMs in about 9 seconds. After the grid voltage was reestablished, the turbine inverter performed an internal check that lasted about six minutes. After this check passed, the turbine rotor started to ramp up, depending on wind conditions, and to automatically reconnect and resume normal operation. The turbine inverter was programmed to perform similar daily internal checks, which caused the system to go offline independent of wind conditions.

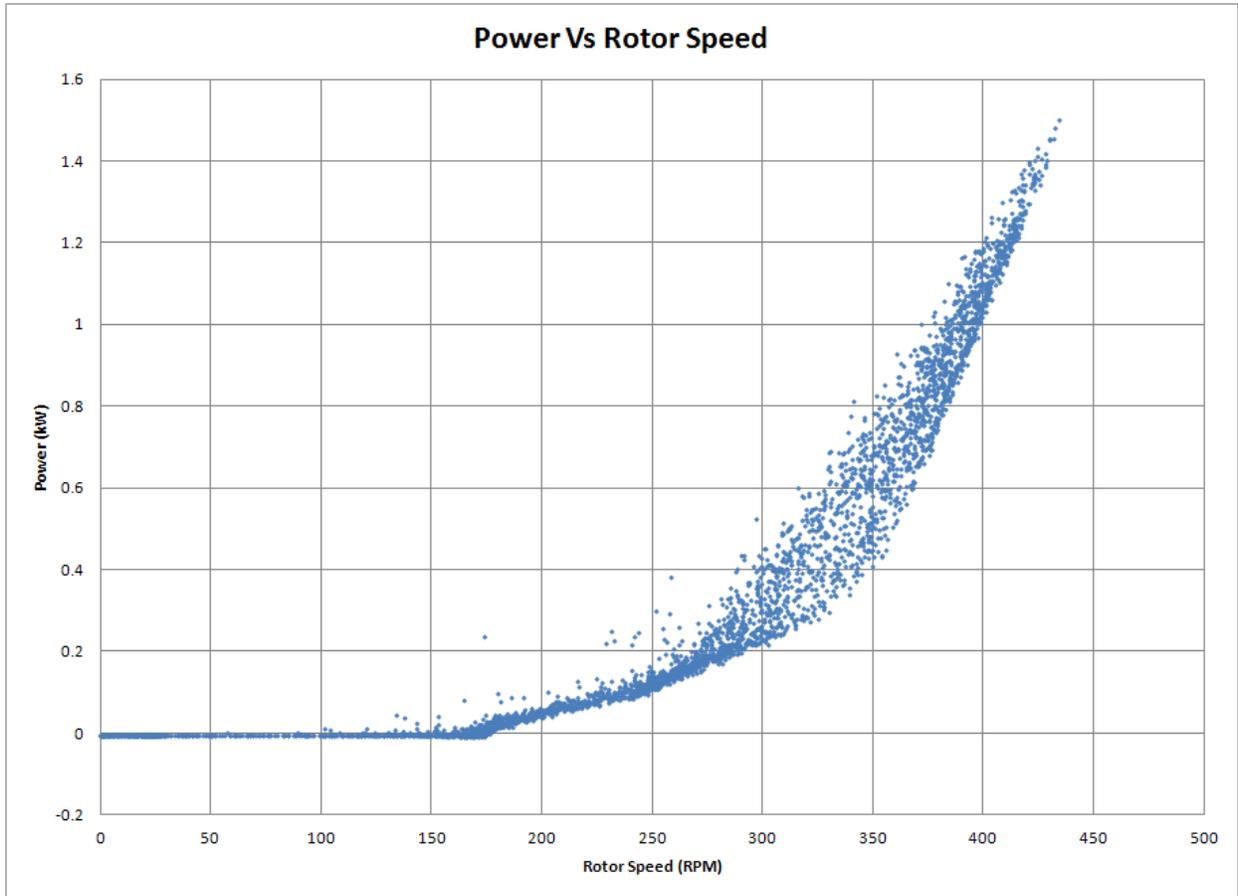
(about 170 RPMs). This coupling rotor speed could be achieved at winds averaging 5 m/s. Figure 7 shows the rotor speed versus power production. Figure 8 illustrates a time series of the turbine behavior as the wind increased above cut-in. NREL did not observe any abnormal behavior during any of the startups. NREL observed similar smooth cut-in transitions when the turbine was returned to service after shutdown or a fault had been cleared.

**Figure 7: Power as a function of rotor speed**

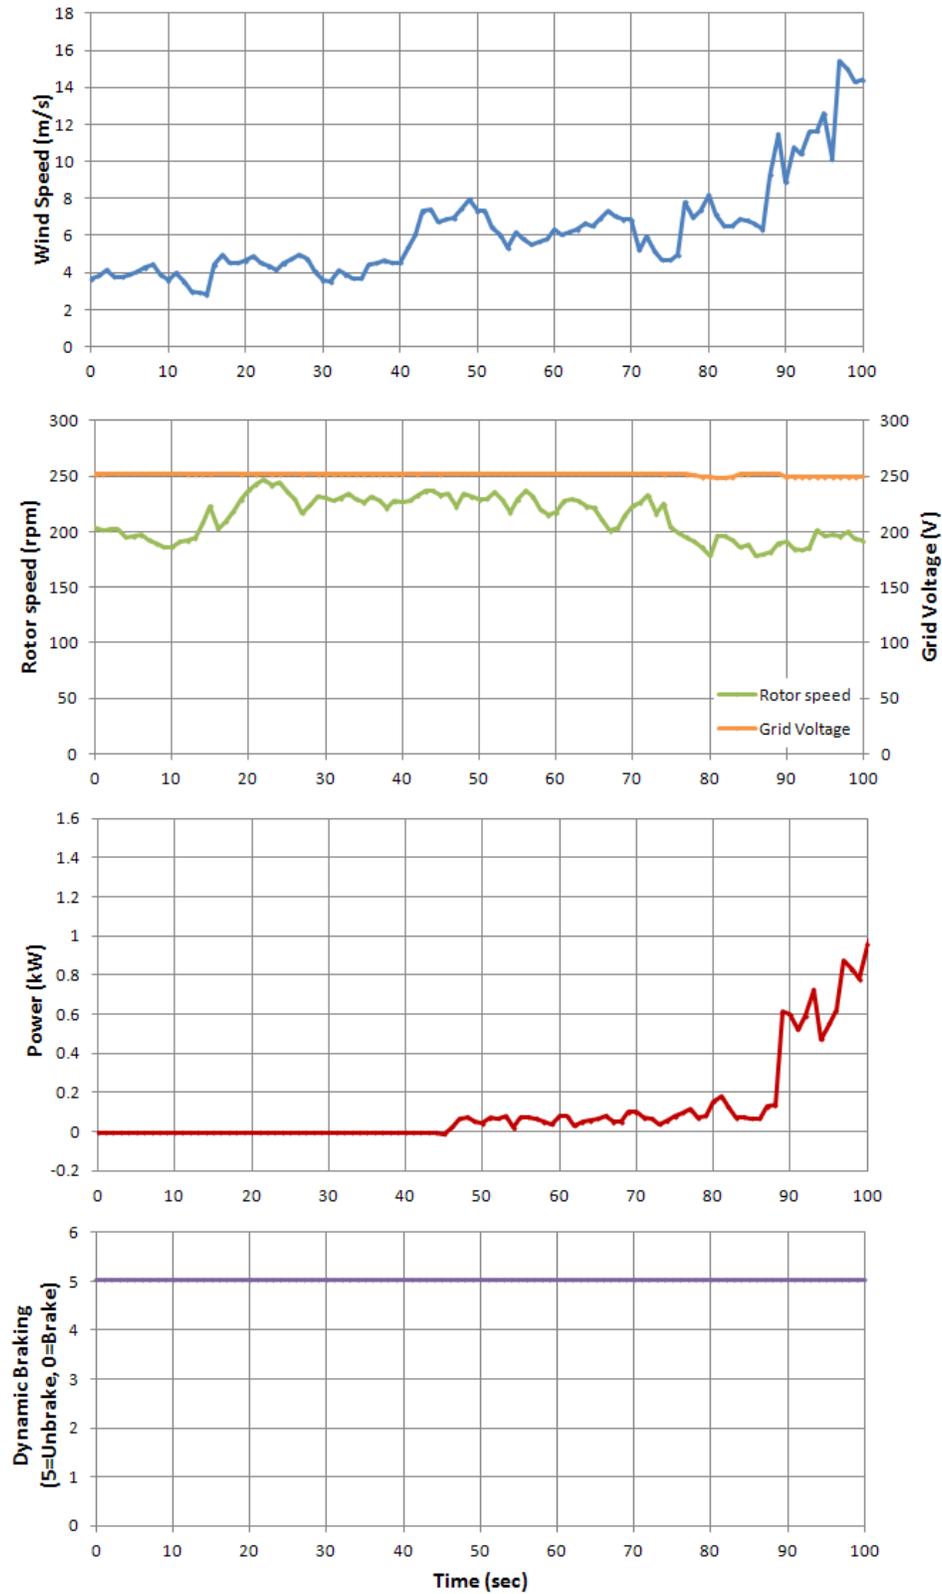
Figure 8: Normal startup in wind speeds increasing beyond cut-in

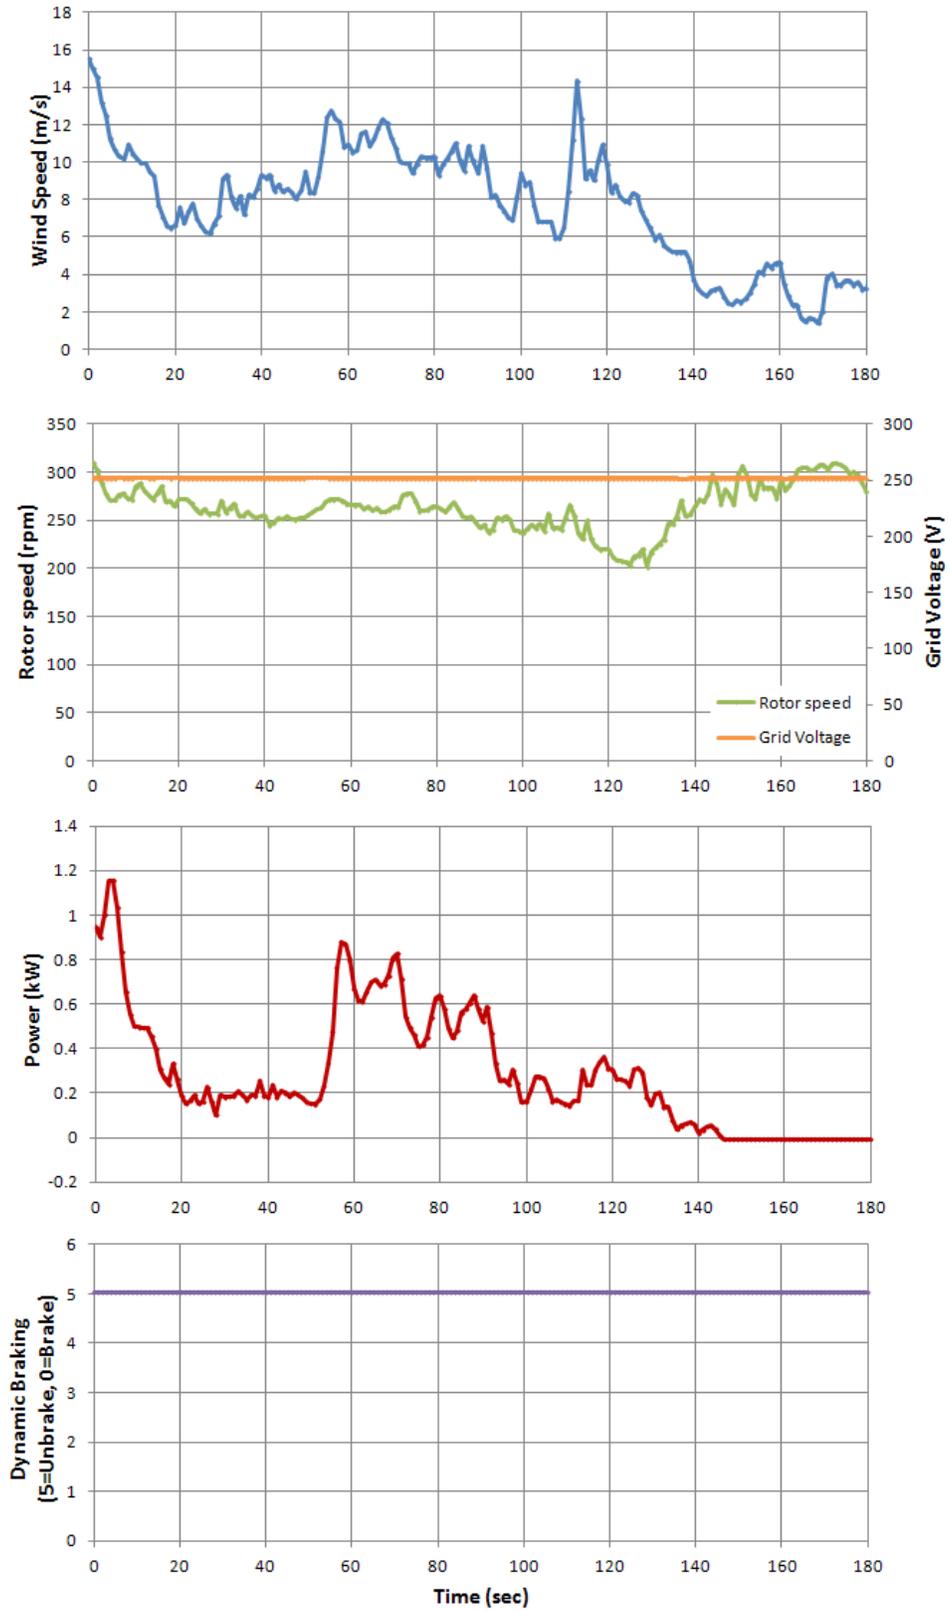
**Figure 9: Normal shutdown in wind speeds decreasing below cut-in**

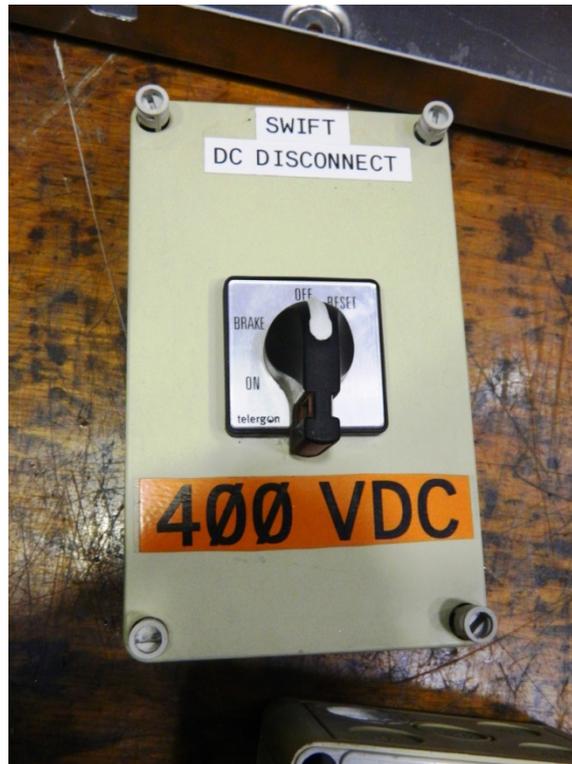
**Figure 10: DC isolation switch**  
Source: NREL 2012

- Disengage the load and/or energy sources: The turbine was equipped with a DC and AC isolation switch to remove the turbine from the grid. The owner’s manual described how to disconnect the inverter from either the DC or AC supply.
- Stop and secure the rotor: NREL found an explanation on how to slow down the rotor but no provision was found on how to stop it completely.
- Stop and secure the yaw mechanism: The turbine had no provisions for securing the yaw mechanism.
- Stop and secure the furling system: The turbine had no provisions for securing the furling mechanism.
- Climb tower: The turbine was not equipped with a ladder or other means of climbing the tower.

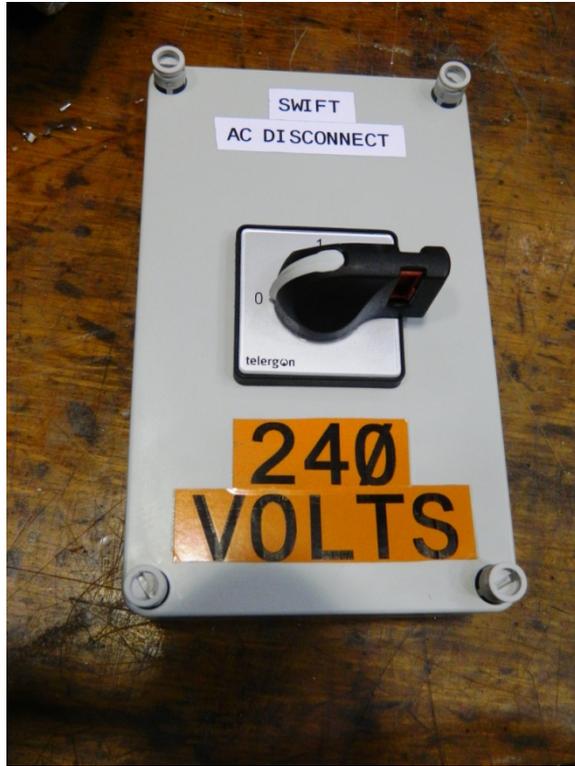
**Figure 11: AC isolation switch**  
Source: NREL 2012

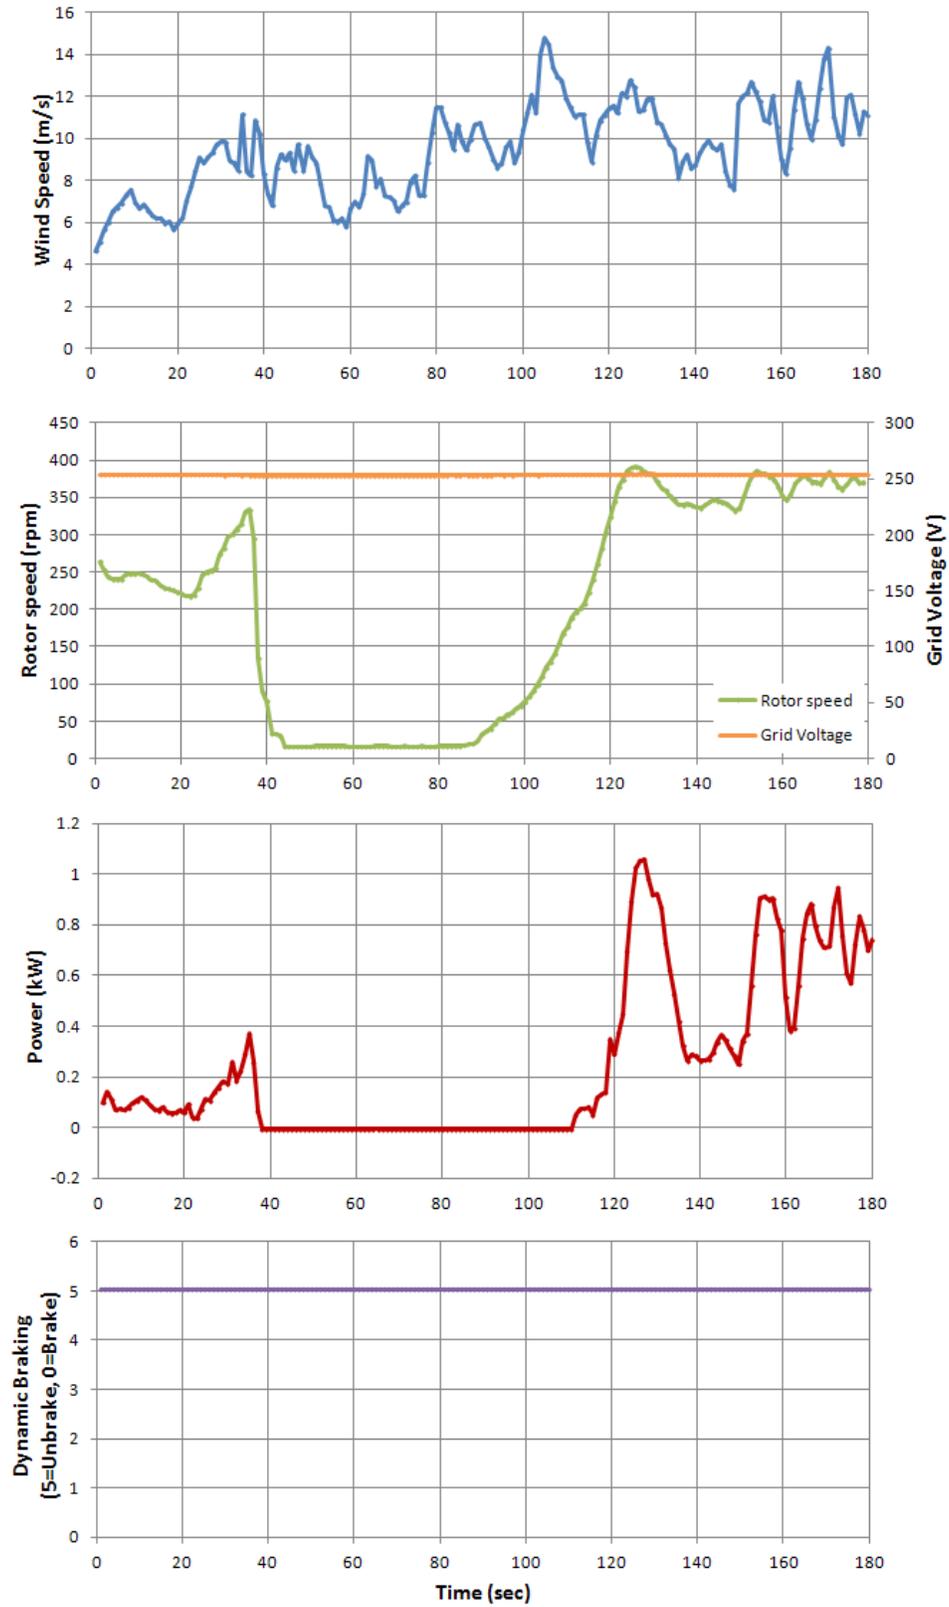
**Figure 12: Turbine response during the application of the DC isolation**

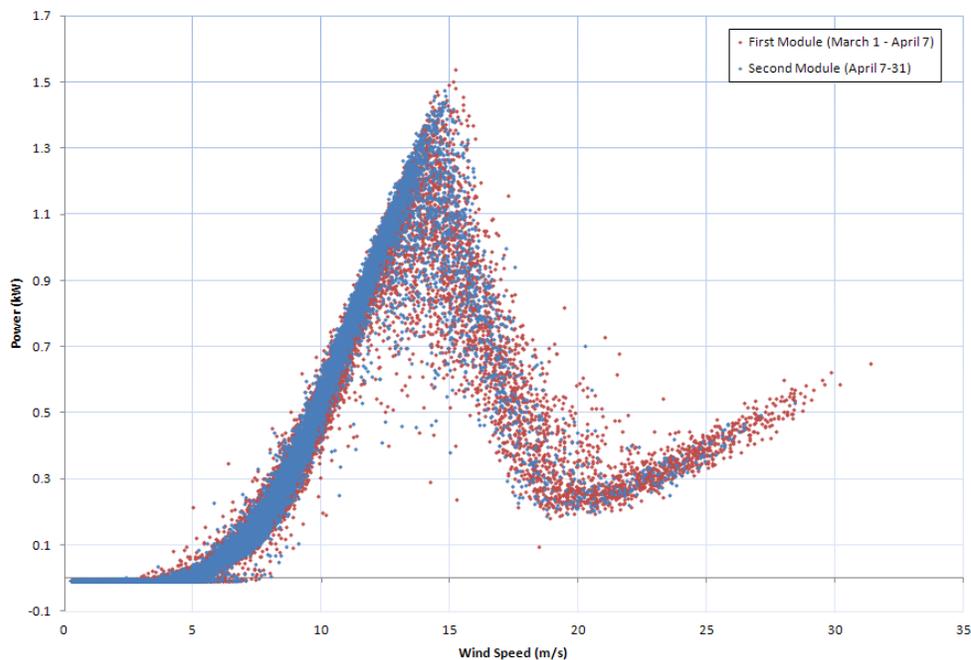
**Figure 13: Power vs. wind speed scatter plot comparison (1- min average)**

The DAS modules, power transducer, and primary wind speed anemometer were used beyond the calibration due dates. The initial power-measuring module failed its post-test calibration. The calibration agency reported that no signal output could be read for that channel as specified in the post-calibration report. An investigation was performed on the data acquired but there were no indications that the module failed during the test. The power reading versus wind speed relationship between both modules stayed consistent throughout the test, as seen in Figure 13. When the module was returned from calibration, some loose parts could be heard that were not present previously. It was concluded that damage may have occurred during shipping. The power transducer and anemometer were found to be in compliance within the Standard specifications. The calibration sheets of the post-test calibrations are included in Appendix A.
