# Duration Test Report for the SWIFT Wind Turbine

I. Mendoza and J. Hur  
*National Renewable Energy Laboratory*

**Technical Report**  
NREL/TP-5000-57126  
January 2013

**Duration Test Report**  
for the  
**SWIFT Wind Turbine**

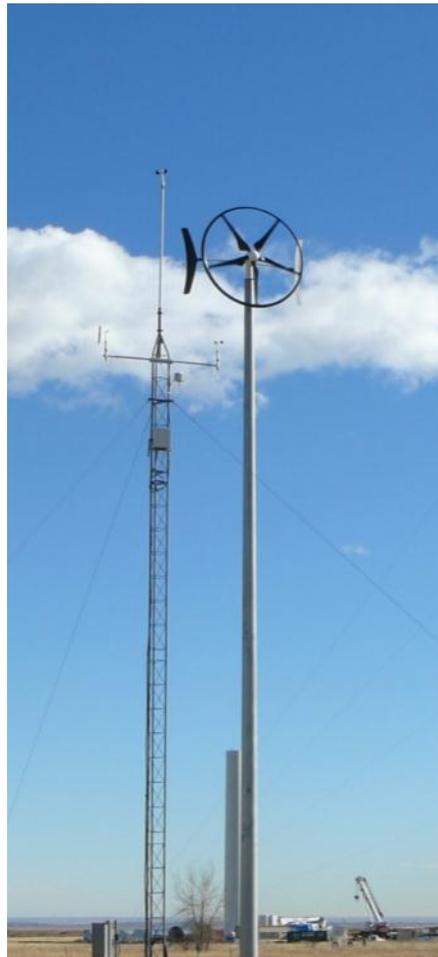
**Figure 1. SWIFT test turbine at the NWTC**

The SWIFT turbine (Figure 1) is an upwind, 5-bladed with an outer ring, fixed pitch, passive yaw, horizontal-axis wind turbine with a rated power of 1kW.

The SWIFT wind turbine was mounted on a 13.7-m (45-ft) monopole tower manufactured for Cascade Engineering by Valmont Industries. The inverter was manufactured by KACO new energy. The concrete foundation was installed by a third party per JDH Engineering designs, under contract to Cascade Engineering. The system

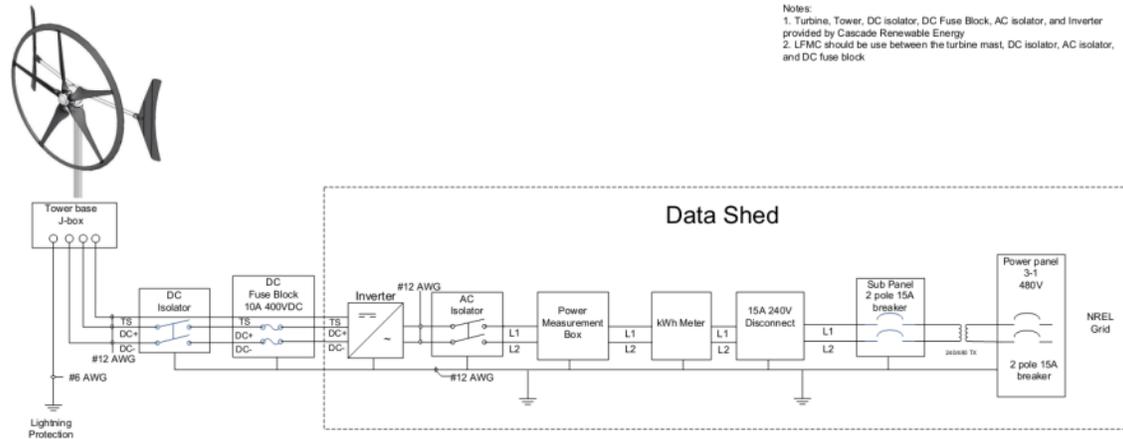
**Figure 2. Electrical single-line drawing of SWIFT installation**

Figure 2 shows the general electrical arrangement of the test. The wire was run from the generator to the controller, which is the point of grid connection, and to the data shed, approximately 46 meters. The connection was made using #12 American Wire Gauge (AWG) wire for the two power lines and turbine signal, and #6 AWG for the ground. The data shed housed the inverter, power instrumentation; disconnect switch, and data acquisition system. The 240 volts alternative current power output from the turbine

inverter was hooked up to a series of insulating step up transformers that raised the voltage to 13.2 kilovolts, allowing the system to tie to the NWTC grid.

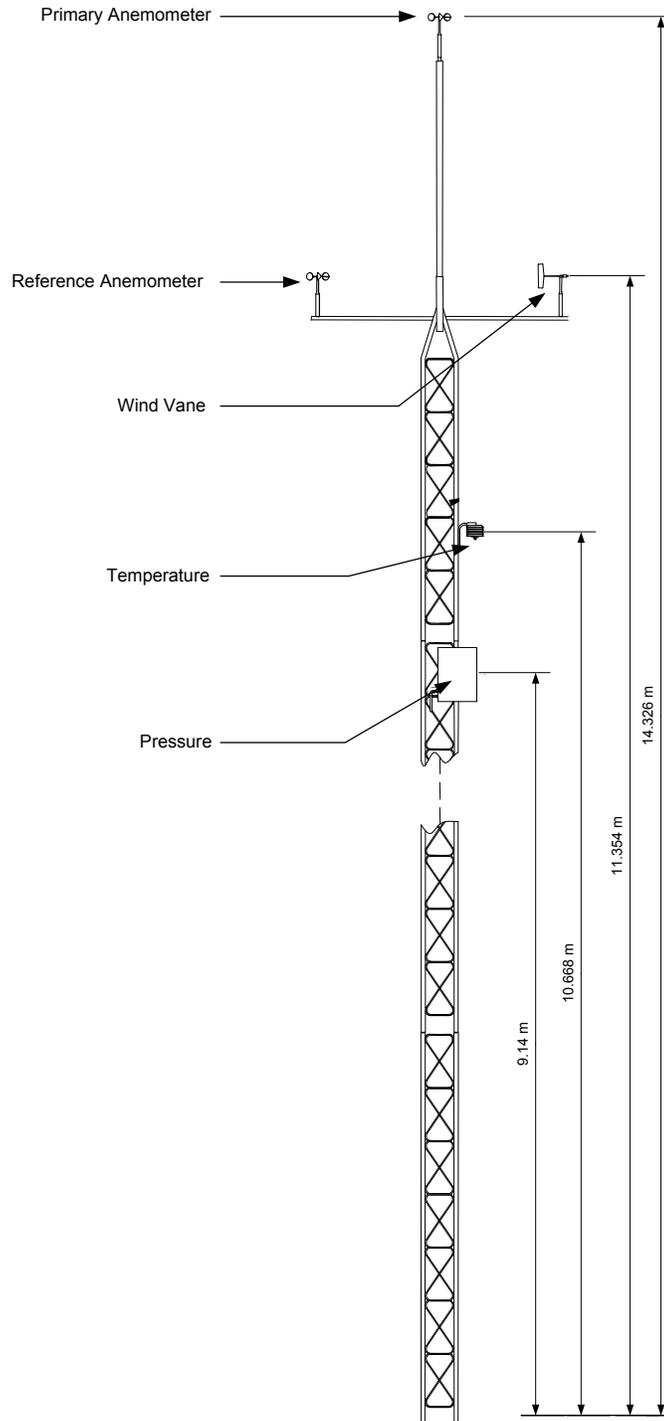
**Figure 4. Meteorological tower and instruments (not to scale)**

Duration test instrumentation consisted of monitoring wind speed, wind direction, turbine power, air temperature, air pressure, precipitation, overall turbine system availability, and dynamic brake status. Figure 4 gives the location and height of the met tower instruments, and Table 2 gives an equipment list that provides the specifications for each of the instruments used.

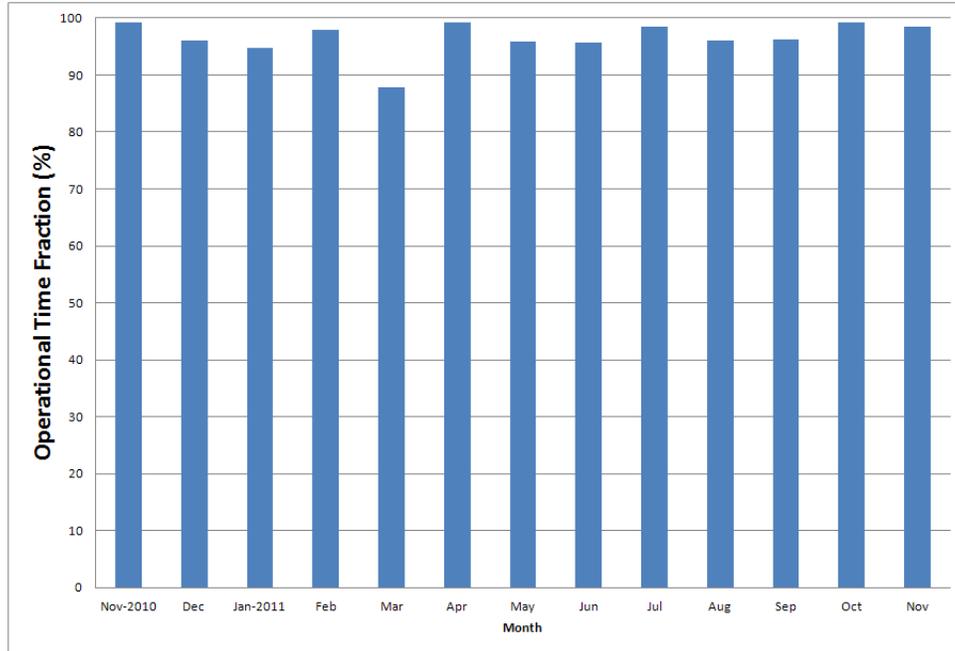
**Figure 6. Operational time fraction for each month**

- The Kaco Blueplanet 1502x inverter performed an automatic daily 5-minute system check causing the system to go offline for an average of 2.5 hours a month independent of wind conditions. This method overestimated  $T_N$  because the entire 10 minute average was labeled non-operational even if the turbine started to produce power. Even with this overestimation the operational time fraction observed during the test period was 96.4%, still above the minimum requirement of 90%.

- On 29 December 2010 the turbine faulted because the inverter failed its daily system check and did not reset the fault until it re-ran the daily check 24 hours later. After discussions with Cascade Engineering it was identified that the inverter required a system firmware upgrade to correct the annoyance faults. Because the firmware upgrade could be considered a system change and forced a restart of the test, it was decided not to implement it. Several of these events occurred during the test period. The month of March 2011 was when most of these events occurred, causing a lower operating time fraction. These faults were the majority of the  $T_N$  events.

- On 16 December 2010 the turbine faulted due to an excessive vibration event, causing the turbine to be offline for almost 3 days because a manual reset was required. NWTC personnel reset the turbine per SWIFT owners' manual operating instructions. During the time of the fault, high wind conditions from a variety of wind directions were observed.

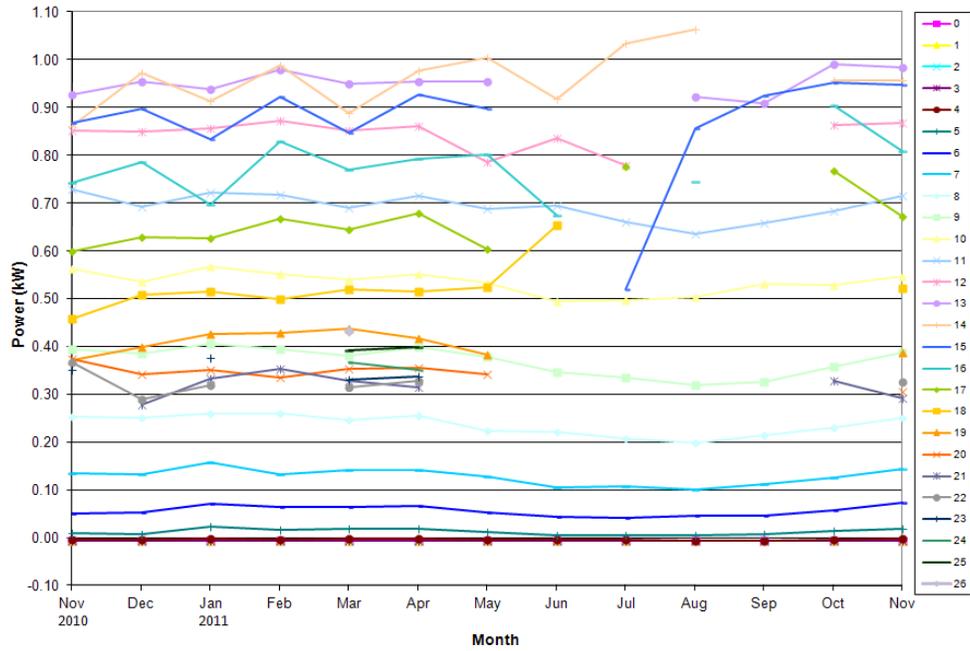
**Figure 7. Power degradation for all wind speeds measured**

A factor of reliable operation is that the turbine should experience no significant power degradation. During the power degradation analysis, the average power level for each wind speed bin was plotted as a function of time over the entire test period. This plot was analyzed for any obvious trends in power production. Figure 7 shows the power degradation plot, which gave the power level in individual wind speed bins for each month. Variations of the power levels from season to season were caused by air density changes. The low point at 15 m/s in July 2011 was caused by a passing storm that brought very low to very high variable winds. The variations of wind speed caused the turbine to produce less power than expected.

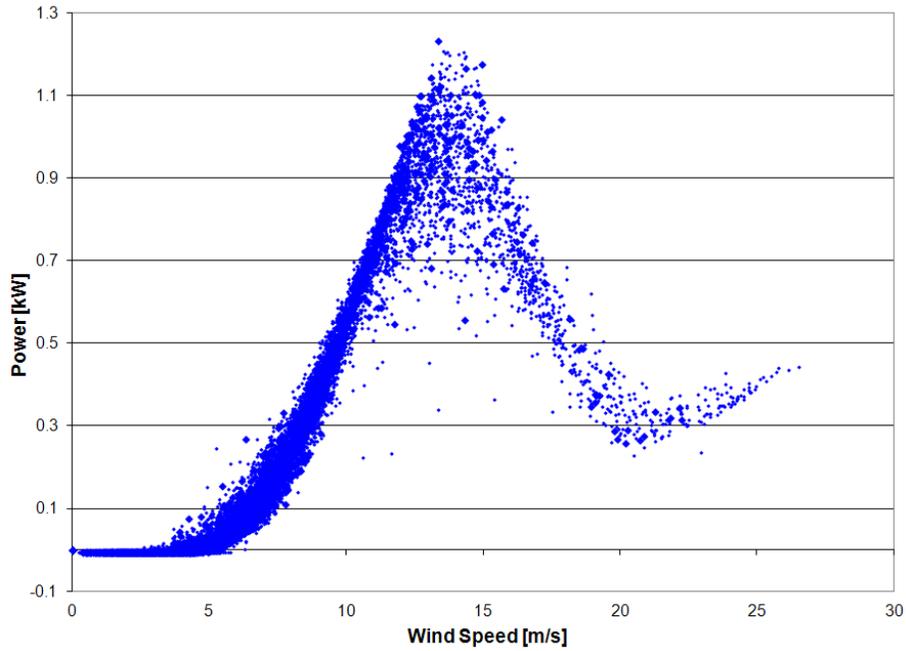
**Figure 8. Scatter plot of power versus wind speed (10-minute averages)**

Figure 8 shows a 10-minute average scatter plot of power versus wind speed during the test. The turbine had a furling mechanism that governed the rotor speed and power production at winds speeds above 10 m/s as shown in the figure. Figure 9 illustrates the turbine power level in individual wind speed bins up to 14 m/s for each month, just before the turbine’s furling mechanism fully engages.

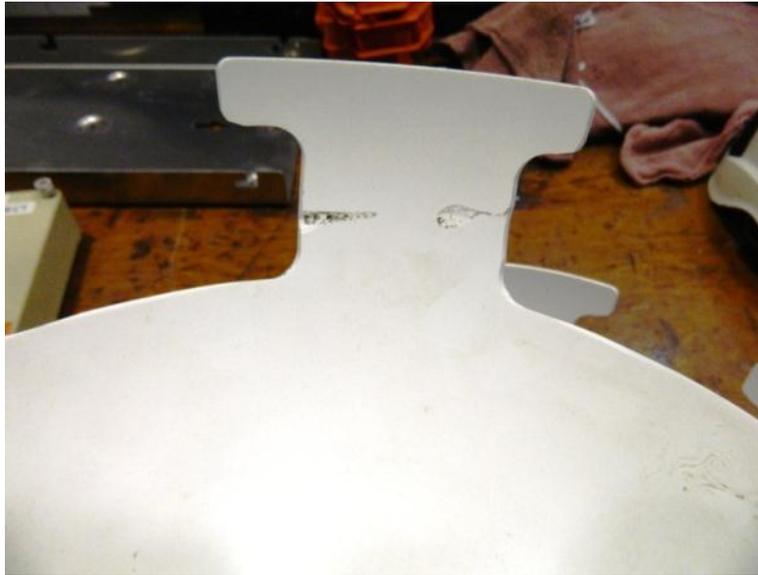
After operating almost 12 months, a rattling sound was detected coming from the turbine's nose cone. The noise was consistent with each rotation of the rotor, and was more evident at low wind speeds than high. The nose cone was replaced with a new one, but after 3 high windy months the rattling started again. No cracks or breaks on the tabs of either nose cone were found. Some wear was noticed on the inside of the nose cone that could possibly reduce the tight fit to the rotor (see Figure A1). During the post-test inspection Cascade Engineering mentioned that the wear could possibly have been caused by the bonding edge that was left when the rotor was manufactured.

The nose cone had some wear inside that caused it to rattle with every rotation of the rotor (see Figure A1). According to Cascade Engineering, the wear could have been caused by the bonding edge left when the rotor was manufactured.

**Figure A1. Wear marks inside the nose cone**  
Source: NREL 2012

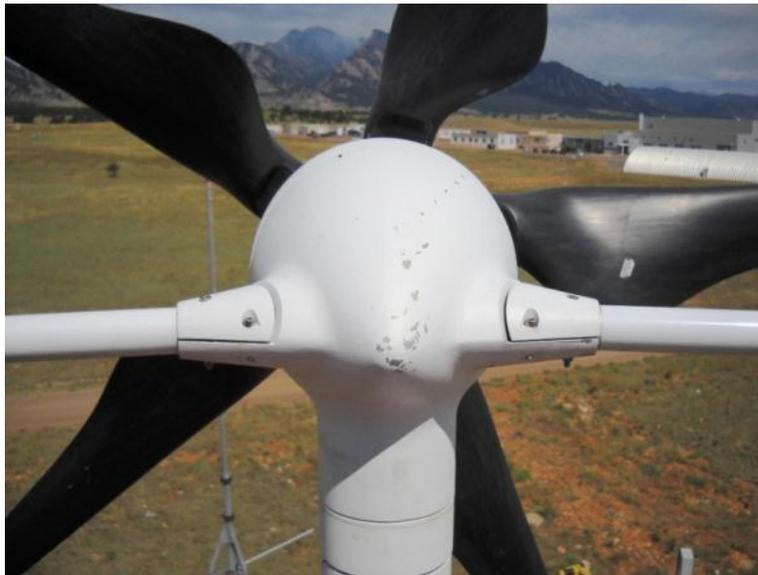
The nacelle was in good condition. Some small paint chips were noticed on the top and on the side boom mountings (see Figure A2 and Figure A3).

**Figure A2. Paint chips on the back of the nacelle**  
Source: NREL 2012

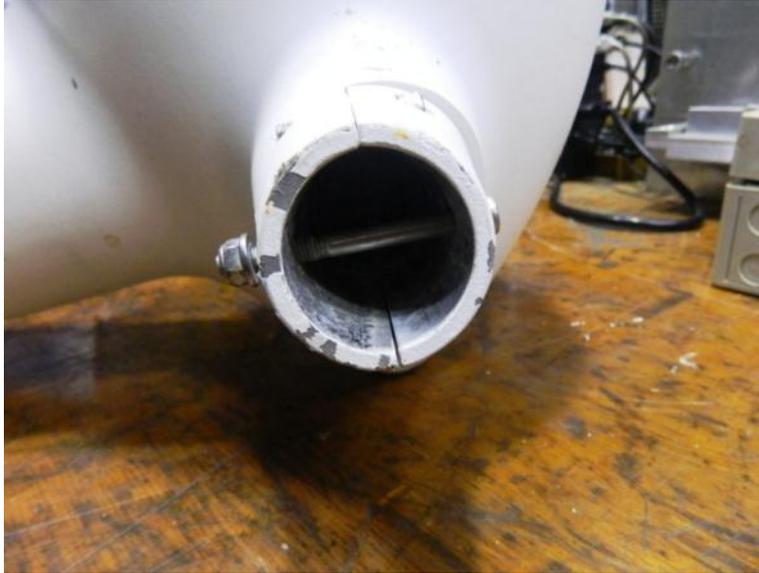
**Figure A3. Paint chips on the side mounts of the nacelle**  
Source: NREL 2012

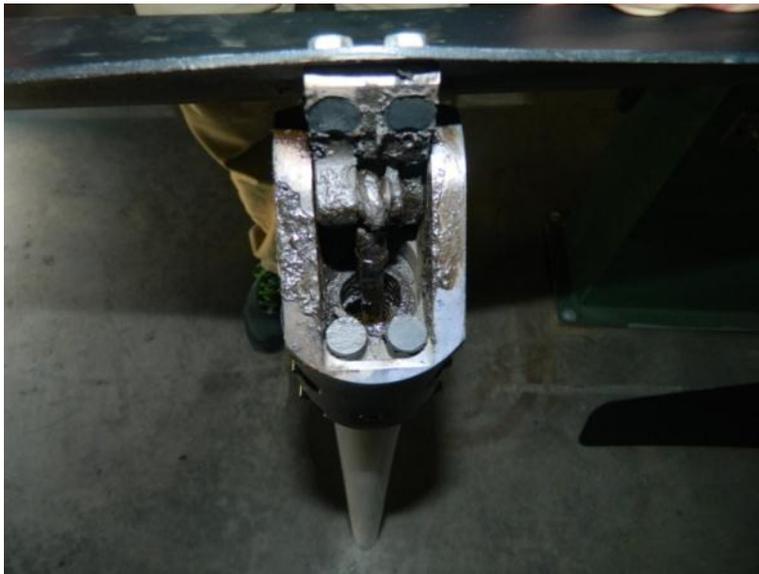
Both tail fins were inspected visually and only some small paint chips—no cracks—were found. Grease applied by NREL inside the side boom left several grease spots. The grease was applied to the furling mechanism to silence the squeaking so that clean background data could be collected for the acoustic noise analysis (see Figure A4 through Figure A6). The furling booms did not have any cracks or signs of wear.

**Figure A4. Inside side furling boom (grease residue from NREL's application)**  
Source: NREL 2012

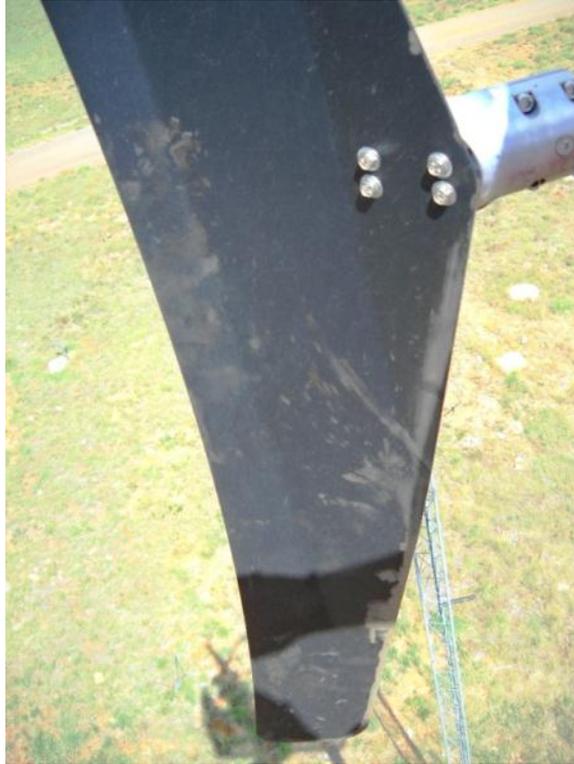
**Figure A5. Furling fin stained with grease residue (NREL applied the grease)**  
Source: NREL 2012

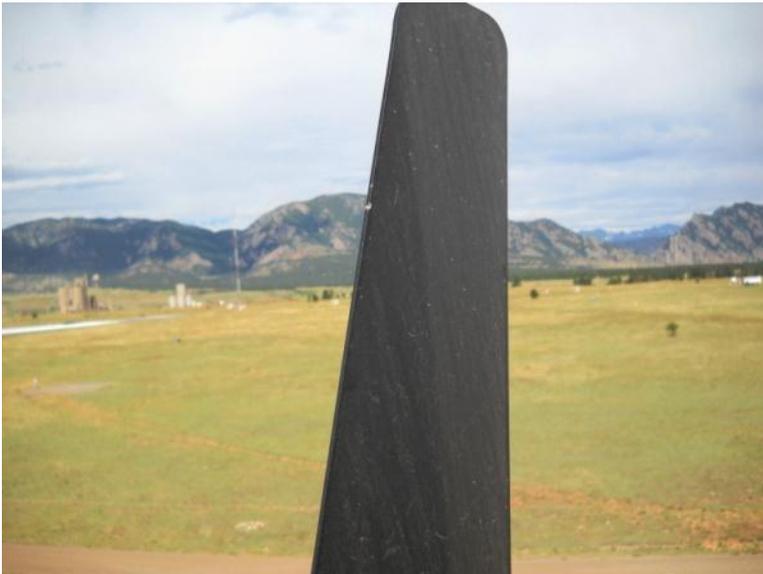
**Figure A6. Paint chip on side fin**  
Source: NREL 2012

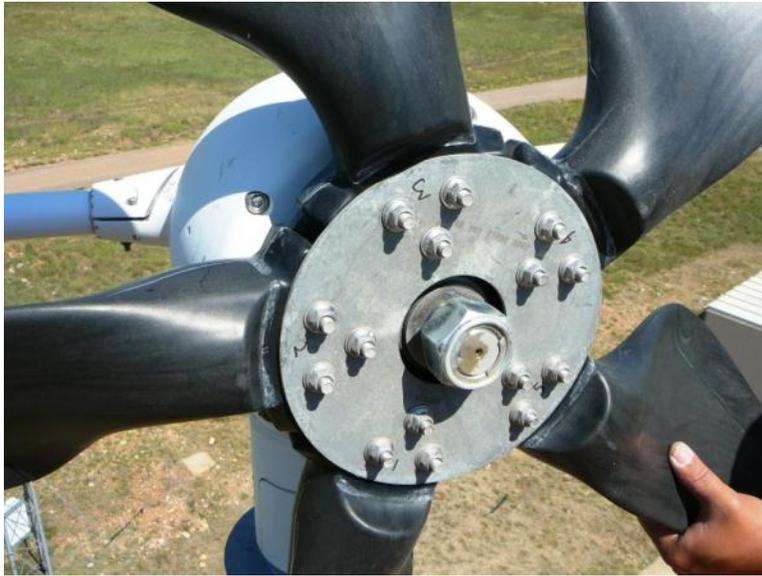
The rotor did not show any cracks or signs of damage. The rotor's glaze coatings were worn out and felt somewhat rough due to exposure to the environment. No power degradation was observed for the duration of the test. The fastening nut torque was verified before removal and it was found to be at the manufacturer's recommended specifications.

**Figure A7. SWIFT rotor with nose cone removed**  
Source: NREL 2012
