Duration Test Report for the Entegrity EW50 Wind Turbine

Joe Smith, Arlinda Huskey, Dave Jager, and
Jerry Hur
National Renewable Energy Laboratory

Technical Report
NREL/TP-5000-57141
December 2012

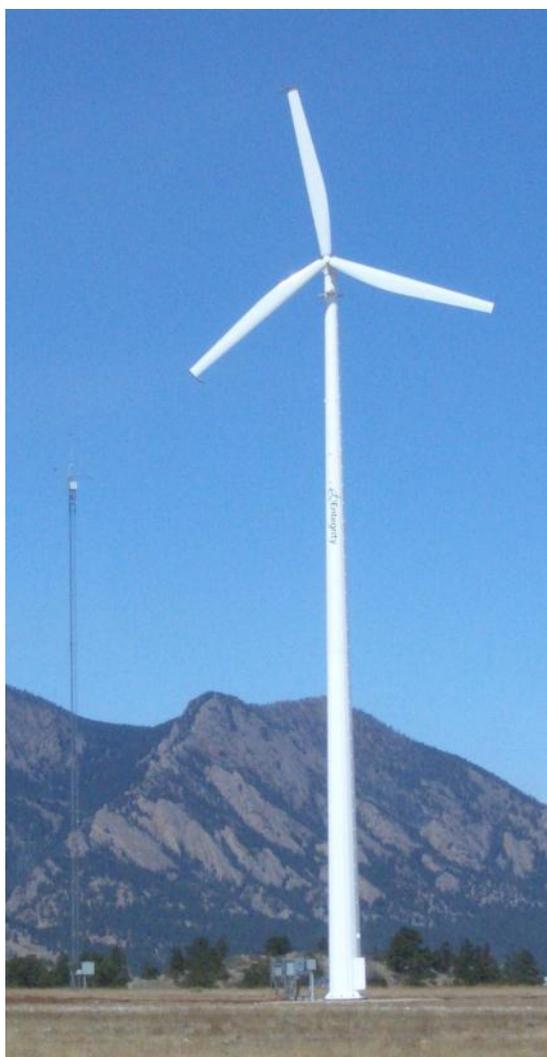
Figure 1. Entegreity EW50 test turbine at the NWTC (PIX# 22243)

The test turbine was an Entegreity EW50 wind turbine. It has an advertised rated power of 50 kilowatts (kW). The EW50 is manufactured by Entegreity Wind Systems Inc. and is a downwind, three-blade, passive-yaw, horizontal-axis wind turbine. The blades are fixed pitch, and the turbine employs an asynchronous generator that operates at a fixed speed to deliver three-phase electric power at 60 Hz. Table 1 lists the configuration of the Entegreity EW50 that was tested at the NWTC. Figure 1 is a picture of the EW50 at the NWTC.

The EW50 wind turbine was mounted on a 30.5-m (100-ft) monopole tower manufactured for the Entegreity EW50 by Maico Industries, Inc. The test turbine used a controller manufactured by

Orbital A/S. The concrete mat foundation was installed per Entegriy designs by a third party, under contract to NREL. The system was installed in March 2009 by the NWTC Site Operations group with guidance and assistance from several Entegriy personnel.

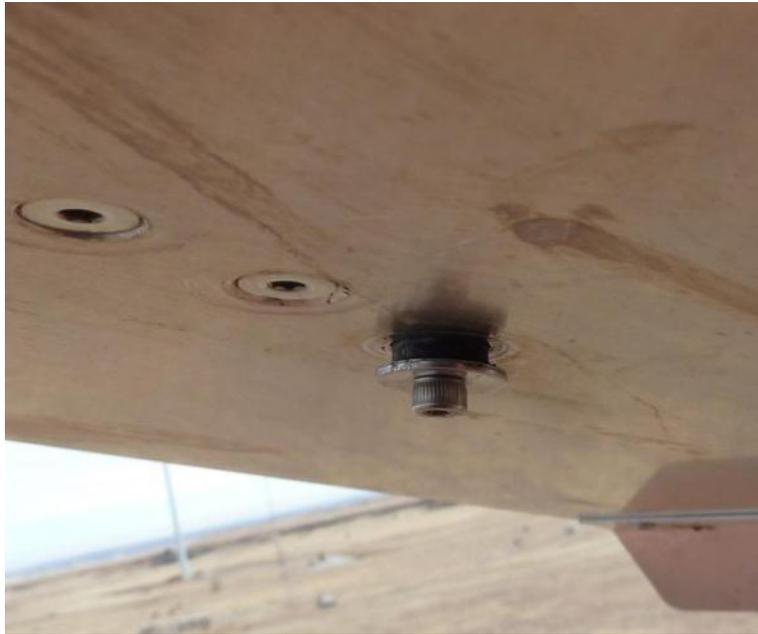
The EW50 tip-brakes are aluminum and a circular steel plate attached to the tip brake is attracted to the electromagnetic, which keeps the brakes in place during normal operation. On 25 January 2011, the rubber bushing that connects the tip-brake to the steel plate was discovered to have deteriorated on one tip brake (see Figure 7 and Figure 8 in Appendix A). Without a properly fitting rubber bushing, the tip brake can move a few degrees around its hinge point, which changes its aerodynamics. However, when the bushings were replaced at the end of January 2011, the EW50 still experienced premature tip brake deployment.

Figure 6. Tip brake #1 bushing has disintegrated, allowing for some play in the tip brake (PIX# 22238)

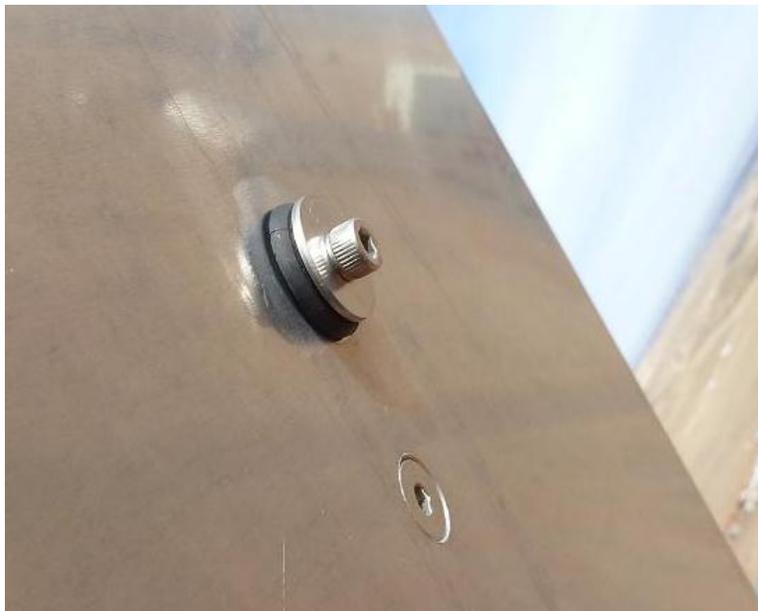
Figure 7. Tip brake #3, the rubber bushing is still intact (PIX# 22239)

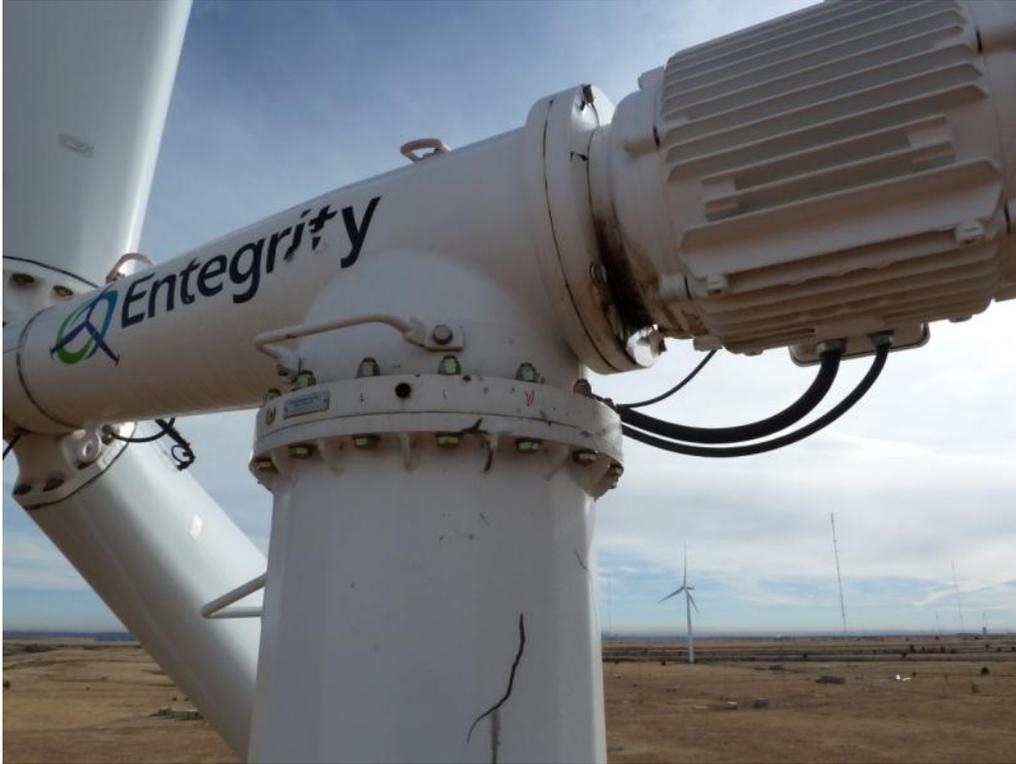
Figure 8. Rust and oil marks near the generator and gearbox connection (PIX# 22248)

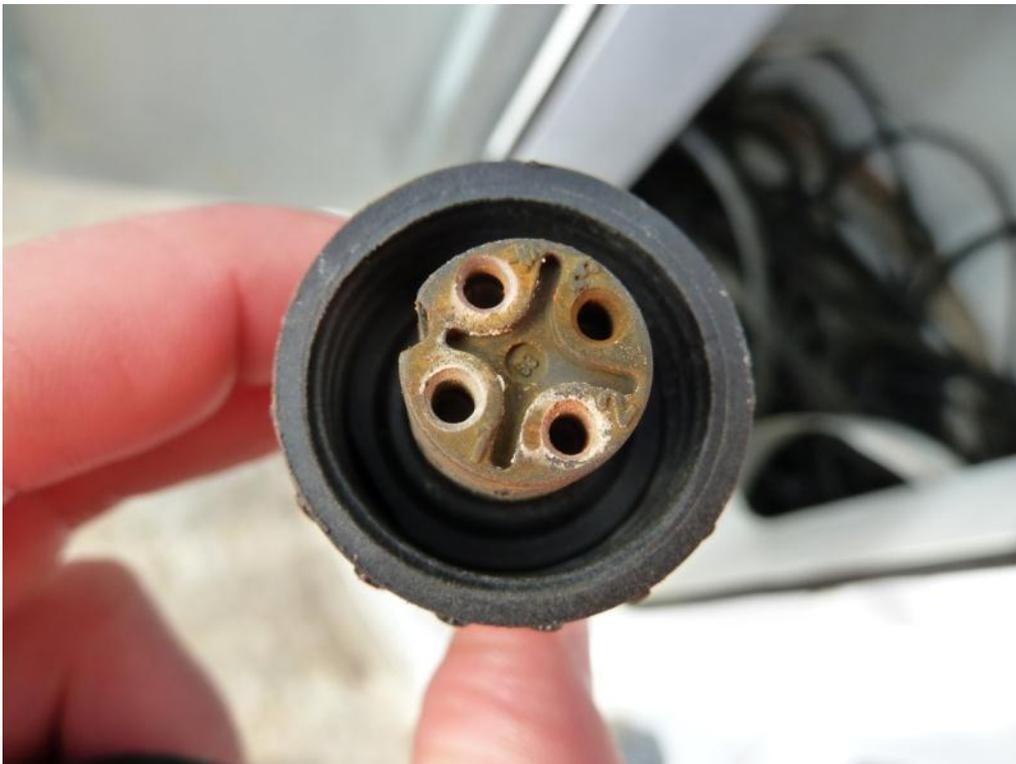
During the 18 August 2011 tear-down and inspection, corrosion was found in the electrical connections to the tip brake's electrical magnet. This could be the cause of the early tip brake

deployment failures, but this was not tested. The blades were in good condition and no cracks were found.

Figure 9. Corrosion around electrical connector to tip brake's electromagnet (PIX# 22241)

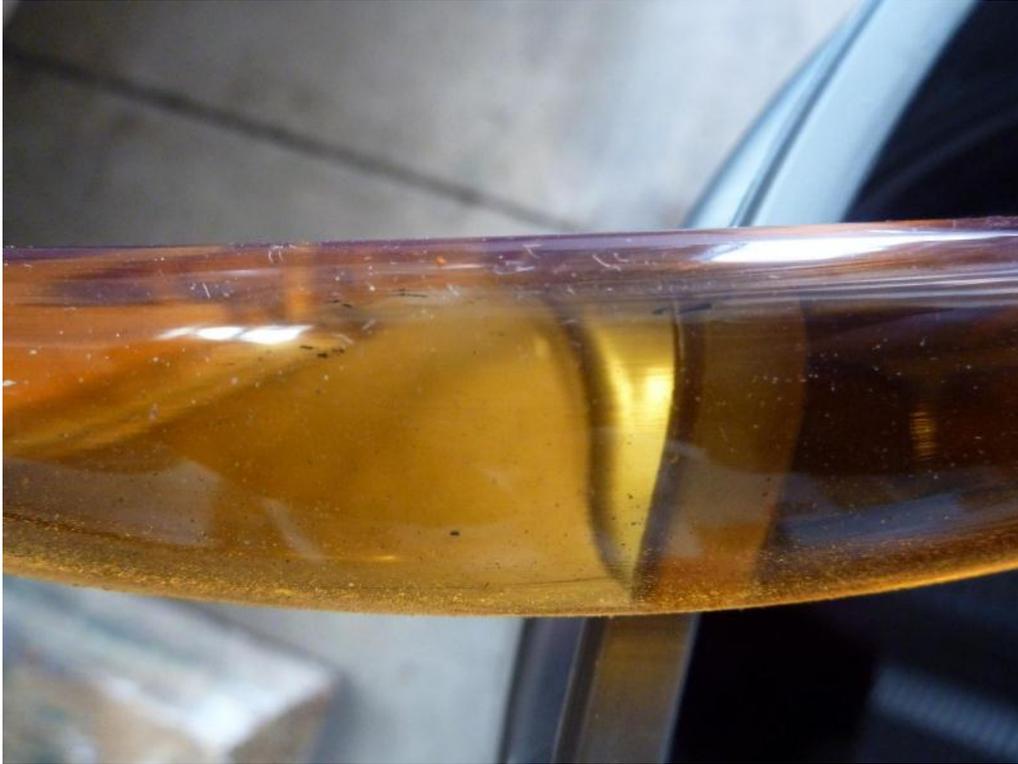
Figure 10. Draining earbox oil; significant contaminants were seen, such as the dark spots inside the clear tube (PIX# 22246)
