# Strategy Guideline: Energy Retrofits for Low-Rise Multifamily Buildings in Cold Climates

K. Brozyna *IBACOS, Inc.*

April 2013

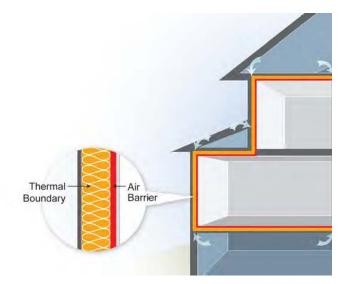
Figure 4. The thermal boundary and air barrier separate the unconditioned space from the conditioned space of a structure, preventing air infiltration indicated by the arrows (DOE 2011) (Courtesy U.S. Department of Energy)

In Figure 4, the attic space is unconditioned. In buildings where the attic space is considered to be conditioned, the thermal boundary and air barrier would extend upward along the roof assembly. The thermal boundary must be continuous around the building envelope.

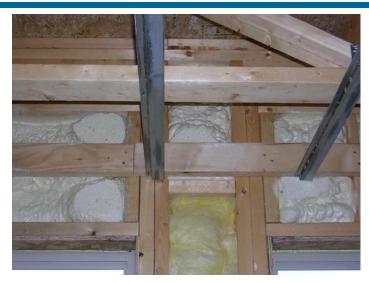
Figure 5. The air sealing benefits of spray foam make it a great option to insulate around rim or band joists

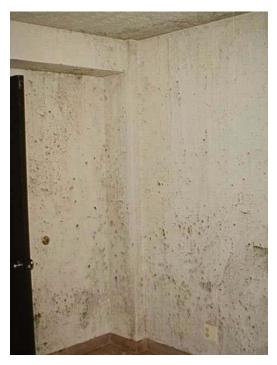
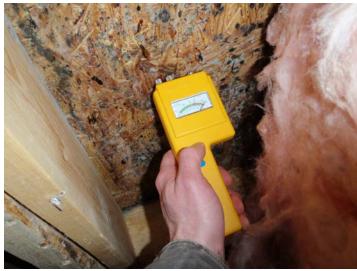
Figure 6. Mold growth on the inside surface of exterior walls (left) and inside the wall cavity (right). Both conditions are likely caused by an improperly air sealed and insulated wood-framed wall assembly.

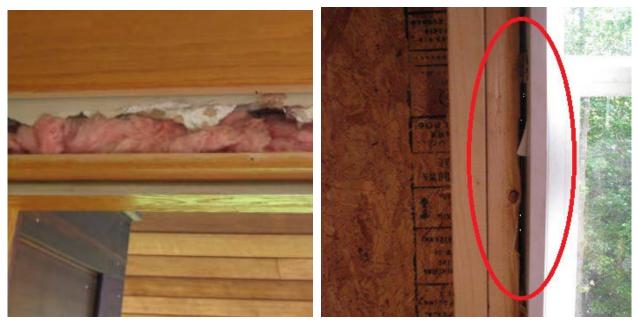
Figure 8. Poor air sealing around windows (ENERGY STAR 2011c)
(Left photo courtesy Efficiency Vermont; right photo courtesy U.S. Department of Energy)

The interior surface (drywall) is a key component of the thermal boundary system and air barrier. Once insulation has been reinstalled and the wall cavity has been enclosed, complete air sealing of the drywall is a critical detail. Any remaining air gaps can be identified by using a blower door in conjunction with an infrared camera or smoke pencil. Figure 8 shows examples of poor air sealing around doors and windows. In the photo on the left, fibrous insulation has been jammed into the gap above the door frame. Fibrous insulation is not an air barrier; it acts only as a filter and allows air to move freely between the interior and exterior. In the photo on the right, the gap between the window and the rough opening is not sealed at all. By contrast, Figure 9 shows two examples of good air sealing with low-expansion spray foam.

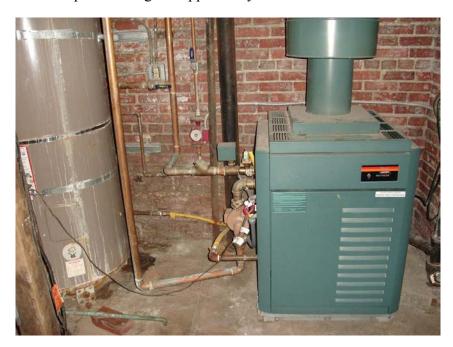
Figure 11. Typical multifamily heating unit without microprocessor controls (Klein 2011) (Photo courtesy Gary Klein, Affiliated International Management, LLC)

Figure 11 shows a typical heating unit for a multifamily building. With such a system, a lack of microprocessor controls provides a good opportunity for retrofit.

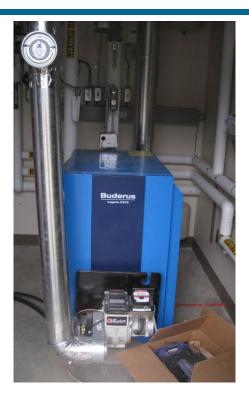
Figure 12. Replacement boiler with microprocessor controls (left); associated water flow control (right)

Figure 12 shows a replacement boiler with integrated processor controls and associated water flow control.
