Retrofitting Vegas: Implementing Energy Efficiency in Two Las Vegas Test Homes

Consortium for Advanced Residential Buildings

April 2013

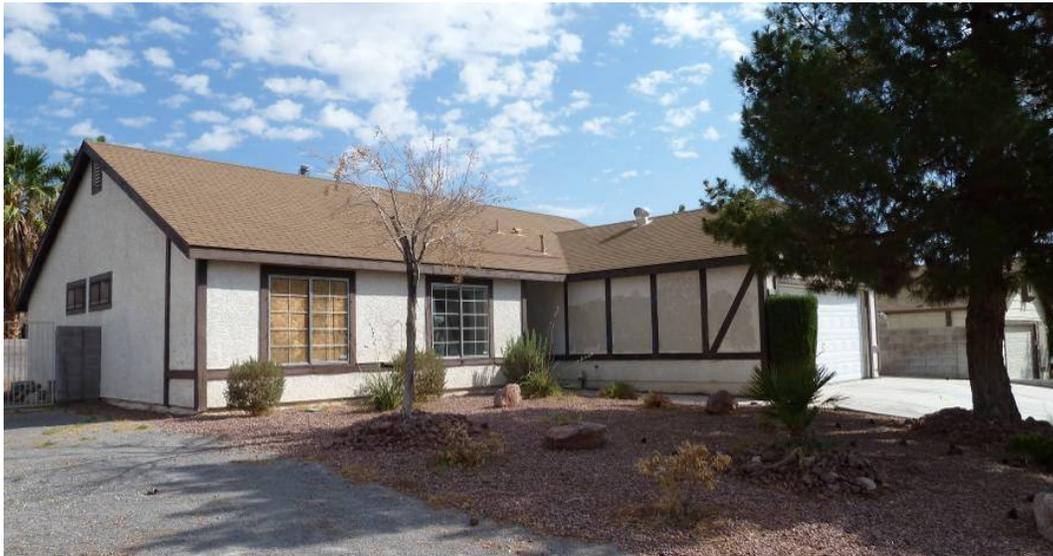
Figure 2. Exterior photo of the Carmen home

The Carmen home is a 1,521-ft² ranch built in 1983. This single-family detached home has three bedrooms, two baths, and an attached garage. At the height of the housing boom, it was valued as high as \$285,000,¹ but now its estimated value is \$97,400.² The price range for homes in this neighborhood is \$70,000–\$130,000. The home was dated, but its overall condition was livable after a thorough cleaning and repair of a couple broken windows.

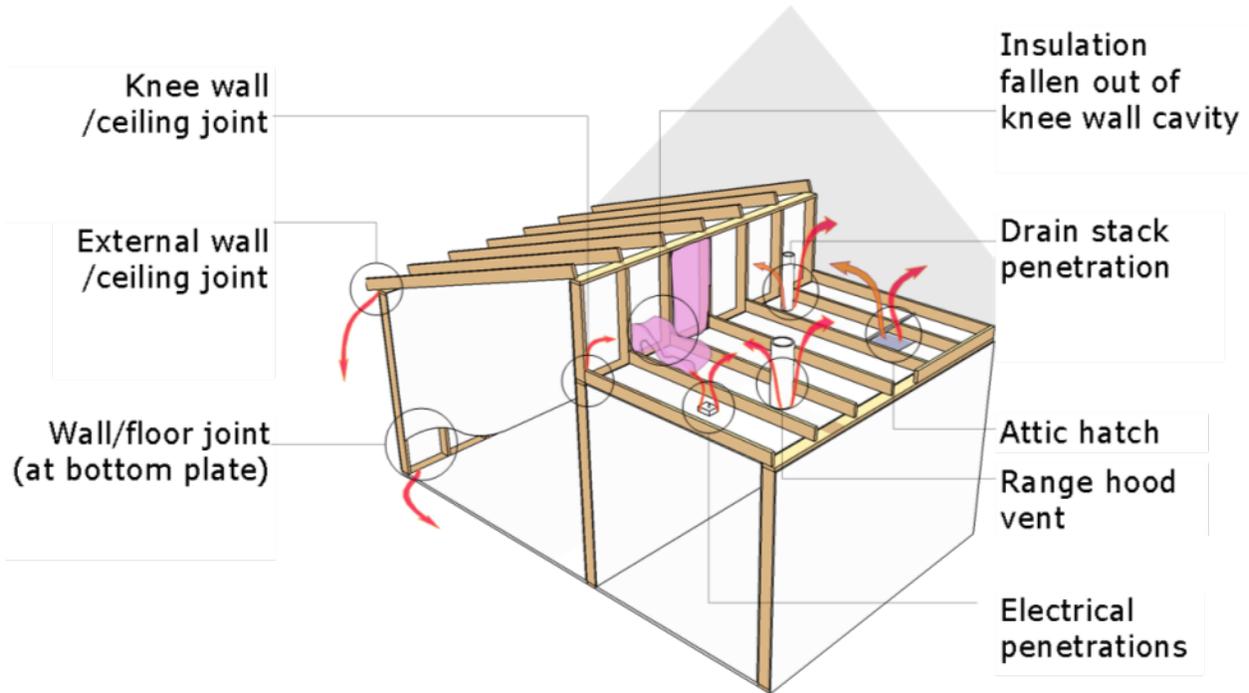
Figure 3. Ceiling leakage points at the Carmen home

IR thermal imaging revealed that many of the interior uninsulated partition walls were communicating with the attic. Penetrations in the top plates to accommodate electrical wiring were the most common culprit for this leakage pathway. Figure 4 shows two instances in which electrical wiring resulted in interior wall cavities that directly communicated with the attic air. These sections were not air sealed, and often did not have ceiling insulation, because it had been pulled or cut back.

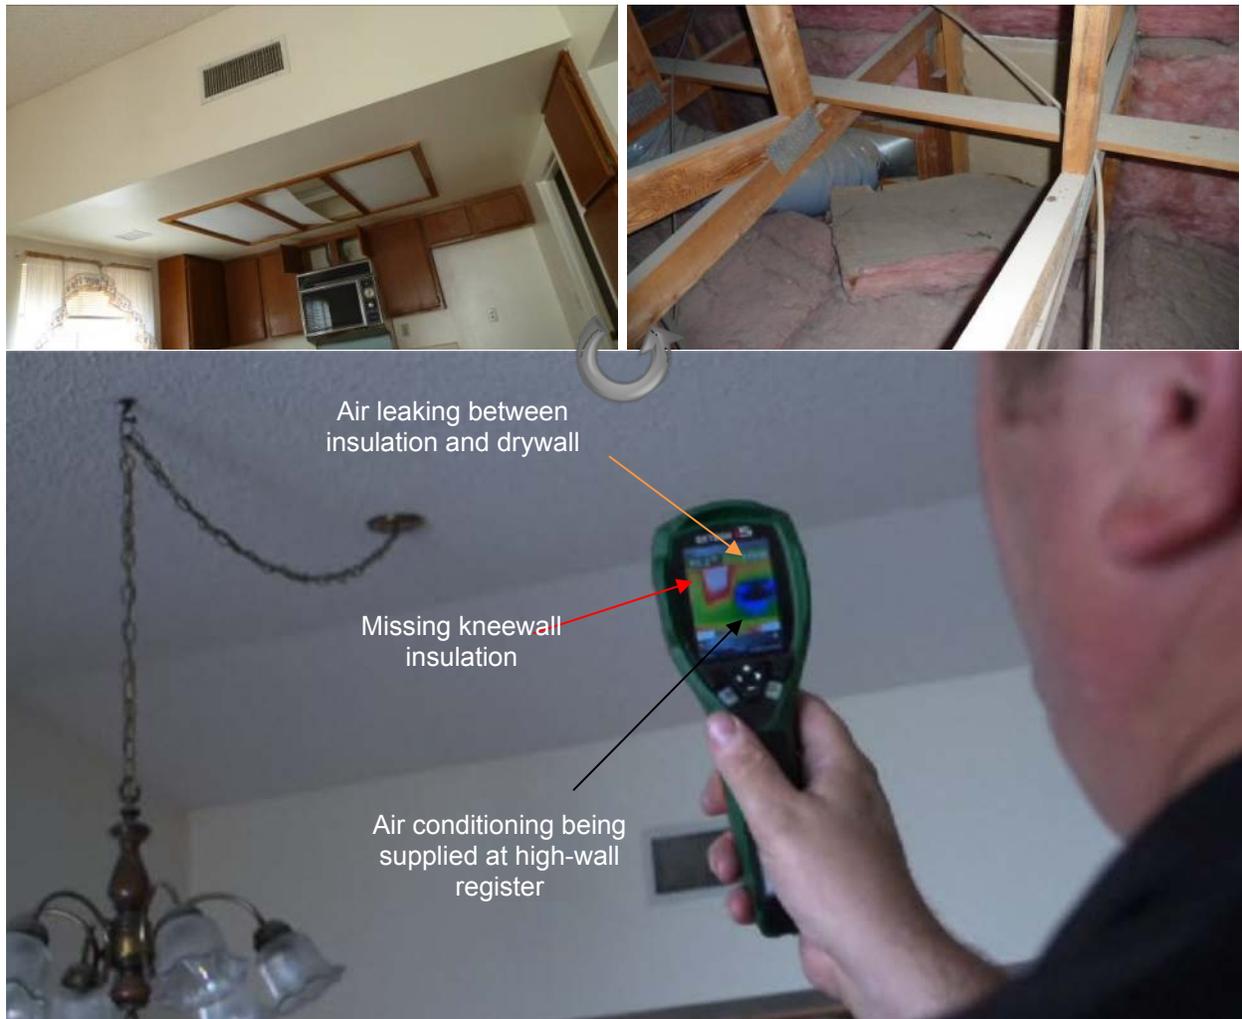
Figure 5. Discovery of poor insulation in the kitchen kneewall

In general, kneewalls were performing poorly, mostly because unsupported batts had been dislodged, leaving uninsulated vertical bays. Figure 5 shows the kneewall at the transition from the kitchen to dining room. The IR camera showed that the bay to the left of the supply register had surface temperatures close to the attic temperature. Further investigation in the attic revealed that this section of the kneewall was not insulated because the fiberglass batt had fallen down. The whole top portion of this kneewall is hot, because all the batts are poorly installed and attic air is leaking between the batt and drywall, significantly reducing the insulation's performance.

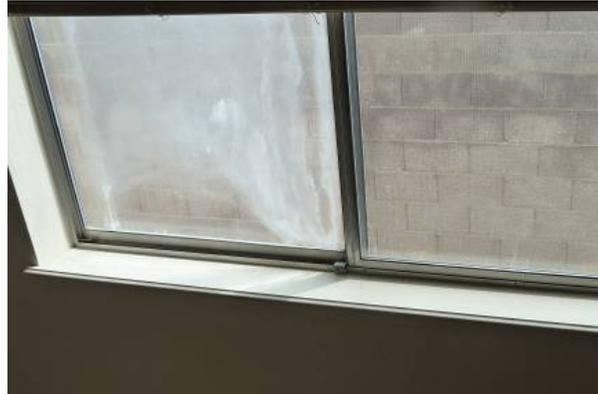
Figure 6. Haze between the window panes is evidence of a broken hermetic seal

The window in the front corner bedroom was broken and temporarily boarded up. Further inspection revealed that the hermetic seal of several dual-pane windows had been compromised. This broken seal creates a pathway for moist air to enter this dead air space. When the window

surface temperature is lower than the dew point of the air, condensation forms. Over time, mineral deposits and a permanent white silica haze are visible (see Figure 6).

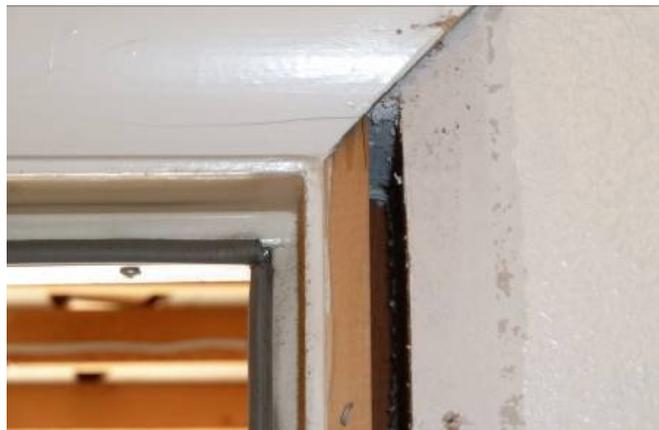
Figure 7. Lack of air sealing around exterior doors

When door trim was removed, there was no evidence of prior air sealing between the exterior door jamb and the rough opening (Figure 7). This is a common source of air infiltration. In some instances, fiberglass batts are stuffed into this opening. This adds some slight insulation value, but is still not an air barrier.

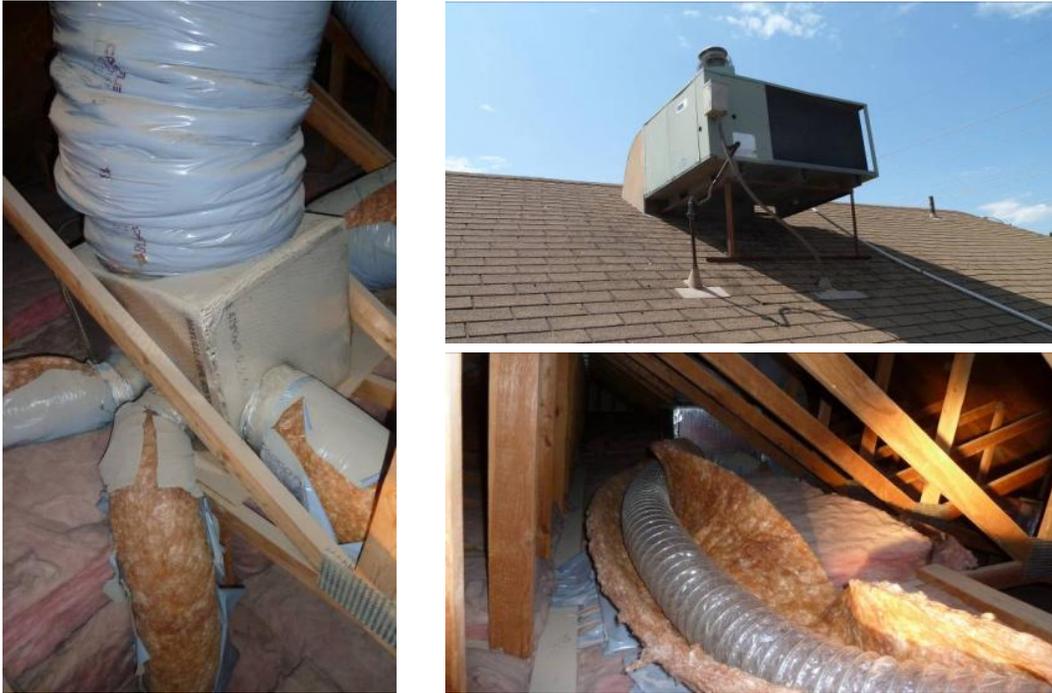
Figure 8. From left clockwise: supply plenum located in the vented attic, roof-mounted packaged furnace/AC, and insulation unwrapping from flex duct because the exterior vapor barrier had deteriorated

rating of 8.5 but was poorly installed and maintained, so the actual delivered efficiency was likely closer to an equivalent SEER 5 equipment rating. Ductwork was run from this exterior unit through the roof deck and was distributed throughout the home through ceiling registers located in the vented attic. The flexible ductwork was in very poor condition with significant deterioration of the exterior vapor barrier and in some instances, the insulation had unwrapped from the inner duct liner. Images of this HVAC system are shown in Figure 8.

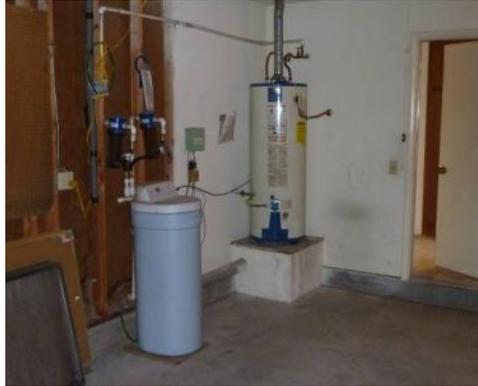
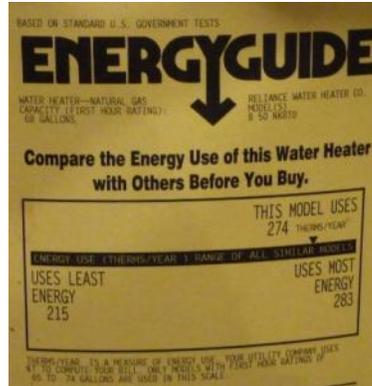
Figure 9. Atmospheric gas water heater located in the attached garage

The domestic hot water system is a 50-gal atmospheric, natural gas water heater located in the attached garage. The rated EF for this unit is 0.55. Based on its serial number, it was likely replaced in 1997. Though not original to the home, this unit is past its effective life expectancy of 11–13 years.

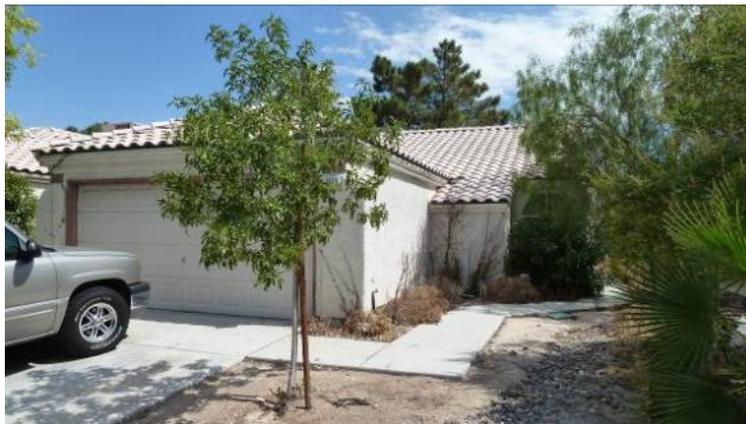
Figure 10. Exterior photo of the Sierra Hills home

The Sierra Hills home is a 1,131-ft² ranch built in 1991. This single-family detached home has two bedrooms, two baths, and an attached garage. Though dated, the overall condition of the home was livable and better than the Carmen home. At the height of the housing boom, this home was valued as high as \$256,000,³ but now its estimated value is \$79,100.⁴ As this home is only half a mile from the Carmen home, the neighborhood price range is the same (\$70,000–\$130,000).

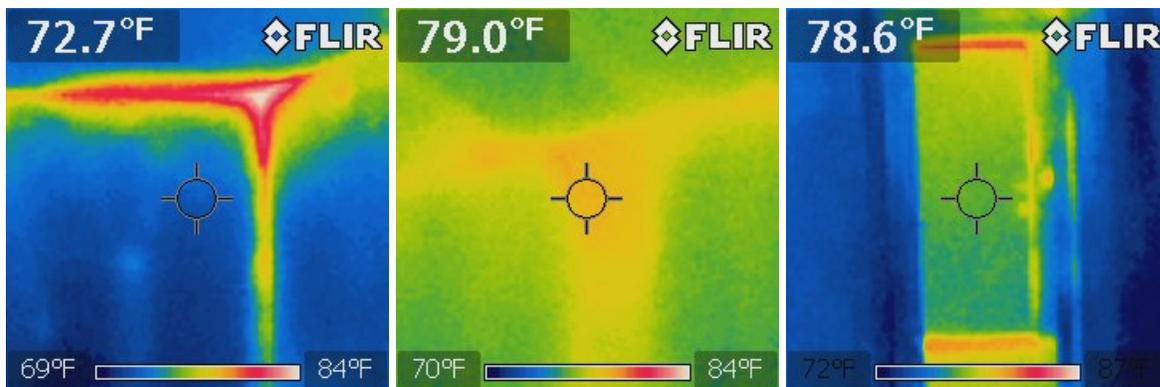
Figure 11. (Left) Top plate corner leakage; (center) kitchen exhaust ducting through interior wall without backdraft damper; (right) leakage around garage door from lack of weather stripping

This home uses 2 × 4 wood framing at 16 in. on center with R-11 fiberglass batt cavity insulation and 1 in. of EPS on the exterior. This was not a gut rehab, so the wall insulation was evaluated using IR thermal imaging. There were the air bypasses typically found in existing homes at the top and bottom plates, around windows and doors, and at penetrations of lights, smoke alarms, registers, and attic hatches in the ceiling plane. The IR images in Figure 11 and Figure 12 show that the surface temperature variation across the drywall was approaching 15°F.

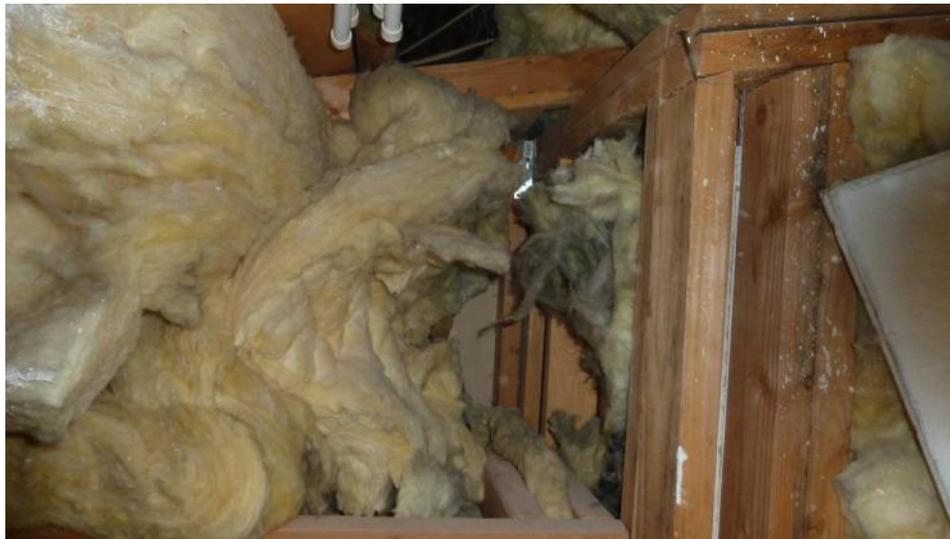
Figure 13. Poor insulating of partially vaulted ceiling kneewalls
(Image courtesy of Building Media, Inc.)

Even though the kneewalls in this home were better than the Carmen home, there still were some issues (see Figure 13). Whenever there is complicated framing, batt insulation is difficult to install effectively. In addition, to achieve the rated performance of the batt insulation, an attic side air barrier should be included to minimize air movement through or around the insulation. Once again, the framing evidenced in Figure 13 would make establishing a continuous attic side air barrier challenging.

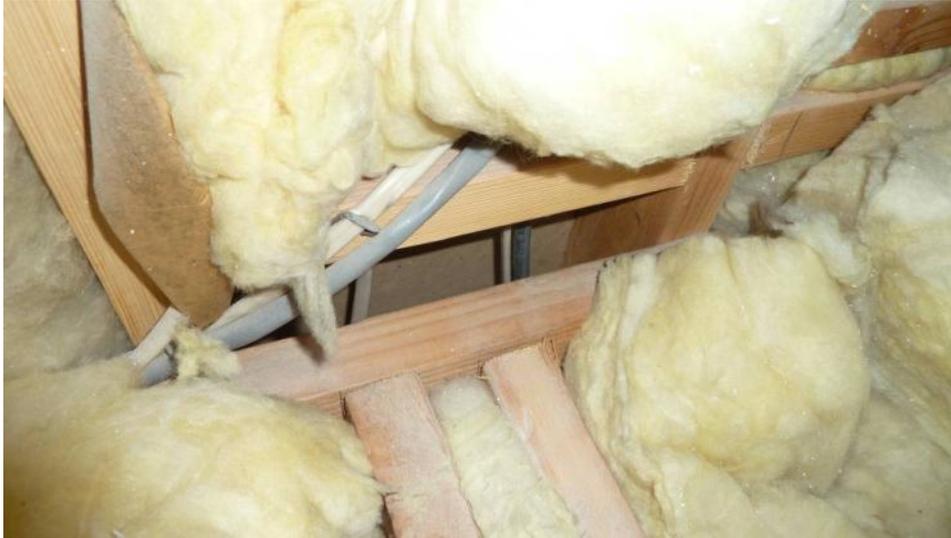
Figure 14. Interior wall cavities that are directly communicating with the attic

Compared to the Carmen home, the Sierra Hills home has more variation in the ceiling plane with a mix of flat and semi-vaulted ceilings throughout the home. This has led to several interior wall cavities directly communicating with the attic air (Figure 14).

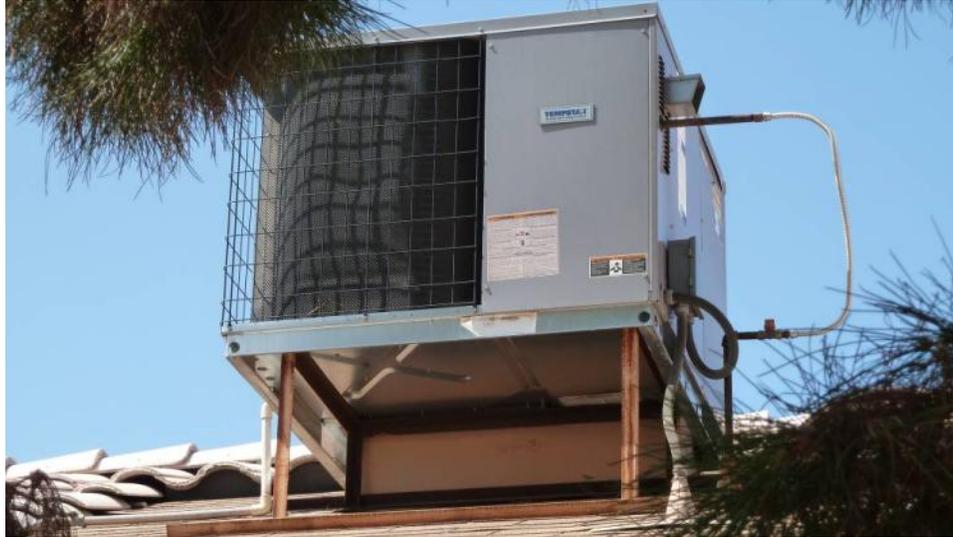
Figure 15. Rooftop packaged furnace/AC located at the Sierra Hills home
(Image courtesy of Building Media, Inc.)

The HVAC system for the Sierra Hills home was a packaged furnace/AC located on the rear roof. It was anticipated that the HVAC equipment would be comparable to the Carmen house system, but the packaged HVAC system was likely replaced in late 2007 or early 2008 (verified with the serial number on the unit: G071141225). For Tempstar units, the second and third number/letter of the serial number represents the year the unit was manufactured and the next two numbers represent the week of the year. This was an unforeseen challenge, as the efficiency of this unit was not suitable to achieve the energy efficiency goals of this project. Also, more than 10 years of usable lifespan remained, so the cost benefit versus the incremental savings benefit was significantly minimized.

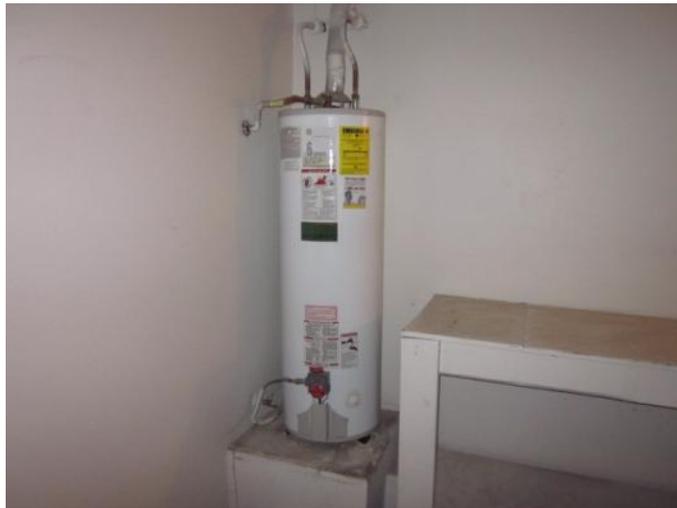
Figure 16. Atmospheric water heater located in the garage of the Sierra Hills home
(Image courtesy of Building Media, Inc.)

Domestic hot water was provided by an atmospheric 40-gal natural gas water heater. Again, the serial number (GENG 0700123945) of the water heater was used to estimate the install date of this equipment. For General Electric water heaters, the first two numbers refer to the month and the second two numbers refer to the year. So this unit was manufactured in July 2000. It was likely installed shortly after manufacturing, so the water heater was likely replaced in early 2001. Therefore, this unit has basically reached its effective life expectancy of 11–13 years.

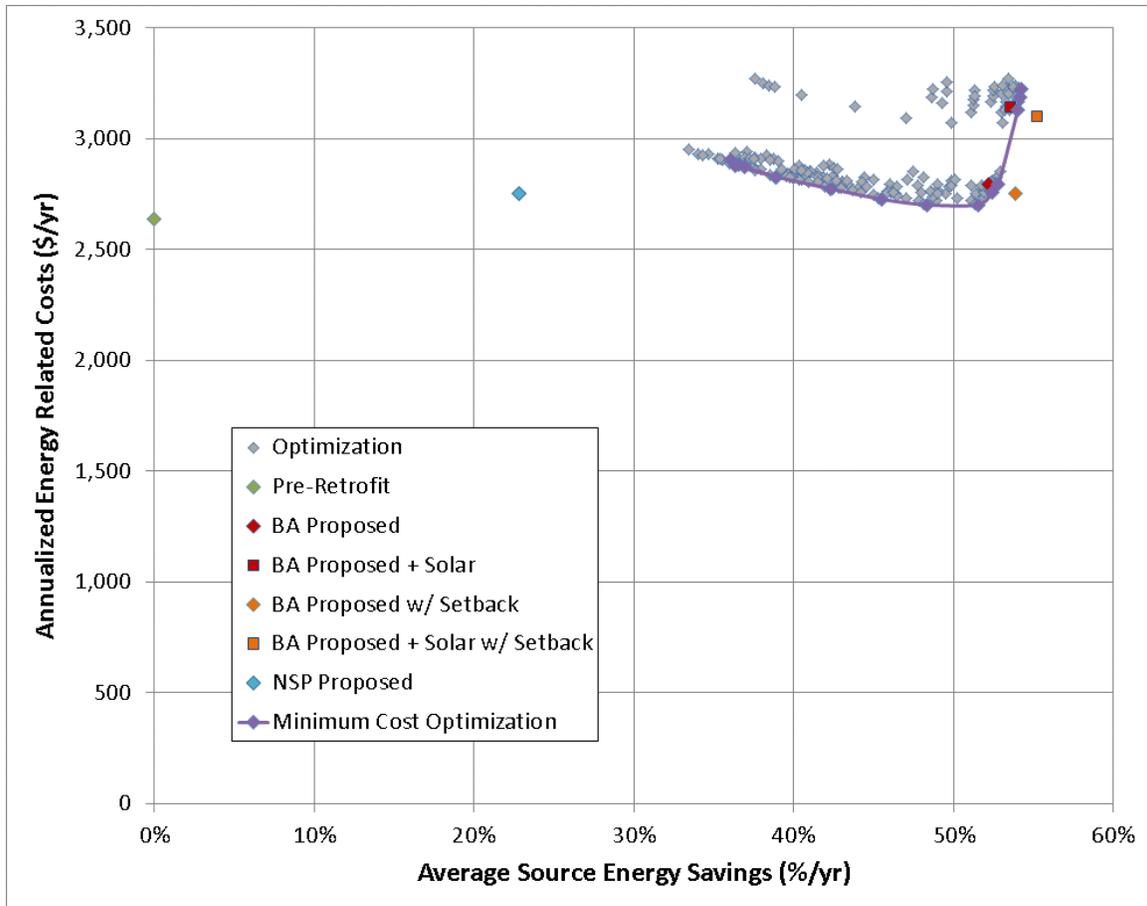
Figure 17. Specification optimization analysis during the design stages of the Carmen home

Based on the goals of achieving 50% source energy savings over the pre-retrofit performance of the Carmen home, CARB performed optimization analysis. The primary focus was on air sealing the building shell and bringing efficient HVAC equipment within the building envelope. Based on the optimization analysis, the following specifications (see Table 5) were proposed to the project team. The building infiltration target for this home was 4.5 ACH50. The base proposed specifications resulted in a 52.2% source energy savings over the pre-retrofit conditions. If a solar thermal system is included, the source energy savings increases to 53.9%.

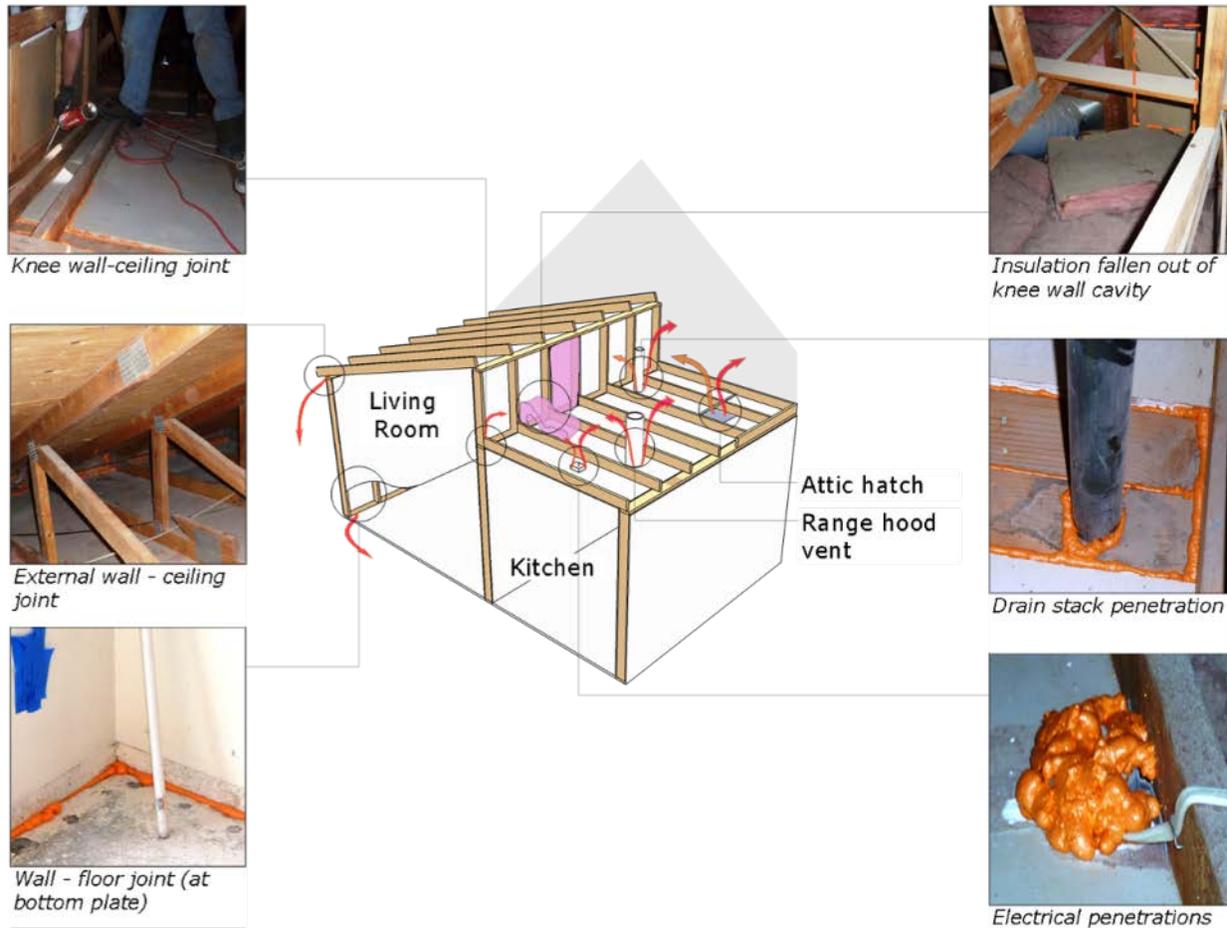
Figure 20. Examples of air sealing at the Carmen home
(Small images courtesy of Building Media, Inc.)

Over the two-day air sealing sessions at each project home, the attendees worked with Mr. Chitwood to air seal all accessible openings, joints, and cracks to maintain a continuous pressure

boundary (see Figure 20). A blower door and an IR camera were used during the session to qualitatively identify air leakage pathways and to quantitatively measure the air sealing efforts.

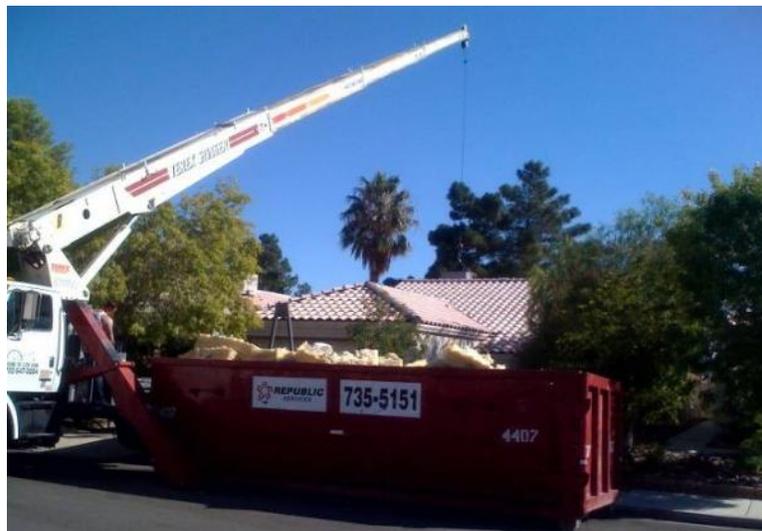
Figure 21. Existing package furnace/AC unit being craned off of the Sierra Hills home
(Image courtesy of Building Media, Inc.)

The existing packaged furnace/AC units were located on the roofs. In the case of the Carmen home, this unit was removed with a crane, the roof was patched, and the new outdoor heat pump unit was located in the backyard. For the Sierra Hills home, the project team decided to maintain the location of the outdoor unit, by placing the new outdoor heat pump on the roof (see Figure 22). This resulted in added cost for a crane (see Figure 21), but simplified running the refrigerant line sets to the indoor air handler unit.

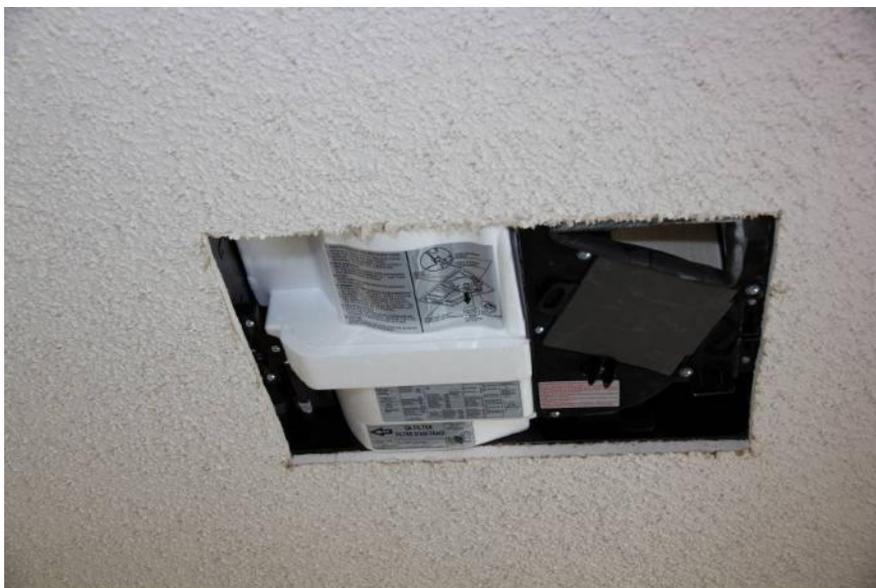
Figure 23. Spot ERVs installed in both homes to provide balanced whole-house ventilation

For ventilation, both homes had Panasonic 80 cfm WhisperGreen exhaust fans located in the bathrooms for local spot ventilation to remove excess moisture from showers. The kitchen ranges also had exhaust hoods that were ducted to outside to remove cooking contaminants from the home. These homes were extensively air sealed, so additional whole-house ventilation was provided in the form of a Panasonic 40-cfm WhisperComfort ERV (see Figure 23). CARB has researched this point source (Arena 2011) to verify that the units do not short-circuit (supply air is directly exhausted before being distributed throughout the home because the supply air and return air are close together).

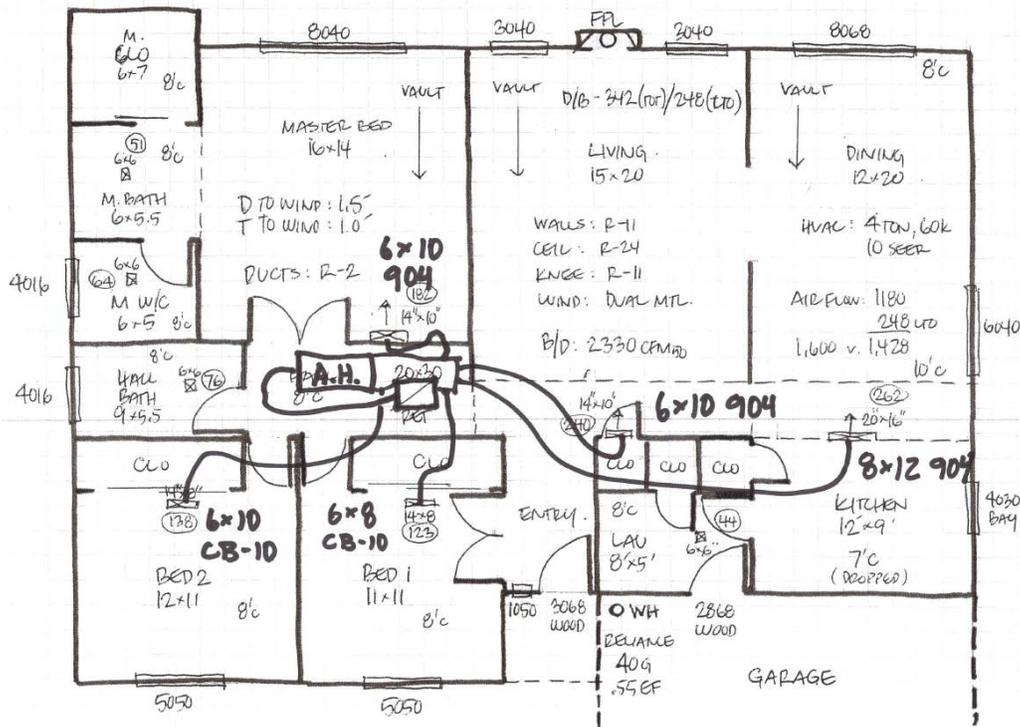
Figure 25. Radial HVAC system as installed at the Carmen home

The other field modification made to the HVAC design was to eliminate the return ductwork for the master suite. The door to the master bedroom was a 5-foot double door set, so the door undercut was calculated to provide a sufficient return air pathway. This left only the central return in the hallway outside the bedrooms. The as-installed HVAC layout is shown in Figure 25.

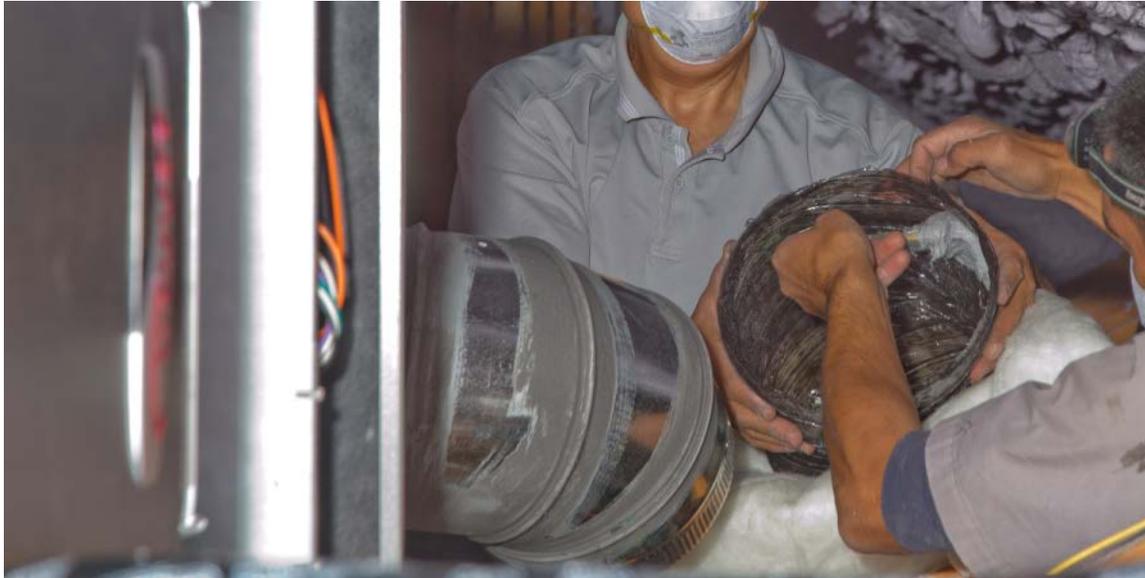
Figure 26. Mastic being applied to inside of flexduct jacket before being slipped over and secured to a branch takeoff elbow with compression bands

CARB calculated the cooling and heating loads during the design process to be 19,411 Btu/h and 19,163 Btu/h, respectively. A 2-ton two-stage ASHP was specified to meet these loads. But as the retrofit was being undertaken, air sealing and building specification goals were exceeded, so the actual building loads were lower than predicted. Therefore, the two-stage ASHP was locked on first stage unless the house was 8°F from the set point, so it operates as an approximately 1.5 ton unit. The class recalculated the duct design based on the final system controls configuration (full-stage lock out) and the in-field revisions to the duct layout (elimination of the dedicated kitchen/laundry supply). Once the target airflows were determined, the attendees worked on best practice installation methods for the various HVAC components (see Figure 26).

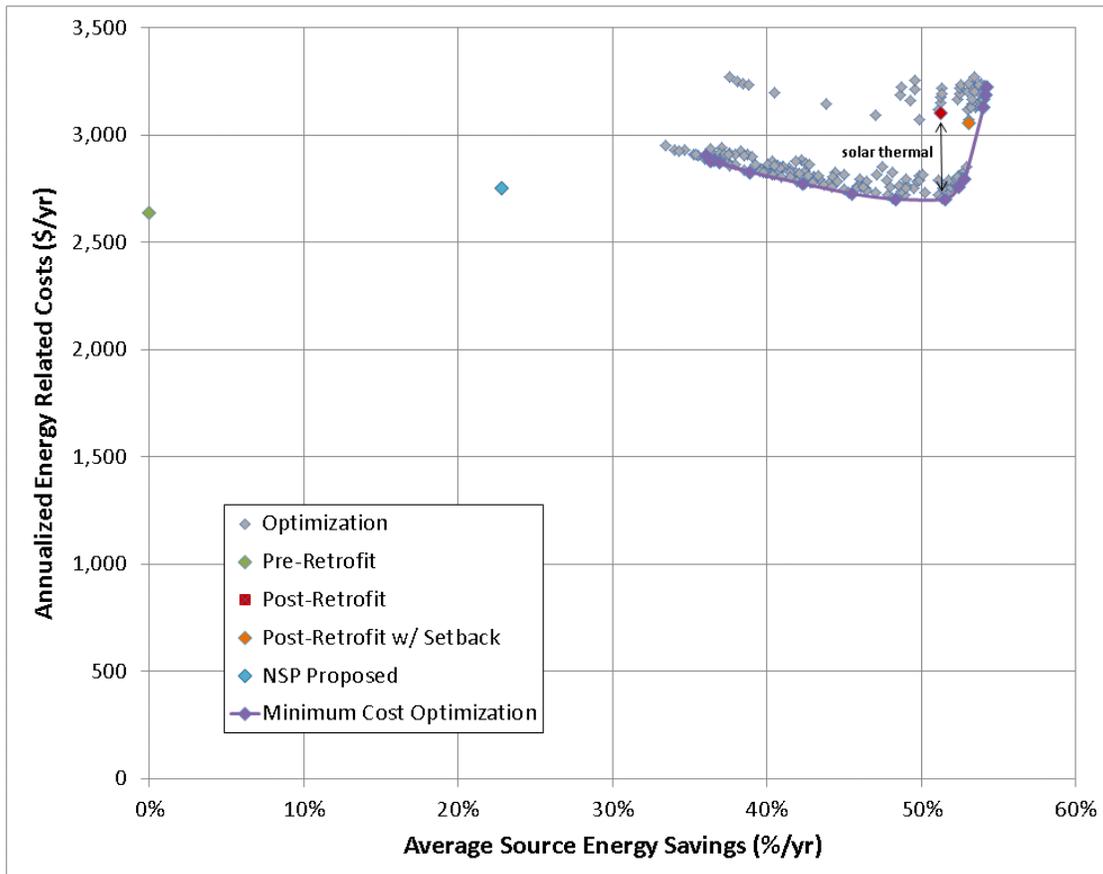
Figure 30. Final energy savings prediction for the Carmen home

The finalized BEopt model in Figure 30 confirms that the Carmen home was a very successful retrofit showcasing how typical homes in the region can be improved to reduce source energy consumption by 50% or more while maintaining annualized costs roughly the same over a 15-year period (after which the retrofit is cash positive). The difference between the final BA home and the minimum cost option was the use of solar thermal with the existing water heater versus a gas tankless water heater.

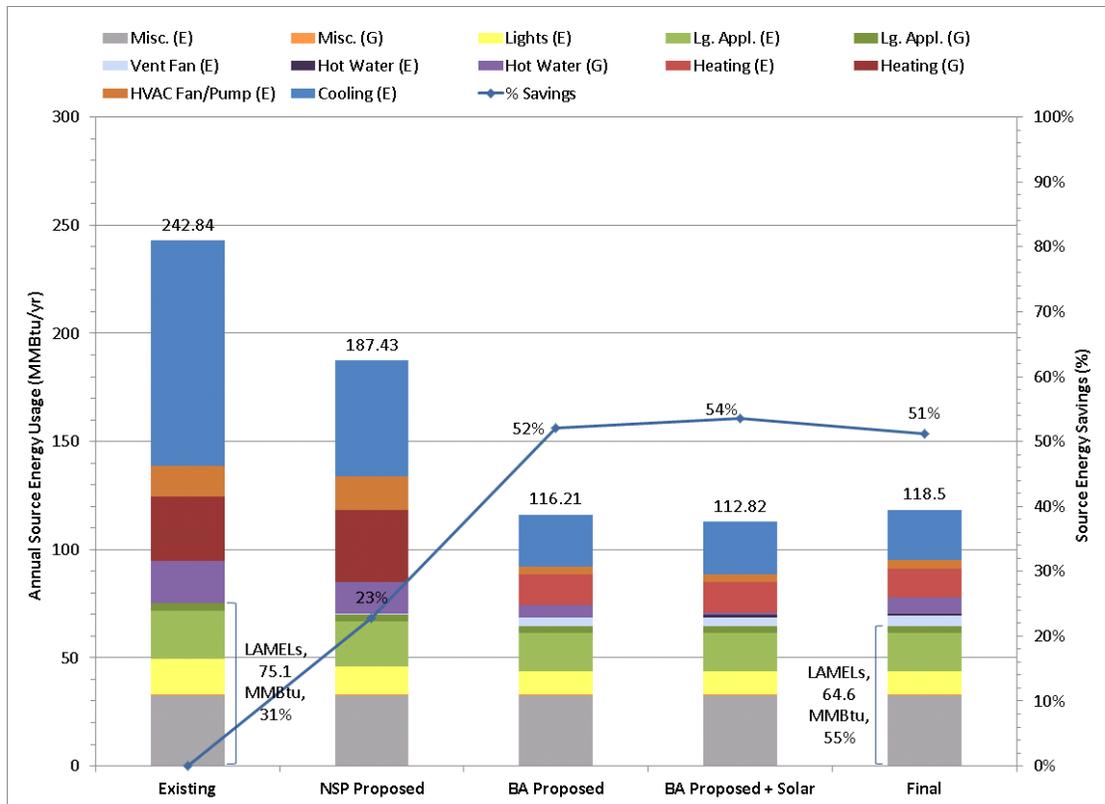
Figure 31. Cumulative contribution to total energy savings, by measure and end use, for the Carmen home

Figure 31 provides a look at the component end use for the various specification packages of the Carmen home. Based on the energy modeling, the predicted annual utility bill savings for the Carmen home is \$1,138 (\$2,543 pre and \$1,405 post = \$1,138) based on current utility rates (NV Energy \$0.11751/kWh and Southwest Gas \$0.76659/therm). This is a 45% savings in annual utility costs.

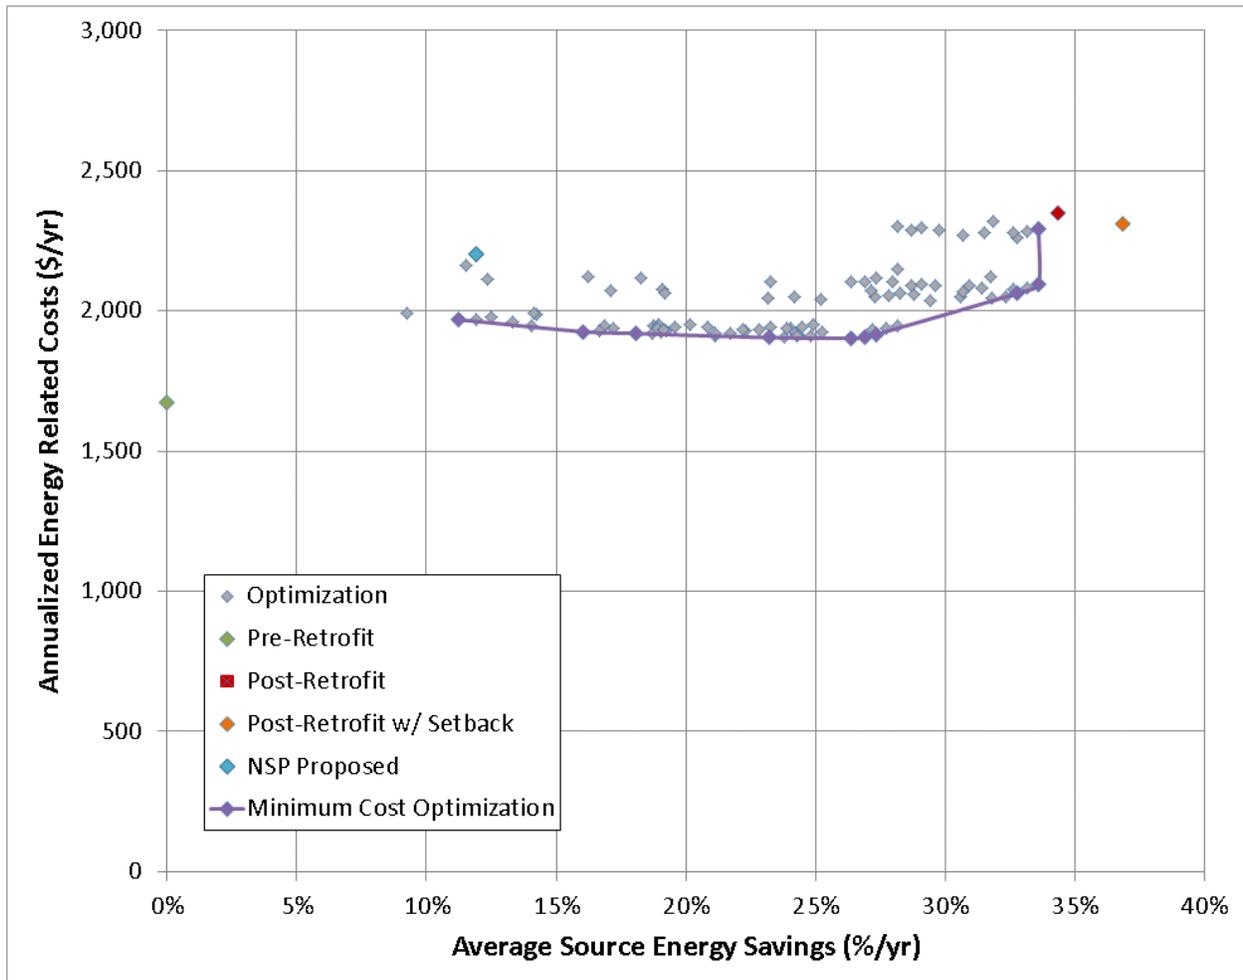
Figure 32. Final energy savings prediction for the Sierra Hills home

In this case, the final retrofit resulted in a 28.2% efficiency improvement over the NSP-proposed specifications and reduced the annualized costs by \$305/year. So if the decision has already been made to make improvements, the efficiency measures recommended by CARB can lead to lower annualized costs with improved comfort.

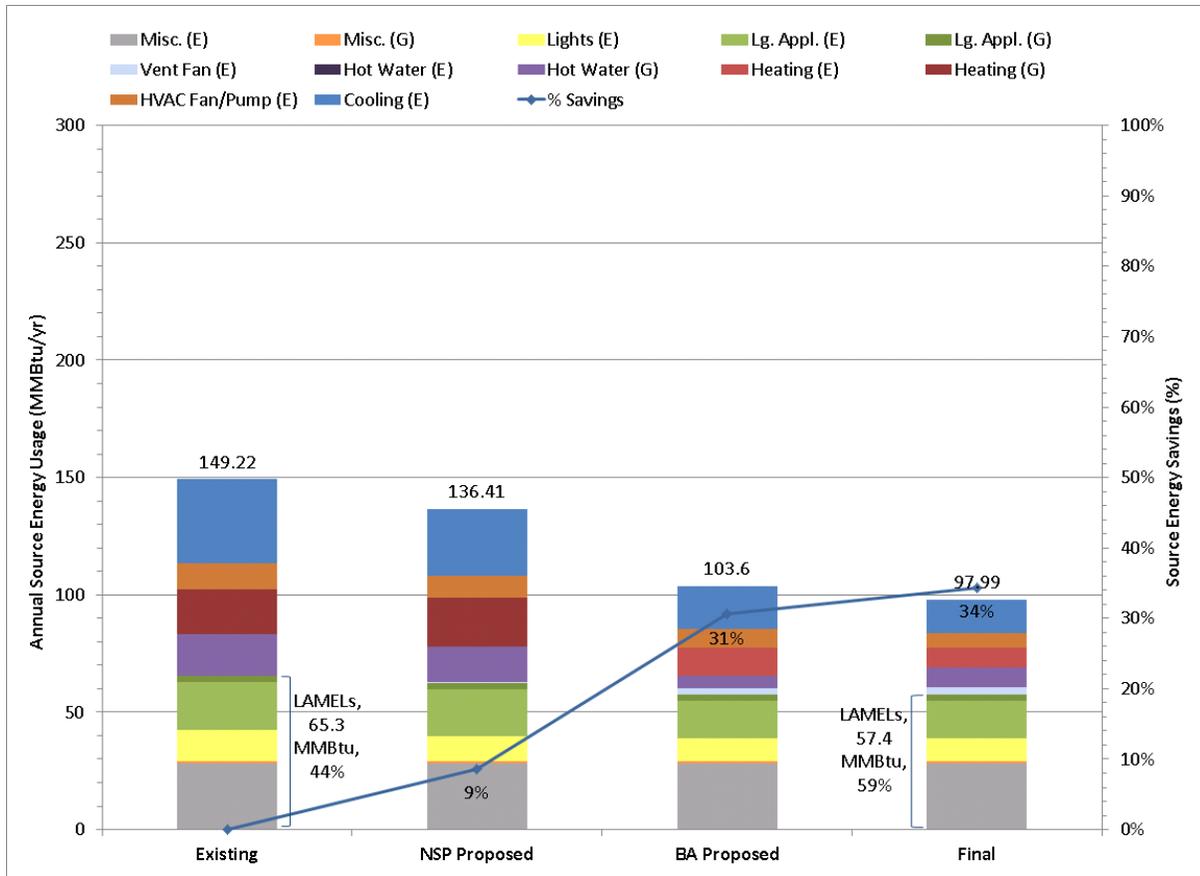
Figure 33. Cumulative contribution to total energy savings, by measure and end use, for the Sierra Hills home

Figure 33 provides a look at the component end use for the various specification packages of the Sierra Hills home. Based on the energy modeling, the predicted annual utility bill savings for the Sierra Hills Home is \$480 (\$1,672 pre and \$1,192 post = \$480). This is a 28.7% savings in annual utility costs.

In the existing home, the LAMELs accounted for 44% of the overall energy consumption. In the retrofitted home, the LAMELs now account for 59% of the remaining energy consumption. This makes achieving higher levels of energy savings difficult for this housing type/class without significantly higher annualized energy related costs.
