Duration Test Report for the Viryd CS8 Wind Turbine

J. Roadman, M. Murphy, and J. van Dam
National Renewable Energy Laboratory

Technical Report
NREL/TP-5000-58970
June 2013

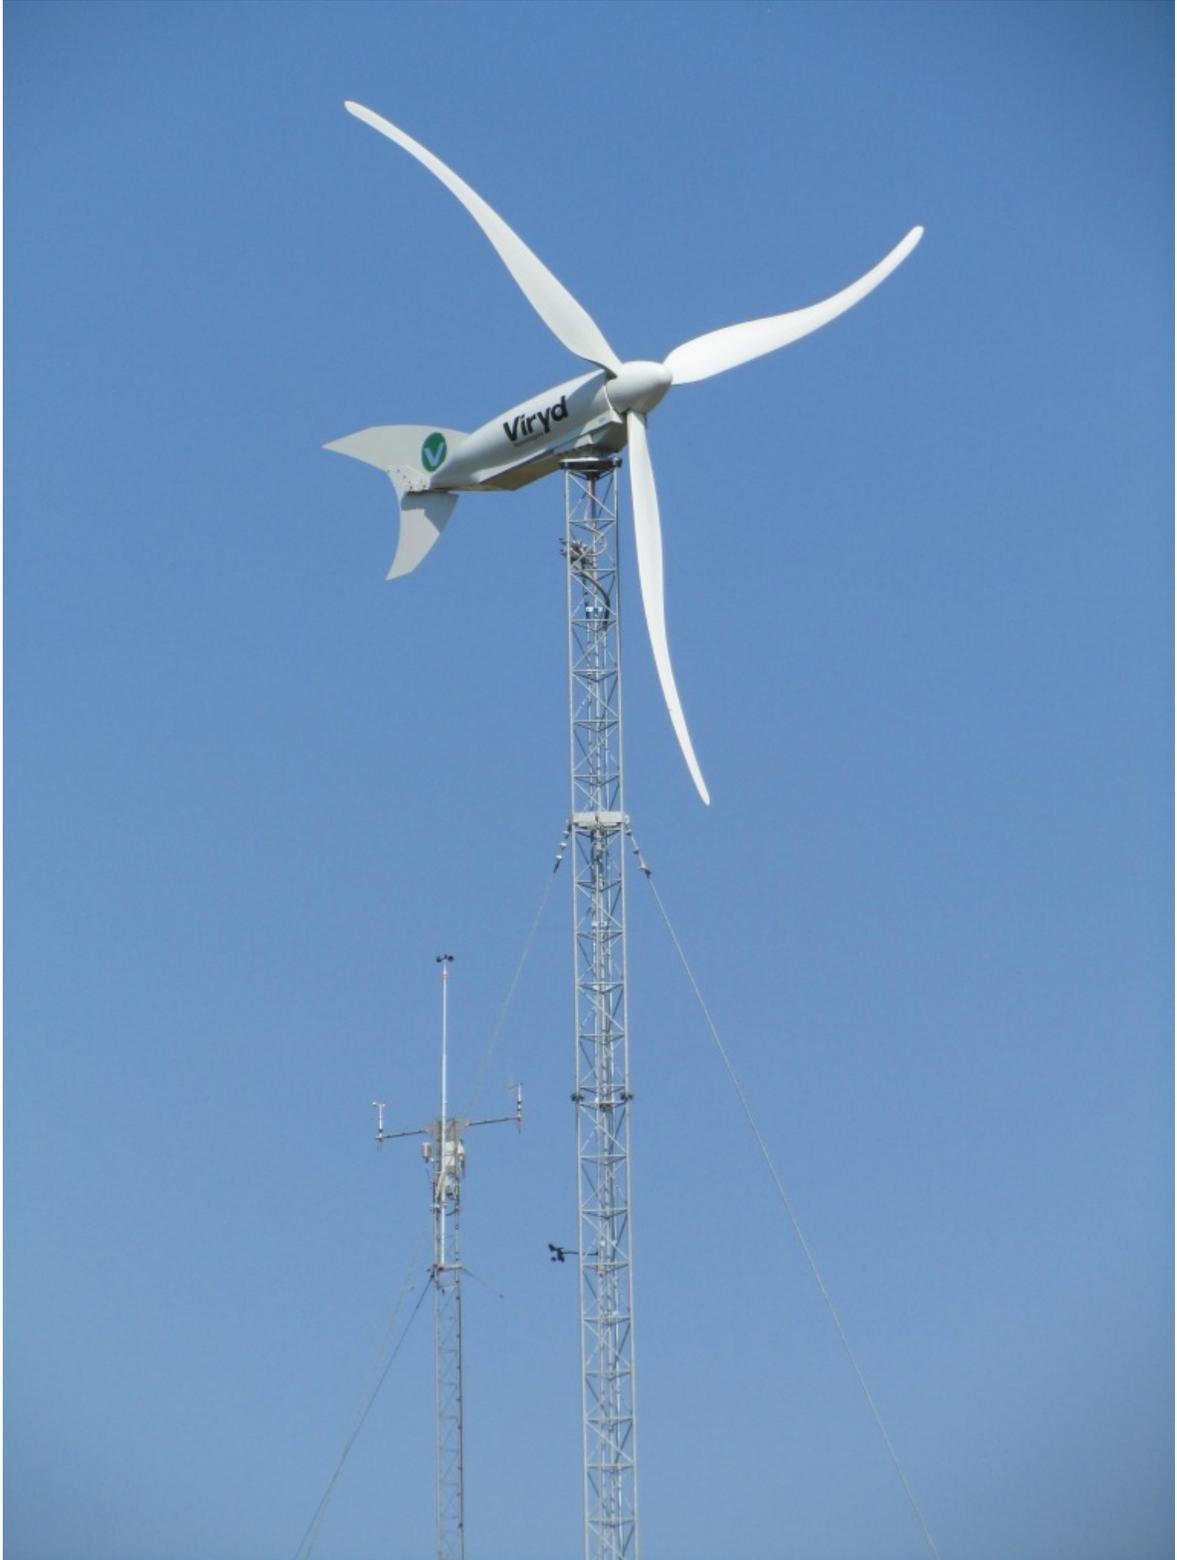
Figure 1. Viryd CS8 test turbine at the NWTC

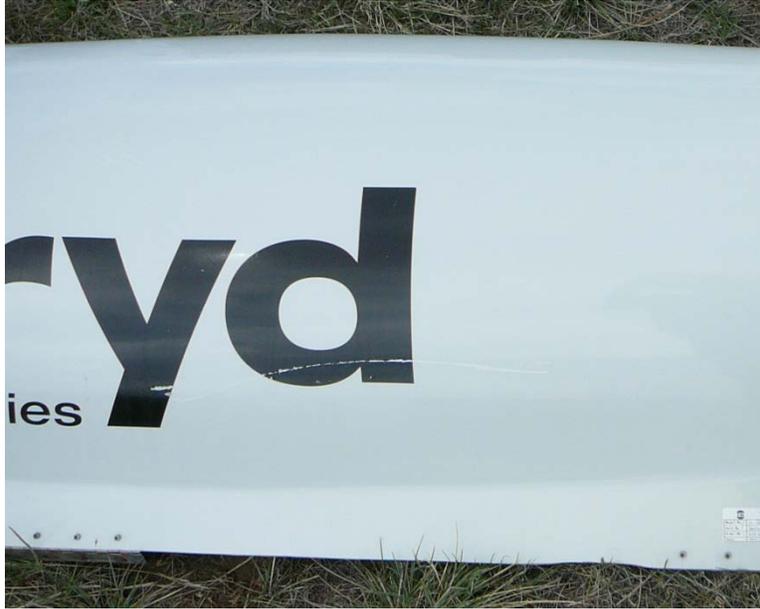
The nacelle cover was found to be in good condition. Minor cracking could be seen in some of the gel coat, but no structural cracking was observed. Minor scrapes in the paint (Figure C1) were also found, caused by the turbine yawing with the covers lowered during the up-tower inspections.

Figure C1. Scratches on Viryd nacelle cover

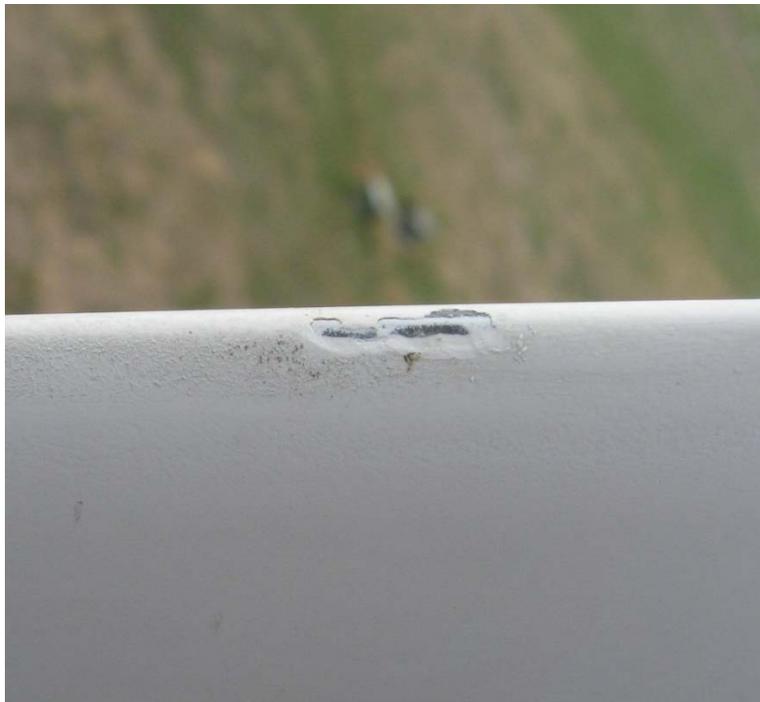
The turbine blades were found to be in good shape. A small chip was observed on the leading edge of one of the blades (Figure C2). All blade roots showed signs of light rubbing on the hub clamping brackets (Figure C3).

Figure C2. Chip discovered on leading edge of blade

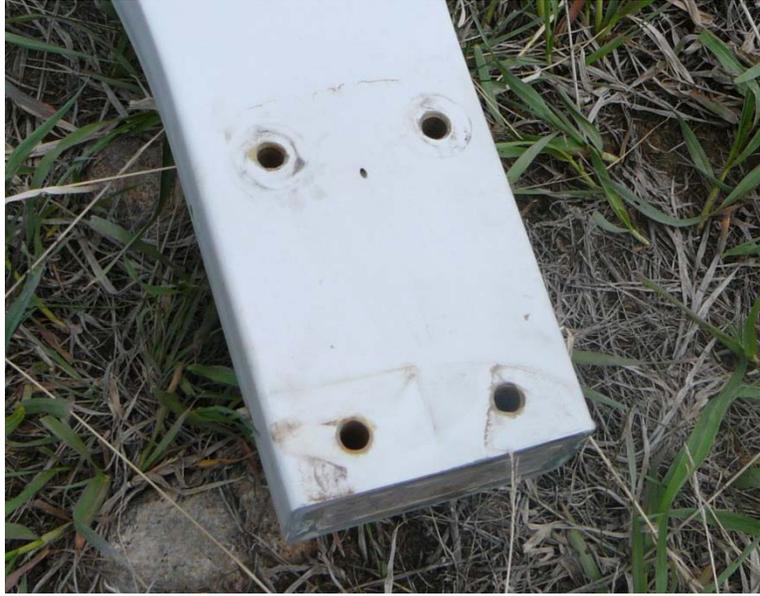
Figure C3. Blade root

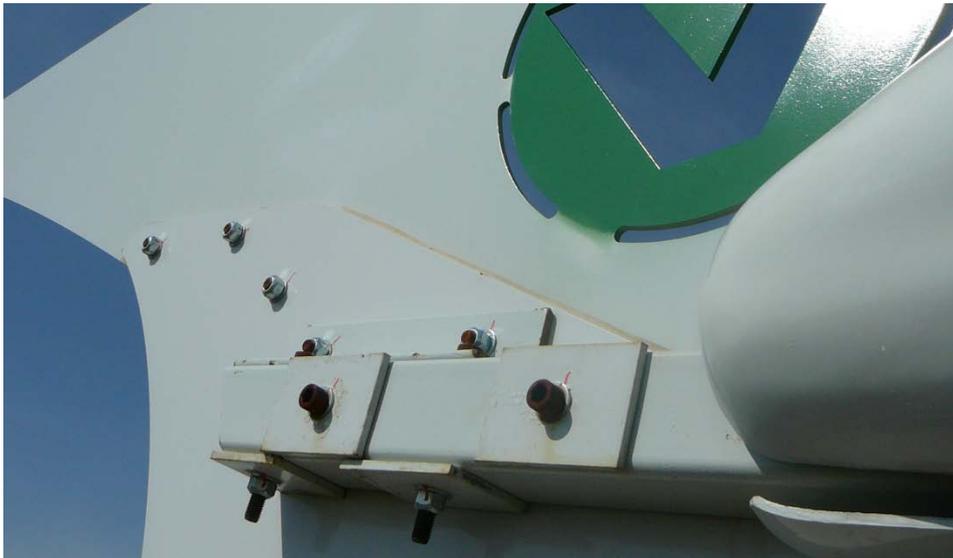
Figure C6. Rusty fasteners on tail

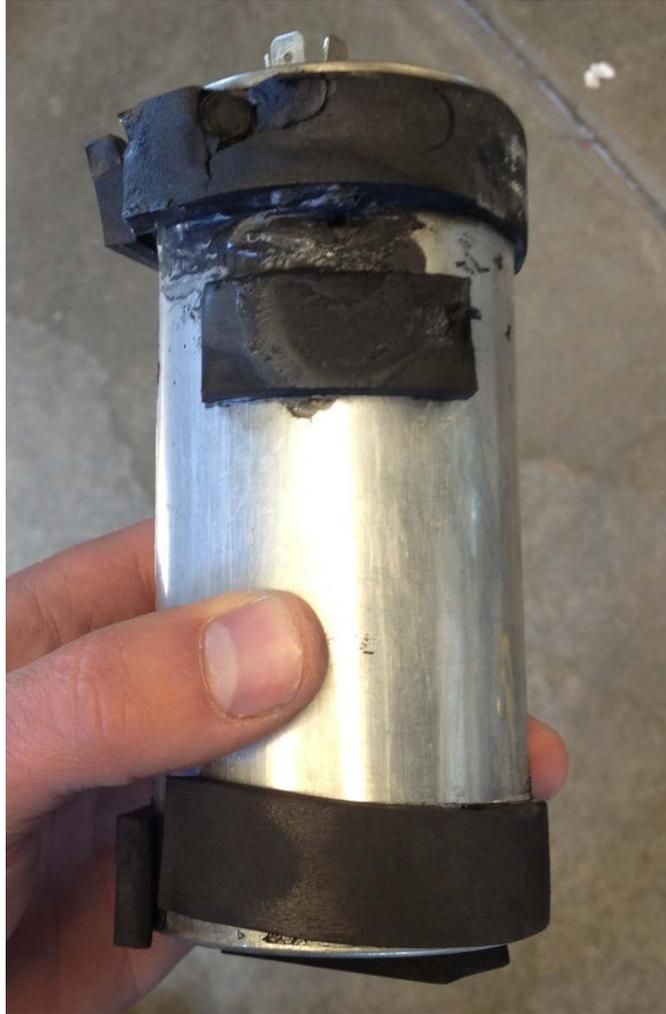
In Figure 7, two distinct power curves are observed, corresponding to a sharp decrease in power and power factor that was observed around 20 May 2012. It is worth noting that both run capacitors were found to be faulty during the post-test inspection (detailed in Appendix C). The NREL team suspect the failure of these capacitors caused the power degradation.

Figure C7. Failed run capacitor
