Safety and Function Test Report for the Viryd CS8 Wind Turbine

J. Roadman, M. Murphy, and J. van Dam
National Renewable Energy Laboratory

Technical Report
NREL/TP-5000-60060
October 2013

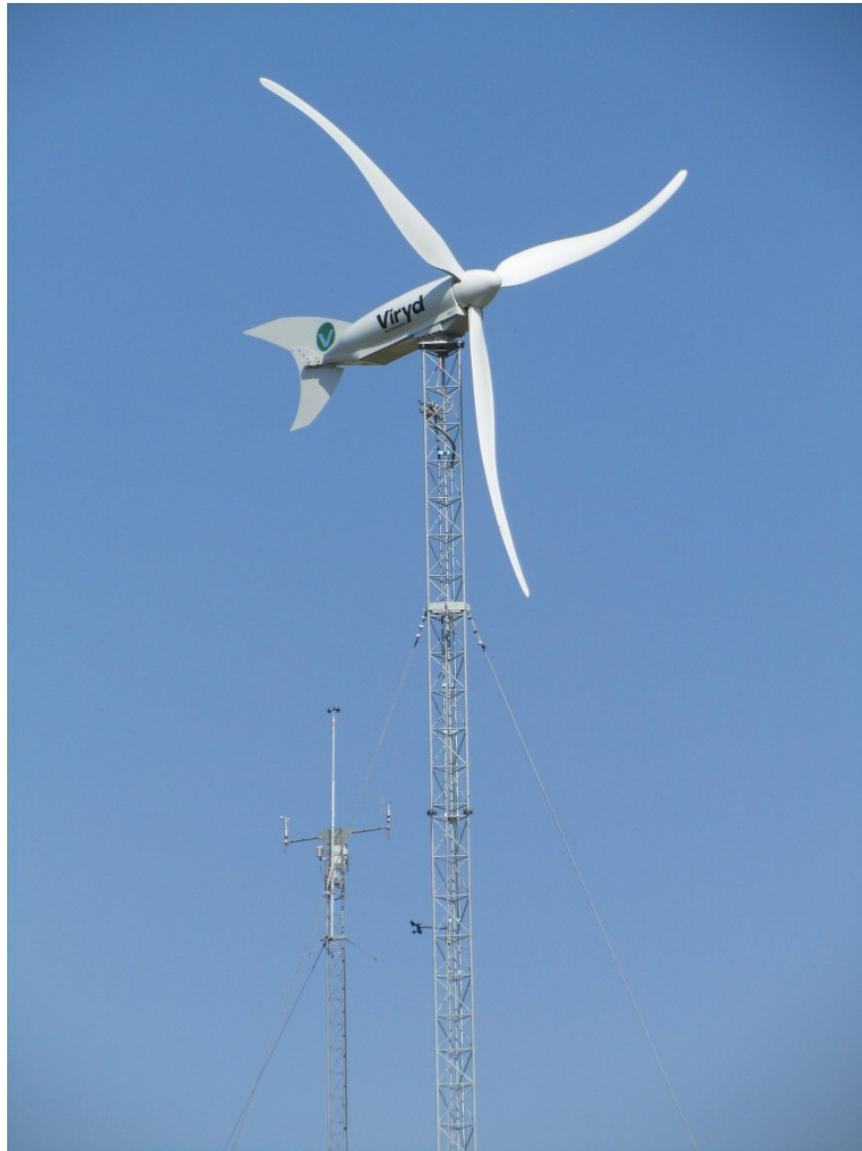
Figure 1. Virya CS8 test turbine at the NWTC
(Photo by Mark Murphy, NREL 22258)

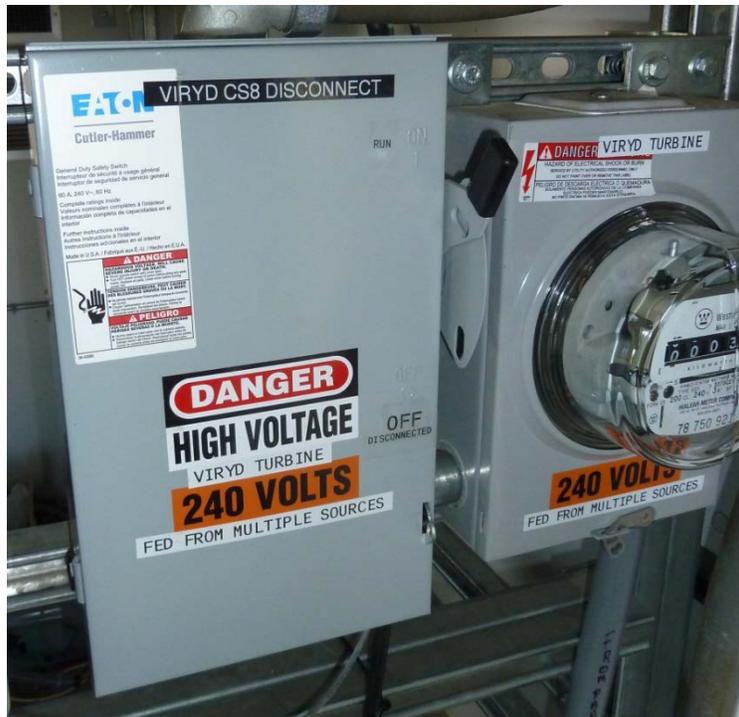
Figure 15. Viryd CS8 lockable disconnect switch and power meter
(Photo by Mark Murphy, NREL)

Viryd provided a lockable disconnect switch between the grid and the turbine (shown in Figure 15).

NREL staff added labels indicating the voltage levels on all enclosures, electrical panels, and disconnect switches (see Figure 15 and Figure 16).

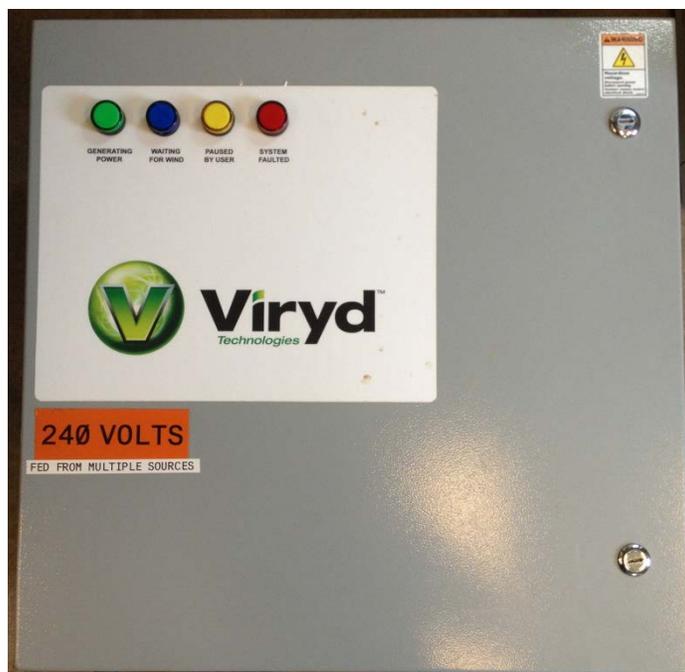
Figure 16. Viryd CS8 controller enclosure, showing a voltage warning and additional voltage labeling added by NREL

There is one safety sign on the turbine that states: “Hazardous voltages, disconnect power before opening. Contact causes severe electrical shock.” See Figure 16.
