# Gearbox Reliability Collaborative Update

**Sandia Reliability Workshop**  
**Albuquerque, NM**  
**August 13-14, 2013**  
**NREL/PR-5000-60141**

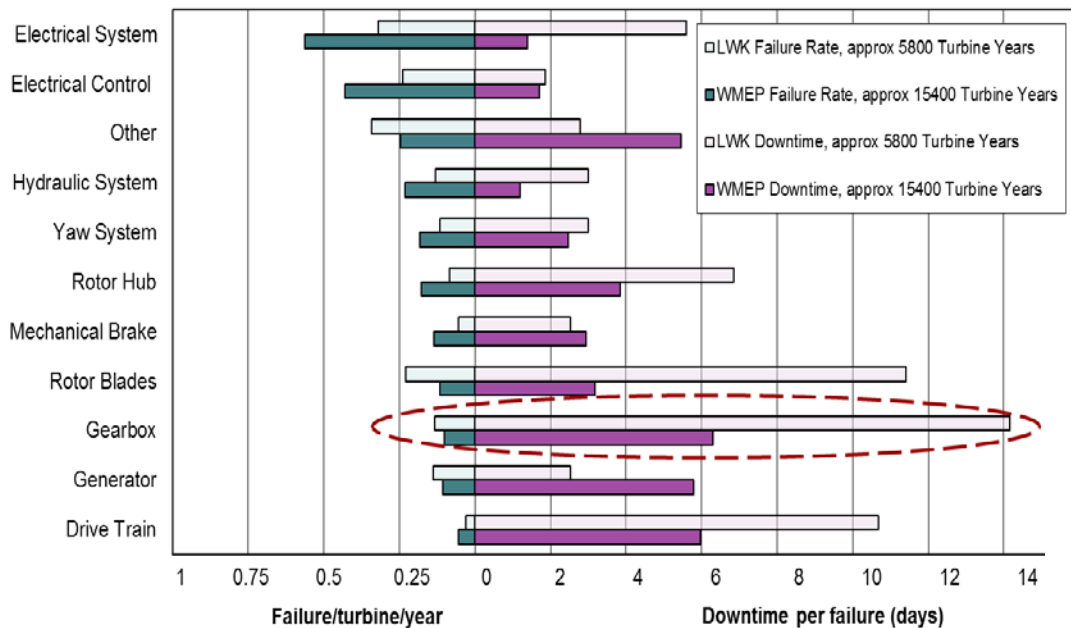
Failure/turbine/year and downtime from two large surveys of land-based European wind turbines over 13 years

- WMEP and LWK databases represent ~2,150 turbines [1]
- Data ranging from 1993 to 2006, when both databases were closed [1]
- Gearboxes do not fail often but cause the highest downtime [1]

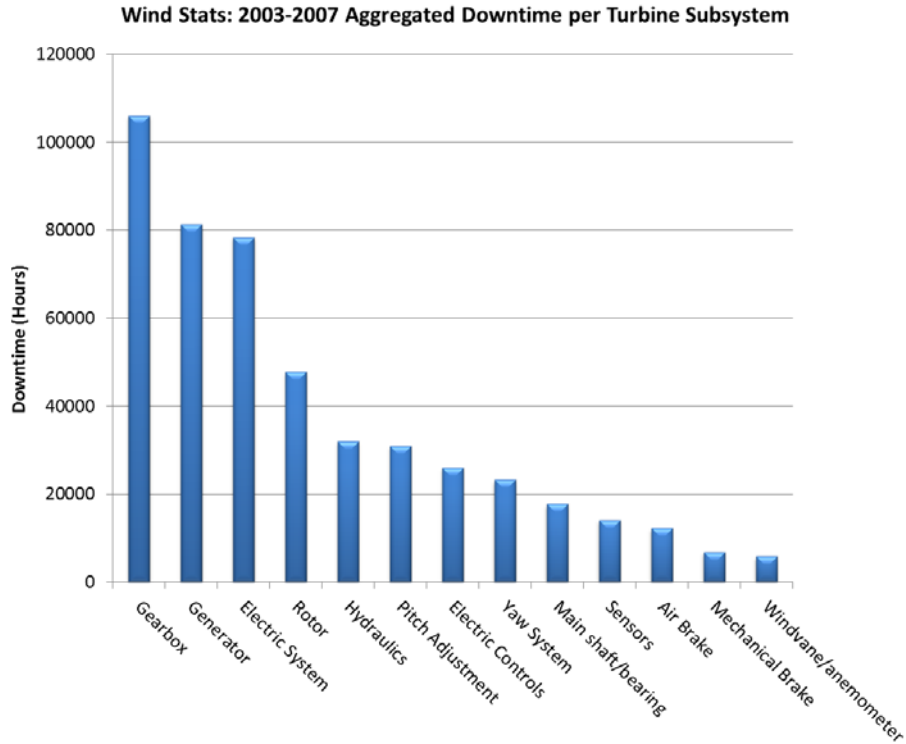
- Aggregated downtime per turbine subsystems from 2003 to 2007 (left) and from 2008 to 2012 (right):
  - Both periods indicate the gearbox as the highest downtime driver
  - The 2008–2012 period shows less downtime than the 2003–2007 period for most subsystems
  - The top four drivers stay the same with a little variation in sequence: gearbox (1 = >1), generator (2 = >4), electric systems (3 = >2), and rotor (4 = >3)

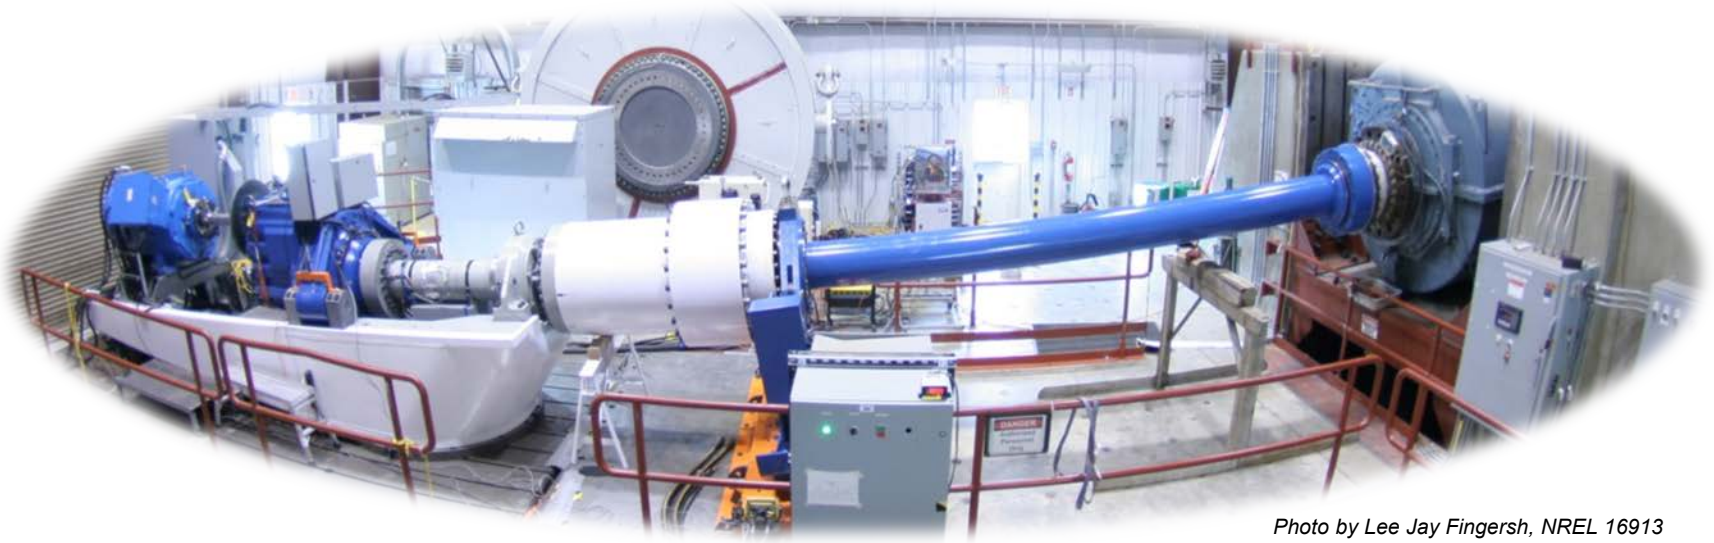
- Use smaller gearbox to control costs: 750 kW
- Lack of public models → redesign/rebuild gearbox
  - First iteration brings to state-of-the-art circa 2007: gearbox 1 and 2
  - Second iteration brings to state-of-the-art circa 2012: gearbox 3
- Significant internal and external instrumentation
  - Main shaft, gearbox, coupling, and generator displacements
  - Planetary section loads
  - High-speed shaft, pinion, and bearing loads recently added

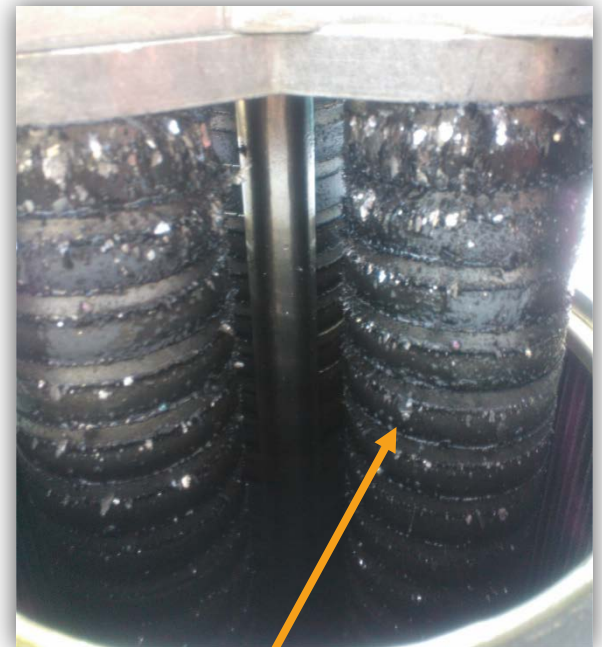
gearbox filter

- Most costly repair
- Commonly due to rolling contact fatigue
- Bearings are designed close to the margins (safety factor close to 1)
- Excellent filtration can save the rest of the gearbox

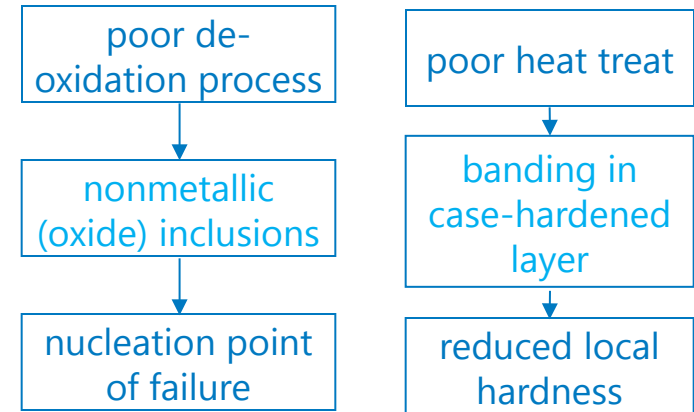
- **Manufacturing defects**
  - Nonmetallic inclusions
  - Microstructural banding
  - Inconsistent induction hardening depth
  - Gear-grinding temper
- **Defects alone are not a *failure mode*, but serve as the *initiation of failure***
- **More common in gears than bearings**

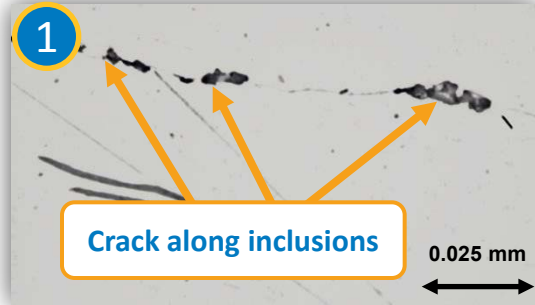
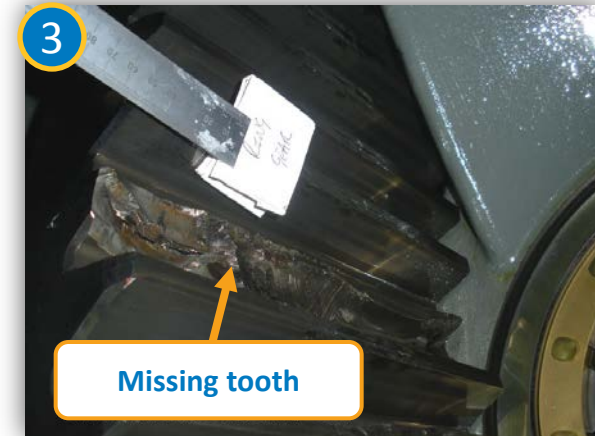
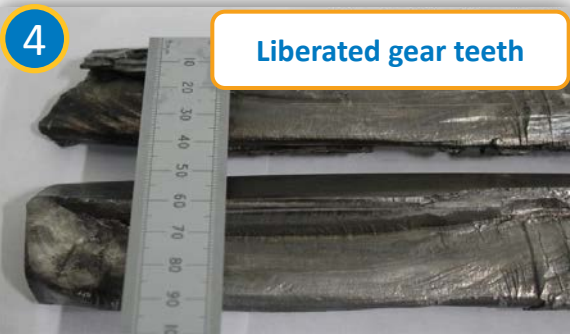
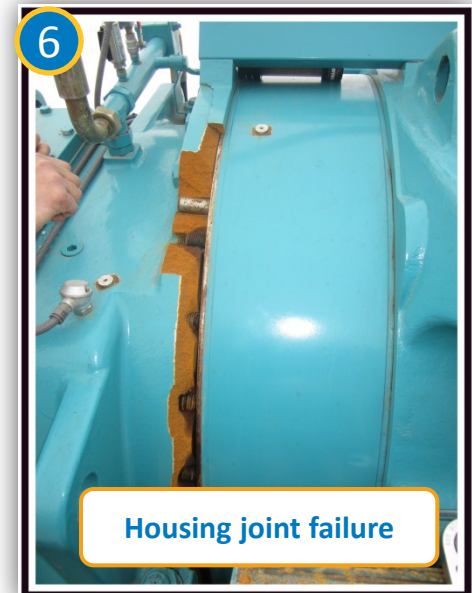
- Gear rating standards assume that the designer has good quality steel and a well-controlled heat treat process

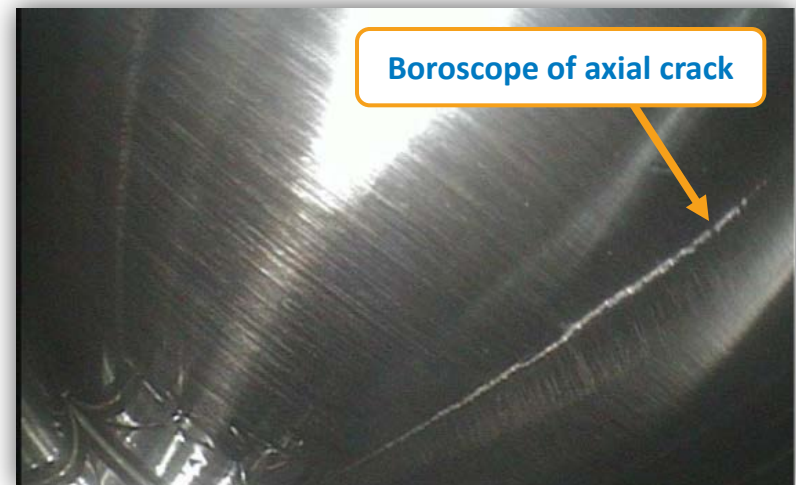
- **Widespread problem with unknown root cause**
  - Topic of research
  - Some OEMs are moving to case carburized bearings
- **Occurrences typically on inner race of cylindrical roller bearings (CRBs)**
  - Current rating standards do not cover this failure
  - White etching areas (local hardening) seem to serve as nucleation points

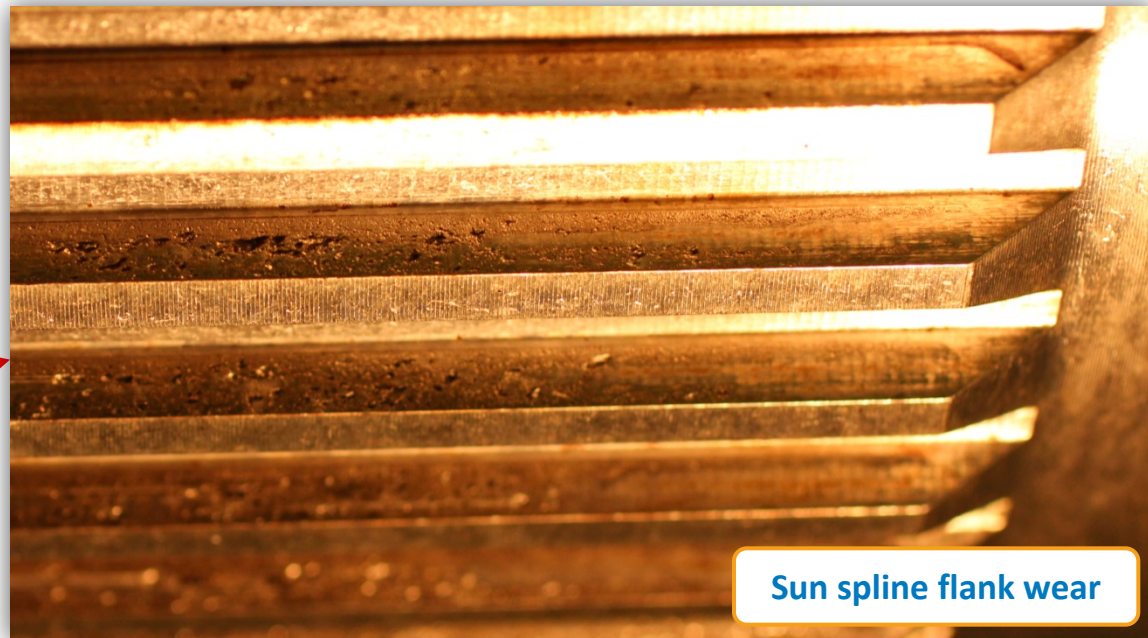
- **Commonly show signs of fretting and pitting**
  - Difficult to lubricate
- **Not a common failure mode**
  - Debris generated is ideally flushed away with minimal consequential damage to gears and bearings
