Disaggregating Hot Water Use and Predicting Hot Water Waste in Five Test Homes

Hugh Henderson and Jeremy Wade
ARIES Collaborative

April 2014

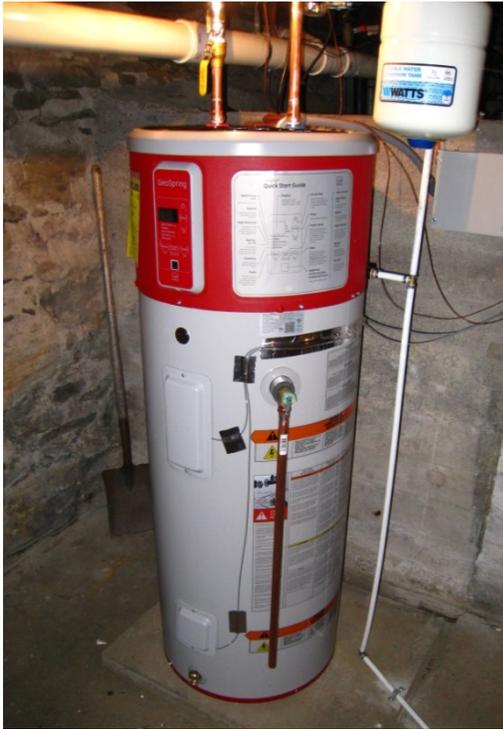
Figure 46. GeoSprings HPWH

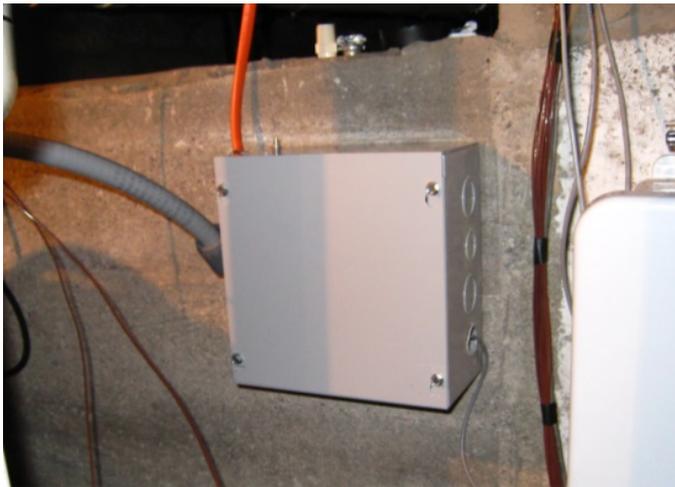
Figure 55. HPWH power is measured inside this enclosure. Inside are the CTs and power transducer.

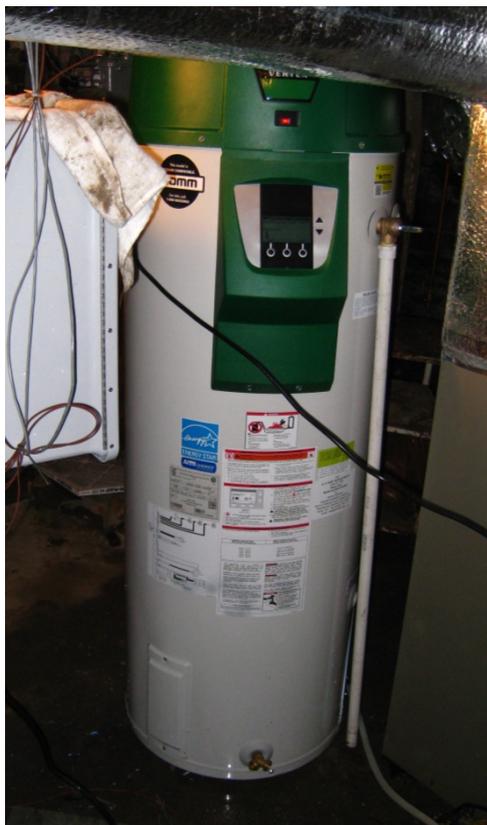
Figure 60. New condensing gas storage water heater installed during retrofit.

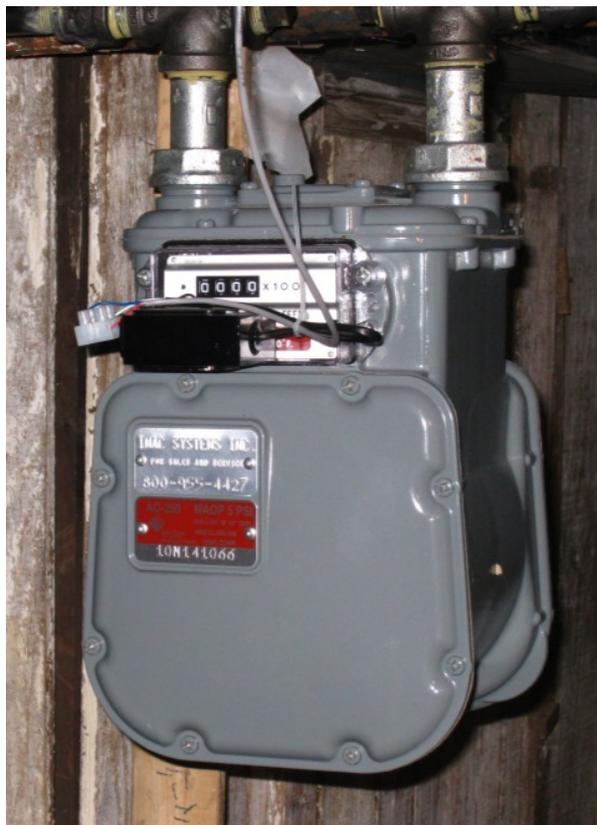
Figure 61. IMAC gas meter with pulser to measure gas use.

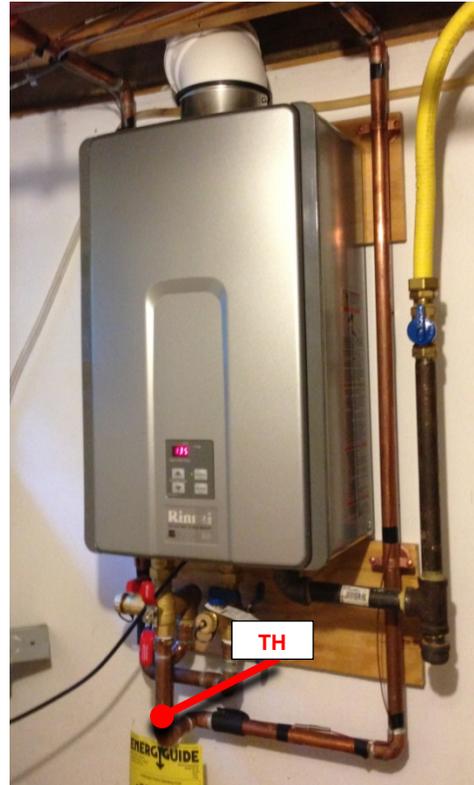
Figure 68. New tankless water heater from retrofit

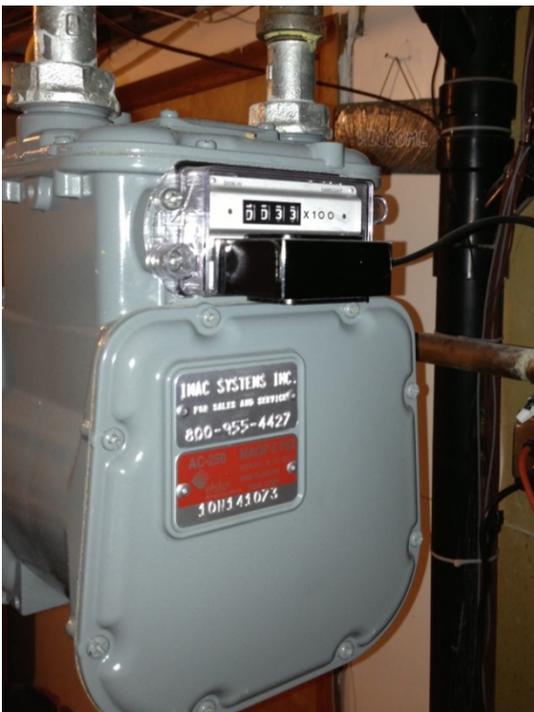
Figure 69. IMAC gas meter with pulser

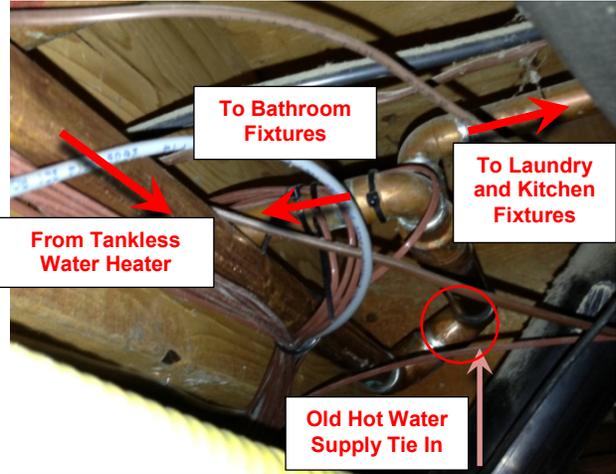
Figure 72. Shows direction of hot water flow after retrofit. The old hot water supply tied into the pipe at the elbow circled in red and was a vertical drop to the old water heater.

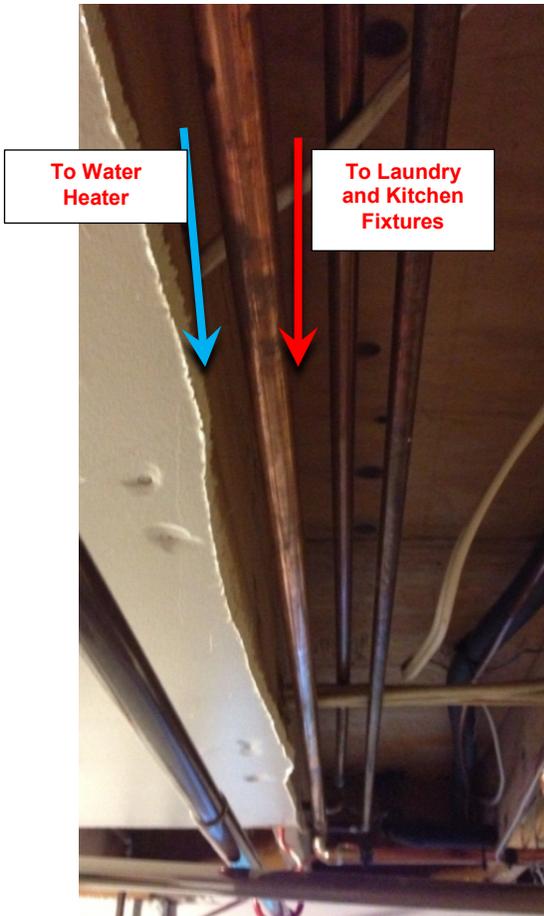
Figure 73. Shows lengthened cold water supply piping
