Evaluation of Passive Vents in New Construction Multifamily Buildings

Consortium for Advanced Residential Buildings

February 2016

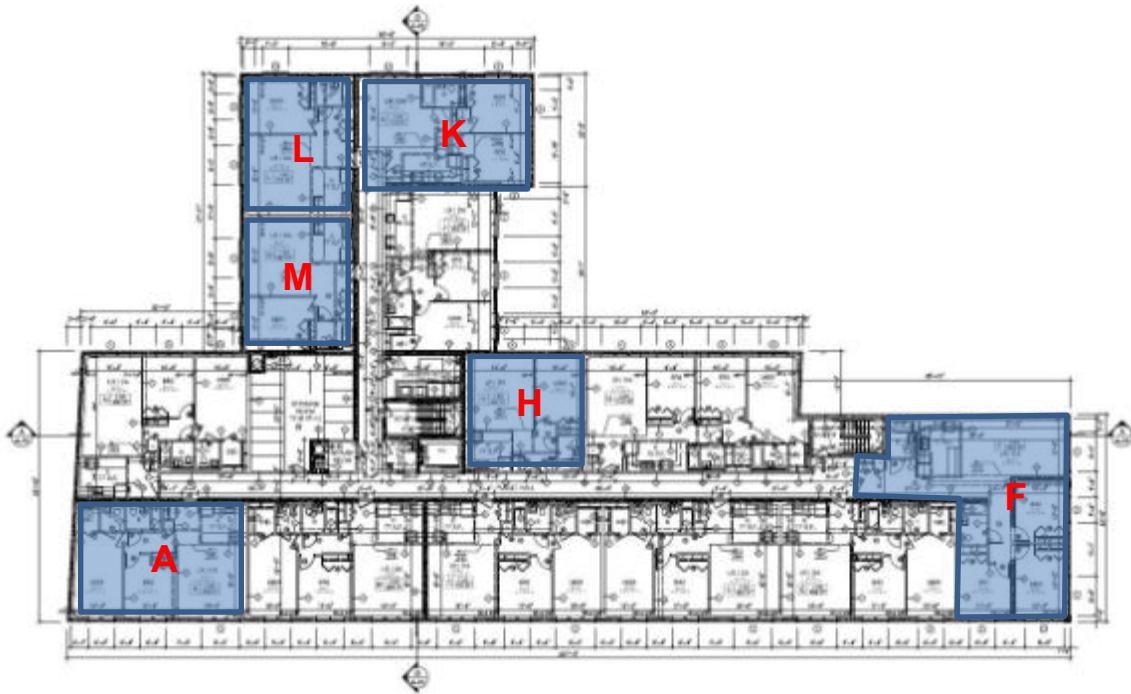
Figure 1. Typical floor plan of Test Building #1

Test Building #1 is located in the Bronx, New York and was part of the original evaluation of ventilation strategies CARB conducted in 2013. It is a five-story, T-shaped building with 13 apartments per floor. Each floor has a laundry room, refuse room, storage room, elevator bank, and two stairwells. Figure 1 shows a typical floor plan. Pressure monitoring was conducted in apartments 3F, 4K, 4L, 4M, 5A, and 5H, which are located on the third, fourth, and fifth floors.

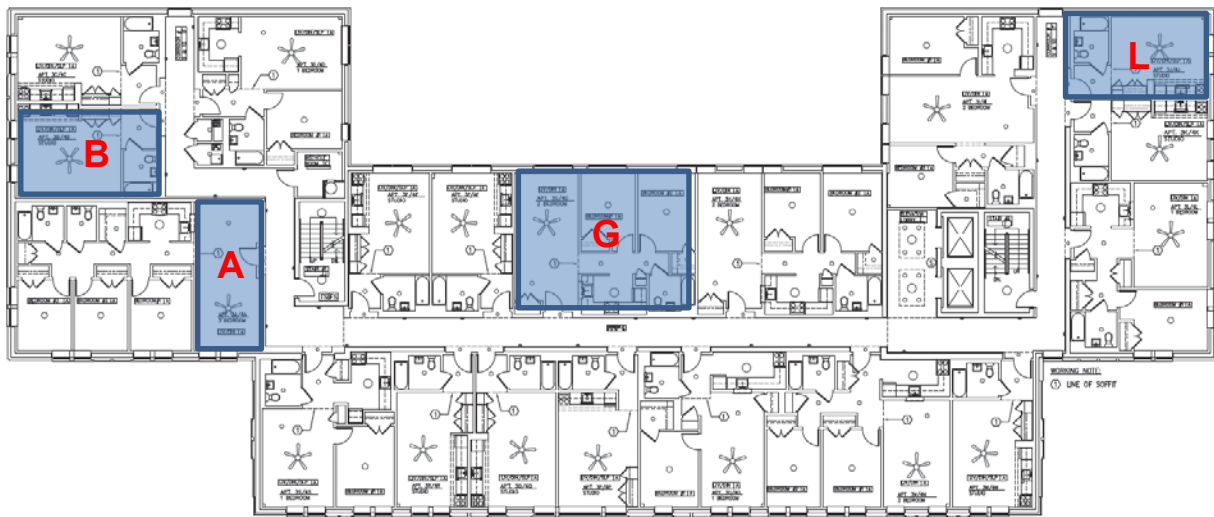
Figure 2. Typical floor plan of Test Building #2

Figure 2 shows a typical floor plan. Pressure monitoring was conducted in apartments 1A, 2B, 3B, 4G, 5B, and 6L, which are located on the respective floors.

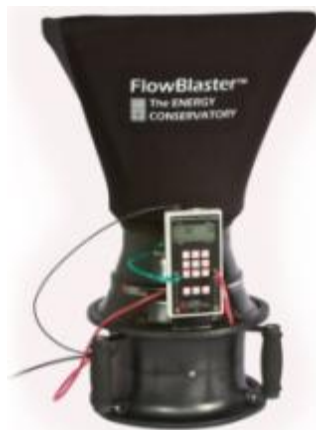
Figure 4. Powered flow hood. Image from The Energy Conservatory

Exhaust flow testing involved using an orifice/pressure box (accuracy $\pm 10\%$) or powered flow hood (accuracy $\pm 5\%$) to measure airflow at apartment exhaust registers and comparing them to design values.

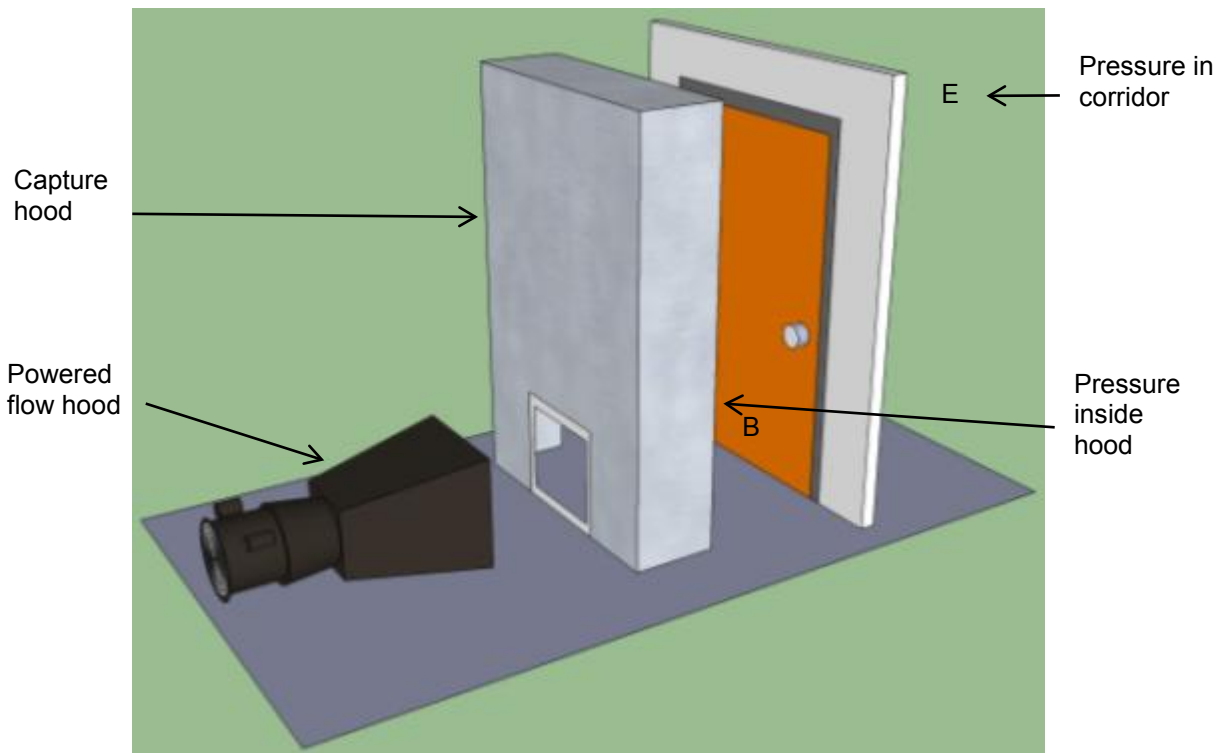
Figure 5. Setup for testing air leakage from a door frame

The testing apparatus for this experiment consists of a capture hood to encapsulate the door and capture airflow and a fan to impart a pressure on the hood and measure airflow. Readings were taken at different pressure drops across the door and the data analyzed to identify a basic curve for predicting airflow through a typical apartment door in the building. These data were then combined with pressure monitoring results to infer the direction and magnitude of airflow across the apartment doors throughout the building over time.

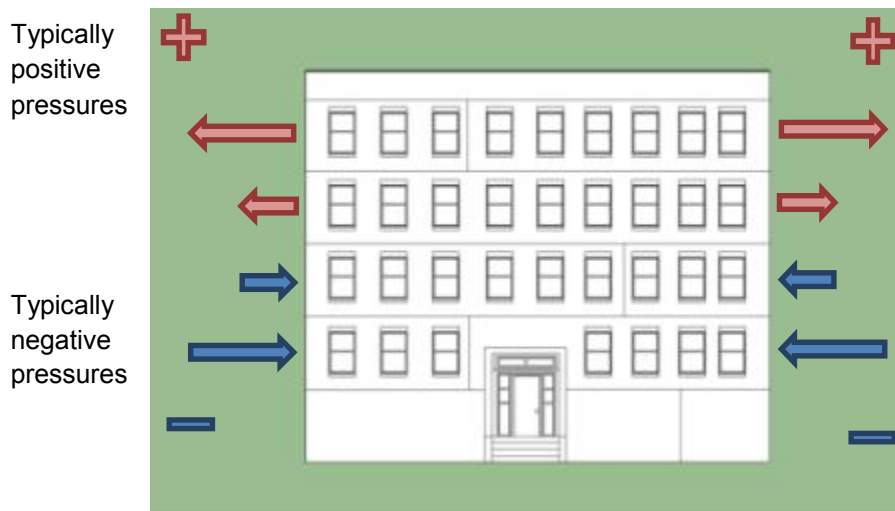
Figure 6. Typical pressure patterns in a multistory building in winter

Airflow patterns in buildings are dependent on pressure differentials. Understanding the major patterns of pressure fields is important to predicting the behavior of the airflow-related systems (mechanical, envelope, etc.) under various environmental and operational conditions. In typical buildings during the winter, as warm air rises, pressures that prevail on the exterior envelope are positive with respect to (WRT) the outside near the top of the building and negative at the bottom of the building. For a typical building, this results in airflow into the apartments on the lower floor and airflow out of the apartments on the upper floors (Figure 6). Because passive vents rely on airflow into the apartments to provide ventilation on all floors, buildings selected for the study were limited to high-performance buildings that required compartmentalization to minimize the impact of these seasonal pressure differentials.

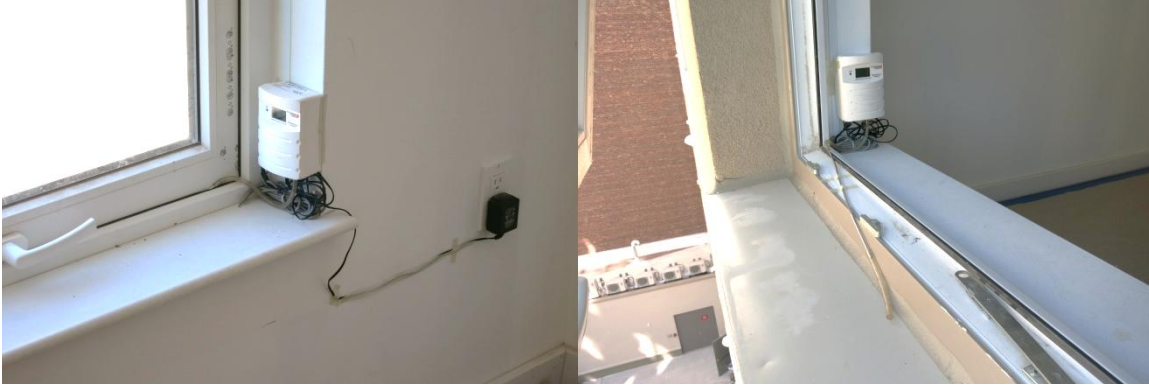
Figure 7. Placement of window data loggers for pressure measurement (shown without exterior shield)

To create this map, an array of pressure sensors was used to monitor pressure differentials between key building areas. Five points were measured with digital gauges over a 1–2 week period. Pressure measurements with an accuracy of $\pm 3.5\%$ between the apartment and the outside were collected at 1-minute intervals and then averaged over every hour to give a general picture of pressure in the spaces over time. Figure 7 shows the placement of window data loggers.

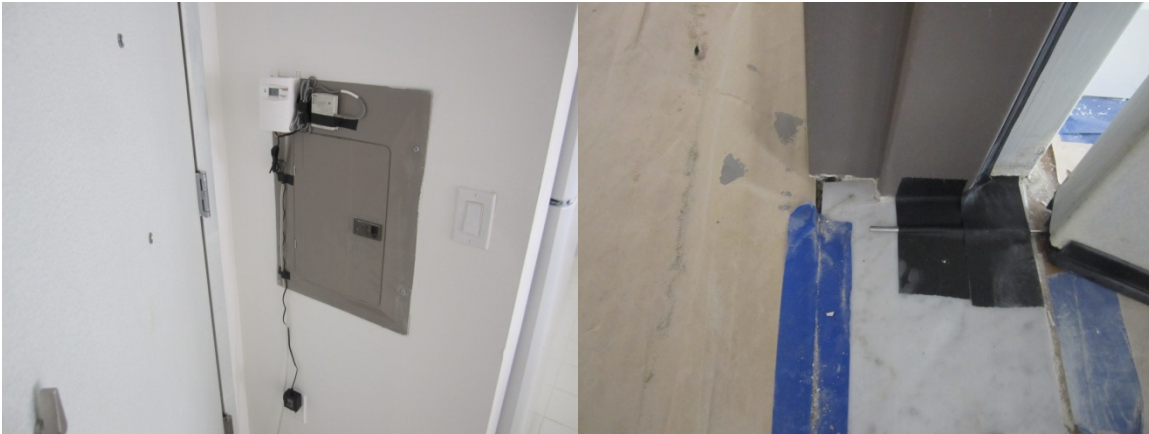
Figure 8. Placement of pressure transducer under corridor door

Pressure measurements between the apartment and the corridor were also taken with data loggers at 1-minute intervals and averaged over every hour. Figure 8 shows the placement of a pressure transducer.

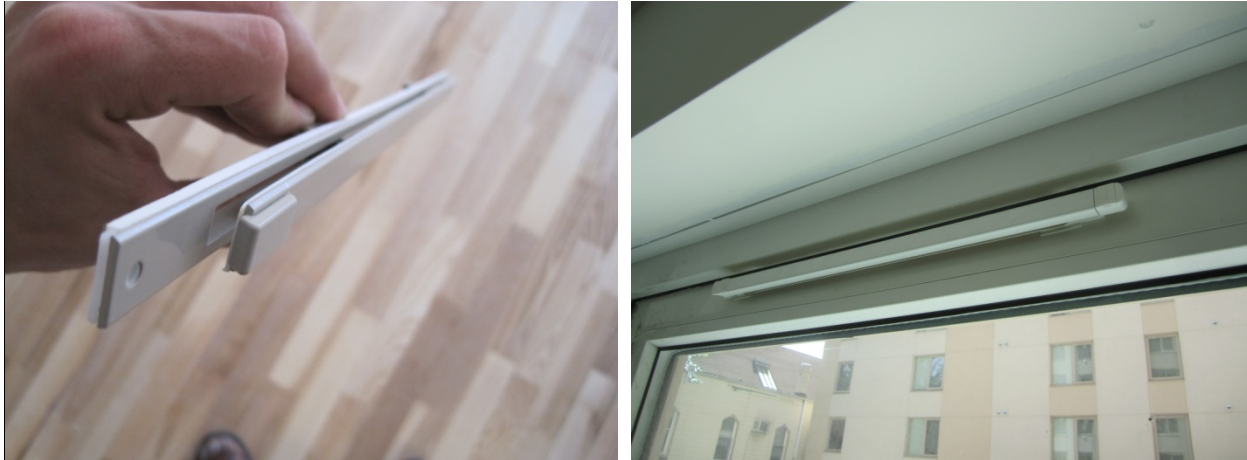
Figure 9. Common trickle vent (left) and installation in a window frame (right)

To evaluate whether the ASHRAE 62.2 whole-house rates are being satisfied by outdoor air, measurements of the amount of makeup air that enters an apartment from the outdoors through passive vents are needed. This test building uses trickle vents, a type of passive vent, to provide outdoor air to apartments. Figure 9 (left) shows a photo of one type of trickle vent; Figure 9 (right) shows another in a typical installation in a window frame. The window manufacturer typically installs the vents. An opening is created in the frame per the trickle vent manufacturer's specifications (typically 2 in.–4 in.²), and the vent is affixed to the window over the opening.

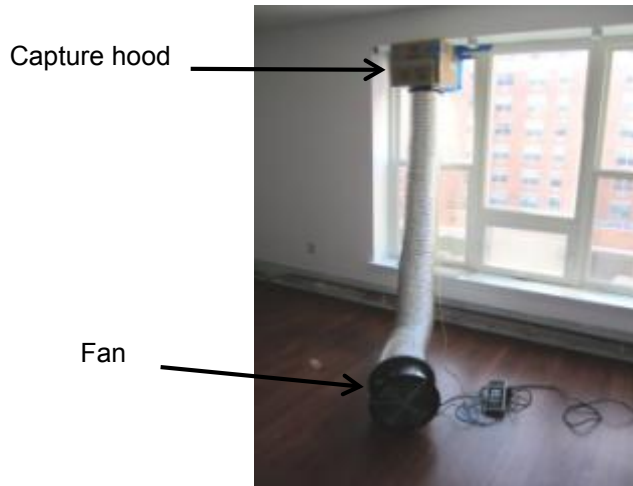
Figure 10. Setup for testing airflow through trickle vents

The CARB team tested a sample of trickle vents to characterize their performance as installed. Five trickle vents were tested by inducing a pressure differential on either side and measuring the airflow. A capture box was sealed around each vent and a Duct Blaster fan from The Energy Conservatory was used to create a pressure on one side. The pressures on the inside and outside aspects of each vent were measured with manometers, and the calibrated fan was used to measure the airflow (accuracy $\pm 3\%$). Figure 10 shows a photo of the testing apparatus.

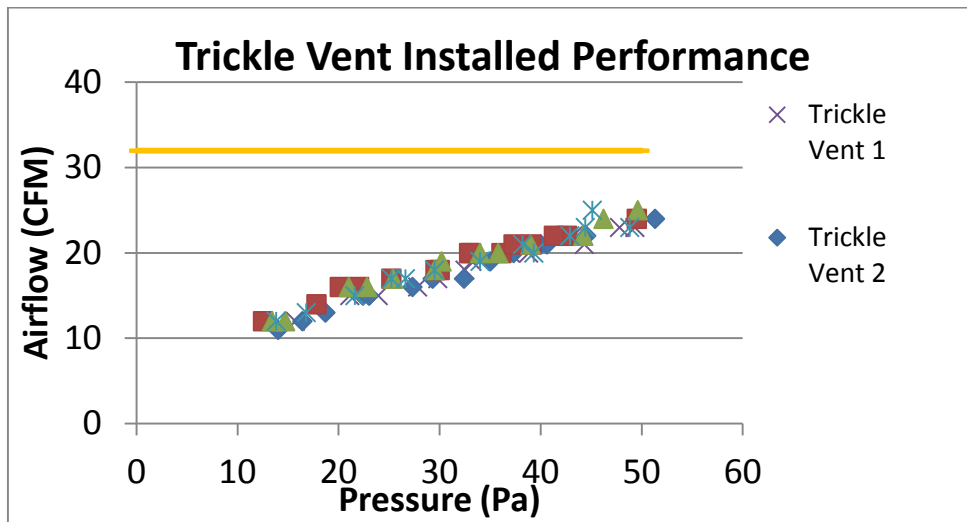
Figure 11. Trickle vent flow at varying pressures

Figure 11 shows the test results for five separate vents. Airflow through the vents was measured at a variety of pressures. A clearly recognizable pattern emerges. The first trickle vent was tested under positive and negative pressures, and the results were almost identical. The remaining four vents were tested under negative pressure only. Figure 11 shows results from the negative-pressure tests only.

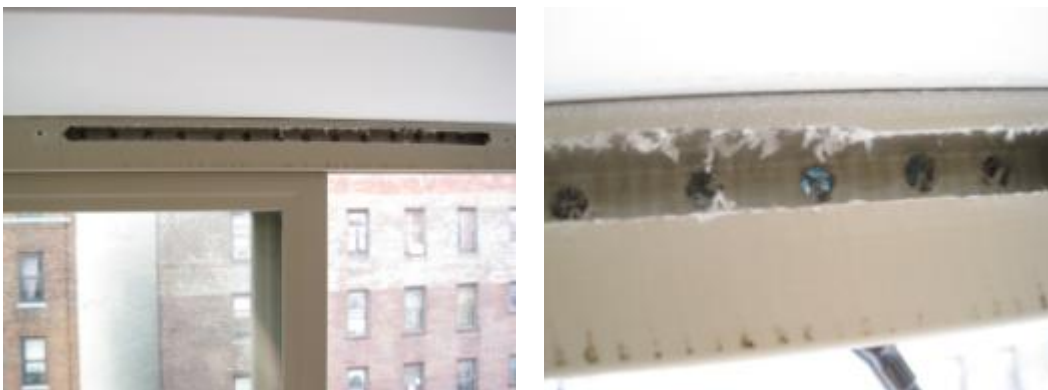
Figure 12. Cut for trickle vent in window frame (left), trickle vent removed; close-up of the opening (right)

Trickle vents must be installed well to function as intended. In a building that CARB evaluated for other studies, the lack of measured performance from a trickle vent prompted an investigation of the installation. The vent cover was removed from the window frame and closely examined. The air pathway was significantly blocked through the layers of the window frame because the vent was poorly manufactured. The initial cut did not go through the depth of the frame, so secondary holes were drilled. The opening should be one continuous space that passes through the entire depth of the frame. Obviously, such defects negatively impact the function of the vents.

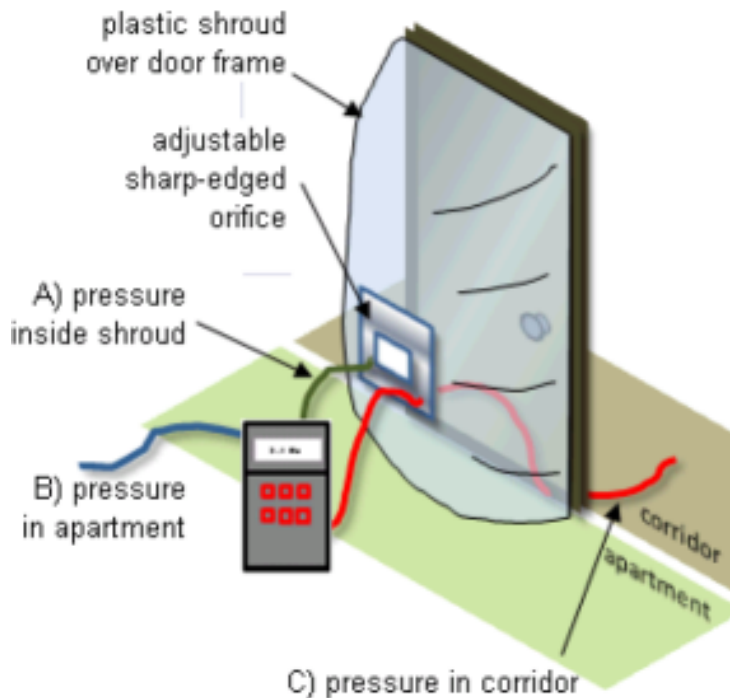
Figure 13. Setup for testing airflow through door gap with a plastic shroud and orifice plate

Another approach used a sharp-edged orifice and pressure measurements to estimate door gap size and airflow under normal operating conditions in the apartment. A plastic shroud was taped over the door frame, and a plate with a sharp-edged orifice was fixed to the shroud. Figure 13 provides an illustration.

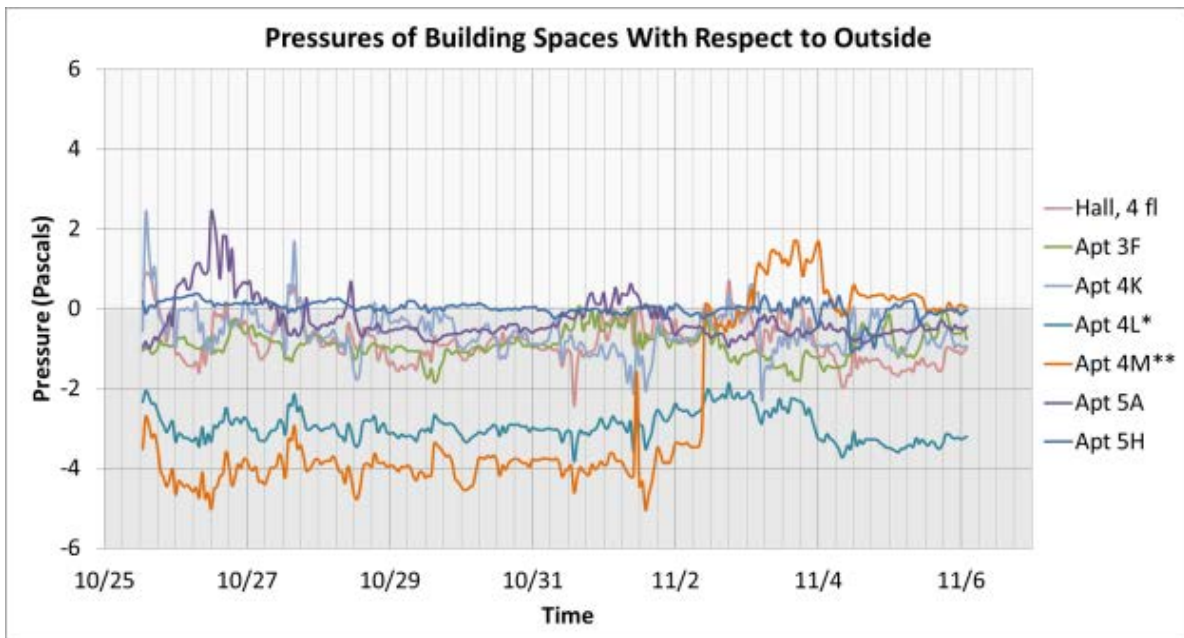
Figure 14. Pressure in several building spaces over time

Figure 14 shows the pressure in several apartments throughout the building as well as the corridor, all WRT a single outdoor reference pressure. The figure shows unoccupied apartments were more negatively pressurized than occupied apartments. Apartment 4L was unoccupied for the entire monitoring period; Apartment 4M was unoccupied until November 2, 2013, when a resident moved in and occupied the space, as demonstrated by the distinct change in pressure at that time.

Notes:
 Apartment 4L was unoccupied for the entire monitoring time.
 Apartment 4M was unoccupied until November 2, 2013.

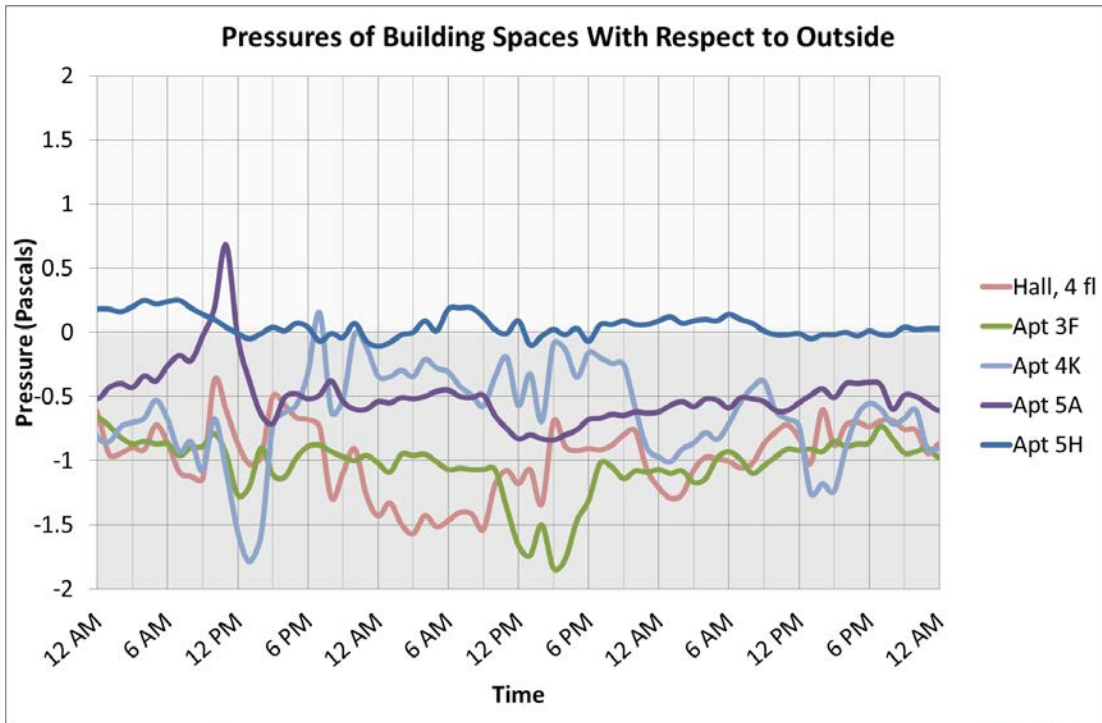
Figure 15. Pressure data monitored in building spaces over a 24-hour period

In this occupied building, the residents and the resident superintendent were unaware of the presence or function of the trickle vents installed in their windows. Several complained of a “stuffy” environment and preferred to open their windows to ventilate the apartments. Figure 15 shows the direct effect of an open window on the pressure in an apartment. Apartment 5H was observed with open windows at each visit, and the resident explained that he preferred more outdoor air than the trickle vent could provide. The pressure in this apartment was essentially neutral WRT the outside and showed free exchange of air with the outside.

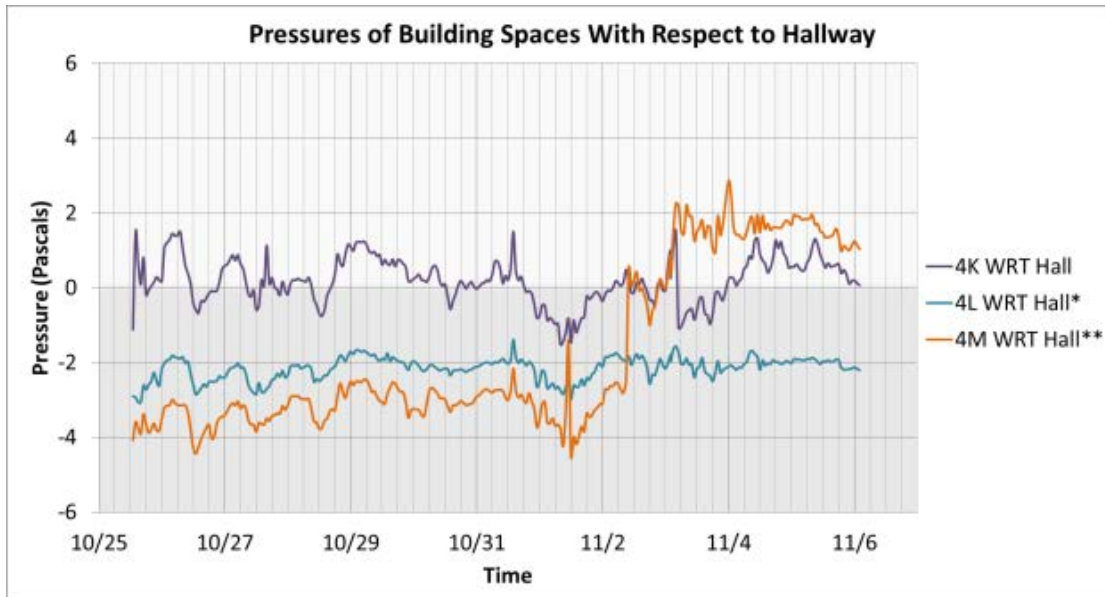
Figure 16. Pressures in apartments WRT hallway

Pressures between apartments and their neighboring hallways were also recorded (Figure 16). Unoccupied apartments appear to be significantly more depressurized relative to the hallway than occupied apartments. This indicates that air predominantly flows into unoccupied apartments from the corridors and concurs with earlier testing that measured the airflow through the corridor door into an unoccupied apartment at 53 CFM–60 CFM. In occupied apartments, open windows obviously dominate the airflow dynamics. In this test building, as well as many others, residents open windows during mild weather.

Notes: Apartment 4L was unoccupied for the entire monitoring time.
Apartment 4M was unoccupied until November 2, 2013.

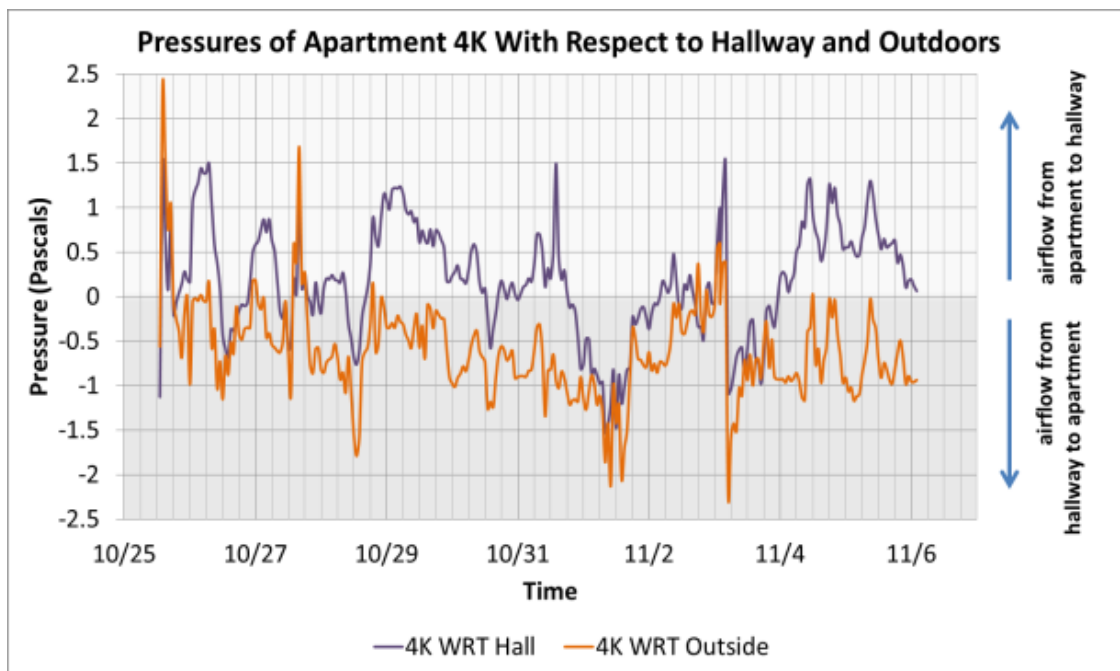
Figure 17. Pressures in Apartment 4K WRT hallway and outdoors

The monitored pressure data from Apartment 4K are quite variable and illustrate the impact of opening windows on the pressure dynamics of the building. Figure 17 shows an observed correlation between the pressure in the apartment WRT the outside and WRT the hallway. When a window is opened in the apartment, pressure WRT the outside approaches zero, and the pressure WRT the hallway increases to positive territory. This change in pressure results in air flowing from the apartment into the corridor for a time, as indicated by the directional arrows. In this building, apartments with their windows open may vent air into the corridor; apartments with their windows closed draw air from the corridor.

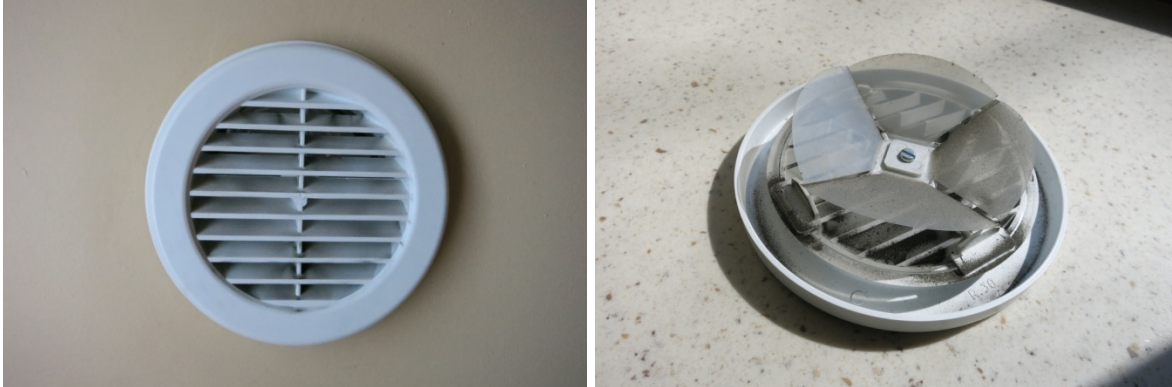
Figure 18. Common airlet (left) and backside of Airlet with flaps (right)

bedroom. Each consists of a 4-in. diameter cylindrical opening that connects the inside of the apartment to the exterior. The cylinder has a filter. The grille that fits over the cylinder has plastic flaps on the back side that are designed to limit the airflow as the pressure increases, similar to a constant air regulator damper. Figure 18 shows an airlet installed and removed.

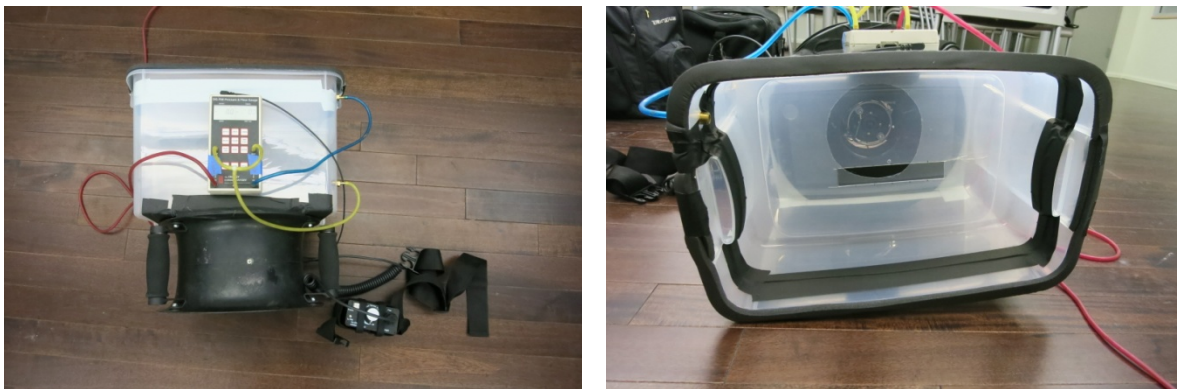
Figure 19. Setup for testing airflow through airlets

In Test Building #2, airlets were tested to characterize their performance as installed. Five airlets were tested by inducing a pressure differential on either side and measuring the airflow. A capture box with a mounted calibrated fan was sealed around each vent. The fan was used to create a pressure on one side. The pressures on the inside and outside aspects of each vent were measured with manometers, and the fan was used to measure the airflow (Figure 19).

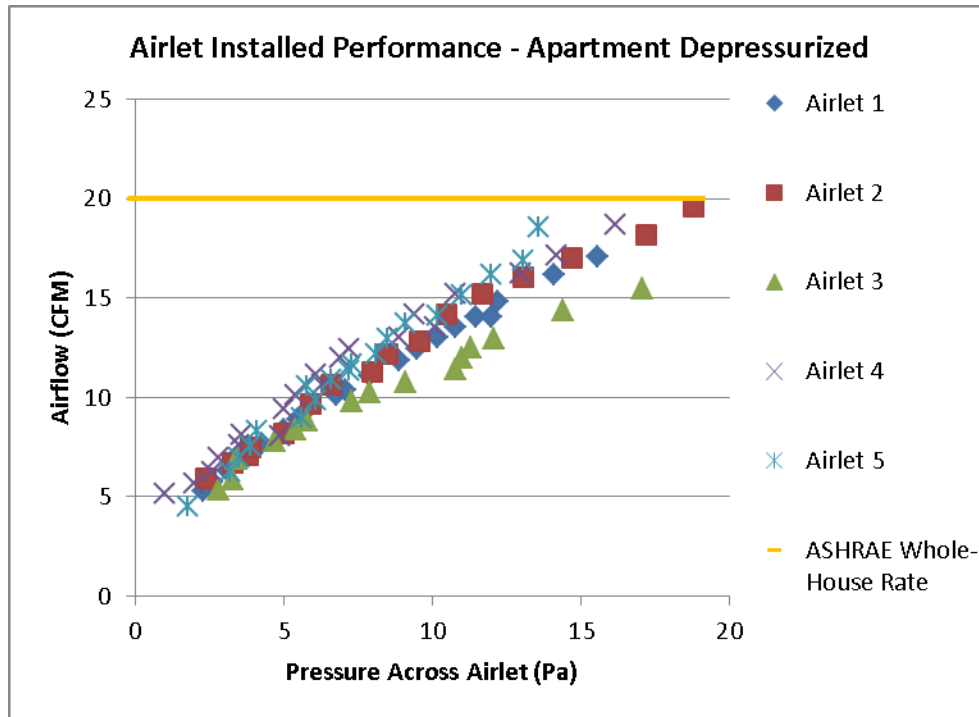
Figure 20. Airlet flow—apartment depressurized WRT outdoors

Five airlets were tested by using this procedure under positive and negative pressures. Because the airlet is a passive device, it provides outdoor air only when the apartment is depressurized WRT the outside. When it is positively pressurized, air flows from the apartment to the outside environment, which is not the intended design operation. Under this condition, the plastic flaps are forced open and may begin to flutter under higher pressures. As a result, the performance is variable under positive pressure. Figure 20 and Figure 21 show the results of the depressurized and pressurized tests, respectively. The orange horizontal line in Figure 20 represents the ASHRAE whole-house ventilation rate for a typical one-bedroom apartment in this test building.

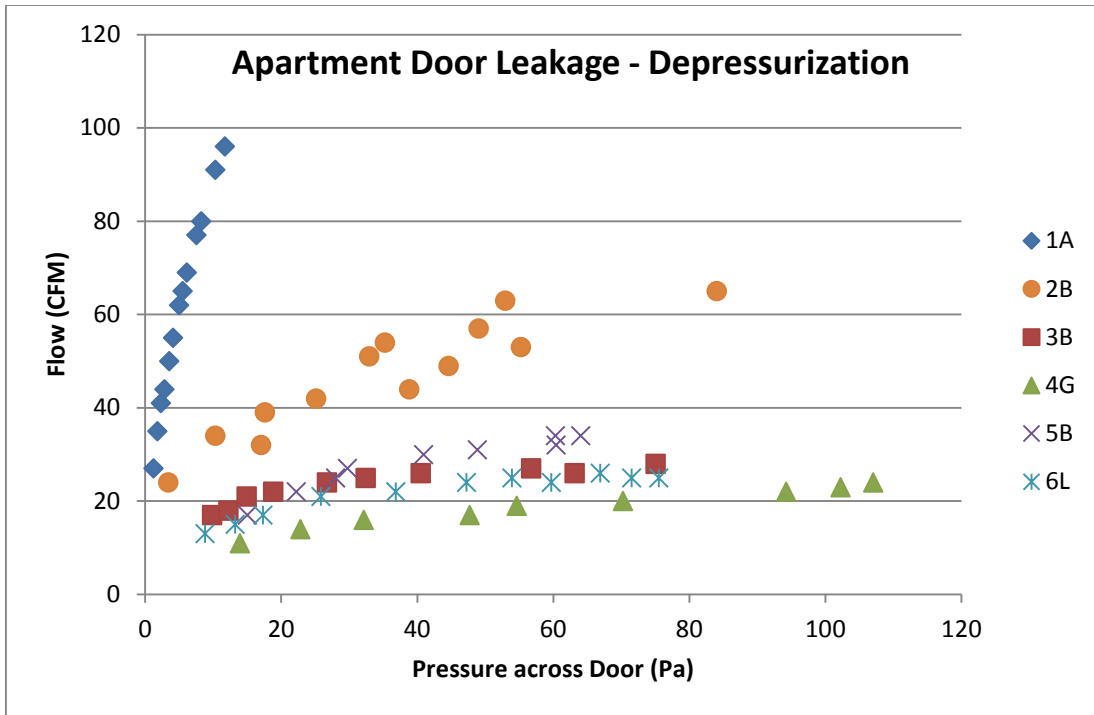
Figure 22. Door air leakage—apartment depressurized WRT corridor

The doors were tested for pressurization and depressurization (Figure 22 and Figure 23). As expected, even at low pressures, door leakage in Apartment 1A was significantly higher due to the missing door sweep. The leakage area for each door was calculated from the data collected. The door leakage area for apartment 1A was 20 in.², because it lacked a sweep. The values for the other four doors were significantly lower, with an average leakage area of 2.5 in.². Except for 1A, these doors had about 90% lower leakage area than Test Building #1.

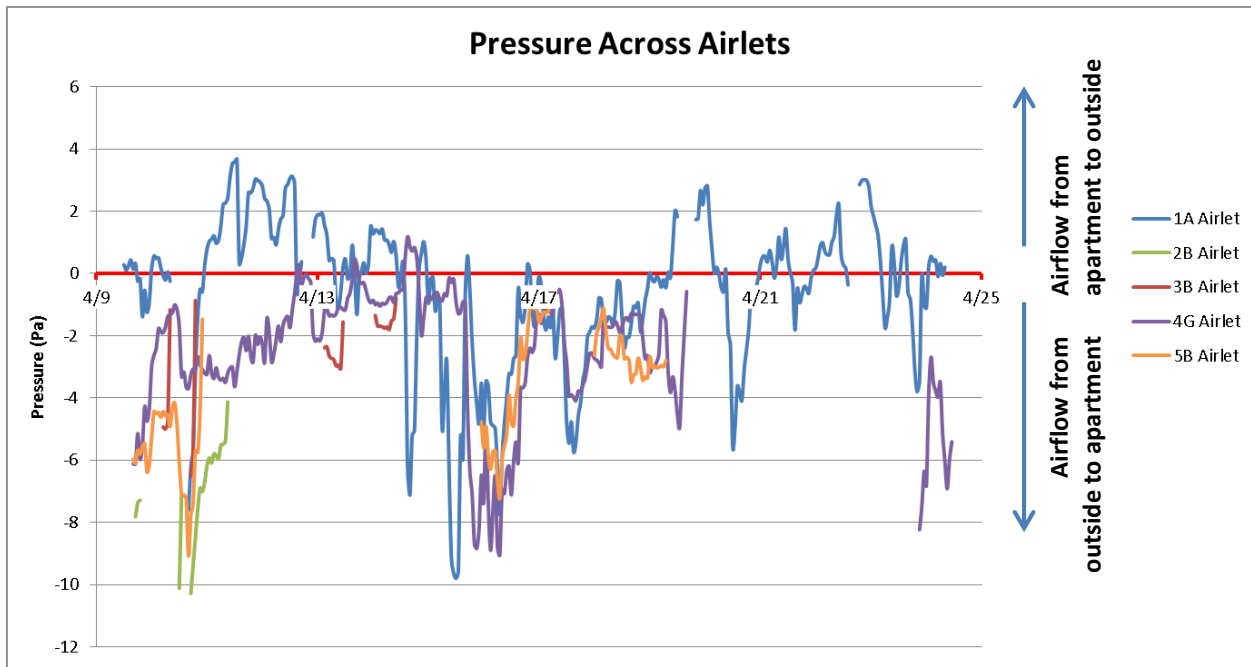
Figure 24. Pressure across airlets (apartment pressure WRT outside) over time

operation of windows impacted the measurements; therefore, only the data about closed windows are plotted. The pressure data logger in apartment 6L malfunctioned; therefore, no data for that apartment were recorded.

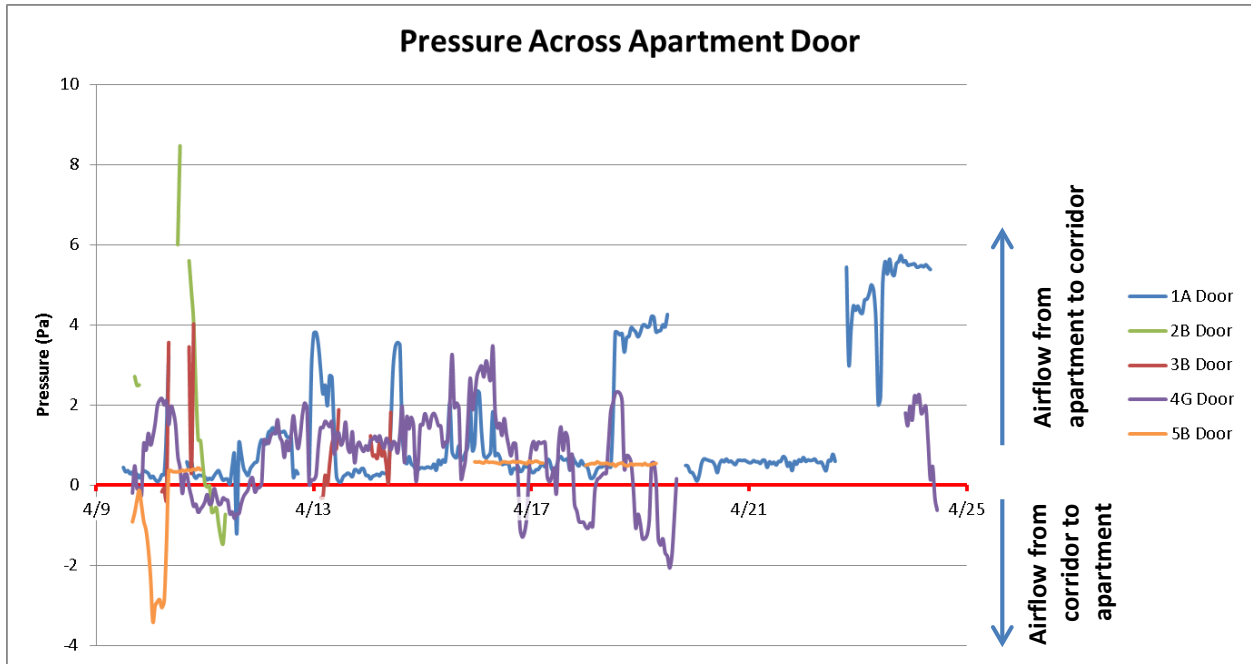
Figure 25. Pressure across door (apartment pressure WRT corridor) over time

The pressure across each apartment door was also monitored and was taken by measuring the pressure of the apartment WRT the corridor. Again, a negative pressure indicated flow into the apartment (Figure 25). In all five samples, the average pressure over the windows-closed periods was positive and resulted in flow from apartments into the corridor. This was contrary to expectations and to CARB’s measurements in other buildings. Investigation revealed that the rooftop unit that supplied the corridors with 1,300 CFM per floor was not operating and was likely also not operating during the monitoring period. The slight negative pressure in the corridors could possibly be attributed to the elevators, refuse room exhaust, or open windows in that space, which were not monitored.

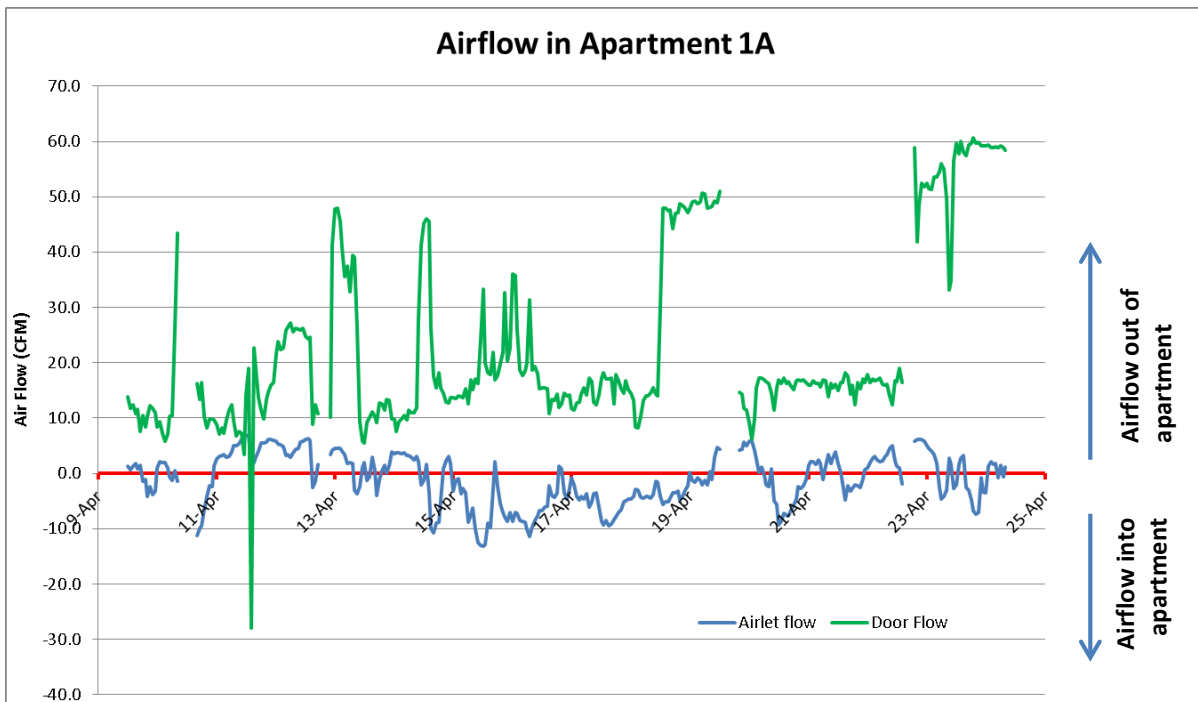
Figure 26. Airflow through airlet and door in Apartment 1A over time

The equations developed in Sections 3.2.3 and 3.2.4 were applied to the monitored pressure data to calculate airflow through airlets and doors. The results for Apartments 1A and 4G are plotted in Figure 26 and Figure 27. The remaining three apartments are not shown because they generated few window-closed data.

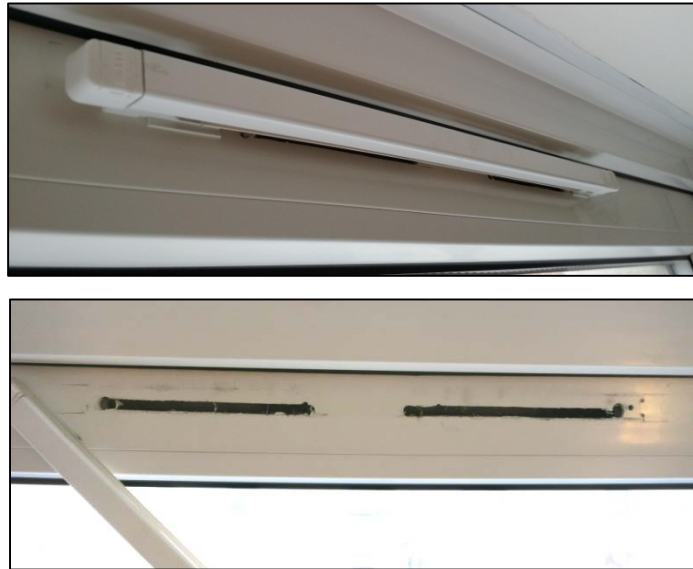
Figure 28. Typical trickle vent in open position (top) and with cover removed (bottom)

frames to provide outdoor air. Each apartment has one trickle vent in the living room and one in each bedroom. Figure 26 shows one such vent in the open position.

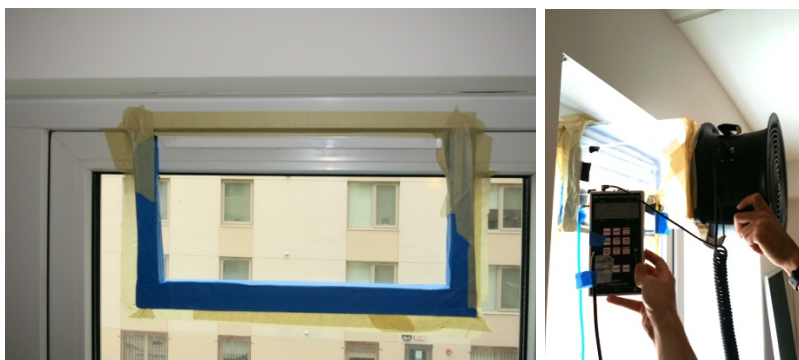
Figure 29. Setup for testing airflow through trickle vents

Five trickle vents were tested to characterize their installed performance. The procedure from Test Building #1 was modified to facilitate the testing process. A Duct Blaster fan from The Energy Conservatory was attached to a capture hood to create a test chamber that puts the trickle vent under negative pressure. An orifice plate accessory from The Energy Conservatory was used to measure flows from 2.4 CFM and higher. Induced pressures during the testing ranged from about 10 Pa to almost 60 Pa.

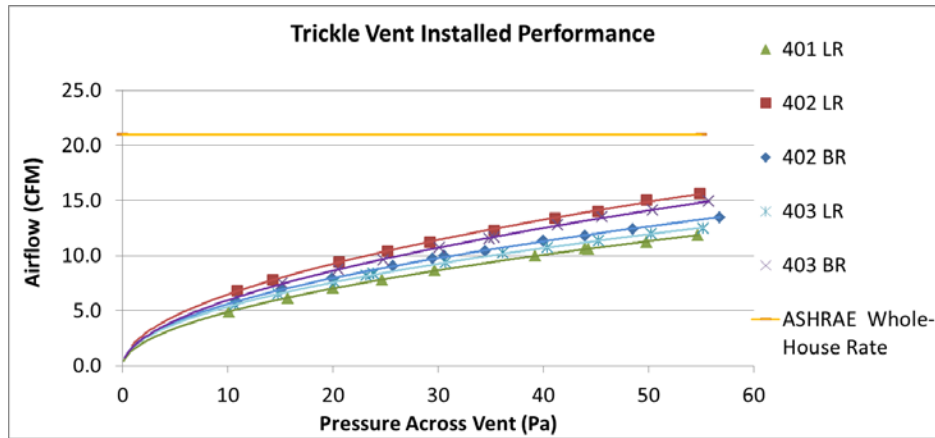
Figure 30. Building #3 trickle vent performance with trend lines added

The data show that the trickle vents deliver 3–5 CFM at 5 Pa. This is slightly lower than the vent performance in the other test buildings at the same pressure. Figure 28 shows the results from the tests of the five trickle vents. The orange horizontal line represents the ASHRAE whole-house ventilation rate for a typical one-bedroom apartment in this test building.

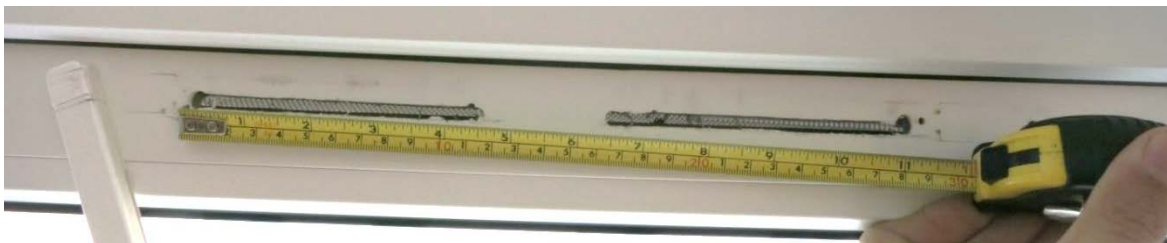
Figure 31. Holes cut in window frame for trickle vent

As described in Test Building #1, trickle vents were installed in windows by cutting holes through layers of the window frames. Figure 29 shows two such holes cut on the interior surface of a frame. Another set of holes is cut on the exterior side. The trickle vent assembly, which consists of an interior operable vent and an exterior hood and insect screen, were attached to the frame over these holes. The holes were presumably cut with a router or other rotary tool. See irregular edges, trimmings, and starter holes in Figure 31.

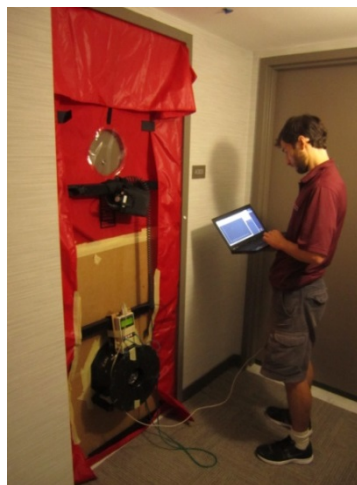
Figure 32. Setup for testing airflow around door with a blower door shroud and Duct Blaster fan

As with the other test buildings, the exhaust airflow and airflow into the apartments were measured through the passive vents, measurements of the unintended makeup air from around the apartment entry door were needed. The flow around the apartment door was tested and measured in nine apartments. The test setup was different from Building #1 and Building #2, because a faster setup was sought. A blower door frame was set up just outside the closed apartment door on the other side of the threshold. The setup pressurized the space between the blower door shroud and the apartment door. The pressure across the door was measured, along with the airflow through The Energy Conservatory Duct Blaster (Figure 32), which was used as a pressurization fan. The Energy Conservatory TECLOG software recorded pressures and airflows from the fan.

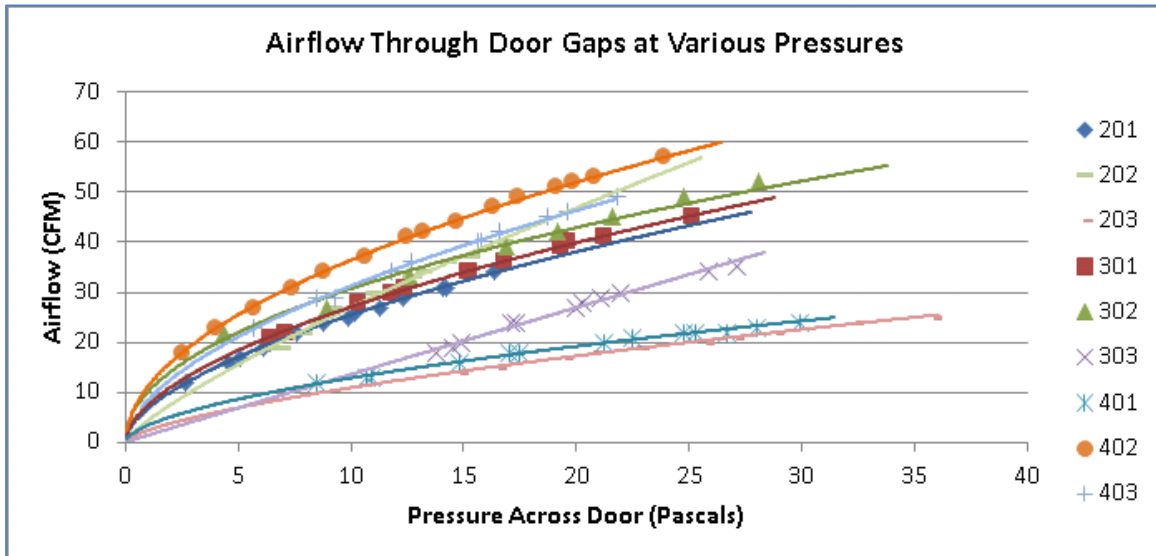
Figure 33. Building #3 door air leakage

area was 4.8 in.². This is much smaller than the door leakage areas from Test Building #1, but almost double the average door leakage area as Test Building #2.

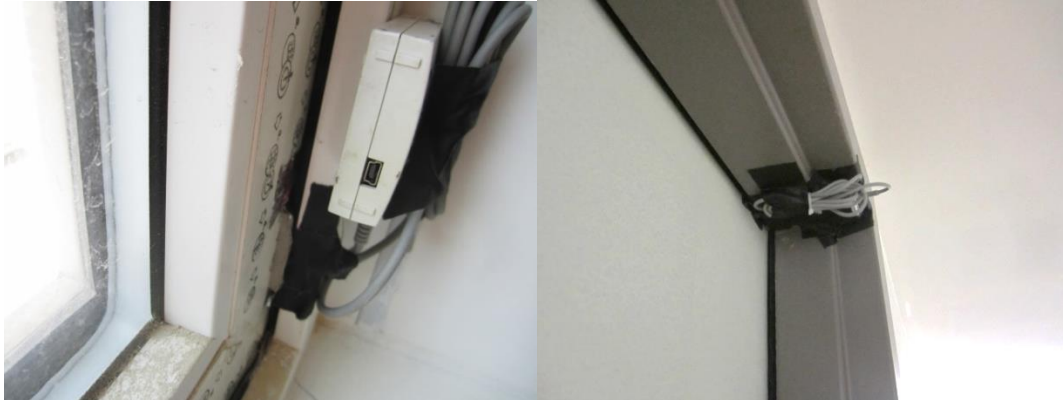
Figure 34. Contact closure data loggers to monitor window opening (left); door opening (right)

and closings and window operation were placed to confirm that apartments were operating under the intended conditions.

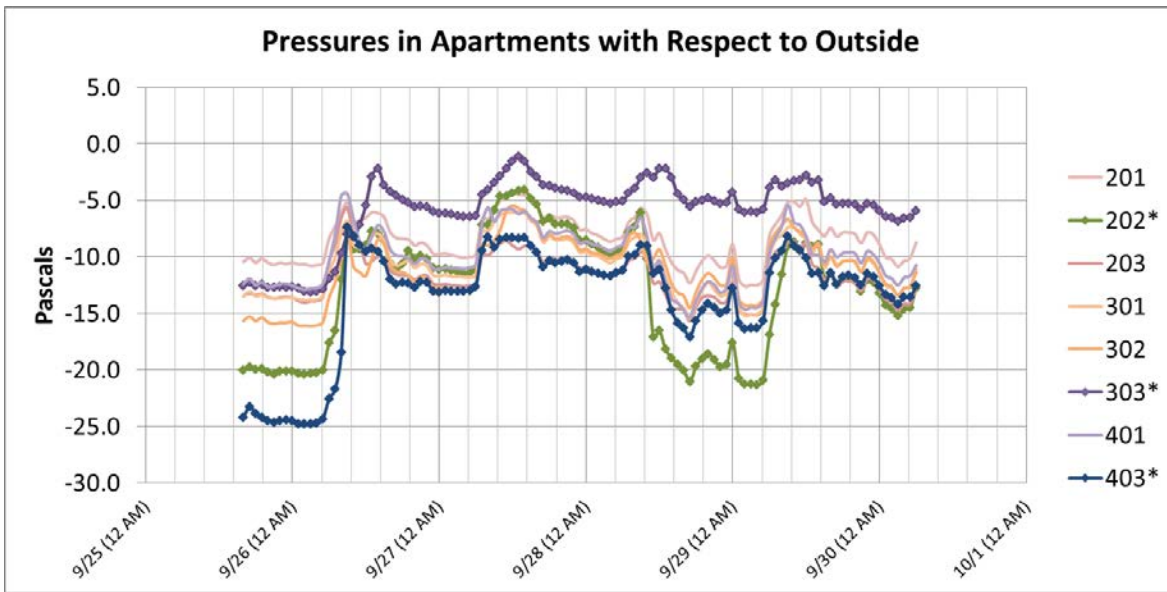
Figure 36. Pressures in apartments WRT outside over 4 days

Figure 36 shows more than 4 days’ worth of measurements. Two of the four apartments that had enhanced sealing (Apartments 202 and 403) maintained a lower negative pressure. This indicated the exhaust fans were able to generate a greater suction on the tighter envelope. Though Apartment 303 also had enhanced air sealing, it lacked a sweep on the door to the corridor, so large amounts of air were allowed to enter through the door undercut. The blower door frame was placed in the entry door during compartmentalization testing, so this leakage is not reflected in the airtightness test results for this apartment (Figure 35). The sweep was installed later in the construction process, after the monitoring period. Not shown in Figure 36 is apartment 402, which had a malfunctioning data logger.
