Evaluation of Passive Vents in New Construction Multifamily Buildings

Consortium for Advanced Residential Buildings

February 2016

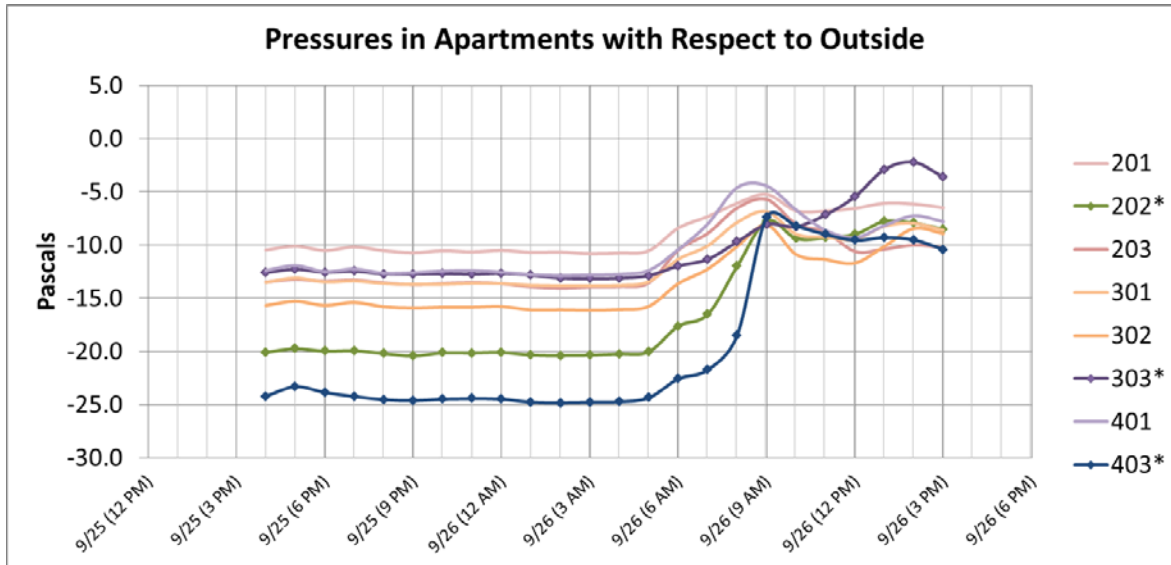
Figure 37. Pressures in apartments WRT outside over 24 hours

Figure 37 shows a 24-hour time scale of the same apartments. The data loggers were launched at 4 p.m. on September 25, 2014, logging every minute. The values shown in the chart are hourly averages. Clearly the two highly sealed apartments that also had weather-stripping and door sweeps (Apartments 202 and 403) were able to maintain a significantly lower pressure, -20 to -25 Pa. The highly sealed apartment that did not have a door sweep (Apartment 303) did not have a significantly lower pressure than apartments that were not highly sealed, which range from -10 to -16 Pa. The apartments all maintained a relatively steady pressure profile for the overnight period. Between 5 a.m. and 6 a.m., pressures began to shift. By 9 a.m., the pressure profiles were significantly different.

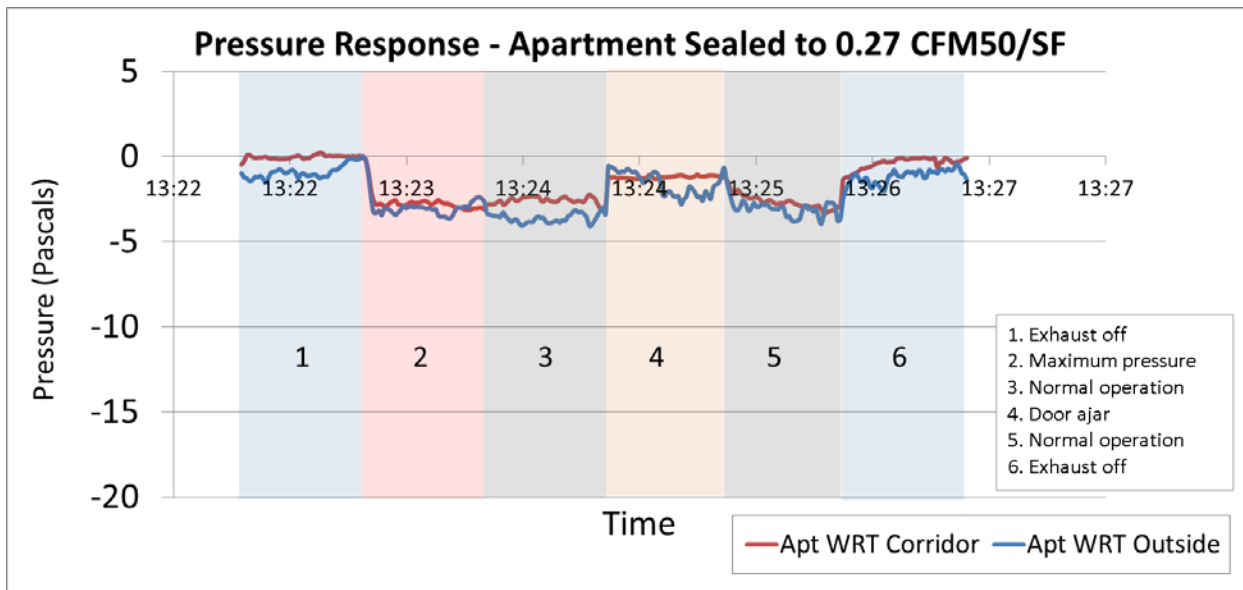
Figure 38. Pressure response in standard apartment, #401 (0.27 CFM50/ft²)

Condition	1	2	3	4	5	6
	Exhaust off	Maximum pressure	Normal operation	Door ajar	Normal operation	Exhaust off
Exhaust fan	off	on	on	on	on	off
Trickle vents	closed	closed	open	open	open	closed
Apartment Door	closed	closed	closed	open	closed	closed
Approximate pressure WRT outside	-1	-3	-3.5	-1.5	-3.1	-1
Approximate pressure WRT corridor	0	-3	-2.5	-1.2	-2.6	0

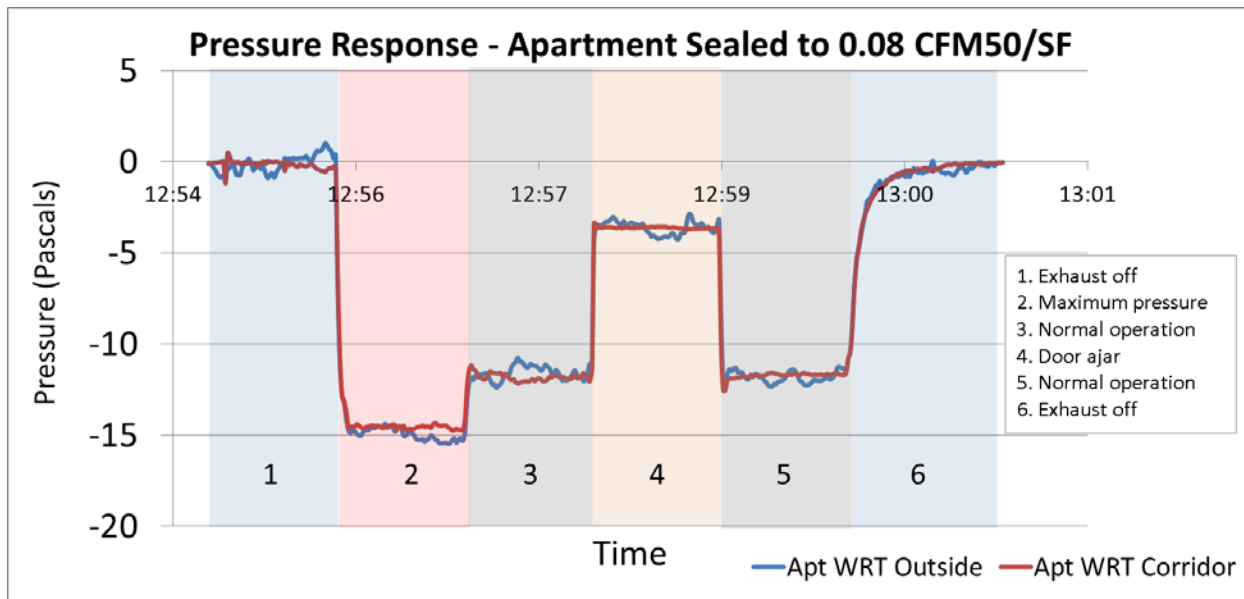
Figure 39. Pressure response in highly-sealed apartment, #402 (0.08 CFM50/ft²)

Condition	1	2	3	4	5	6
	Exhaust off	Maximum pressure	Normal operation	Door ajar	Normal operation	Exhaust off
Exhaust fan	off	on	on	on	on	off
Trickle vents	closed	closed	open	open	open	closed
Apartment Door	closed	closed	closed	open	closed	closed
Approximate pressure WRT outside	0	-15	-12	-3	-12	0
Approximate pressure WRT corridor	0	-15	-12	-3	-12	0
